Table 21
Whitefish Point Harbor Breakwaters
Whitefish Point, Michigan

Date(s)	Construction and Rehabilitation History
1968	Construction of a 507-ft-long south breakwater and a 587-ft-long north breakwater was completed at the site (Figure 56). The south breakwater consisted of a 323-ft-long steel sheet-pile cantilever wall and a 184-ft-long sand-filled cellular steel sheet-pile structure (Figure 56). The cells were 25.5 ft in diameter and were capped with reinforced concrete. Riprap was placed on each side of the cells, The entire breakwater was constructed to a +8 ft lwd el. The north breakwater was constructed with sand-filled cellular steel sheet-pile structures that were also capped with reinforced concrete. The shoreward cells were 25.5 ft in diameter, while the lakeward cells had a diameter of 30.2 ft (Figures 56 and 57). Riprap was placed on each side of the structure, and the crest el was +8 ft lwd.
1969	A 270-ft-long interior breakwater was constructed (Figure 56) for wave absorption. This structure consisted of steel sheetpiling installed at an el of +8 ft lwd and riprap installed at 0.0 ft lwd on each side of the structure (Figure 57). The weight of the riprap ranged fr

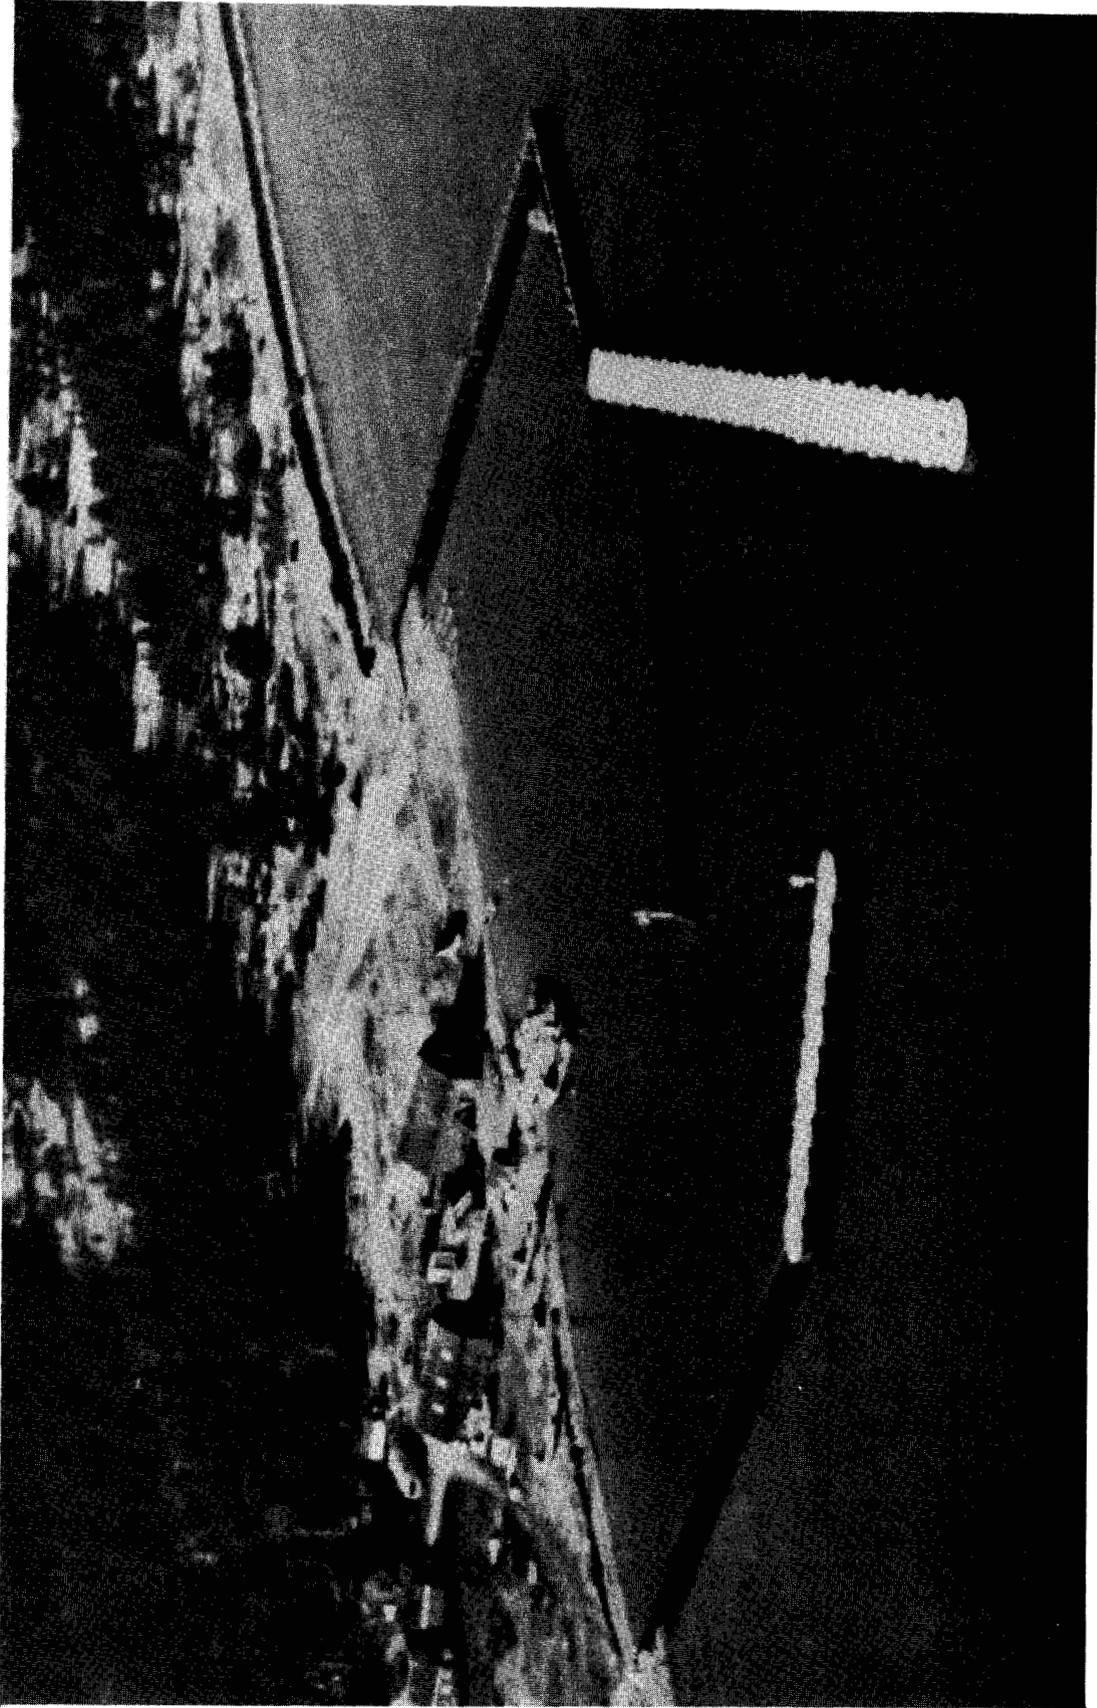
Figure 58. Aerial view of Whitefish Point Harbor Michigan

1986	The breakwaters appear to be functioning well and presently are in good condition. An aerial view of Whitefish Point Harbor breakwaters is shown in Figure 58.

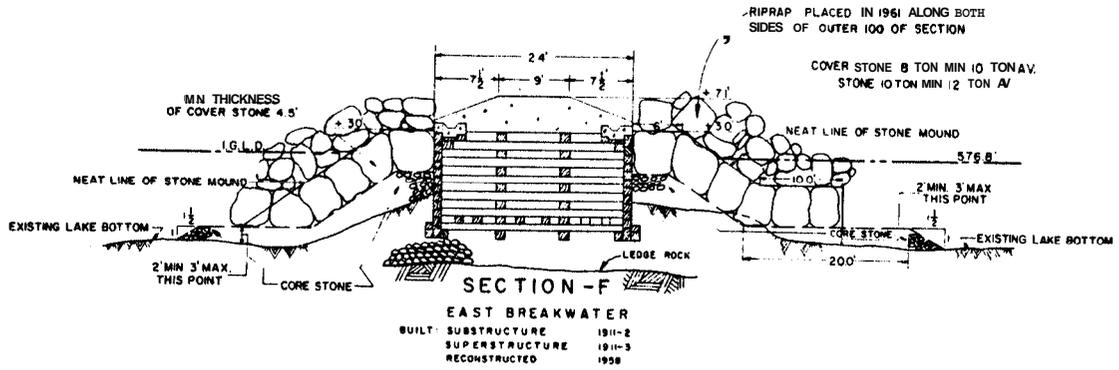
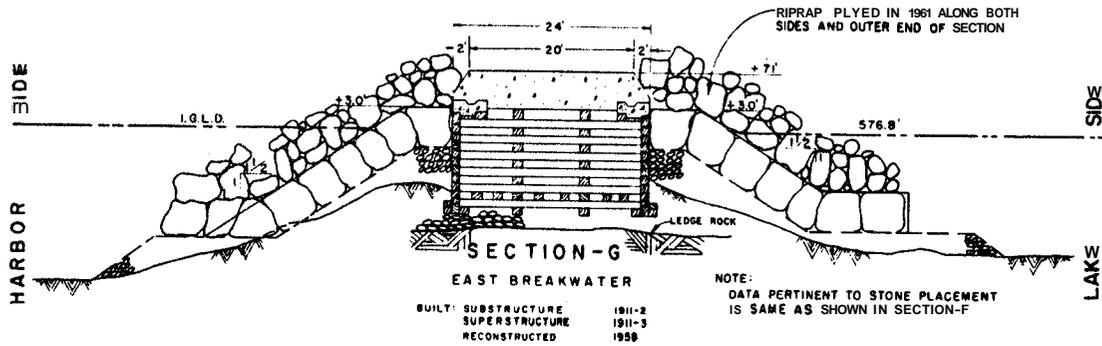
Figure 61. Typical structure cross sections, Manistique Harbor, Michigan

1981	An inspection of the breakwaters revealed that the east breakwater had some areas where the concrete cap was in an advanced state of deterioration, and the stone fill had washed away. The west breakwater required some stone fill also and new concrete in some areas. Breakwater repairs were made subsequent to the inspection.
1986	The structures have been reconstructed and repaired during their history and presently are in fair condition.

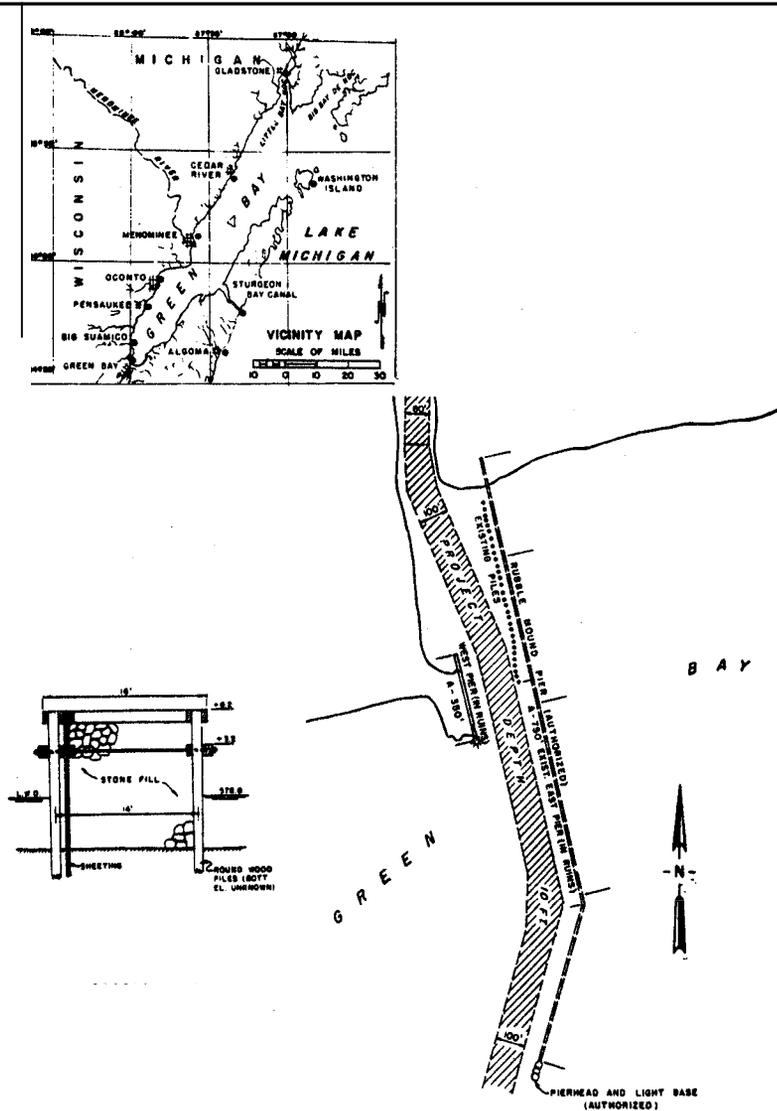
Figure 62. Cedar River Harbor, Michigan

Date(s)	Construction and Rehabilitation History
1883-1885	A 750-ft-long west pier and a 350-ft-long east pier were constructed during this period at the mouth of Cedar River (Figure 62). These structures were built with wood piles spaced 14 ft apart (width) and filled with stone (Figure 62). The original crest el was +8.2 ft lwd. A timber cap provided a 16-ft-wide crest width.
1965	Construction of a new west pier and a 2,100-ft-long rubble-mound east pier with a cellular sheet-pile pierhead (Figure 62) was authorized. Construction, however, has not yet occurred.
1986	The existing piers are in ruins.

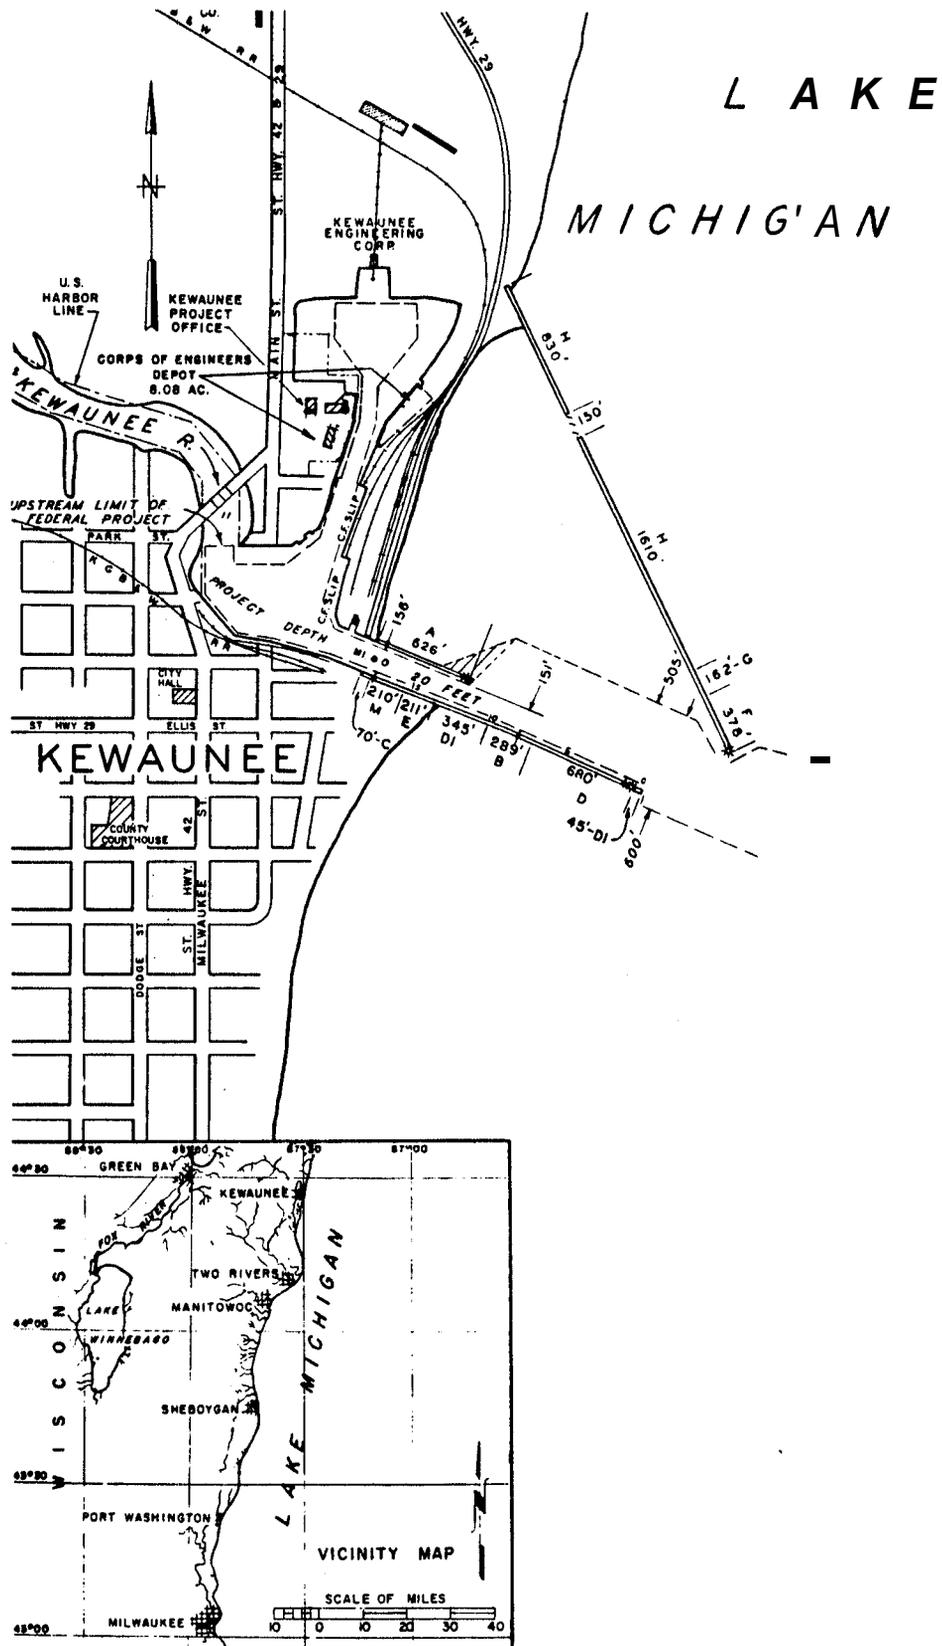
Figure 71. Kewaunee Harbor, Wisconsin

1983	A site inspection revealed that the structures were generally in good condition. Minor concrete repairs and the placement of additional riprap were recommended for the north breakwater. The work has subsequently been completed. It was noted also that settlement of the north pier on the channel side had occurred.
1986	During their lifetime the structures have undergone reconstruction and normal maintenance repairs. Presently they are considered in good condition.

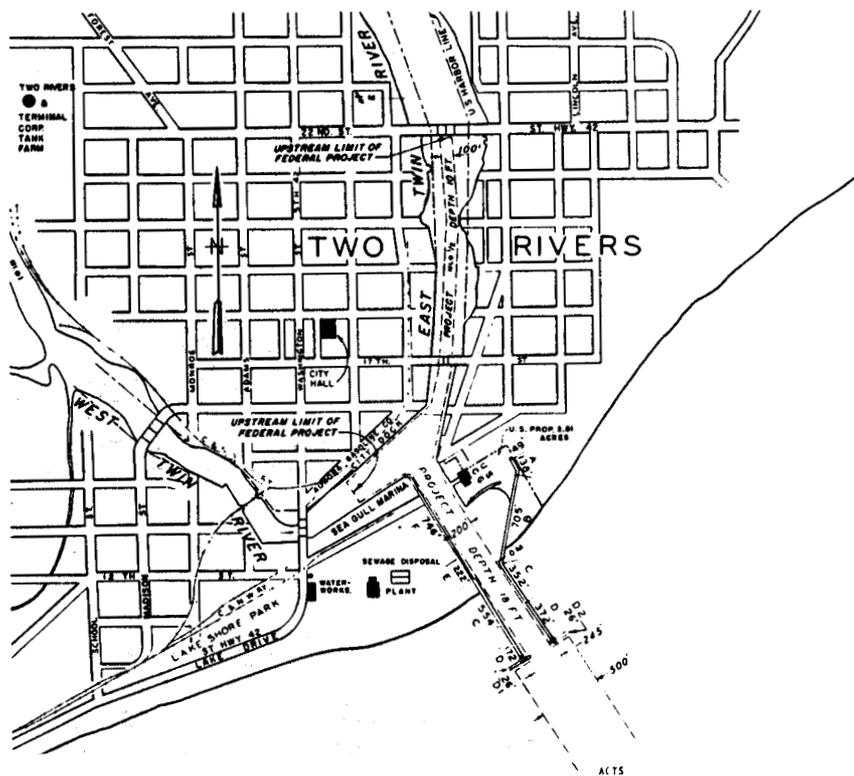
Figure 73. Two Rivers Harbor, Wisconsin

Date(s)	Construction and Rehabilitation History
1984	A site inspection revealed the north pier to be in very good condition and the south pier to be in fair to poor condition. The south pier had sheeting boards that were deteriorated and loose in some areas and not effectively retaining fill material,
1986	The overall condition of the structures is presently considered fair.

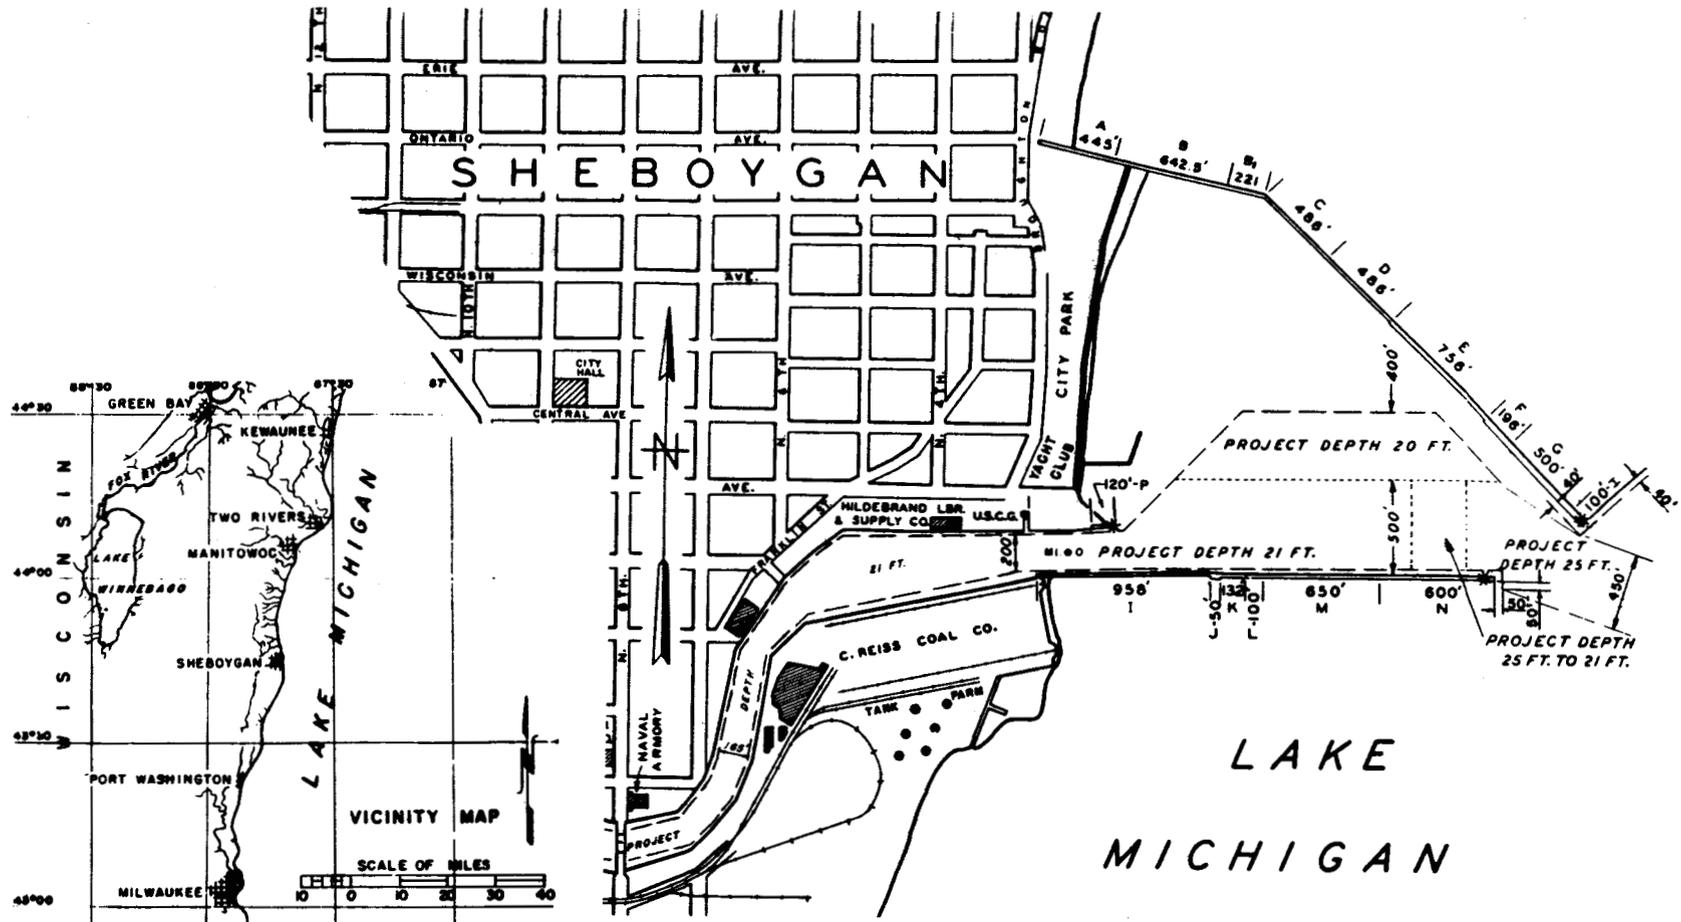
Figure 77. Sheboygan Harbor, Wisconsin

1984	A site inspection of the south pier indicated the channel side of the structure was in good condition. Fill rock was needed, however, in some areas, and the concrete cap was leaning toward the channel in one area.
1986	The structures presently are considered to be in good condition overall.

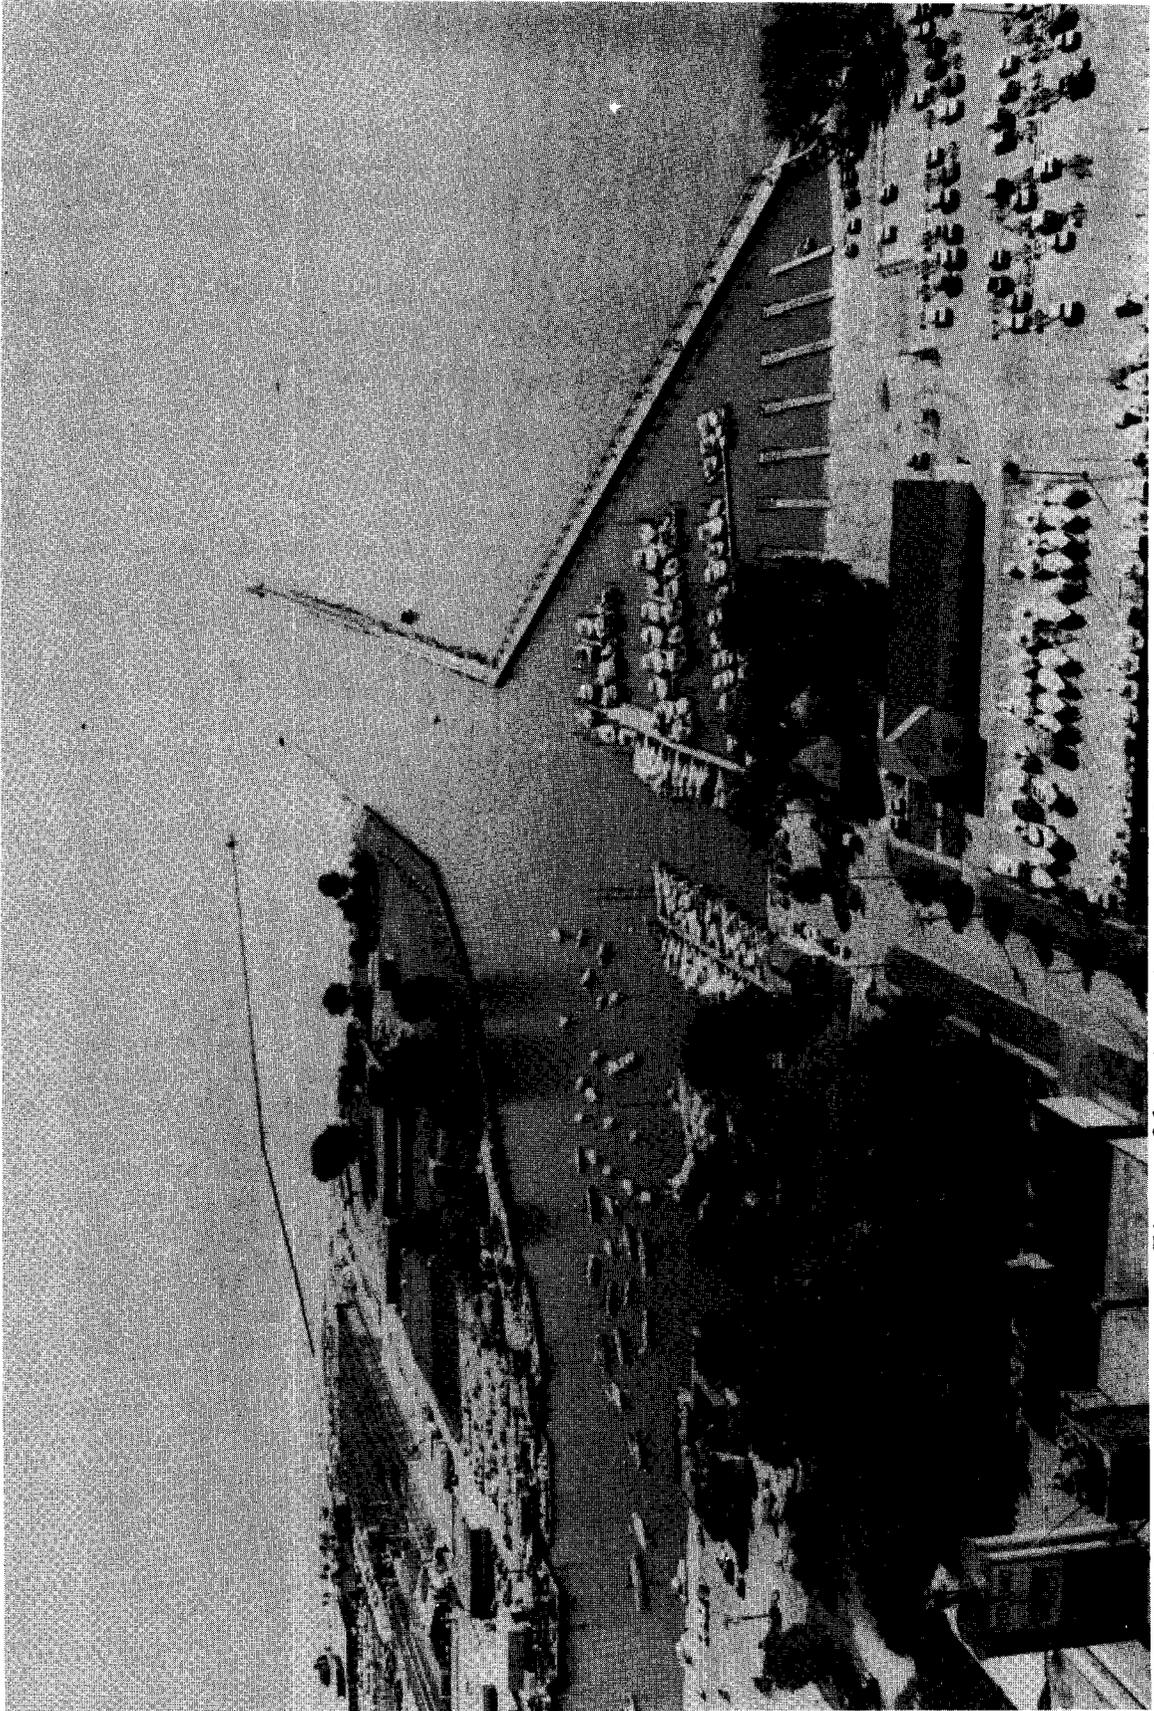
Figure 96. Aerial view of Waukegan Harbor, Illinois

1981	A superstructure condition survey indicated that the structures were in good condition.
1986	The structures have undergone rehabilitation and maintenance during their lifetime; however, they are presently considered to be in good condition. An aerial photograph of the harbor structures is shown in Figure 96.

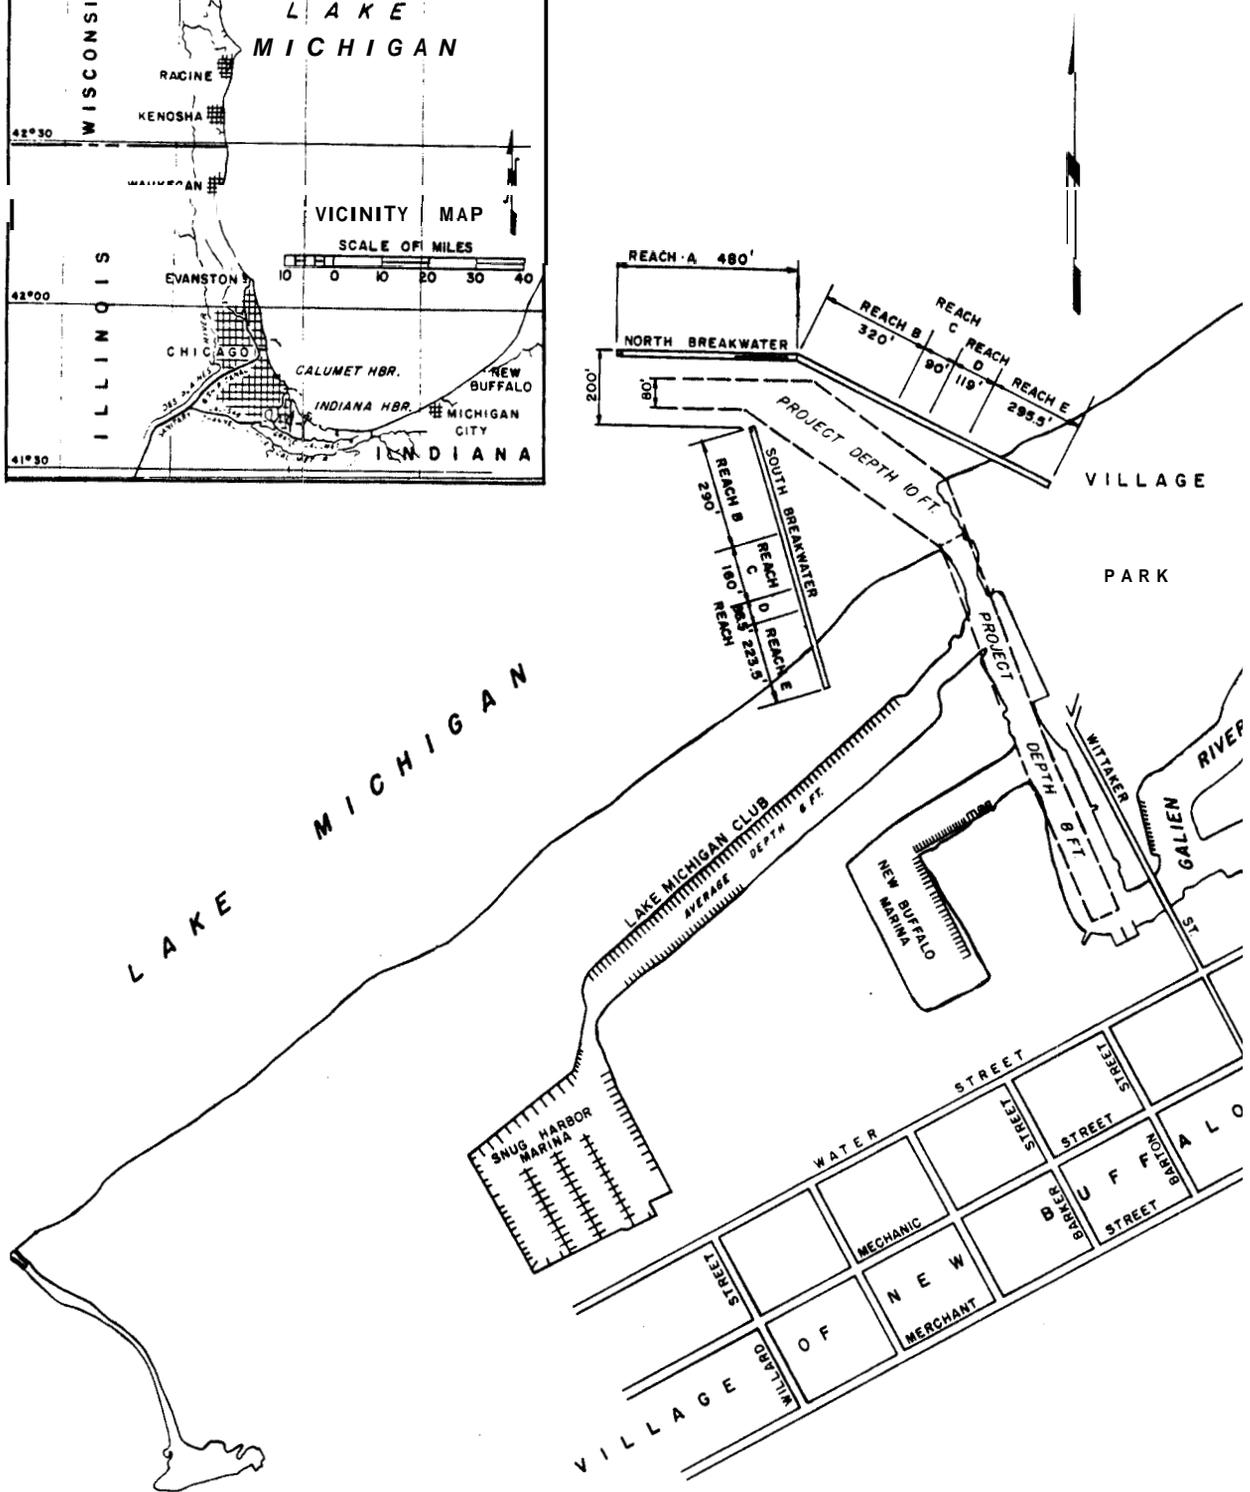
Figure 108. New Buffalo Harbor, Michigan

1980	<p>An inspection of the structures at the site indicated that voids existed in the outer reach (Reach A) of the north breakwater and minor Settlement had occurred, particularly around the head of the structure adjacent to the navigation lights. The remaining portion of the rubble-mound north breakwater also consisted of many voids with some stones deteriorating (cracking or crumbling into smaller pieces). The outer portion of the south breakwater (Reaches B and C), although in better condition than the north structure, also had experienced some settlement and contained some gaps where waves washing through the structure was noted. The inner portion of the breakwaters was in good condition.</p>
1983	<p>Stone was placed in the voids of the outer portions of each breakwater (Reaches A and B, north breakwater, and Reach B, south breakwater, Figure 108). A site inspection in the latter part of the year revealed that some of the smaller stone (used to fit the voids) had washed out. Voids in the trunk sections of the breakwater (Reaches C and D, north structure, and Reach C, south structure) still existed along with settlement of 1 to 2 ft in some areas.</p>

1986	<p>The structures are presently considered in fair condition. Maintenance repairs of the breakwater have been recommended but not yet implemented.</p>

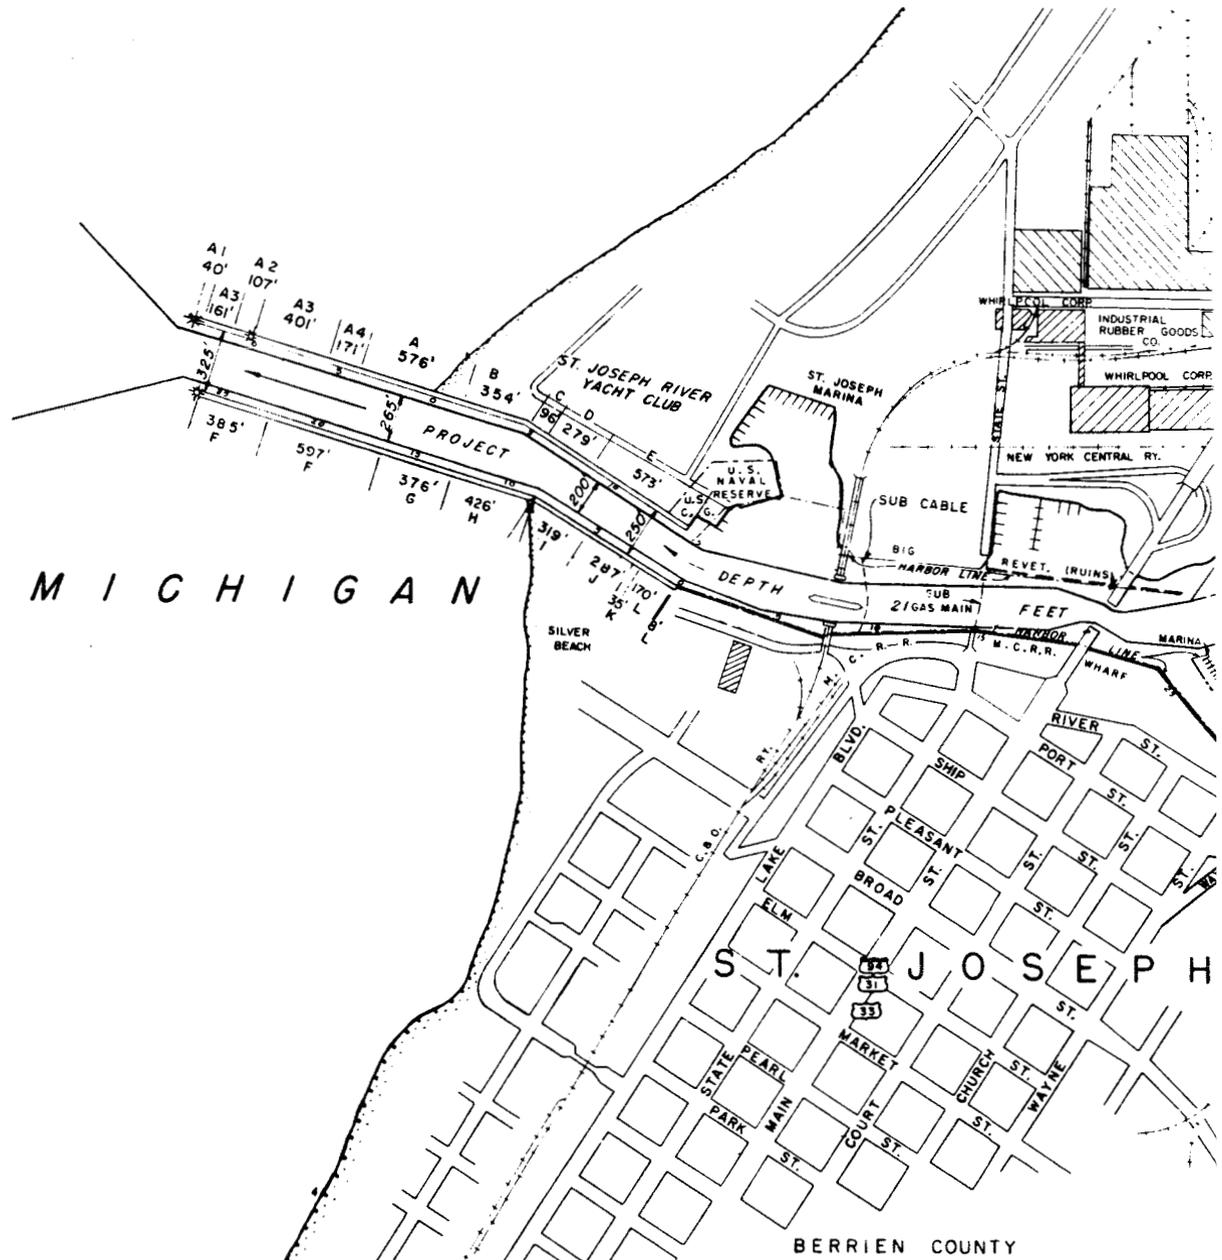
Figure 110. Saint Joseph Harbor, Michigan

1982	Stone fill in portions of the north pier (Figure 110, Sections A1, A, and B) was replenished, and new concrete caps were installed in these areas.
1985	An inspection of the structures revealed that fill stone was 3 to 6 ft low in areas of the north pier and that cracking of the superstructure was prevalent in places. It was also noted that fill stone in the south pier was settling which was also causing cracking of the concrete superstructure. Maintenance repair of the structures has been recommended but not yet performed. The piers are considered to be in fair condition.
