TECHNICAL REPORT REMR-CO-3

CASE HISTORIES OF CORPS BREAKWATER
AND JETTY STRUCTURES

Report 4

PACIFIC OCEAN DIVISION

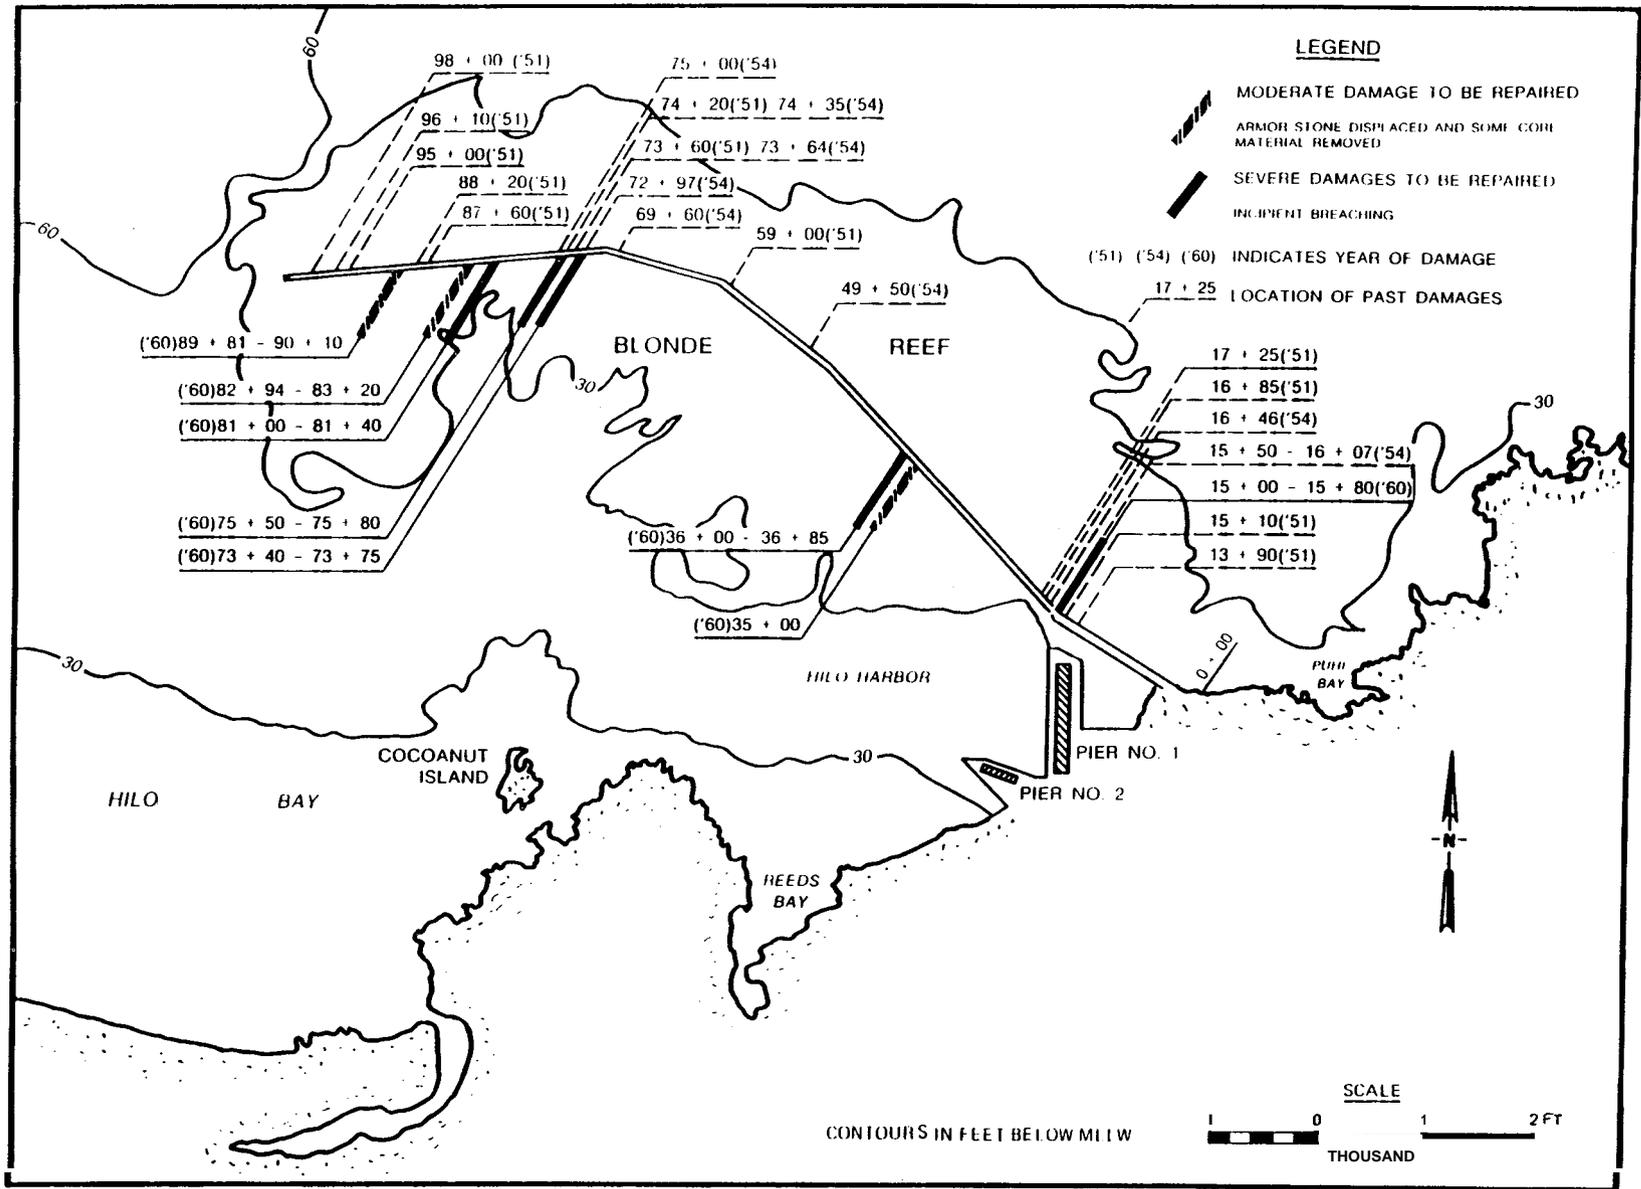
Figure 4. Hilo Breakwater damage summary, 1951-1960

1960	The tsunami of 1960 caused breakwater damage (Figure 4), but it was not as severe as that sustained by the 1946 tsunami. Less severe damage was attributed to the direction of wave attack. The 1960 approach was less direct than that of 1946; therefore, wave energy reaching the structure was less than what had occurred in 1946. Between 1946 and 1960 average annual maintenance costs were \$25,000. It was thought that the 1946-1948 repair work did not key the replacement armor into the existing structure, thus resulting in weaker cross sections in these repair areas.
1965	Storm waves of February 1965 caused additional damage at sta 15+00, 36+30, 73+40, 83+00, and 90+00.
1967	Between the 1960 and the 1967 tsunami, no repair work was done due to the possibility of total rebuilding of the breakwater as one leg of a proposed tsunami barrier for Hilo Harbor. The average annual cost of structure maintenance had been \$43,900 for the first 37 years of the project.

Date(s)	Construction and Rehabilitation History
1968	Repair work was completed in August. A total of 11 areas was repaired. Due to the severity of wave overtopping and the recurrence of damage in many areas, the armor stone weight used for repair of the crown was increased from a minimum of 8 tons to a minimum of 10 tons. The remainder of the repair work followed the original cross section design. The total cost of repair was approximately \$124,500.
1971- 1973	An inspection on 7 April 1971 revealed deterioration of the structure at various points along the entire length, but it was thought that immediate repair of 1,700 ft at the shoreward end of the structure was needed to protect the berthing area. Emergency repair work was completed in 1973 at a cost of \$184,000. The original cross section design was used for repair.
1975	Major repair of the breakwater was completed. Both new and reset 8- and 10-ton minimum weight armor stones were used to repair various areas along the entire length of the structure. The structure slopes and crown elevation were unchanged from the original design cross section. The total cost of the work was approximately \$591,000.

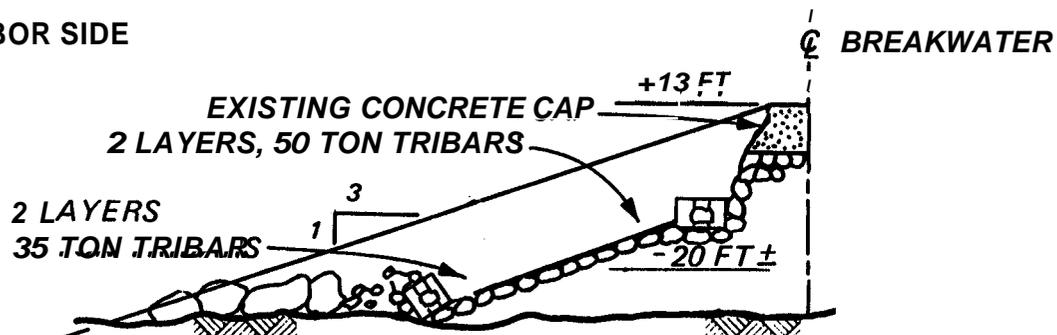
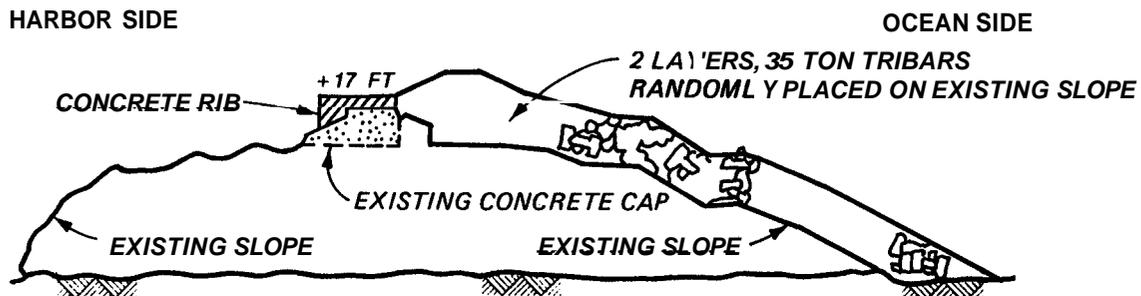
Figure 9. Kahului breakwater repair, 1966

1965	During 2-3 February, 1 month after awarding the tribar-placing contract, a storm with hindcasted deepwater wave heights of 27 ft and period of 17 sec caused damage to the heads of both breakwaters.
1966	Major rehabilitation (Figures 5 and 9(a,b)) consisted of repair of both breakwater heads and the first 355 ft shoreward of the east breakwater head. On the inboard quadrants of the breakwater heads, <u>two layers of 35-ton tribars</u> were placed over the <u>lower third of the side slope</u> , and <u>two layers of 50-ton tribars</u> were placed over the <u>upper two-thirds</u> . Two layers of 35-ton tribars were placed on the sea-side slope of the east breakwater head and buttressed against the concrete rib cap constructed on the crest; 827 and 181 35-ton reinforced tribars were placed on the east and west breakwaters, respectively; and 43 and 173 50-ton reinforced tribars were placed on the east and west breakwaters, respectively. Except for the concrete rib cap, all repair work was model tested (Jackson 1964). The total cost of repair work was \$1,560,000.

a. Tribar repairs to inboard quadrant of head sections

b. Repair of sea-side slope of east breakwater head

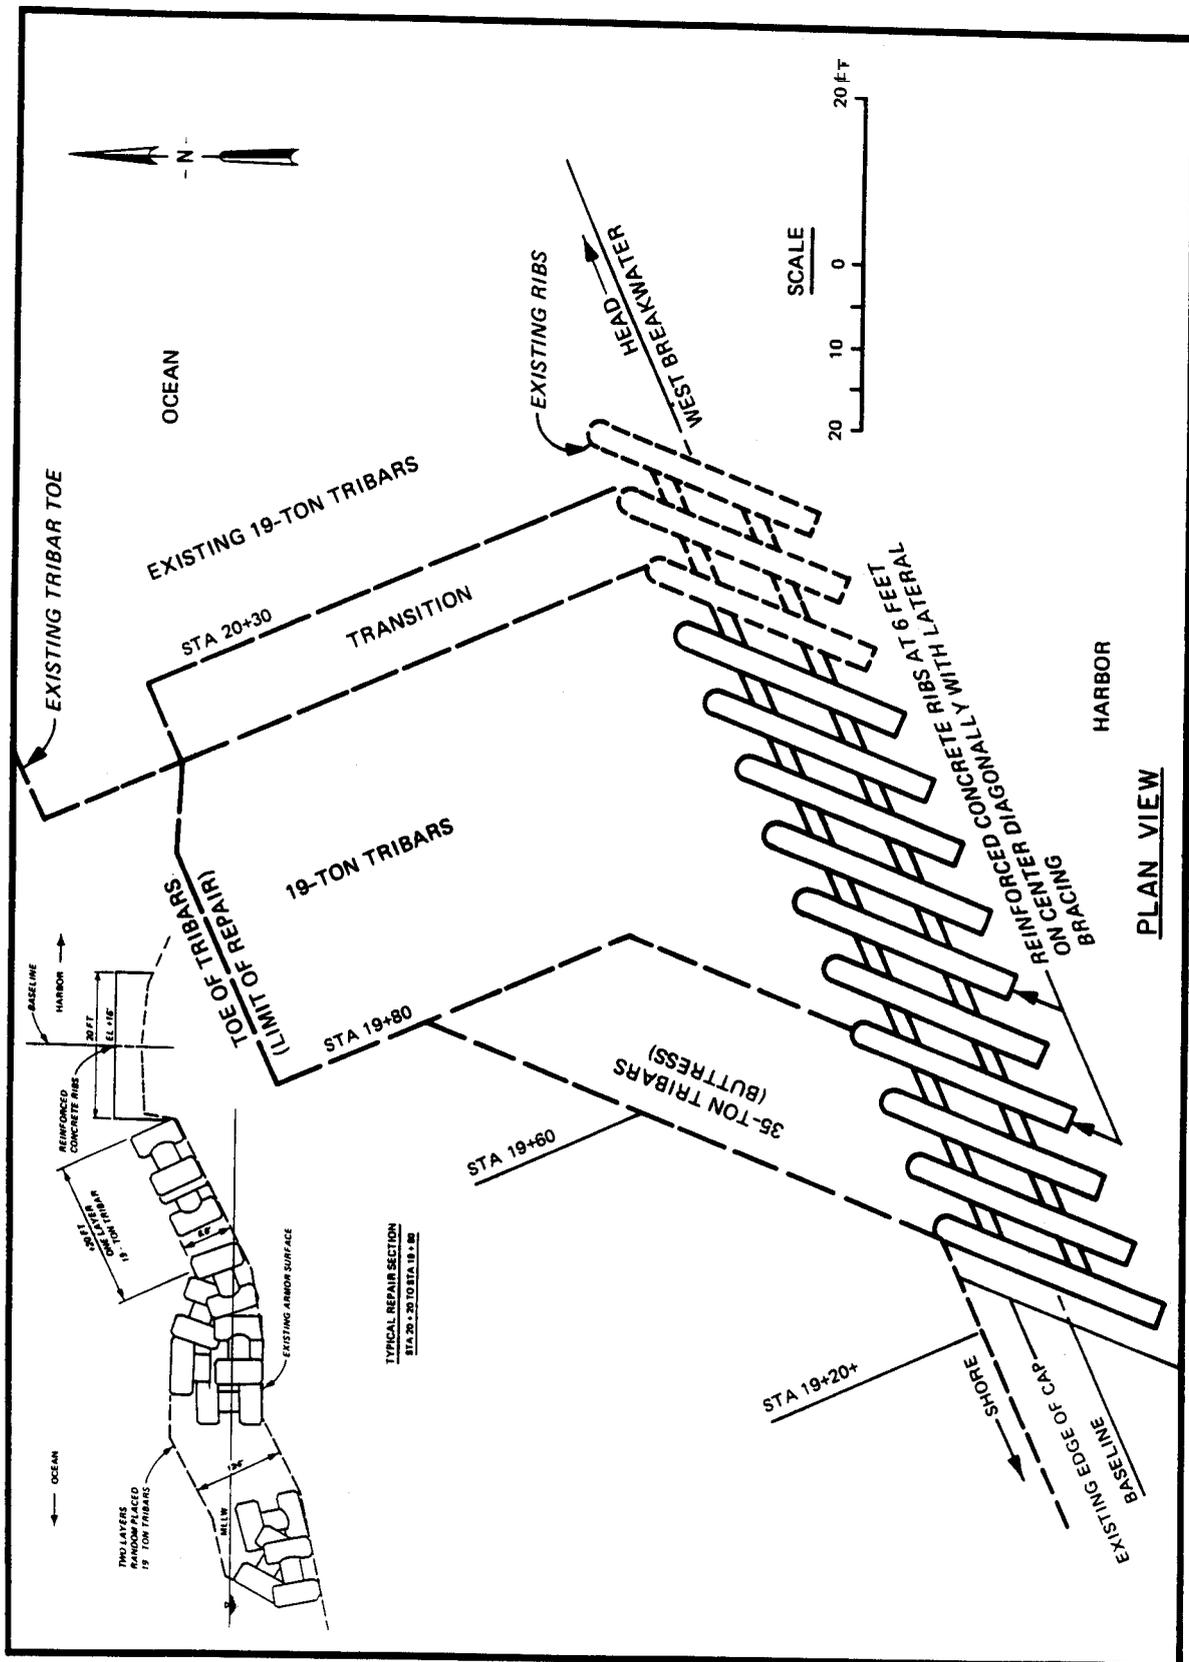
Figure 10. Kahului west breakwater repairs of 1973

1977	<p>A 1973 breakwater inspection indicated considerable damage and settlement of the 33-ton tetrapods on the seaward quadrants of both breakwater heads. In addition, the 8-ton armor stone along both trunks was failing and required repair. In 1977 the following repairs were completed (Figure5): on the west breakwater, <u>257 30-ton reinforced dolosse were placed in two layers over the 33-ton tetrapods on the sea-side quadrant of the head; 291 20-ton reinforced dolosse were placed on the sea-side slope of the west breakwater trunk; on the east breakwater 61U 30-ton reinforced dolosse were placed in two layers over the 33-ton tetrapods on the sea-side quadrant of the head; 164 20-ton reinforced dolosse were placed in a double layer on the sea-side slope, of the trunk beginning at the shoreward end of the 35-ton tribars; and, beginning at the point where the 20-ton dolos ended and extending shoreward, two layers of 6-ton unreinforced dolosse (455units) were placed on the sea-side slope of the east breakwater trunk.</u> The total cost was \$3,290,000.</p>

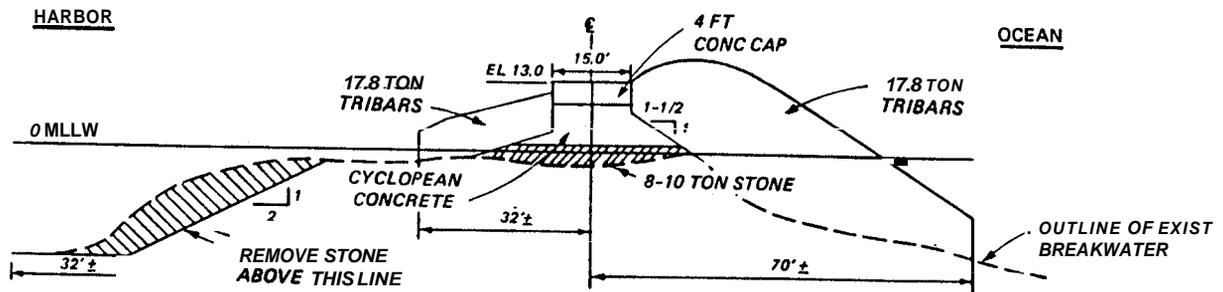
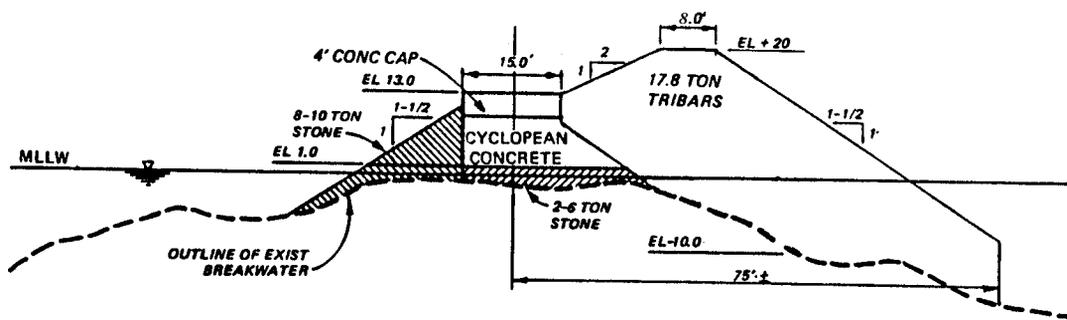
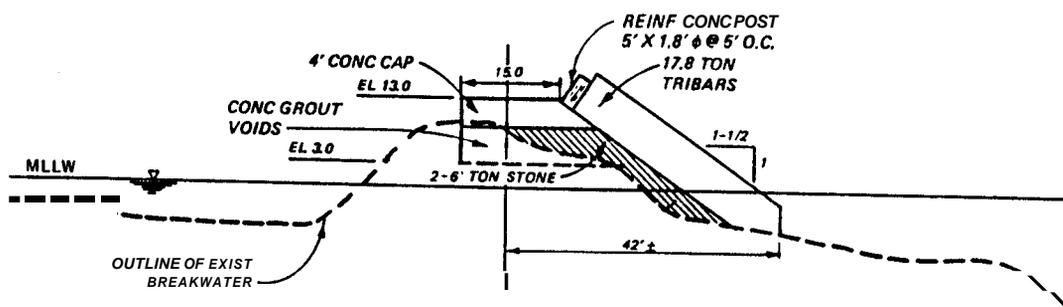
Figure 16. Typical cross sections for 1959 repair of Nawiliwili breakwater

<u>Date(s)</u>	<u>Construction and Rehabilitation History</u>
1926	The original Corps-constructed (Figure 15) 2,150-ft-long rubble-mound breakwater was completed (construction started in 1922). It consisted of one-layer 8-ton keyed and fitted armor stone over core stone (500 lb and less) with 1-V:1-H slopes and a 15-ft-wide crown at +11.0 ft mllw. Except for severe wave action, it was considered to be a satisfactory empirical design cross section.
1927-1953	Minor repair work was done at various times during this period. In 1931 114 stones were reset, and 3,153 tons of stone and concrete blocks were placed (no details available) at a cost of \$46,040. In 1930, 1932-37, 1945, 1951, and 1952, 1,998 tons of stone were used in repair work at a total cost of \$78,285. Details of the repair work were not found.
1954-1957	The breakwater was severely damaged as the result of a storm in 1954 (hindcasted depth-limited breaking wave height of 24 ft at structure) which destroyed the head, washed 100 ft of core stone shoreward, and settled capstone to an elevation of a few feet below mllw with little lateral movement. Storm waves displaced armor stone and exposed and removed core material between sta 17+50 and sta 20+45 in 1956. Observed wave heights of 16 ft at the breakwater in September 1957 caused additional armor stones and core displacement between sta 16+00 and 20+45 and displacement of a few armor stone and core exposure between sta 14+00 and sta 16+00. Hydrographic and topographic surveys of January 1958 revealed that Hurricane Nina (depth-limited breaking waves at structure on 1 and 2 December 1957) displaced a few armor stones and exposed core material on the sea-side slope between sta 14+00 and sta 15+00. It also caused settling and raveling of all armor stone on the crown and sea-side slope between sta 15+00 and sta 20+20, resulting in an exposed core and large voids between armor stones and all armor stone and core above mllw (sta 19+25 to sta 19+50 and sta 20+20 to sta 20+45) which was displaced shoreward.

1958-1959	The head was rebuilt 100 ft landward of the original head (new head at sta 20+45), and 500 ft of the adjacent trunk were repaired (Figure 16) at a cost of approximately \$1,000,000 (model tested by Jackson, Hudson, and Housley 1960). Additionally, <u>17.8-ton tri-bars were randomly placed in two layers on the sea-side slope of the head and uniformly placed in one layer on the sea-side slope</u>

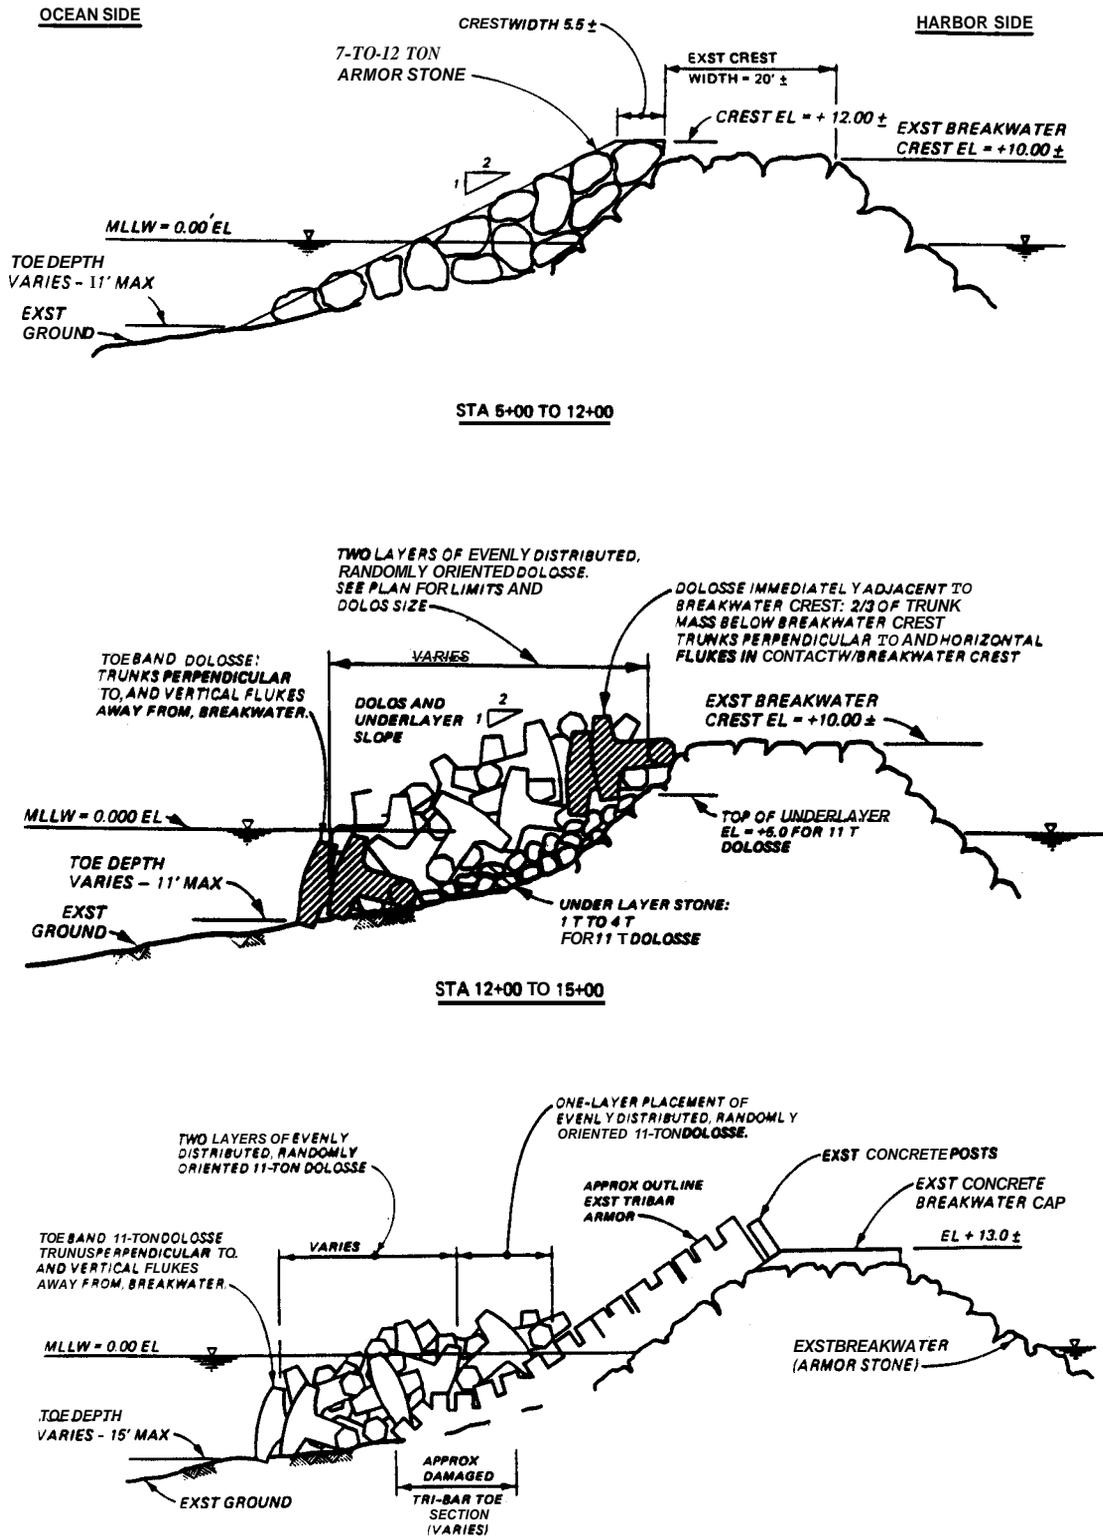
Figure 17. Typical cross sections for 1977 repair of Nawiliwili breakwater

1968- 1976	After the storm of 16 June 1976, a field inspection and subsequent underwater inspection revealed <u>98 tribars broken in the one-layer tribar area</u> , 43 above water and 55 below water. Damage was thought to be due possibly to <u>slippage of the tribar toe</u> . Model tests of the tribar rehabilitation had recommended the use of large buttressing stone, and there is no evidence of their existence on the tribar toe.
1977	The existing one-layer tribars and a 300-ft section of the sea-side slope shoreward of this area were repaired (model tested by Davidson 1978). <u>Two layers of 11-ton unreinforced dolosse (485 units) were placed from the toe to approximately +5.0 ft mllw over the one-layer tribar area.</u> Two layers of the same size unit (449 units) were placed from the toe to the crown on the sea-side slope of the trunk for a distance 300 ft shoreward of the tribar area. The design condition for the dolosse overlaying the tribar was a 12-sec, 19.4-ft breaking wave in an 18.5-ft water depth. On the other hand, the design condition for the dolosse overlaying the old existing armor stone was a 16-sec, 8.9-ft breaking wave in a 10-ft water depth. Portions of the sea-side slope shoreward of this area (approximately 300 ft) were repaired with one layer of 7- to 12-ton stone. This armor stone repair was not model tested. The total cost of repairs was approximately \$2,000,000. Typical cross sections of the repair areas are shown in Figure 17.

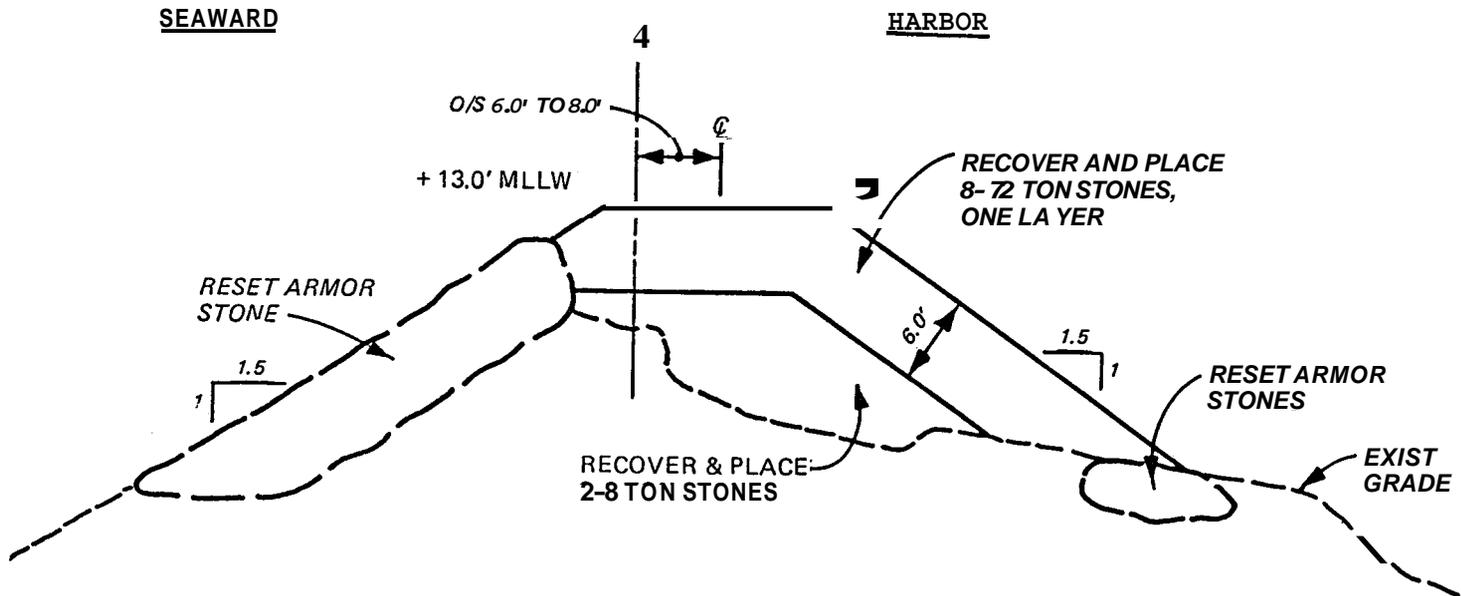
Figure 22. Typical cross section showing 1984 repair of Port Allen breakwater head

<u>Date(s)</u>	<u>Construction and Rehabilitation History</u>
1935	The 1,200-ft-long structure was completed as an extension to a privately constructed breakwater (Figure 21).
1982	Until damaged by Hurricane Iwa of November 23, the old 8-ton keyed-and-fitted armor stone structure had no repair history. The breakwater light at the seaward end had been damaged and repaired several times (Coast Guard cost) prior to its present destruction. The estimated 20-ft breaking waves at the structure first dislodged the stones on the inboard crest which eventually resulted in the total destruction of the outer 130 ft of the breakwater. Overtopping waves also displaced crest stone and exposed under-layer stone on a 150-ft length at the extreme root of the structure. Minor damage also was sustained along the inboard slope.
1984	The head was rebuilt, and the minor damage on the inboard slope was repaired at a cost of \$178,000. The breakwater was shortened to a total length of 1,126 ft. The outer 74 ft was abandoned. The repair was accomplished by resetting stone remaining on the structure and by retrieving stone from the harbor and replacing it on the structure using the old keyed-and-fitted construction (Figure 22). The crown elevation on the last 80 ft of structure was increased to +13.0-ft mllw. This was done to improve the stability of the inboard slope by decreasing wave overtopping. The root of the breakwater was not repaired.
