TECHNICAL REPORT REMR-CO-3

**CASE HISTORIES OF CORPS BREAKWATER
AND JETTY STRUCTURES**

Report 9

SOUTHWESTERN DIVISION

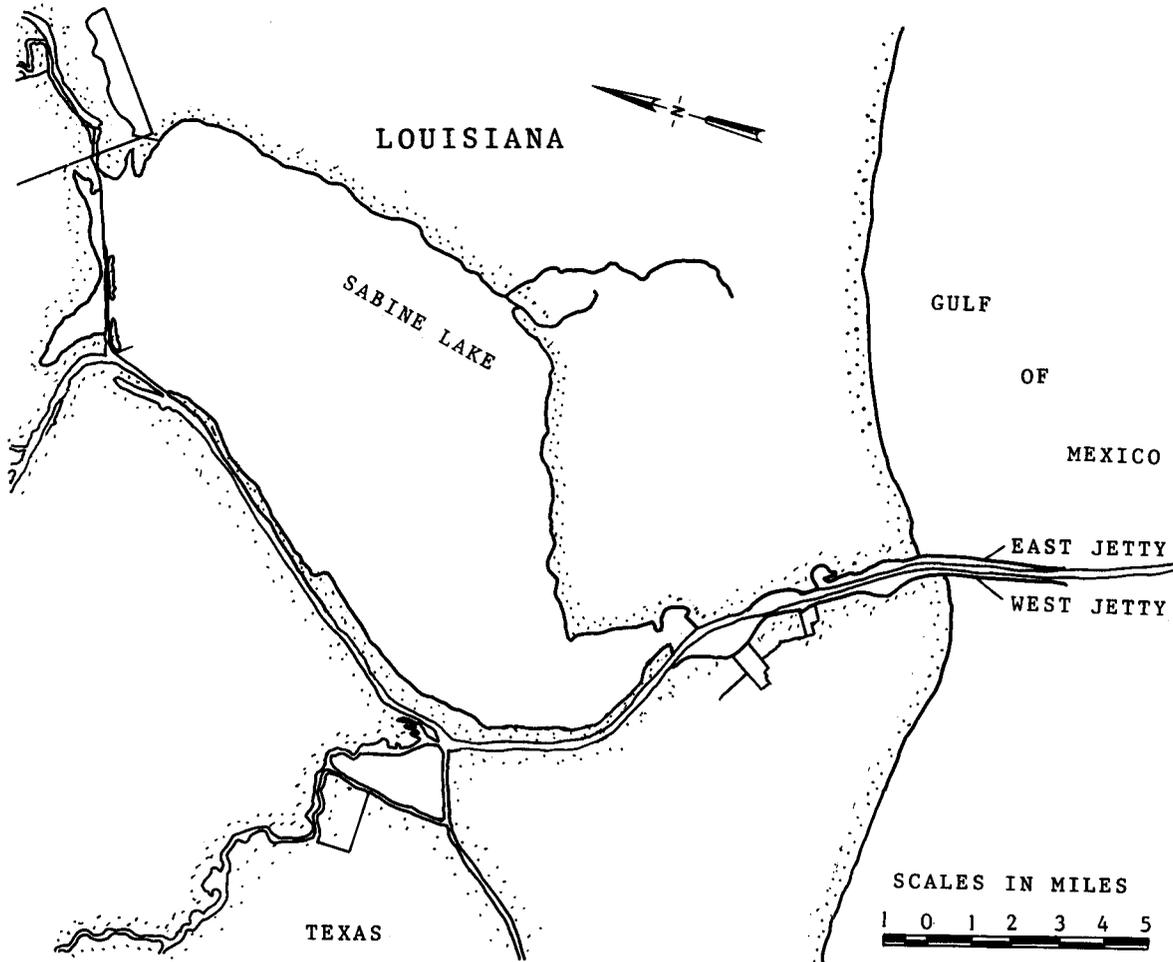
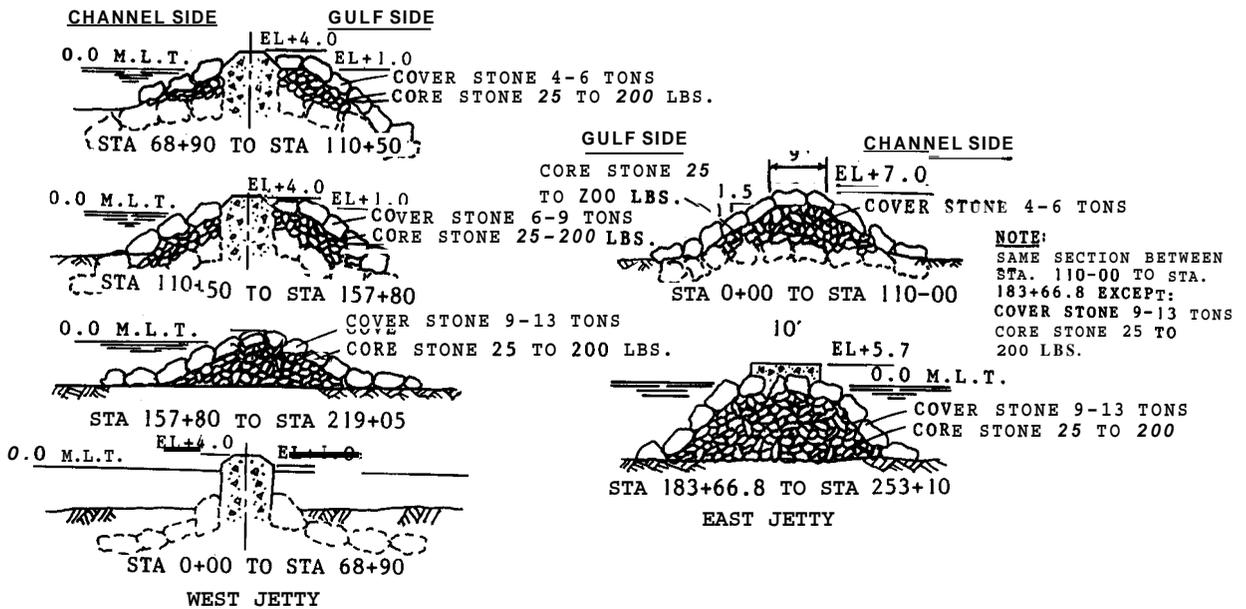
Figure 2. Location map and typical cross sections of Sabine Pass jetties

1986	No work has been done on the jetties since the 1960's , and they are considered to be in good condition, except for a 6,000-ft section at the west jetty's shoreward end.

1936- 1941	The jetties were capped with concrete. The east jetty cap, placed from sta 183+67 to sta 253+10 , had an elevation of 5.7 ft mlt and a top width of 10 ft. The west jetty cap was placed on the existing cap to an elevation of +4 ft mlt and an overall width of 10 ft. Stone totaling 23,130 tons and 15,070 cu yd of concrete were placed at a total cost of \$608,000 .
1957- 1958	The west jetty was repaired using 60,200 tons of stone at a cost of \$834,800 (location of repairs unknown). Cover stone weighed 9 to 13 tons each, and core stone weighed 25 to 200 lb each,
1960- 1966	Repairs were made from sta 60+00 to sta 183+67 and sta 68+00 to sta 179+50 on the east and west jetties, respectively (Figure 2). The east jetty was brought up to +7 ft mlt with a 9-ft crown width and 1V:1.5H side slopes. A similar cross section was used on the west jetty from sta 68+00 to sta 90+75 with the cover layer placed over the concrete cap. The remainder of the west jetty cap section was raised with core stone to +1 ft mlt, 1V:1.5H side slopes and covered with armor stone. The core stone varied from 25 to 200 lb. The cover stone varied from 4 to 13 tons between the landward and seaward ends of the repairs, respectively. A total of 430,000 tons (approximate) of stone was placed at a total cost of \$3,961,000 .

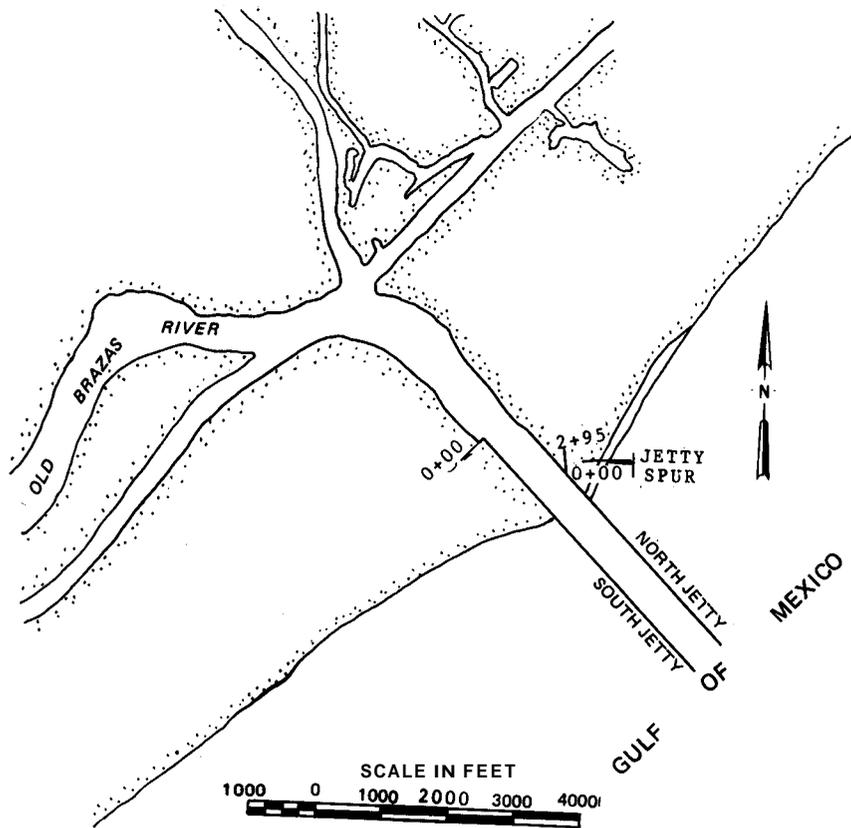
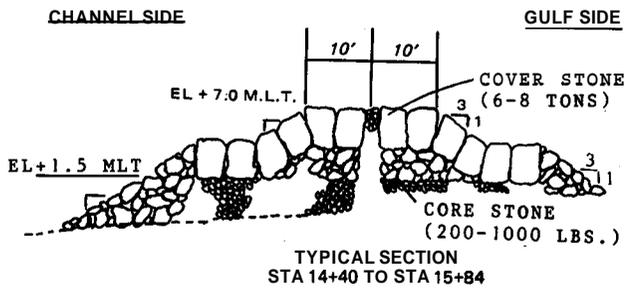
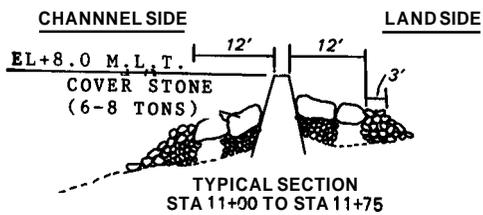
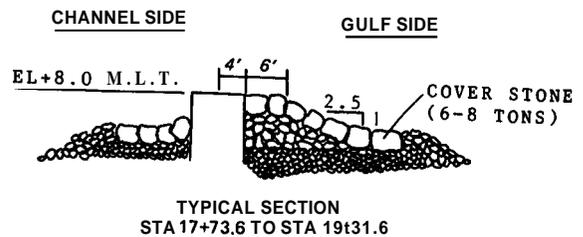
Figure 5. Plan view of Freeport Harbor jetties and typical south jetty repair sections

1986	Except for the more recent repair sections, the jetties are in poor condition, with many voids under the concrete caps and numerous cracks in the caps themselves. Jetty rehabilitation has been delayed pending authorized project improvements which include relocating the north jetty and channel deepening.

1968	Two sections of the south jetty, from sta 11+00 to sta 11+75 and sta 17+70 to sta 19+30 , were repaired by buttressing the concrete cap with stone and placing concrete between sta 18+00 and sta 19+05 (Figure 5). The landward section was subjected to undermining and piping beneath the cap. The cap on the outer section had collapsed, due to undermining, with about 20 ft at +1 ft mlt and the remainder between +1 and +8 ft mlt. The concrete was placed to the original dimensions of +8 ft mlt and an 8-ft width. Stone was placed on the gulf side of the cap to +8 ft mlt, a 6-ft top width and 1V:2.5H side

Date(s)	Construction and Rehabilitation History
1968 (cont.)	slope. The remaining repairs consisted of buttressing the cap with 12-ft-wide bedding and cover stone layers. A 3-ft-wide layer of toe protection was placed along the outer edge of the repair sections. Stone sizes were 6 to 8 tons for the cover layer, 200 to 1,000 lb for the core (placed on seaside of outer section only) and toe protection, and 0.5 in. to 200 lb for the approximately 3-ft-thick bedding layer. Cost totaled \$65,300 using 4,410 tons of stone.
1977	Minor repairs were made at a total cost of \$9,200. (No details are available.)
1984	Two sections of the south jetty were repaired (Figure 5), and a 295-ft-long rubble-mound spur was placed at sta 8+40 on the north jetty's landward side. The south jetty repairs, from sta 14+40 to sta 15+85 and sta 19+20 to sta 20+20, consisted of a +7 ft mlt crown elevation, a composite width (including the cap width) of 20 ft and 1V:3H side slopes. A bedding layer of 0.5-in. to 200-lb stone was placed to +1.5 ft mlt and extended 26.5 ft from the jetty center line. Stone sizes were 6 to 8 tons for the cover layer and 200 to 1,000 lb for the core and toe protection. The toe protection was placed on a 1V:3H slope along the outer edge of the cover and bedding layers. The spur projected landward from the north jetty at a 30-deg angle and was built to an elevation of +6 ft mlt, a 5-ft top width, and 1V:1.5H side slopes. One-half inch to 200-lb blanket stone were used, except for a 90-ft section adjacent to the jetty. Single 4- to 6-ton stones were placed along the crown. The purpose of the spur was to minimize sand movement over the lower (+4 ft mlt) landward jetty section that was building a channel side shoal with the potential for future channel encroachment which would require subsequent maintenance dredging.

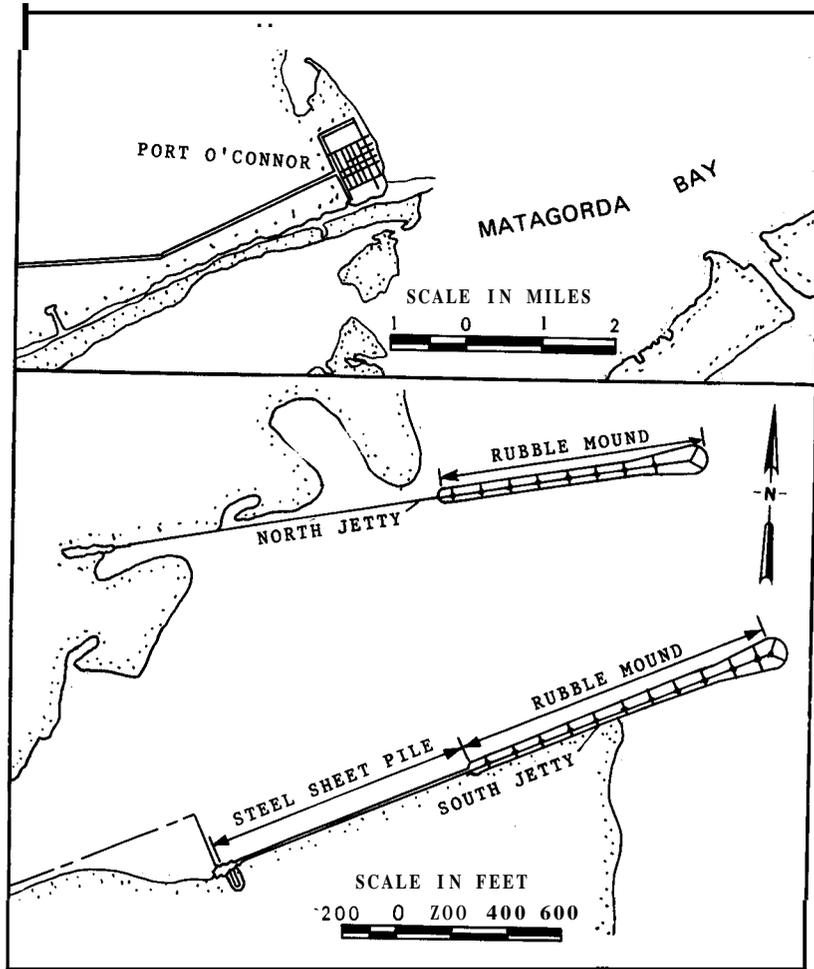
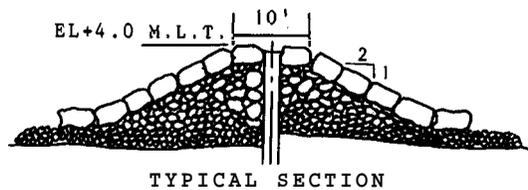
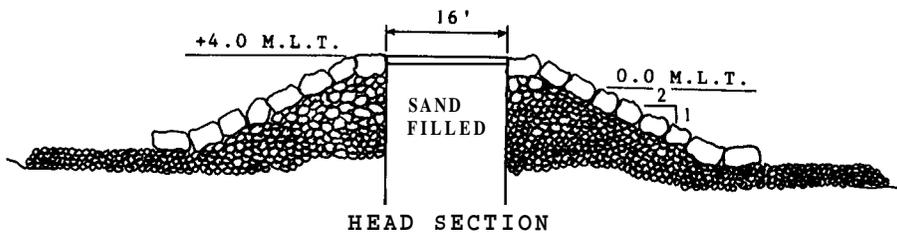
Figure 9. Location, plan view, and typical sections of Port O'Connor jetties

Date(s)	Construction and Rehabilitation History
1964- 1965 (cont.)	time of the repairs the jetties were in fair condition (mostly general corrosion), except at their outer ends where scour and active soil pressures were evident, and the shoreline was eroding at the landward ends. The cover stone size was determined from Hudson's slope stability formula and a maximum depth-limited wave height of 12 ft. Existing elevations along the jetties varied from +2 to -11 (seaward ends) ft mlt. The rehabilitation cost was \$397,800 and required 46,910 tons of stone.
1971	Riprap stone (0.5 in. to 200 lb) was placed on the north jetty landward end. The shoreline had eroded leaving a gap of approximately 50 ft. A total of 600 tons of stone was placed at a cost of about \$9,000.
1984	Except for general deterioration (corrosion) at several locations of the exposed sheetpiling, the jetties were considered to be in good condition (visual inspection). The present overall lengths of the north and south dikes are 2,300 and 2,250 ft, respectively.

1964- 1965	The jetties were rehabilitated by placing a rubble-mound cross section (Figure 9) along the outer 800- and 1,200-ft sections of the north and south jetties, respectively. In addition, scour protection was added to the remainder of the south jetty channel side, and shore protection was added at the landward ends of the dikes. The rubble-mound sections, with the existing jetties at the center line, were placed to an elevation of +4 ft mlt; side slopes were 1V:2H, and the crown width was approximately 10 ft (two cover stones wide, one on either side of the sheetpiling). The section was built up on a 2-ft-thick bedding layer (3 ft at seaward end) of 0.5-in. to 200-lb stone, a core of 200- to 1,000-lb stone, and a single layer of 2- to 4-ton cover stone. Filler stone (0.5 to 4 in.) also was placed with the core stone (a section 3 ft wide on either side of the sheetpiling and extending downward at 1V:1H side slopes). The bedding layer extended from 5 ft (landward) to 15 ft (seaward) beyond the toe of the cover stone layer. The landward 700 ft of south jetty bay side rubble mound consisted of a 2-ft-thick bedding layer placed between 0 and +2 ft mlt followed by a 2-stone-wide cover layer (+4.5 ft mlt crest elevation). South jetty scour protection was placed on 950 ft of the channel side (landward of the rubble-mound section) and consisted of a 2-ft-thick by 10-ft-wide layer of 0.5-in. to 200-lb stone. The north jetty was extended 50 ft landward, and a 30-ft-long perpendicular spur was added at the landward end (bay side) of the south jetty. This shore protection used 0.5-in. to 200-lb stone placed between 0 and +4 ft mlt with a 4-ft crown width and 1V:2H side slopes. At the

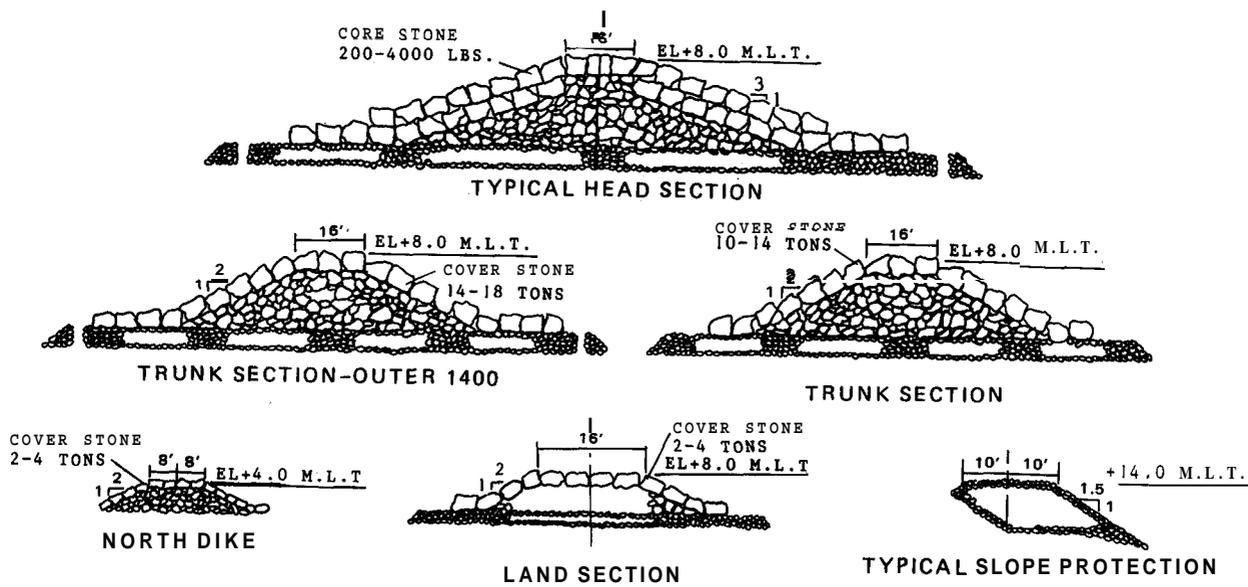
Figure 10. Typical cross sections of Matagorda Ship Channel jetties

Date(s)	Construction and Rehabilitation History
1970- 1972	Inspections during 1970-1971 showed that some 10 to 20 cover stones from the top layer on the slope around each jetty head had been displaced. Also, near the landward end of the north jetty, on its channel side, several cover stones had shifted down the slope. In 1972 repairs were made to the jetties by resetting existing cover stone and placing additional cover stone at these sections and possibly others. No other details are available.
1980	An inspection showed that the north and south jetty heads required resetting of about 15 and 40 cover stones, respectively. Also three sections near the landward channel side of the south jetty showed some slippage of the cover layer, exposing the underlying core stone. The remaining jetty sections were considered to be in good condition.
1984	The jetties were inspected and considered to be in good condition except for 15 to 20 displaced cover stones at the head of each jetty.

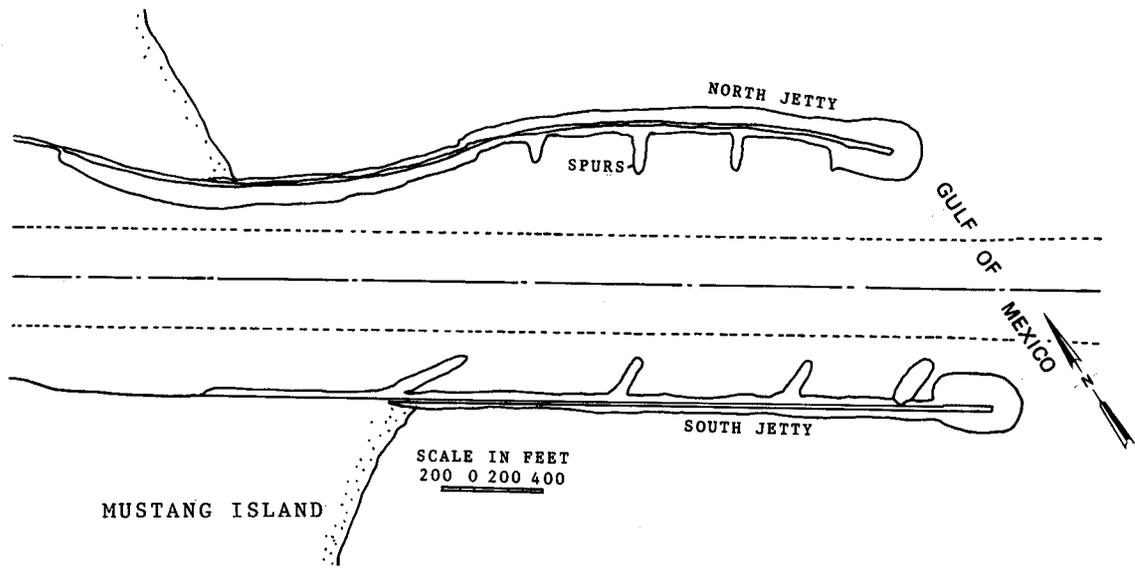
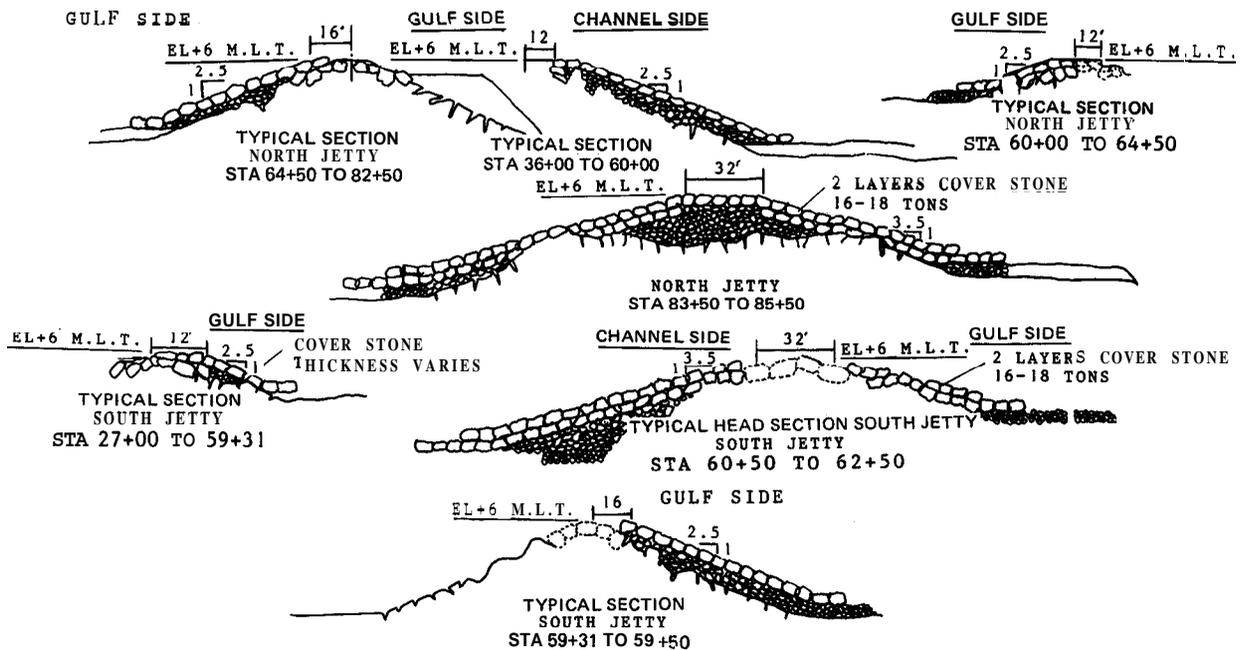
Figure 11. Aransas Pass jetties, plan view and typical cross sections

1967	<p>Hurricane Beulah's passage in October displaced cover stone at several locations, with an estimated 100 pieces missing or displaced from each jetty. Near the landward ends of the jetties sand was washing or piping under the concrete caps and into the ship channel. It is not known whether this piping was due to the storm or if it had been a previous problem. These sections were located from sta 12+00 to sta 24+00 on the north jetty and from sta 10+00 to sta 25+00 on the south jetty (landward ends at sta 0+00).</p>

1978	Seven sections of the south jetty totaling 980 lin ft between sta 8+70 and sta 24+50 were repaired by placing stone on the landward side of the concrete cap. Scour beneath the cap had caused piping and removal of sand along its landward face. Although this condition had existed for several years, repairs were considered necessary due to the size of the scour holes and concern for human safety. The repairs consisted of placing a 1.5-ft-thick bedding layer of 0.5- to 6-in. stone extending 12 ft from the cap and covered with a 2.5-ft thickness (but not to project above the cap) of 200- to 1,000-lb riprap extending 8 ft from the cap. Total cost of the repairs was \$60,700.
1984	The jetties were inspected and considered to be in good condition with the exception of 10 to 20 cover stones that were displaced along the channel side of each jetty's head section, displaced cover stone along the north jetty channel side, and settlement of some supporting stone beneath the concrete caps.

Date(s)	Construction and Rehabilitation History
1908- 1917	The north or Haupt jetty was repaired and extended 3,490 ft landward which closed the gap, and a 7,385-ft-long south jetty was constructed (Figure 11). The jetties were roughly parallel, spaced 1,500 ft apart, with the south jetty extending 1,150 ft seaward of the north jetty. The jetties were built up to +5 ft mlt and crest widths of 10 to 20 ft using small riprap (15 to 200 lb), large riprap weighing 200 lb to 7 ton, and crest stone greater than 7 tons comprised 7 percent of total. The total quantity of stone placed on the north and south jetties was 162,400 and 253,900 tons, respectively. These totals include minor repairs made during 1916-1917 . The total cost for jetty improvements during this period was \$1,544,500 . In 1911 , portions of the Mansfield and Nelson jetties were removed from the channel at a cost of \$14,300 . The authorized 20-ft channel depths were obtained during construction as the tidal flow and resulting bottom scour were gradually confined.

Date(s)	Construction and Rehabilitation History
1964- 1966	<p>The jetties underwent major rehabilitation using the recommendations and design proposed in 1962 (Figure 11). The new seaward ends of the 4,950- and 3,550-ft-long repair sections terminated 790 and 1,135 ft from the original seaward ends of the north and south jetties, respectively. The south jetty repairs consisted of a rebuilt gulf side slope, a 200-ft-long head section, and a 250-ft channel side spur located 550 ft landward of the head. The north jetty repair section had the landward 2,410-ft channel side and adjacent (seaward) 2,250-ft gulf side slopes rebuilt. The final 300 ft were rebuilt as a transition and 200-ft head section. The head sections had a crown elevation of +6 ft mlt, a 32-ft crown width and 1V:3.5H side slopes. The 16- to 18-ton cover stone was placed as a double layer on the side slopes and single layer on the crown. The 200- to 4,000-lb core stone was partially supplemented with 0.5- to 4-in. filler stone (in a section extending beneath the crown at 1V:1H side slopes) for the purpose of decreasing structure permeability. The 0.5-in. to 200-lb blanket stone was placed in a 5-ft-thick layer and extended 50 ft beyond the toe of the cover layer. The jetty trunk sections were rebuilt to +6 ft mlt and a 1V:2.5H side slope. The crown extended two cover stones in width from the existing 12-ft-wide concrete cap sections or 14 ft from the center line of the north jetty grouted cap (1,800-ft section). The single layer of cover stone varied from a minimum of 2 to 4 tons at the south jetty landward end to a maximum of 16 to 18 tons at the jetty seaward ends. The blanket layer was placed in 3-, 4-, or 5-ft thicknesses and extended 10 ft beyond the toe of the cover layer. Prior to placing the core stone the existing void spaces were chinked with filler stone. The filler, blanket, and core stone size ranges were the same throughout the repair sections (see above). The south jetty groin consisted of core stone placed to -18 ft mlt, a 10-ft crown width, and 1V:1.5H side slopes. The core stone was placed on a 5-ft layer of blanket stone which extended 10 ft beyond the toe of the core stone. The total cost of rehabilitation was \$3,367,000 and required 410,250 tons of stone. The jetty design was based on Hudson's slope stability formula, depth- and fetch-limited wave heights, and a maximum storm surge level of +13 ft mlt. The 18-ton maximum cover stone was inadequate for maximum design conditions but was selected for practical and economic reasons.</p>

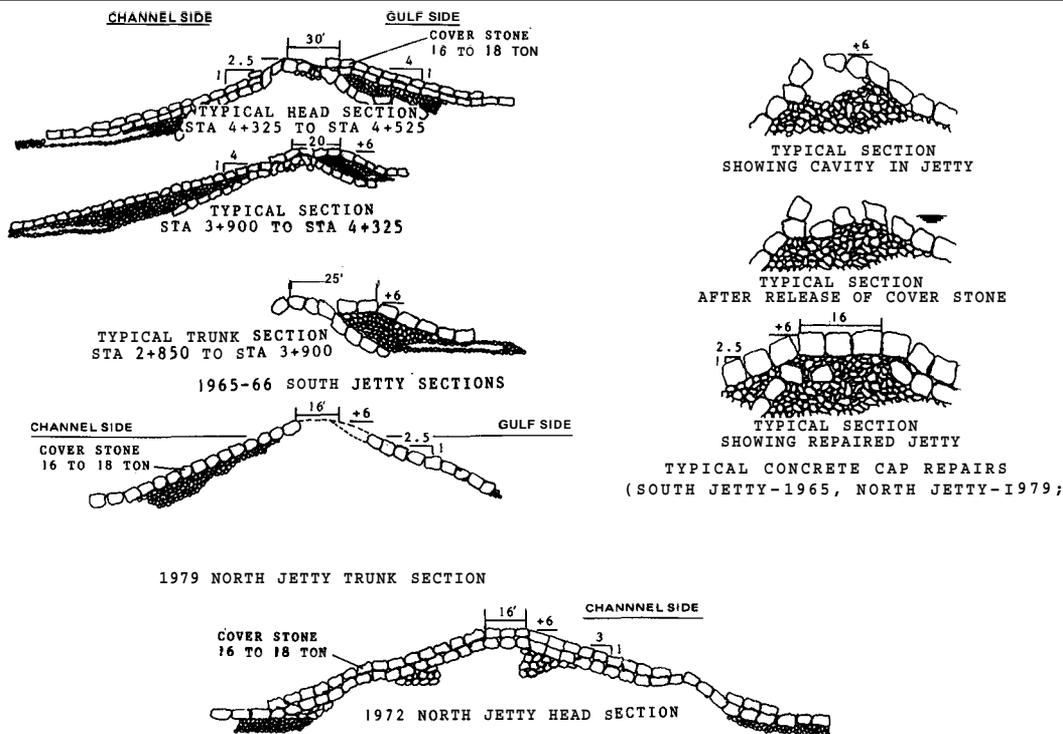
Figure 15. Typical repair sections of the Brazos Island jetties

1977- 1979	<p>By the end of 1977, sections of the north jetty concrete cap had collapsed, other sections were cracking, and its seaward end needed repair. All of the noted areas of cap damage were located along the channel side. The damaged areas were similar to those seen previously on the south jetty cap where undermining and settlement of the underlying stone had created cavities beneath the cap. It was thought that Hurricane Anita in August 1977 was the force which triggered most of the cover stone breakage and collapse, because the jetty was considered to be in good condition during a June 1977 inspection. The north jetty channel shoreline was continuing to erode. Since 1962, the shoreline had receded about 200 ft, a rate of 13 ft per year. The channel end of the 1971 shoreline protection was now offshore. (The 1961 shore protection stone was virtually non-existent.) During 1978-1979, repairs were made to the north jetty and adjacent shore protection. The seaward 35 ft and 1,700 ft of the jetty trunk were brought up to grade using 16- to 18-ton cover stone, 100- to 4,000-lb core stone (2,000-lb maximum on landward 1,000 ft of trunk), and 0.5-in. to 200-lb blanket stone. The trunk section (Figure 15), starting 500 ft from the seaward end and extending landward, had a 16-ft crown width, a +6 ft mlt crown elevation, and 1V:2.5H side slopes. The concrete cap was broken up, and the released cover stone projecting above +1 ft mlt was removed and used as cover stone in the shore protection (Figure 15). New core and a single layer of cover stone then were placed to obtain the required design geometry. A 3-ft-thick bedding layer was placed from</p>

1980	<p>In August, storm waves from Hurricane Allen caused significant damage to the jetty heads and a section of the north jetty trunk had been breached. The breached section was about 50 ft long and located 350 ft from the head.</p>
1984	<p>There are several places along the jetties where the foundation has settled, resulting in the cover stone lying below mlt.</p>

Date(s)	Construction and Rehabilitation History
	<p>breaking up the concrete cap at sections where underlying cavities had formed. The released cover stone was left in place and overlaid with new cover stone bringing the sections up to the +6 ft mlt design elevation. The north jetty repair, located approximately 3,500 ft from the seaward end, brought the channel side up to grade by placing blanket stone, resetting existing cover stone, and adding new 200- to 1,000-lb core stone and 2- to 4-ton cover stone. The 3-ft-thick blanket of 0.5-in. to 200-lb stone extended 10 ft beyond the toe of the cover layer. The section was brought up to +6 ft mlt and a side slope of 1V:2.5H. Water depths were -35 ft mlt along the seaward end of the north jetty toe and from -20 to -40 ft mlt along the seaward end of the south jetty toe. The authorized 38- by 300-ft channel has been maintained since 1957. Hudson's slope stability formula was used in the design with 10- to 35-ft wave heights. The design storm surge was +13 ft mlt. The stone sizes used were smaller than required to satisfy a no-damage criterion, with slope stability coefficients varying from 2.5 to 12.5 but being used for practical and economic reasons. The total cost of the repairs was \$584,000 using a total of 60,600 tons of stone.</p>

Date(s)	Construction and Rehabilitation History
1977-1979 (cont.)	<p>the base of the existing jetty and extended 10 ft beyond the end of the new cover layer. The seaward end repair was identical to the 1971-1972 work, except that 1V:3H side slopes were used throughout. Displaced cover stone was reset on the adjacent 100 ft of jetty. The north jetty shore protection was extended 1,470 ft along the channel shoreline; this included 150 ft of the existing shore protection which was salvaged and rebuilt, and repairs were made to the existing section. The design was nearly identical to that used in 1968 on the existing shore protection. (Toe protection was 200 to 1,000 lb and placed with a top width of 5 ft.) The jetty design was based on Hudson's equation with a maximum wave height of 26.5 ft (trunk) and a maximum surge level of +10 ft mlt. Similar to previous improvements, the selected jetty design was chosen for economic and practical considerations in lieu of a "no damage" design. Total cost of the jetty repairs and shore protection was \$5,905,000 using approximately 140,000 tons of stone.</p>
