Technical Report HL-93-7
August 1993

Scour Protection for Dam No. 2, Arkansas River, Arkansas

Hydraulic Model Investigation

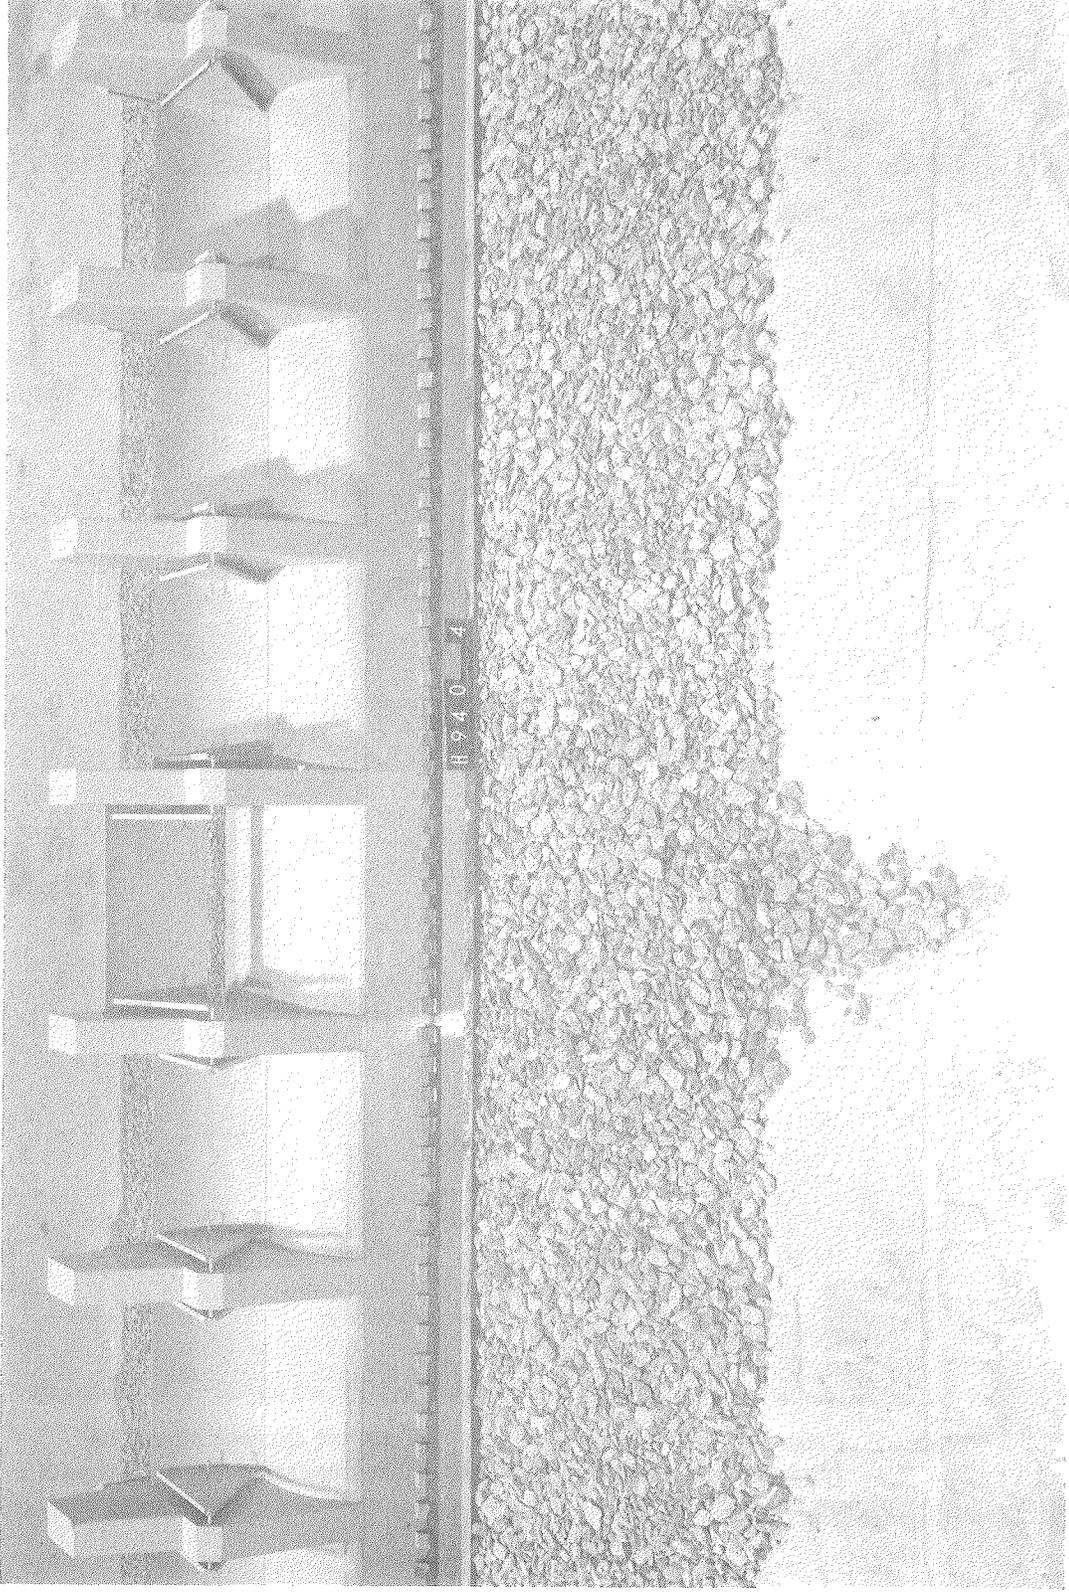
Tests 1-5 were conducted with gate 8 opened 14 ft and the pool and tailwater conditions shown in Table 1. A 14-ft gate opening was considered to be representative of a gate opened half-way. The tests were conducted by setting the appropriate discharge with a high tailwater, lowering the tailwater to the desired elevation, running this condition for a specified time period, turning off the discharge, and draining the model slowly so the riprap and scour pattern would not be disturbed to observe if riprap displacement had occurred. Riprap No. 7 downstream from the stilling basin was found to be unstable with pool el 162 and tailwater el 135 (Test 5, Table 1). The tests indicated that gate openings of 14 ft and greater should not be allowed with the tailwater lower than el 140. Results from Test 5 (Table 1) are shown in Photo 1.

Photo 1. Failure of Riprap No. 7 and scour in the exit channel after 6 hr (prototype) of operation with gate 8 opened 14 ft, normal upper pool el 162, and tailwater el 135

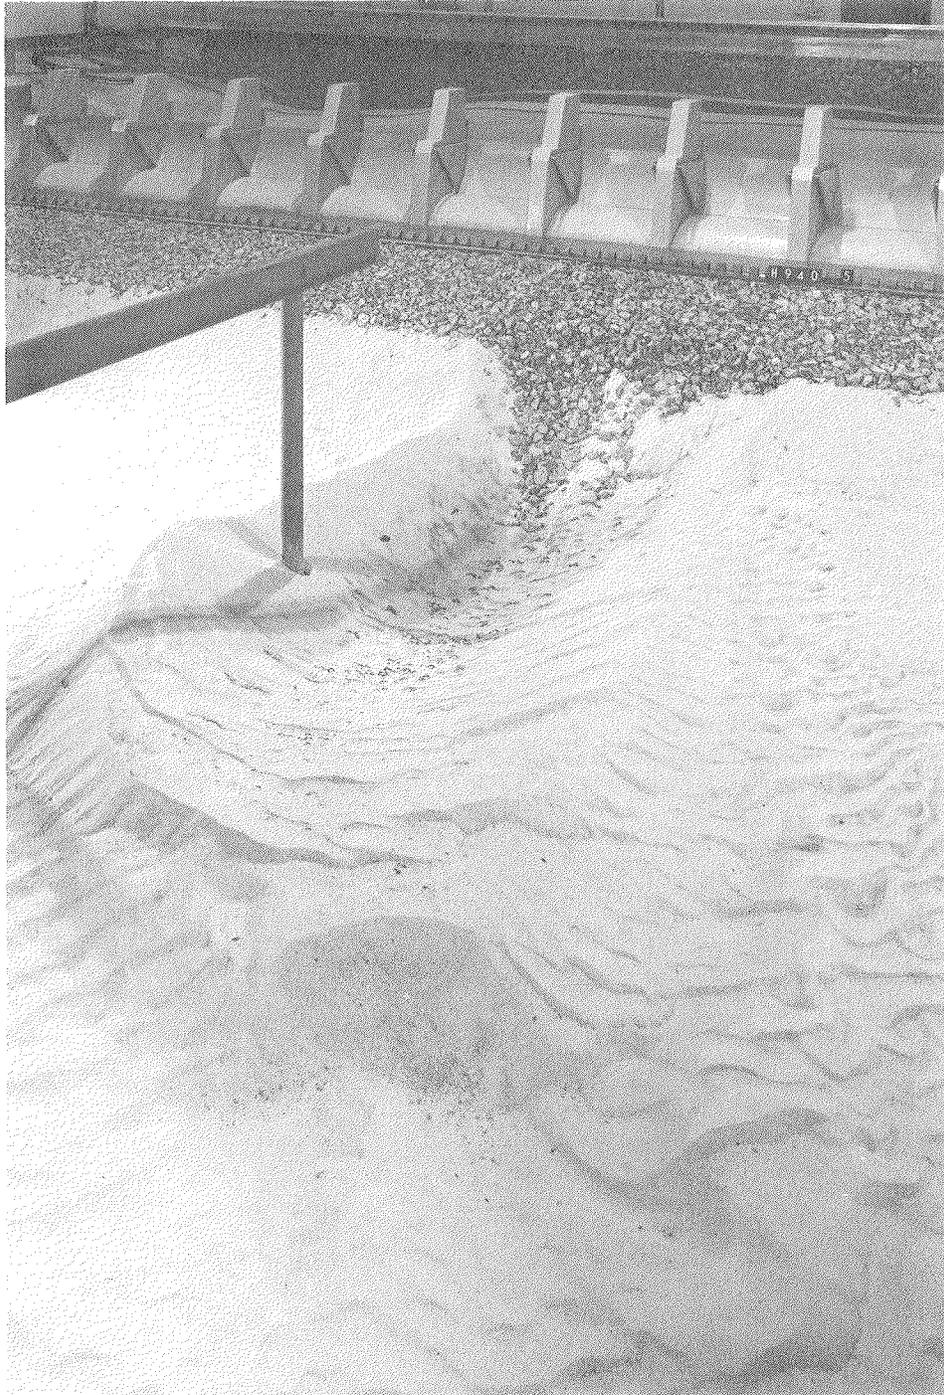
Tests were conducted to determine the stability of Riprap No. 7 downstream from the stilling basin for flow conditions caused by normal upper pool (el 162), one gate fully open, and various tailwater elevations. The riprap was found to be unstable for tailwater elevations below 150. Results from Test 8 (Table 1) are shown in Photo 2.

Photo 2. Failure of Riprap No. 7 and scour in the exit channel after 6 hr (prototype) of operation with gate 8 fully opened to the normal pool and tailwater el 145

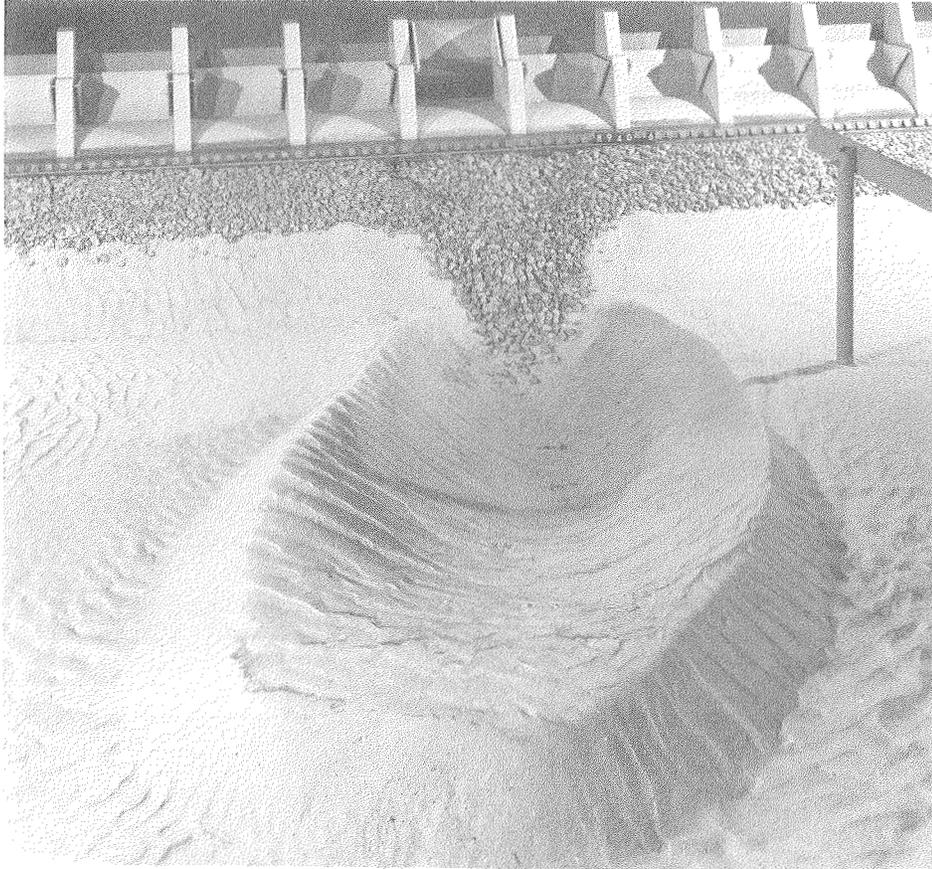
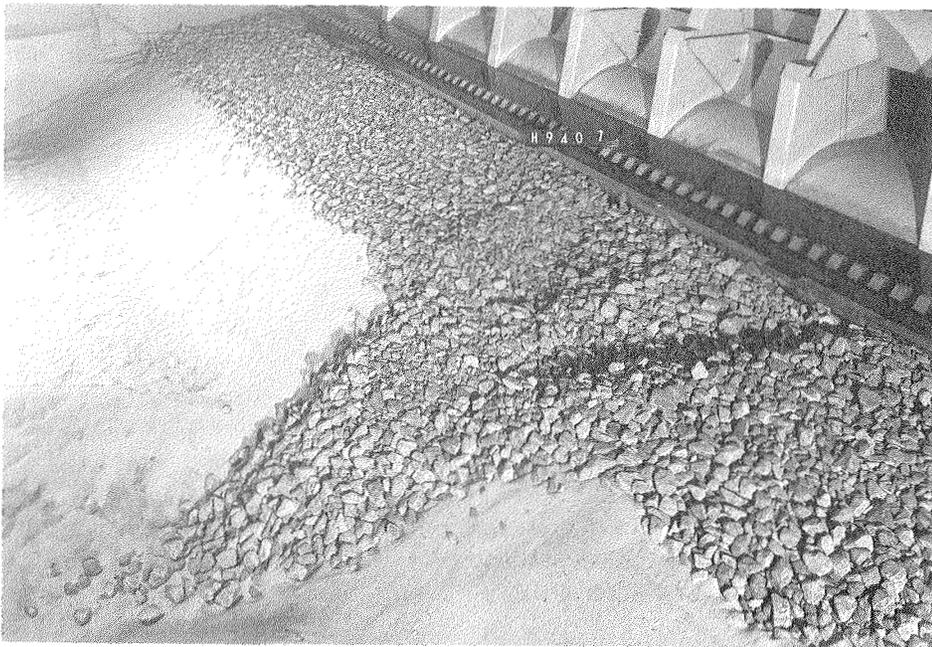
Riprap No. 7 was then tested under abnormal conditions. The first of these tests (Test 9, Table 1) reproduced pool (el 170) and tailwater (el 147.5) elevations that existed during the December 1982 barge accident. The riprap failure for this condition was severe, as shown in Photo 3. The test was conducted with gate 10 fully open for a duration of 4 hr 30 min prototype time (45 min model time).

Photo 3. Failure of Riprap No. 7 and scour in the exit channel after 4.5 hr (prototype) of operation with gate 10 fully opened, upper pool el 170, and tailwater el 147.5

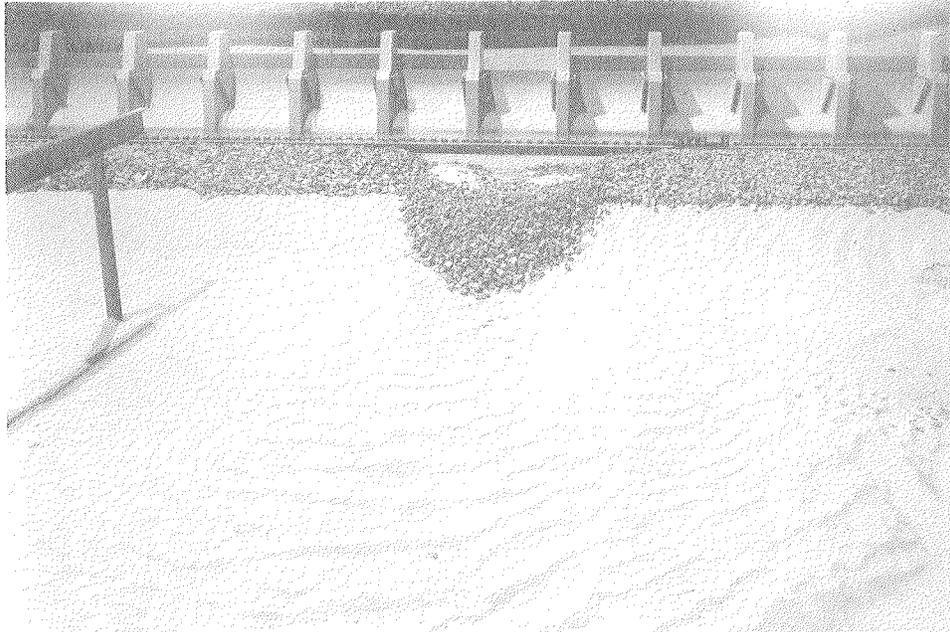
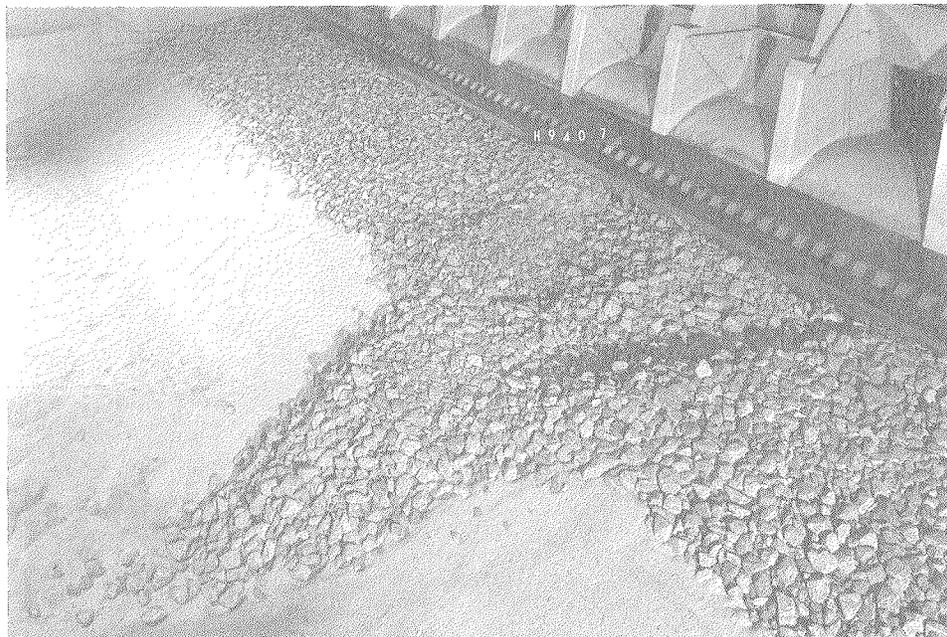
Previous tests had shown that Riprap No. 7 would fail with one gate fully open, normal pool, and tailwater elevations lower than 150. Engineer Technical Letter 1110-2-290¹ suggests that new project stilling basin design conditions include one gate fully open with normal headwater and minimum tailwater (gate misoperation). This type flow condition was observed to determine the adequacy of the existing stilling basin and the effects of this type flow on the Riprap No. 7 (Test 16, Table 1). The riprap was tested with the normal pool elevation, an extremely low tailwater elevation of 122 (3 ft

Photo 4. Failure of Riprap No. 7 and scour in the exit channel after 8 hr (prototype) of operation with one gate fully open, normal upper pool elevation, and tailwater el 122

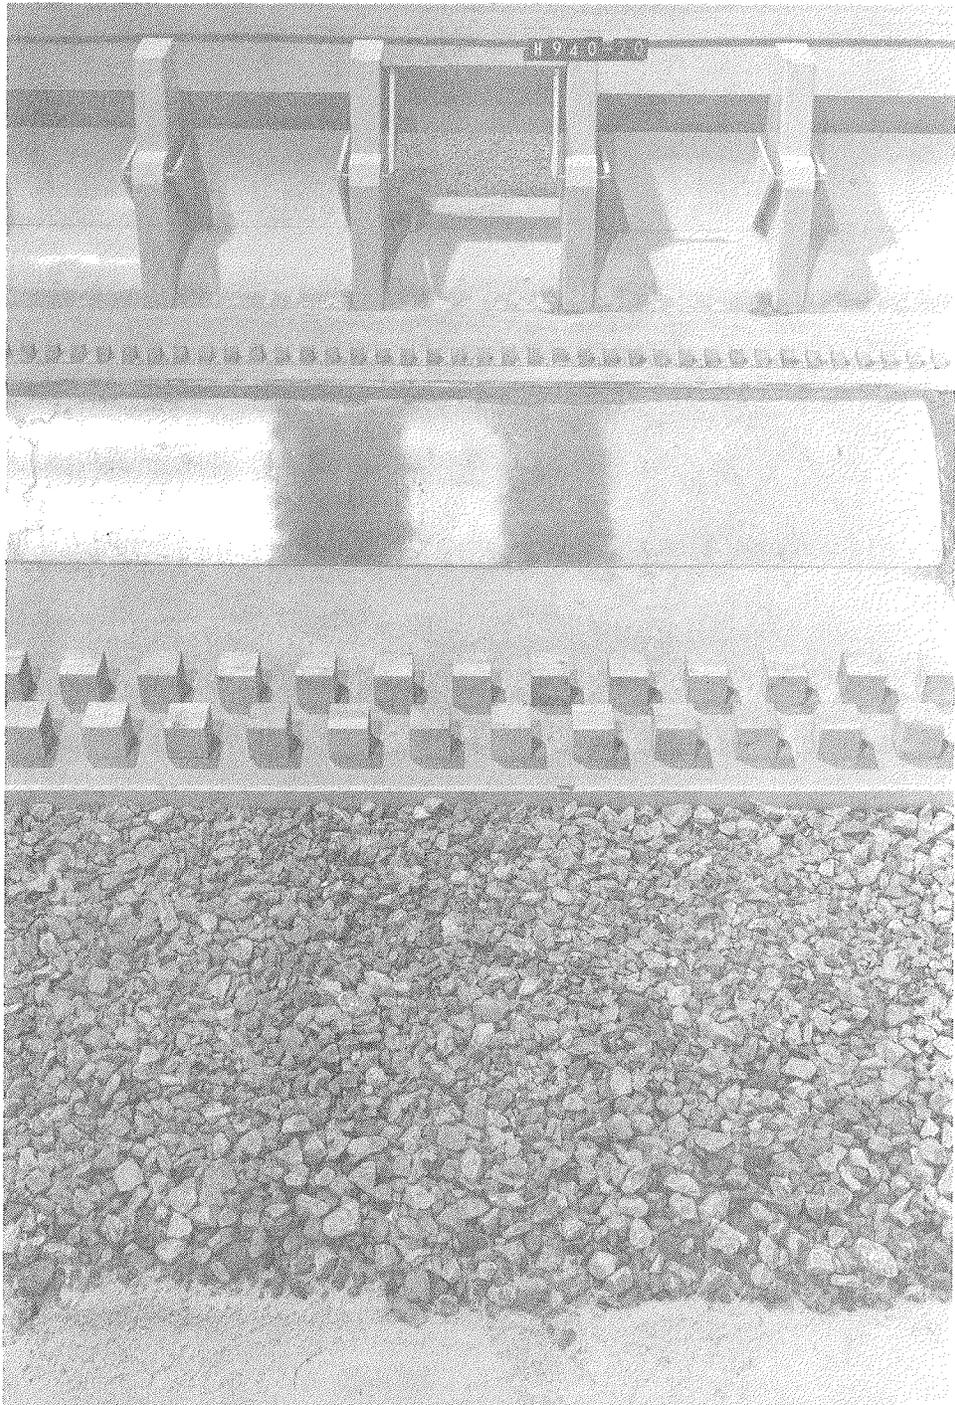
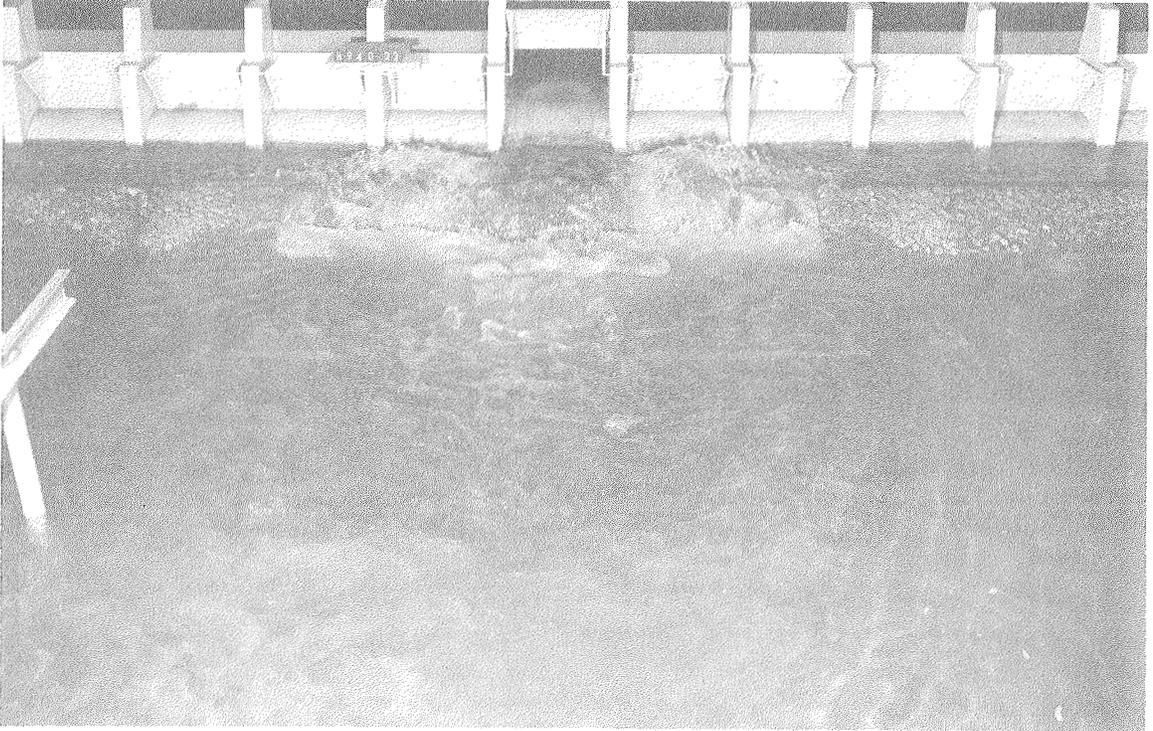
The type 6 scour protection design shown in Photo 10a was a secondary stilling basin located immediately downstream from the existing basin. Details of the basin are shown in Plate 6. The basin design was based on guidance provided in EM 1110-2-1605.¹ Flow conditions with normal upper pool, gate 6 fully open, and tailwater el 113 are shown in Photo 10b. A forced hydraulic jump occurred in the secondary basin, but Riprap No. 7 placed downstream from the basin was stable and scour in the exit channel was minimal. This basin was originally designed to function with upper pool el 170 and tailwater el 132. These are the conditions that would have existed during the barge accident if the tailwater was at its minimum elevation for the discharges that occurred. The basin performed adequately for these conditions. The conditions stated previously, normal upper pool el 162, one gate fully open, and tailwater el 113, were considered more severe and the basin also functioned satisfactorily for these conditions.

Photo 10. Type 6 scour protection design (Continued)

b. Flow conditions with one gate fully open normal upper pool, tailwater
el 113

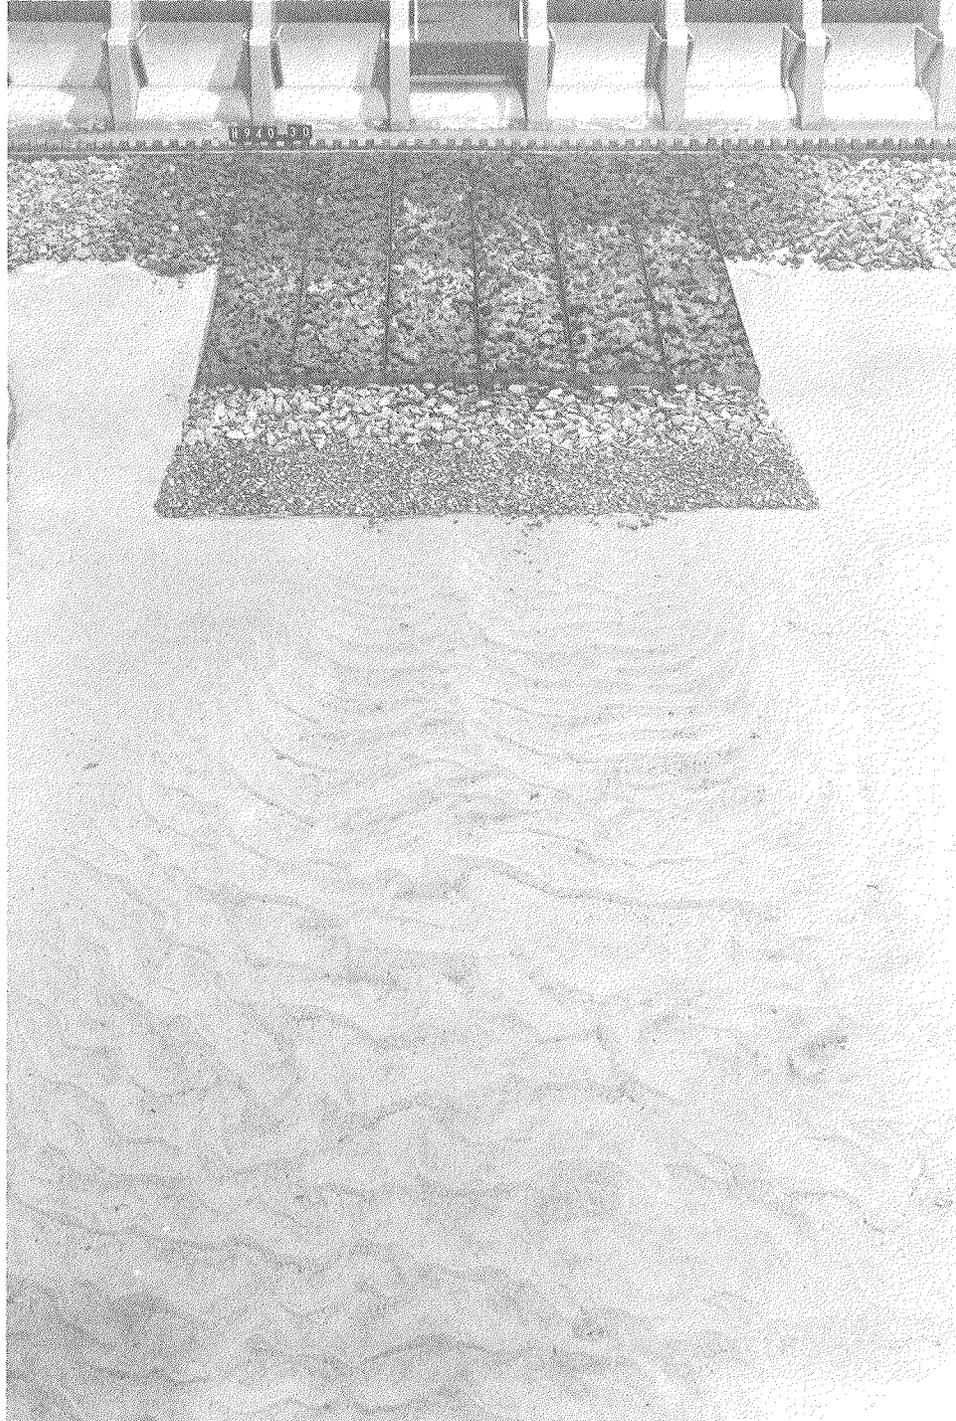
To provide protection for the area immediately downstream from the barges, Riprap No. 7 was placed at el 87 for a length of 50 ft, followed by a 50-ft-long blanket of Riprap No. 8. Riprap No. 8 consisted of a 36-in.-thick blanket of stone with a D_{50} size of 16 in. and the gradation shown in Plate 8. The purpose of placing the smaller Riprap No. 8 was to reduce the local turbulence above the stone protection downstream of Riprap No. 7 and to transition a less turbulent flow condition on the natural channel bottom. These modifications were designated the type 9 scour protection design. This design was tested with gate 13 opened fully to the normal upper pool and tailwater el 113 for 8 hr (prototype). The results shown in Photo 13 revealed that the riprap was stable and scour was minimal.

Photo 13. Type 9 scour protection design after 8 hr (prototype) of operation with normal upper pool, gate 13 fully open, and tailwater el 113

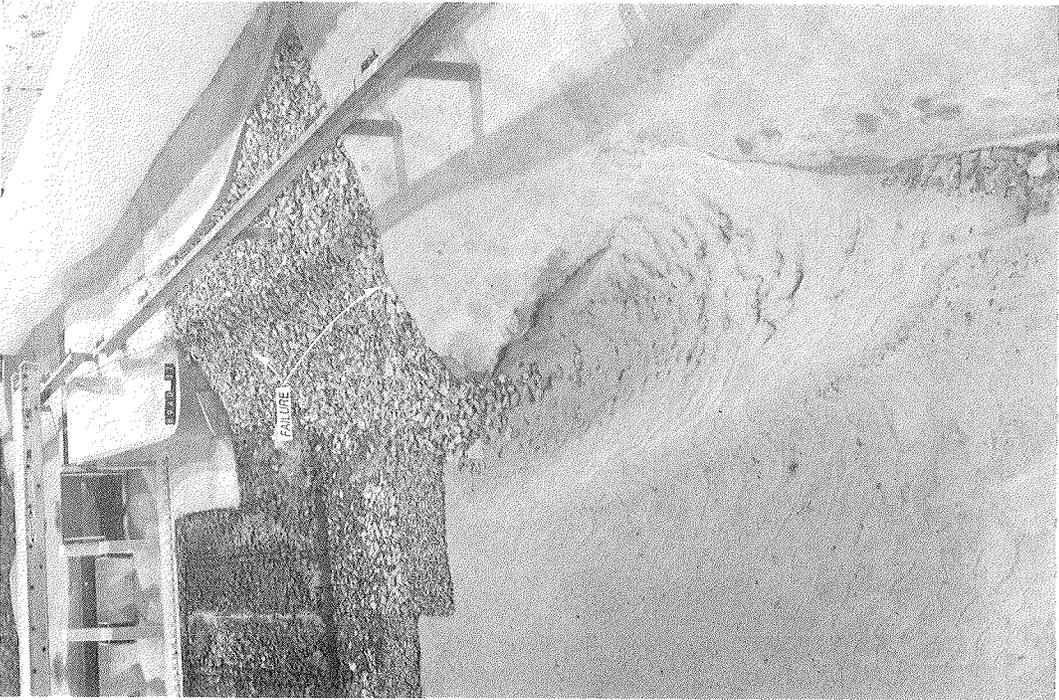
A test was then conducted for 8 hr (prototype) with gate 1 opened fully to the normal upper pool and tailwater el 113 to determine the stability of Riprap No. 7 on the side slope for this flow condition. Some of the riprap in the sacrificial dike (approximately 40-60 ft downstream from the training wall) was displaced, but overall, the riprap held favorably. The riprap was considered adequate protection if a flow condition of this nature could be brought under control and improved in an 8-hr period.

Photo 16. Failure of Riprap No. 7 on side slope

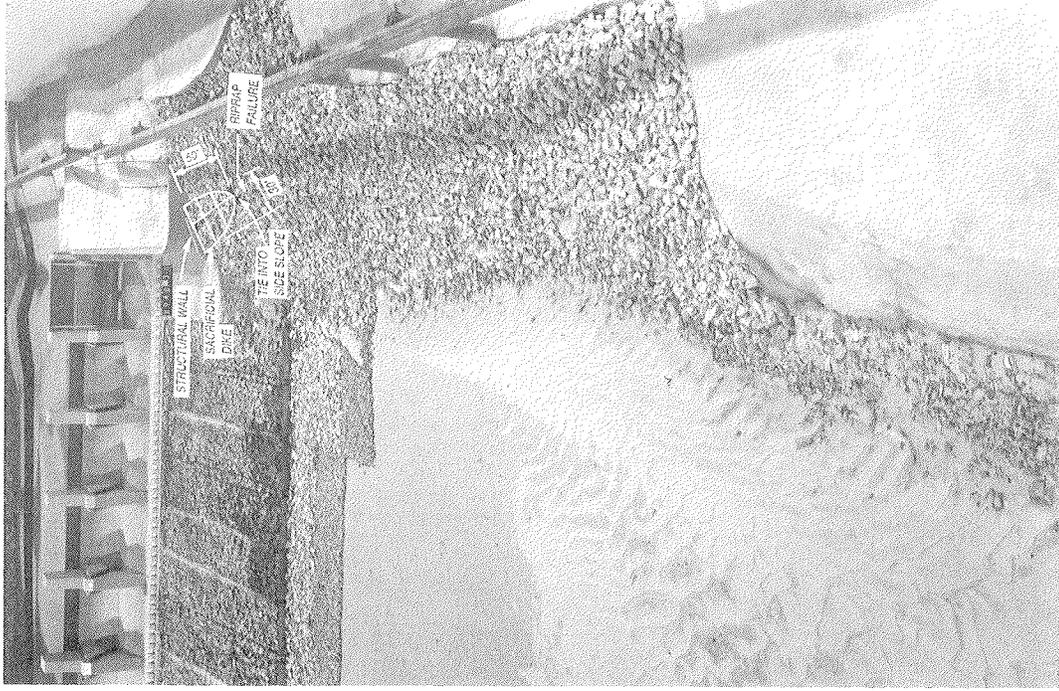
extended an additional 320 ft farther downstream on the left bank, providing side slope protection 600 ft downstream from the end of the training wall. This was done to move the disturbance caused by the transition from the Riprap 7 to the nonerodible material on the side slope farther downstream. A test was conducted for 8 hr (prototype) with gate 1 opened fully to the normal upper pool and tailwater el 130. Riprap was displaced in several areas and the filter was exposed about 94 ft downstream from the training wall as shown in Photo 17. The toe of the left side slope was undermined for the entire length causing riprap on the side slope to fail.

Photo 17. Failure of Riprap No. 7 on left bank

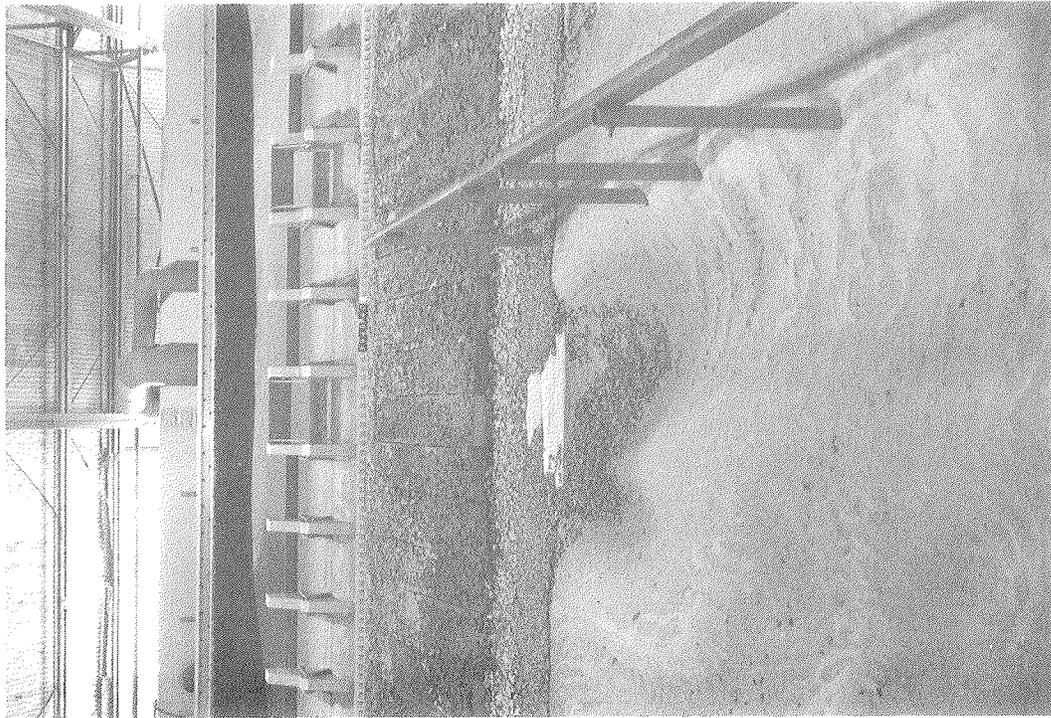
A test was then conducted downstream from gate 10 where the barges were 6 ft higher than their original placement. Riprap No. 8 downstream from the barges failed during this test due to the flow conditions that occurred with gate 10 opened fully to the normal upper pool and tailwater el 135. The entire 50-ft blanket was washed away as shown in Photo 18. An additional 50 ft of Riprap No. 7 (total length of 100 ft) followed by 50 ft of Riprap No. 8 was placed downstream from gate 10 and the test repeated. Again, the Riprap No. 8 was washed downstream. Riprap No. 8 was replaced with Riprap No. 9 ($d_{50} = 24$ in.). The gradation of this riprap is shown in Plate 11. A test was conducted for 8 hr (prototype) with gate 10 opened fully to the normal upper pool and tailwater el 135. Riprap No. 9 washed downstream as shown in Photo 19. Test results indicated that a significant amount of additional riprap will be required if the downstream ends of the barges are placed much higher than el 91.5. Since the Riprap No. 9 failed with the tailwater at el 135, tests were not conducted with lower tailwater.

Apparently, the group of raised barges caused the flow to attack the area downstream from these barges more severely than if the barges were lowered. An additional thickness of Riprap No. 7 was required at the downstream ends of the barges that had been raised 6 ft to prevent loss of material beneath the raised barges. The lateral transition of the riprap downstream from a barge raised 6 ft to a barge lowered 6 ft is not desirable due to the formation of

Photo 18. Failure of Riprap No. 8 downstream from a group of raised barges

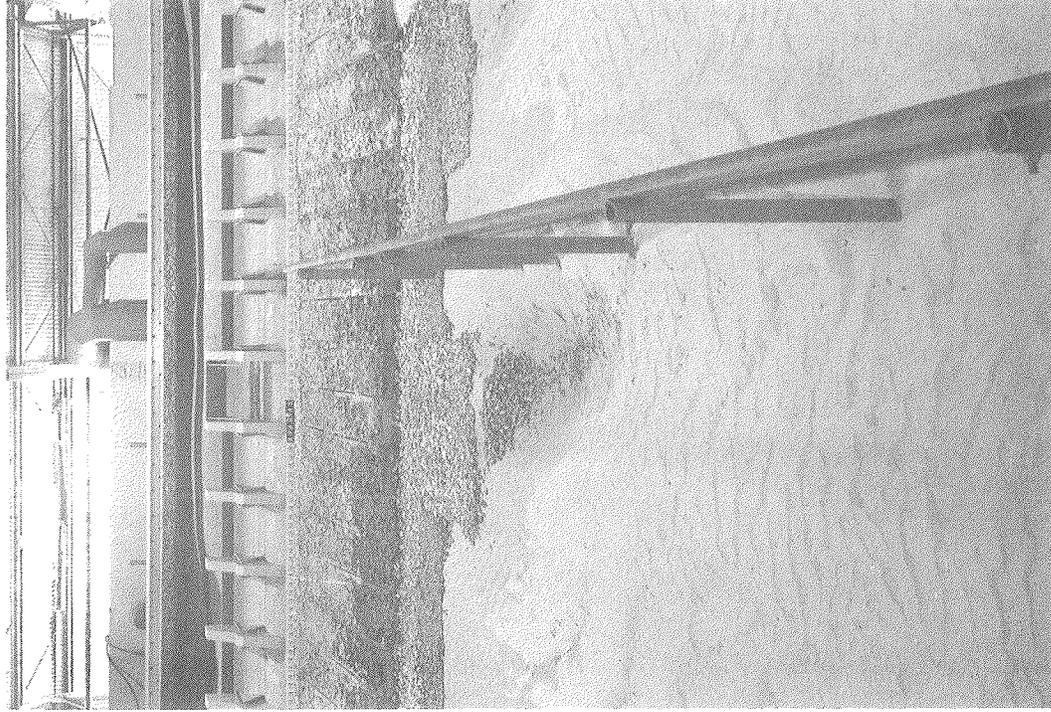
Photo 19. Failure of Riprap No. 9 placed downstream from a group of barges raised 6 ft higher than original placement

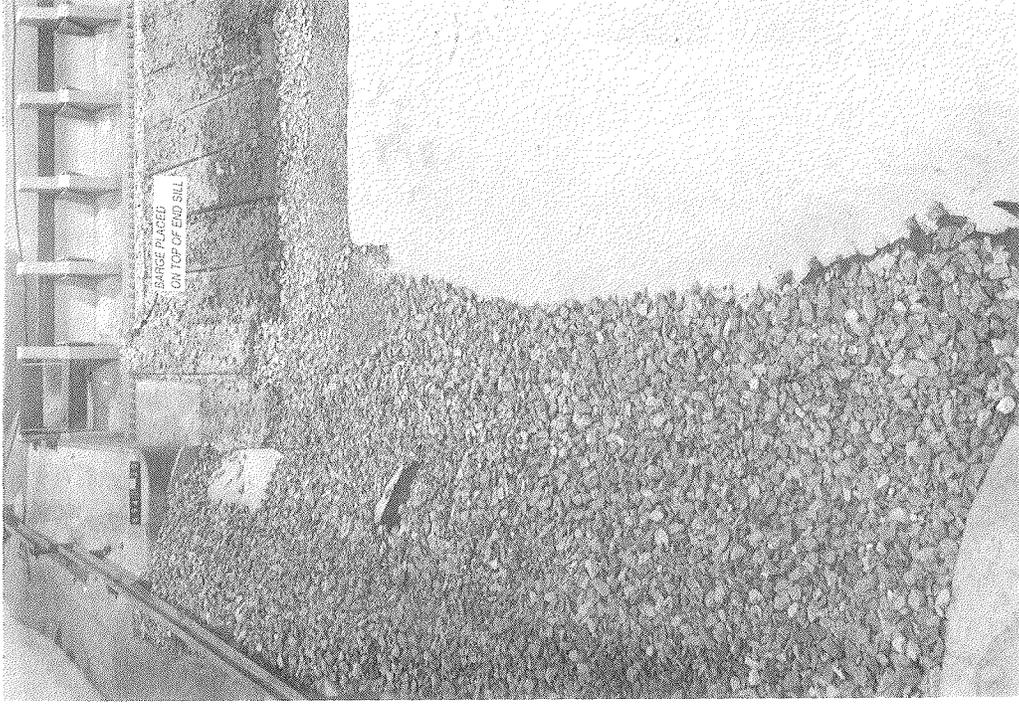
Tests were requested by the Little Rock District to determine the stability of the scour protection in case a barge was not placed properly and the upstream end of the barge became lodged on the end sill. A test was initiated with a barge between gates 15 and 16 placed on the end sill. The test was conducted for 2 hr (prototype) with gate 16 opened fully to the normal upper pool and tailwater el 113. Severe riprap displacement occurred along the side slope as shown in Photo 21. The raised barge concentrated flow downstream from gate 16 and prevented it from spreading out. This caused direct attack on the side slope riprap. Another test was conducted depicting this type placement behind gate bay 7. The same test conditions were observed, but for 8 hr (prototype), and no riprap failure occurred. The end of the barge acted as a baffle deflecting the jet upward and downstream, and the spray falling back to the water surface was not strong and concentrated. Therefore, riprap failure did not occur. The flow conditions caused by the raised barge are undesirable, and much emphasis should be placed on constructing the barge revetment as uniformly as possible.

Photo 21. Failure of Riprap No. 7 on right bank due to barge on end sill

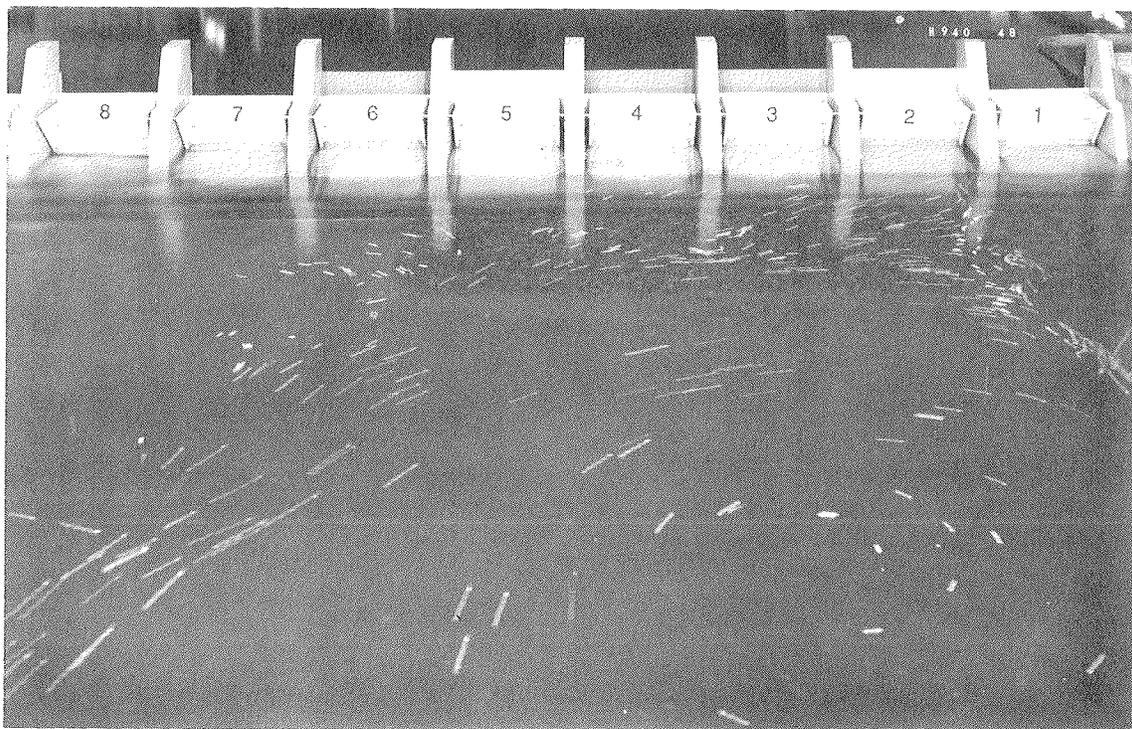
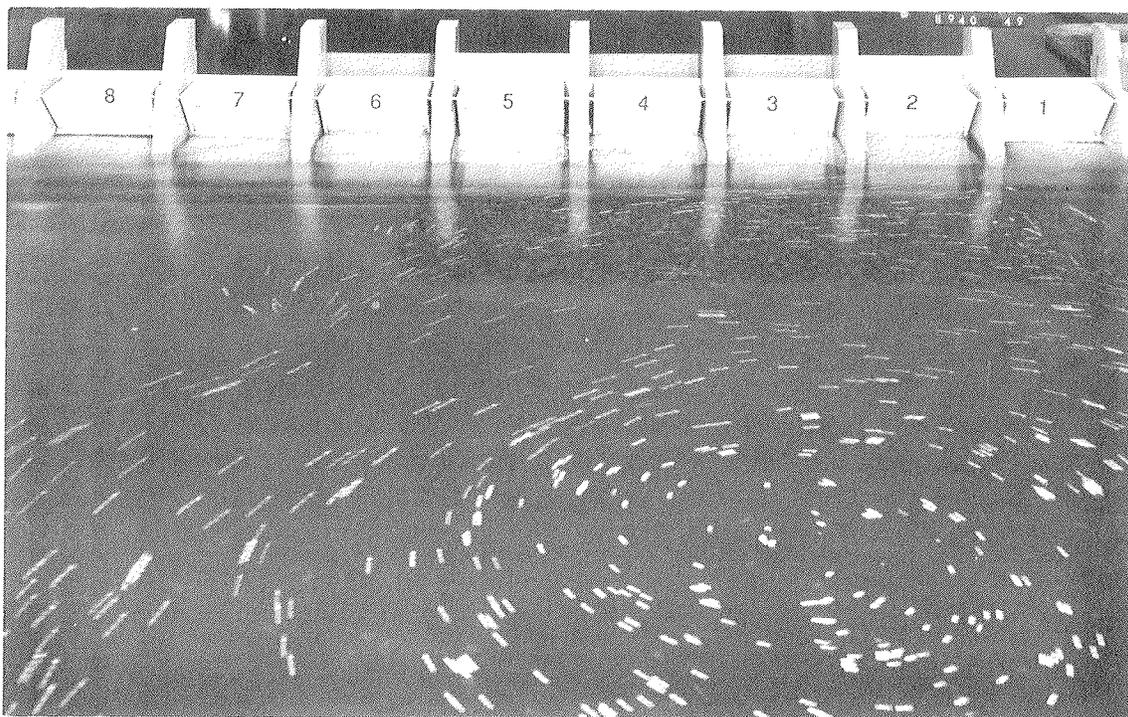
Photo 22 shows flow conditions downstream from gate 4 with a discharge of 50,000 cfs and pool el 162 when gates 2-6 are closed. This condition would exist when barges are being placed in the vicinity of gate 4. No adverse flows were observed and velocities were less than 3.5 fps on the surface. Flow circulation occurred in the working area but was considered slight.

Photo 22. Flow conditions with gates 2-6 closed, a discharge of 50,000 cfs, and pool el 162

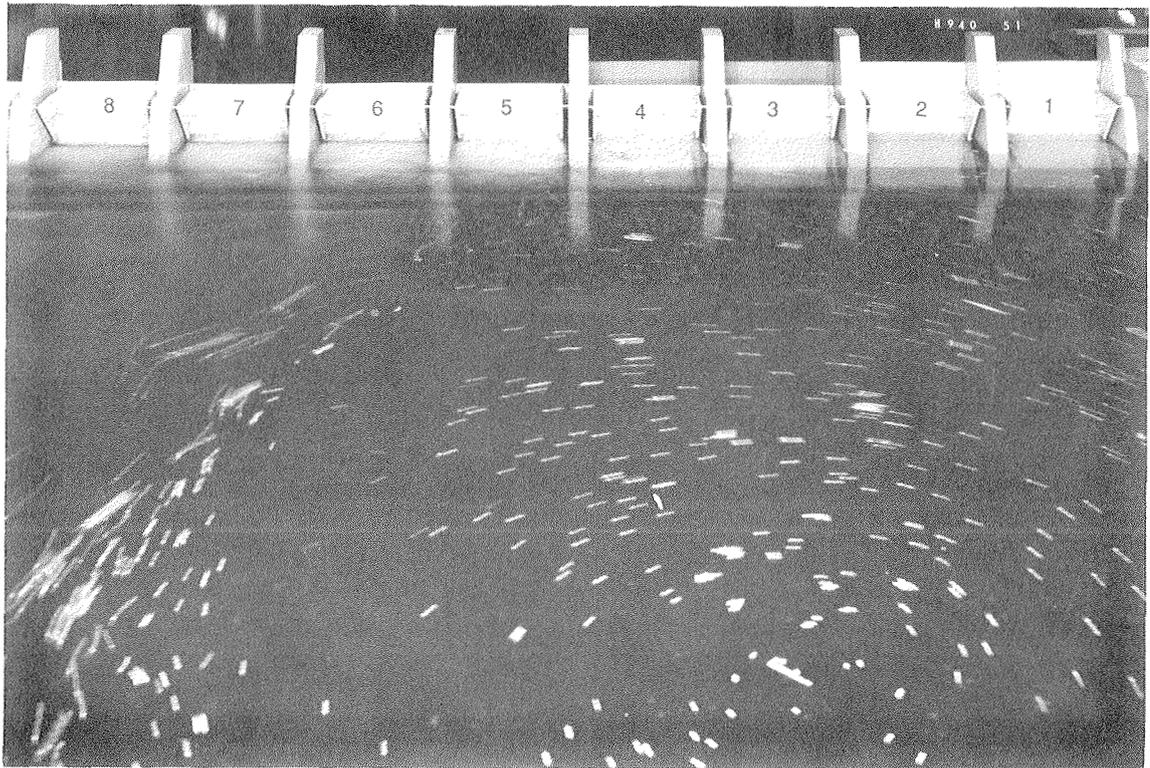
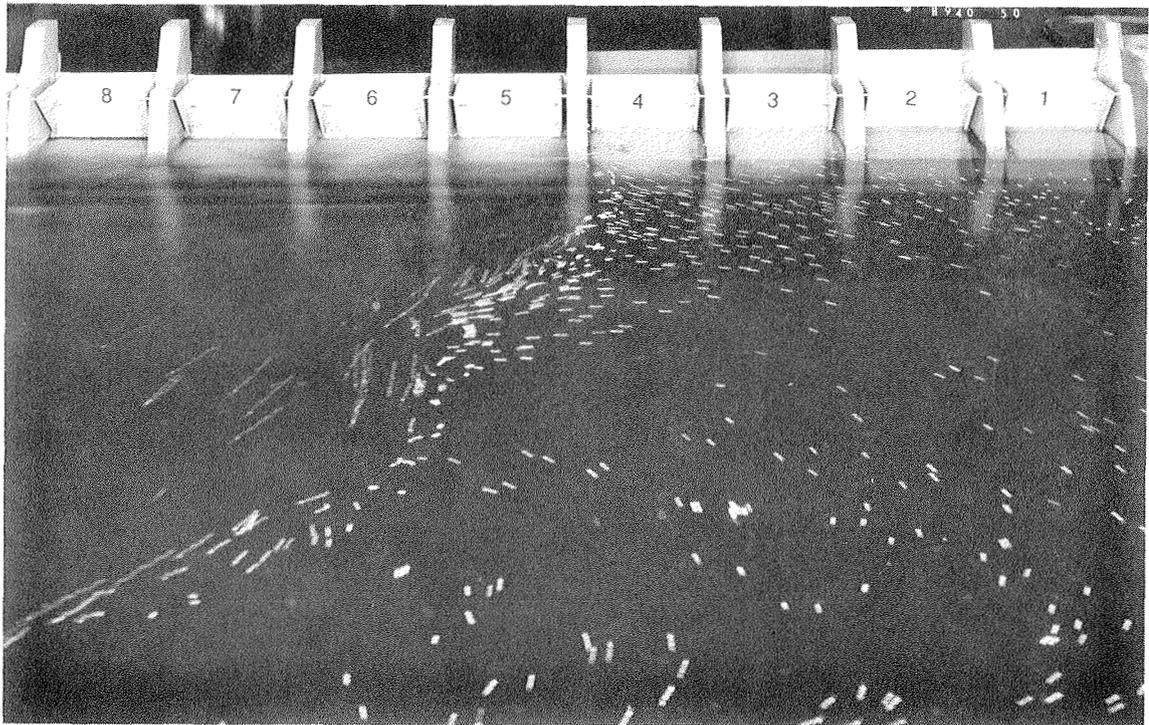
Photo 23 shows flow conditions with gates 1-4 closed for a discharge of 50,000 cfs and pool el 162. These conditions would exist when barges are being placed in the vicinity of gate 2. No adverse flow conditions were observed, flow circulation was minimal, and velocities were less than 3.5 fps. Photos 24 and 25 show flow conditions for a discharge of 15,000 cfs with gates 2-6 and 1-4 closed, respectively. A larger flow circulation pattern was observed with the higher tailwater, but no harmful conditions were observed.

Photo 23. Flow conditions with gates 1-4 closed, discharge of 50,000 cfs, and a pool el of 162
