*General Investigation Research and Development Program*

## **Flood-Fighting Structures Demonstration and Evaluation Program: Laboratory and Field Testing in Vicksburg, Mississippi**

July 2007

Final report

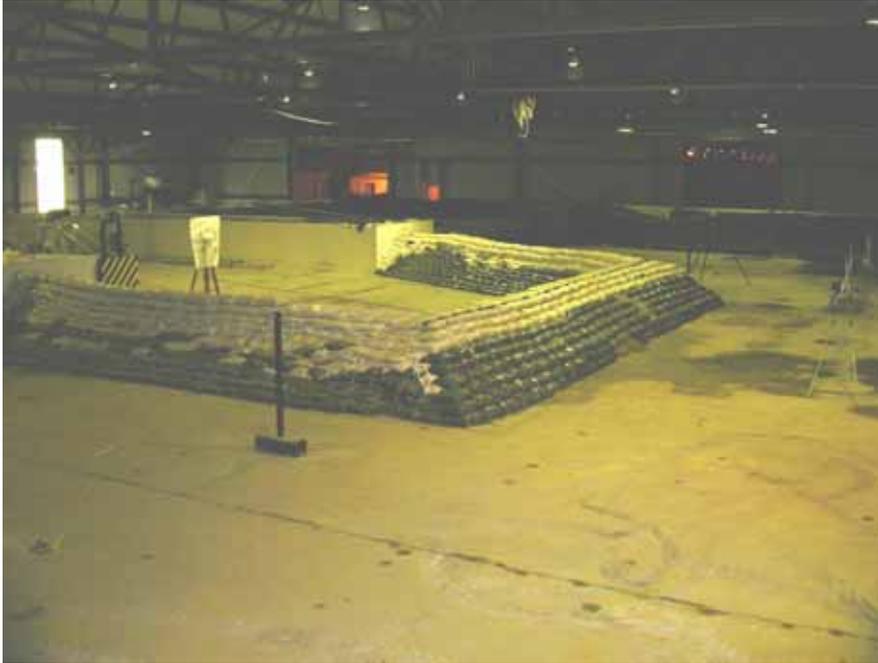
Figure 2-28. Sandbag levee after repair

Figures 2-27 and 2-28 and accompanying text show and explain the failure that required rebuild. A four-man crew took 11 hr (total 44 man-hours) to repair the damage. The rebuild was required from calibration needed to establish the limiting wave forces for all future tests. For this reason, the rebuild is not considered part of the test repairs.

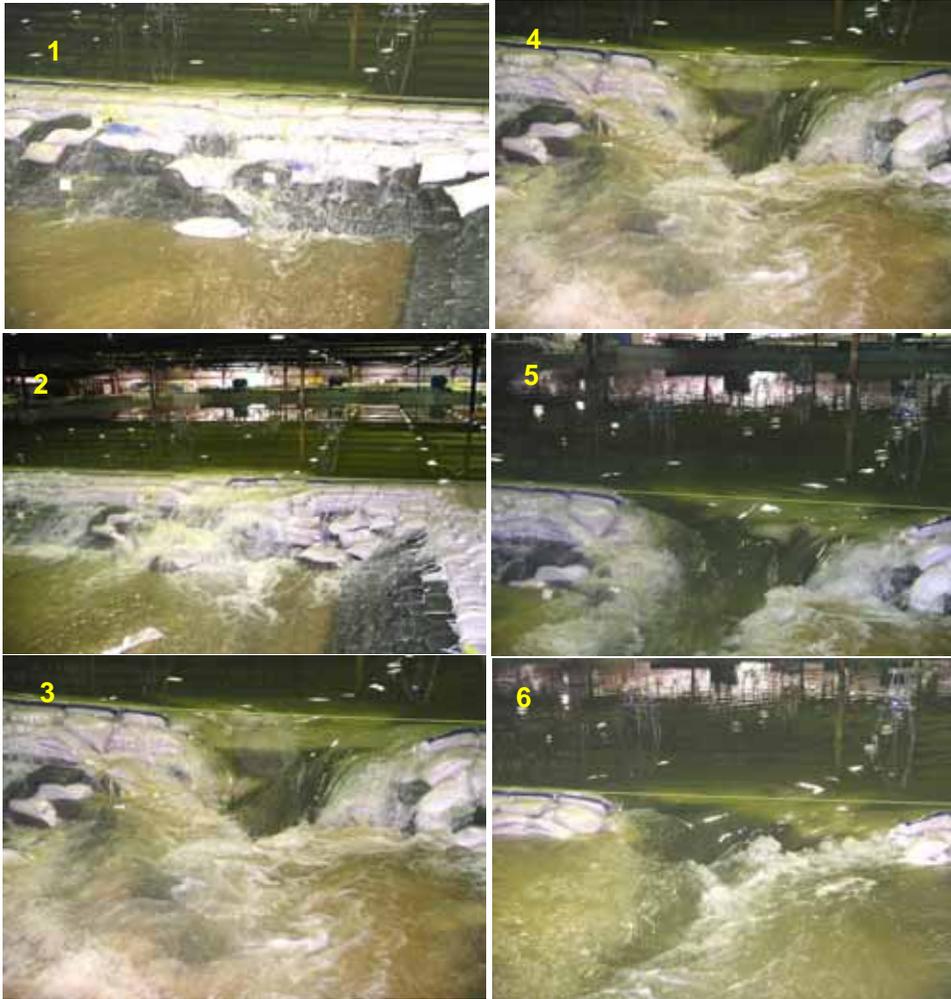
However, the pool overtopped the levee at an elevation of 37 in. (approximately 1 in. above the crest), and continued for a period of 5.7 min. Progressive levee failure occurred as the total flow rate increased from 30.3 to 96.0 gpm/ft. A total flow rate of 2450 to 7,760 gpm is shown in Figure 2-36. Failure and results of failure are shown in Figures 2-37 through 2-40.

The levee failed during overtopping before the pool elevation reached 37.5 in. The pumping rate continually increased until failure occurred. Thus, the structure failed before the test criterion was reached. Figure 2-37 shows the structure prior to testing. Figure 2-38 shows the progressive failure during overtopping. Figure 2-39 shows the sandbag levee after failure. The autopsy of Figure 2-40 shows that the bags became filled with water by the wave action and emptied as the sand flowed out like water (liquefaction). The wave action caused the untied bags to empty. Once the sandbags became light enough, the waves washed the bags from the levee causing failure. Some of the bags found on the landside were completely empty.

Figure 2-38. Sandbag levee progressive failure while testing

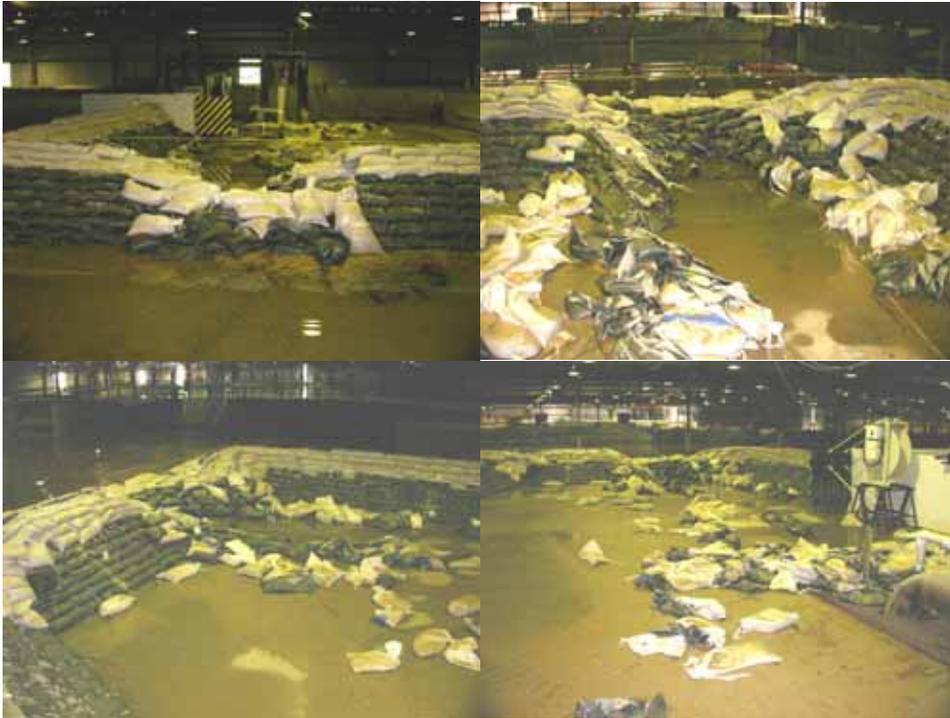
Figure 2-39. Sandbag levee after failure

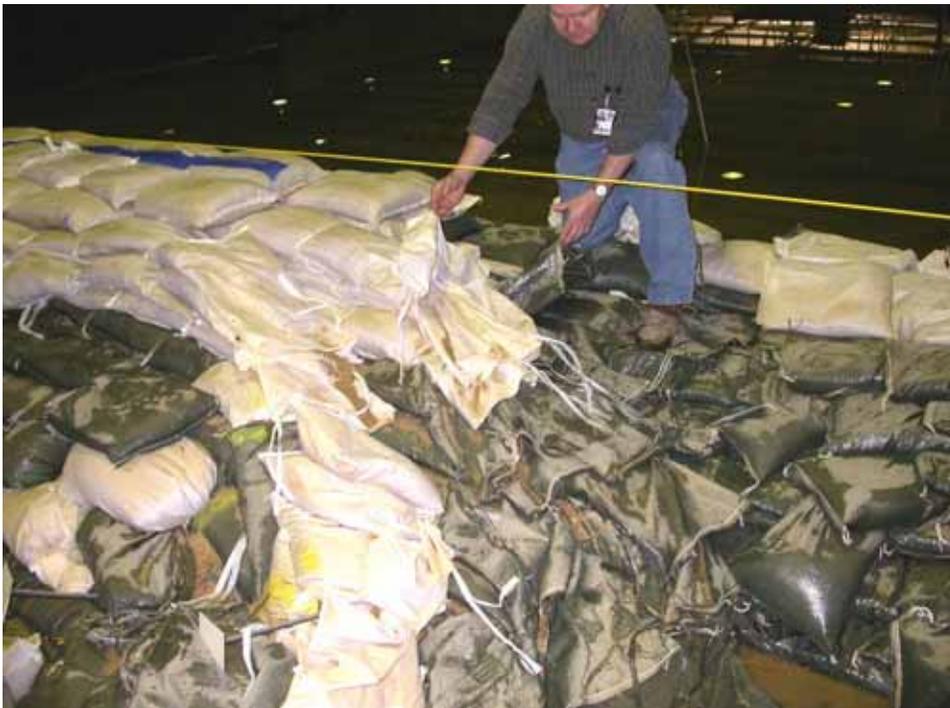
Figure 2-40. Sandbag levee autopsy after overtopping

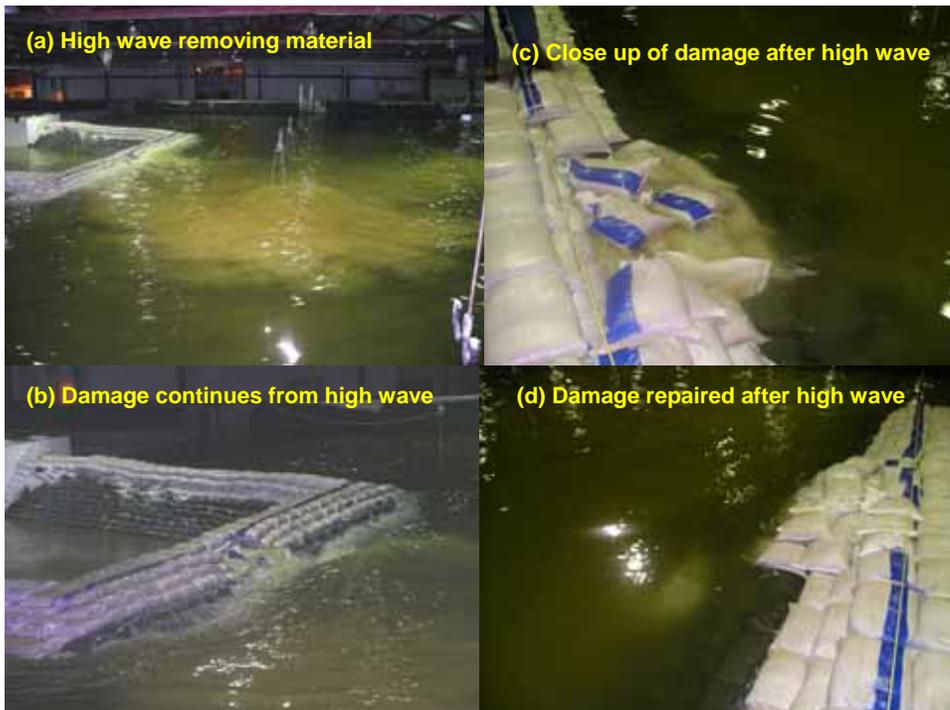
The levee experienced damage at the center section. Sandbags were pulled back into the pool as the waves overtopped and water rushed back into the pool as the waves moved back toward the wave machine. Figure 2-41 shows the levee during the test, the damage after the test, and the levee after Repair 1.

Figure 2-41. Sandbag levee damage and levee after field repair 1

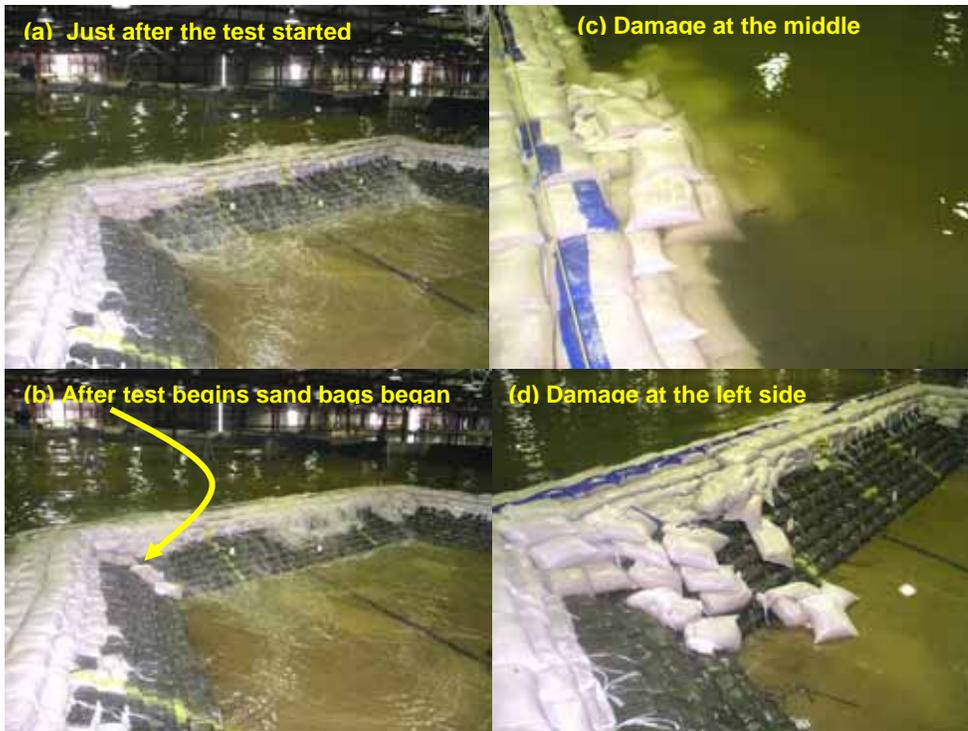
Figure 2-42. Damage to levee during the 10- to 13-in. waves, water at 80 percent of barrier height

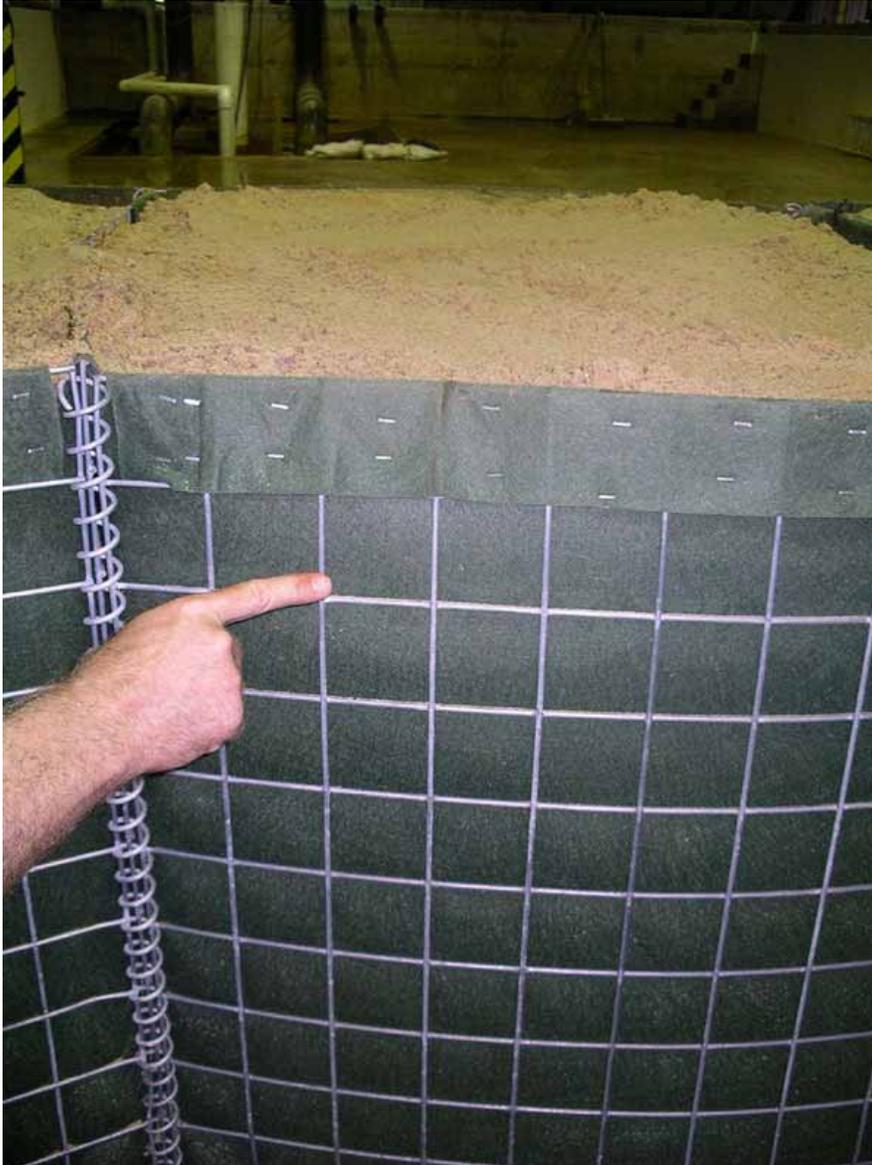
With reservoir level at 24 in., the log impact tests were begun. The 12-in. log impacted the structure and bounced back without causing noticeable damage. The structure displaced slightly and recovered to its original position. The 16-in. log impacted the structure and bounced back also without causing any noticeable damage. The structure displaced slightly and recovered to its original position, but vertical deformations of the sand fill ranging from 4.02 to 0.72 in. were noted. Figure 2-85 shows the minor change in seepage flow rate during impact testing and Figure 2-86 shows the area where the logs hit, viewed from the pool side.

Figure 2-86. Log impact zone on center wall, pool side

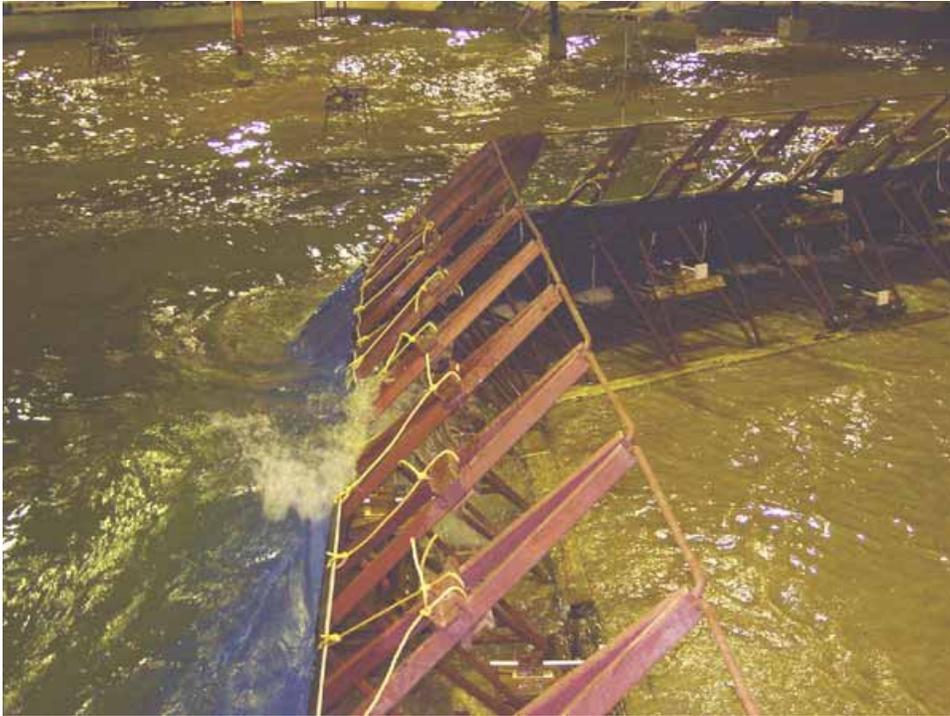
Figure 2-230. Aborted wave test showing wave overtopping along left wall

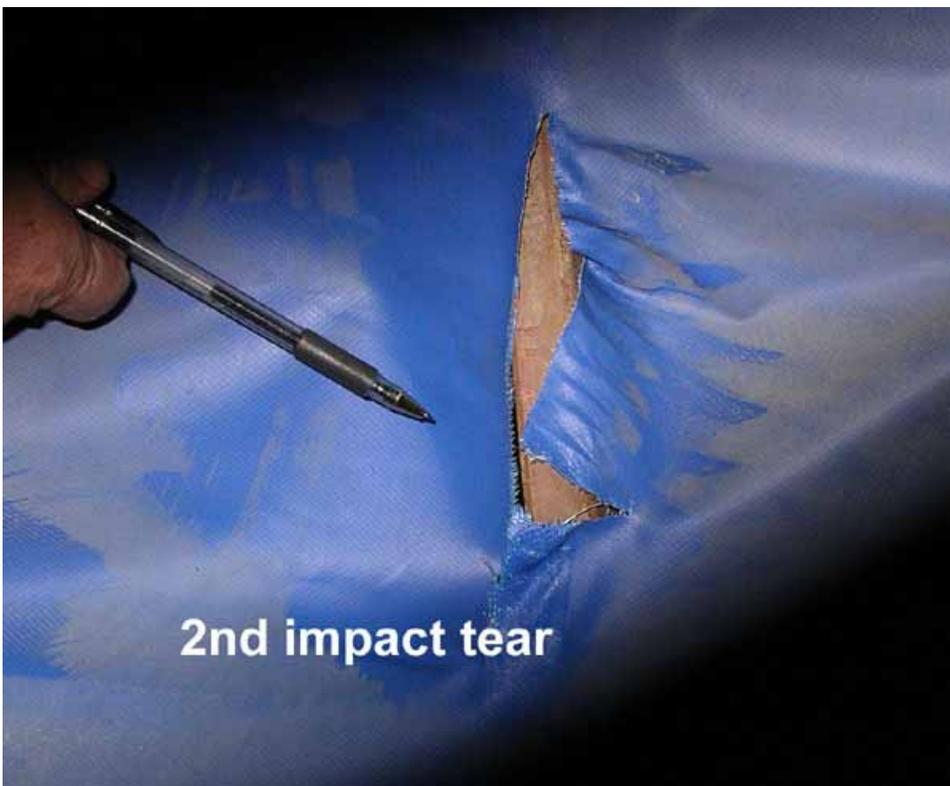
Figure 2-242. View of gash caused by large log. Note frame member behind slit

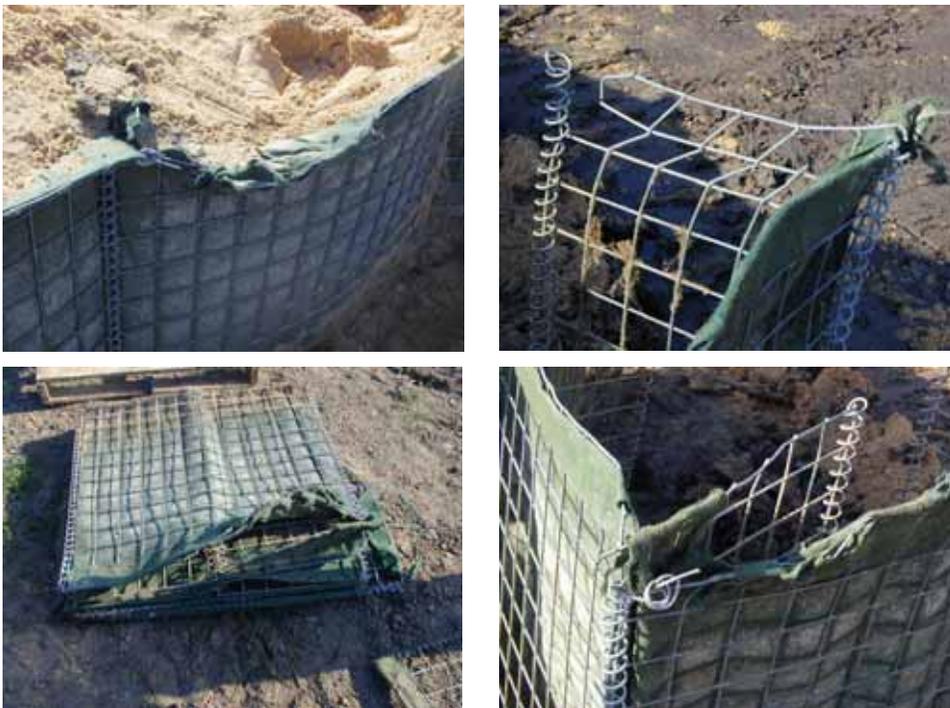
Figure 3-104. Units damaged during removal process
