TECHNICAL REPORT HL-90-19

A STUDY OF VEGETATION ON REVETMENTS SACRAMENTO RIVER BANK PROTECTION PROJECT

PHASE 1

LITERATURE REVIEW AND PILOT STUDY

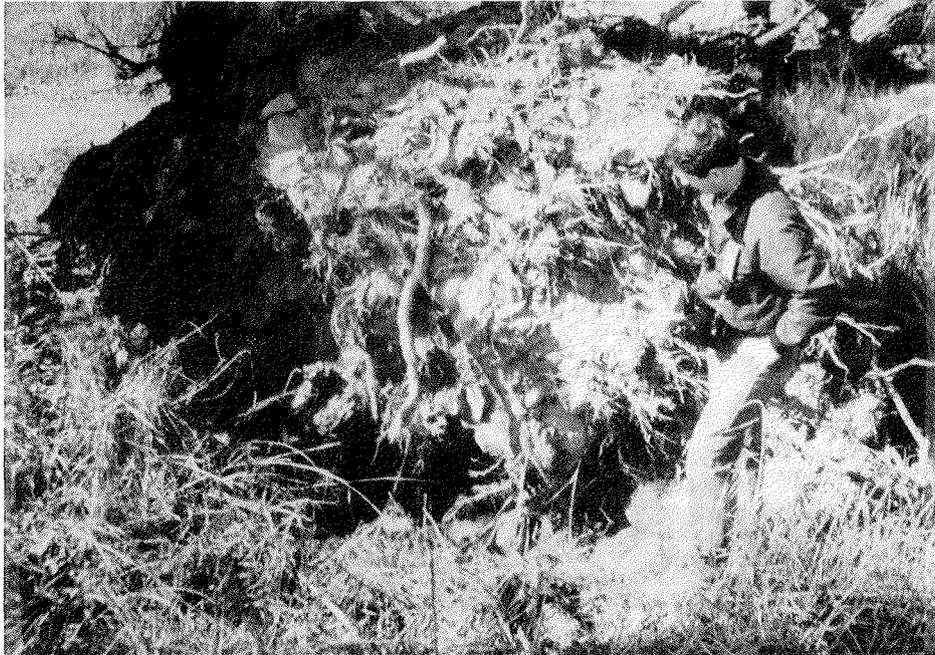
Figure 7. Large cottonwood uprooted from cobble revetment by wind, near Sacramento River, February 1989

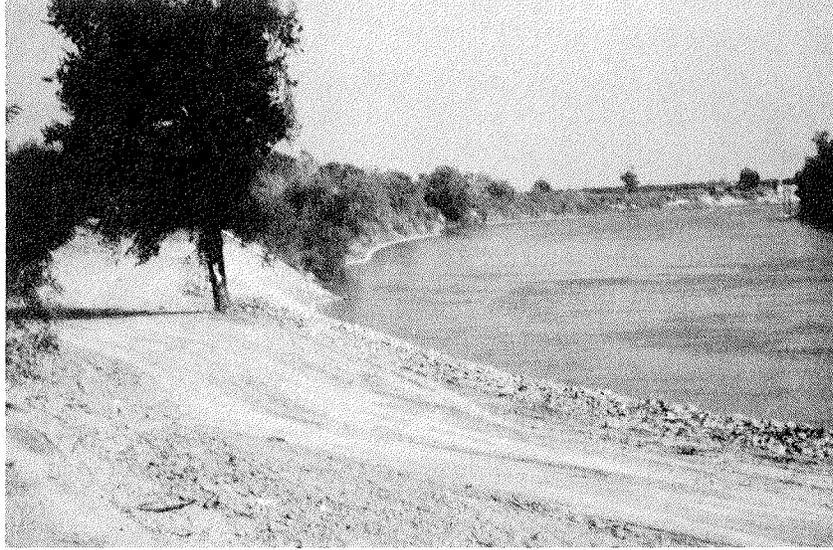
a. Looking upstream from Sacramento River, RM 72.5R, August 1987. Recently constructed revetment in foreground, overgrown revetment in background

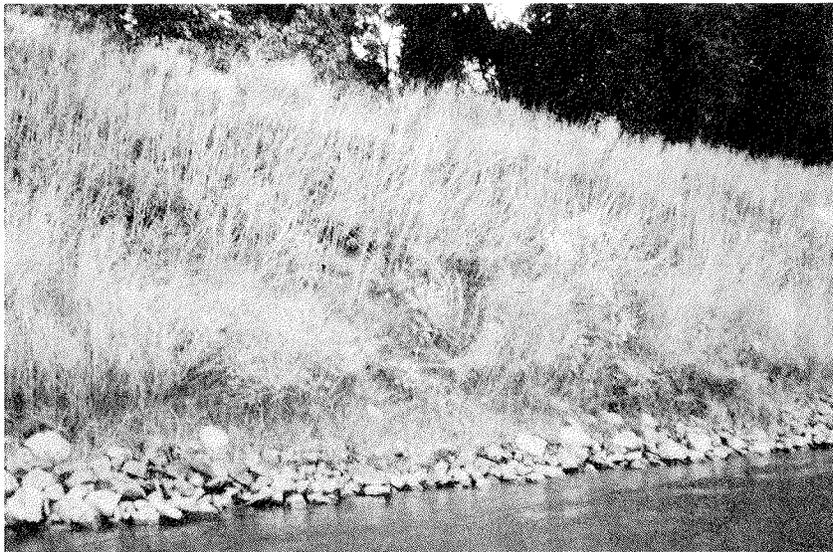
b. Sacramento River, RM 91.2R, September 1989. Rock riprap revetment overgrown by grasses and forbs (referred to as Type 1 vegetation in Part IV of text)

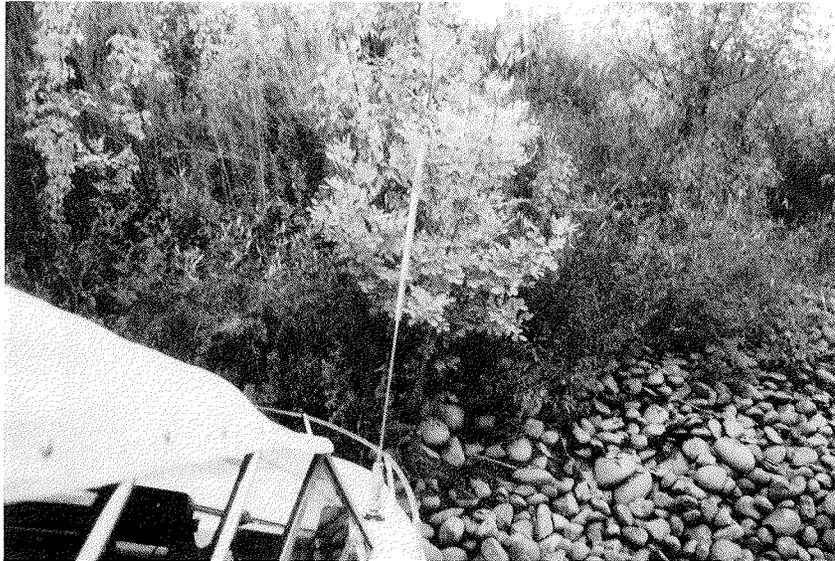
c. Cobble revetment, Sacramento River, RM 104.6R,
September 1989. Type 2 vegetation (see Part IV)

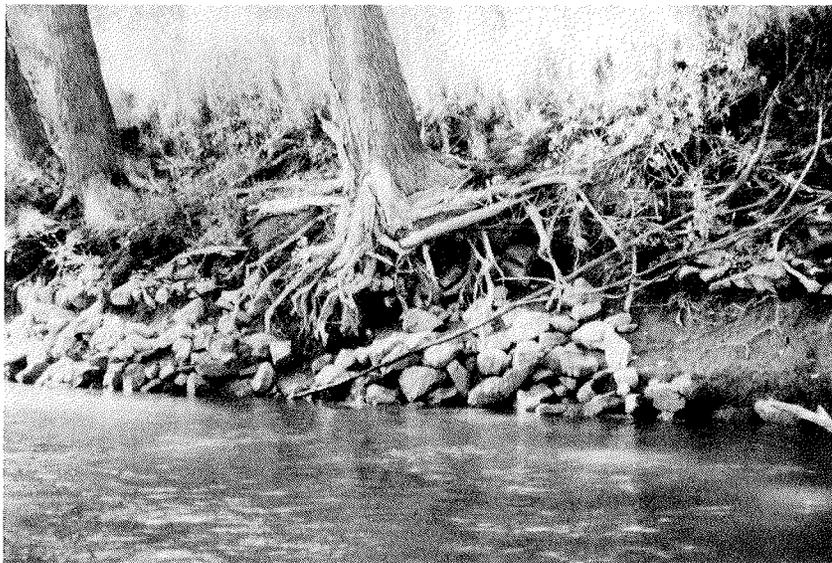
d. Riprap revetment, Sacramento River, RM 141.5R,
September 1989. Type 3 vegetation (see Part IV)

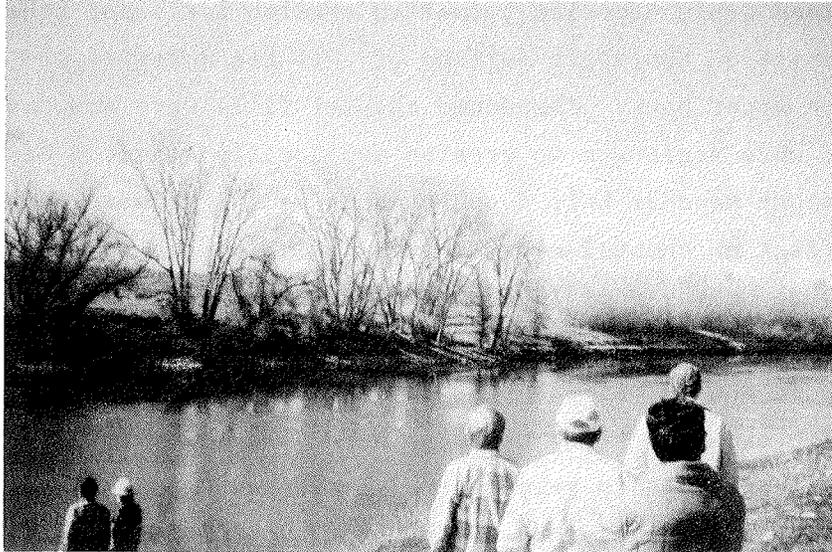
Figure 14. Longitudinal sediment berm on revetment, Sacramento River, February 1989. Trees on opposite bank are growing on a sediment deposit on a revetment

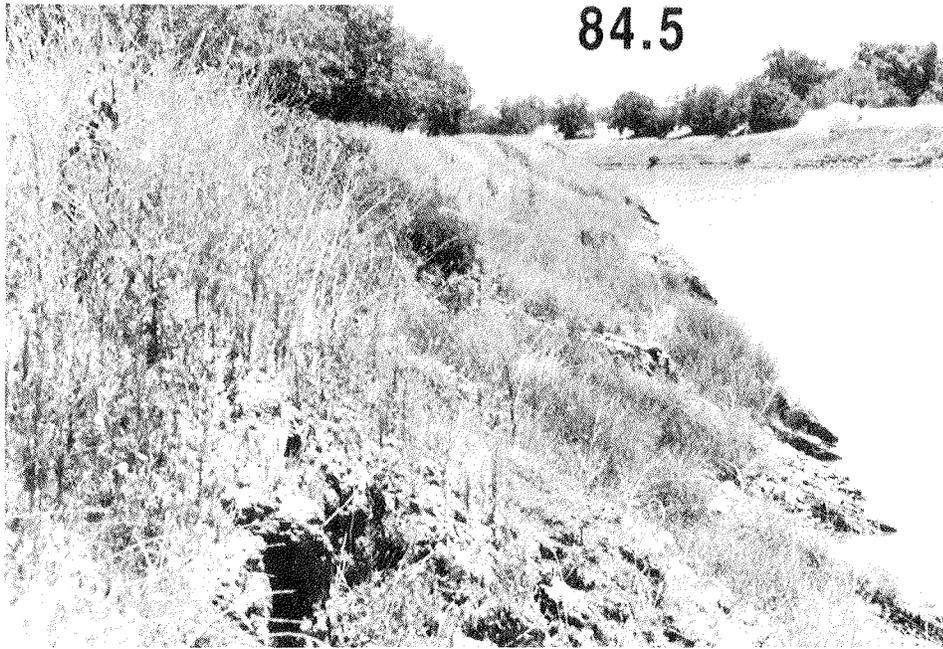
a. RM 84.6 to 85.4L

Figure 20. PL-99 damage sites, pilot study reach (Sheet 1 of 3)

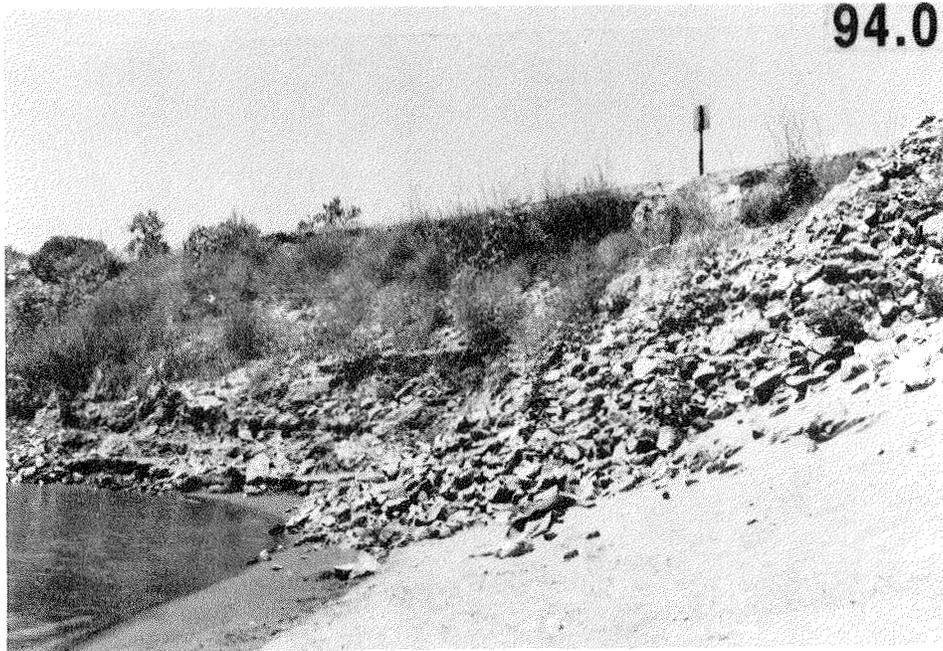
c. RM 94.0L

Figure 20. (Sheet 2 of 3)

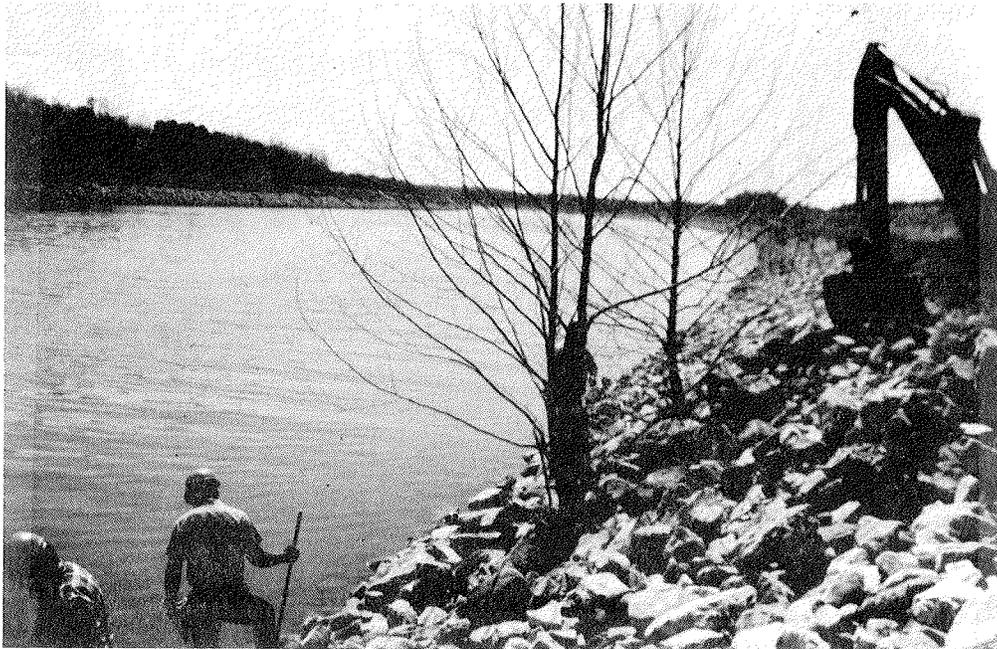
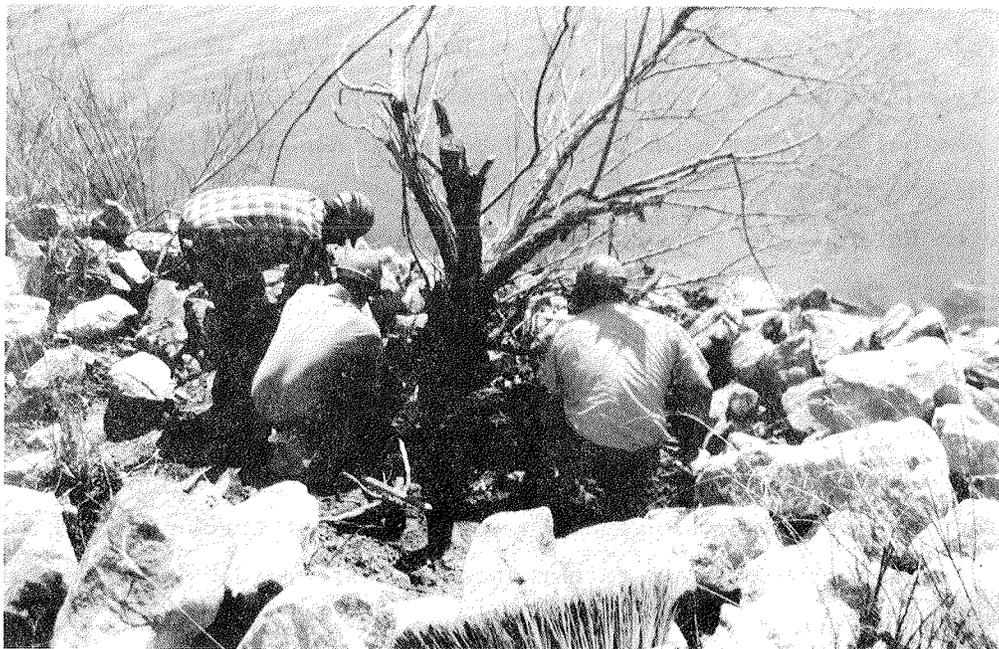
Figure 33. Tree growing in riprap slope protection, Divide Section, Tennessee-Tombigbee Waterway, Mississippi

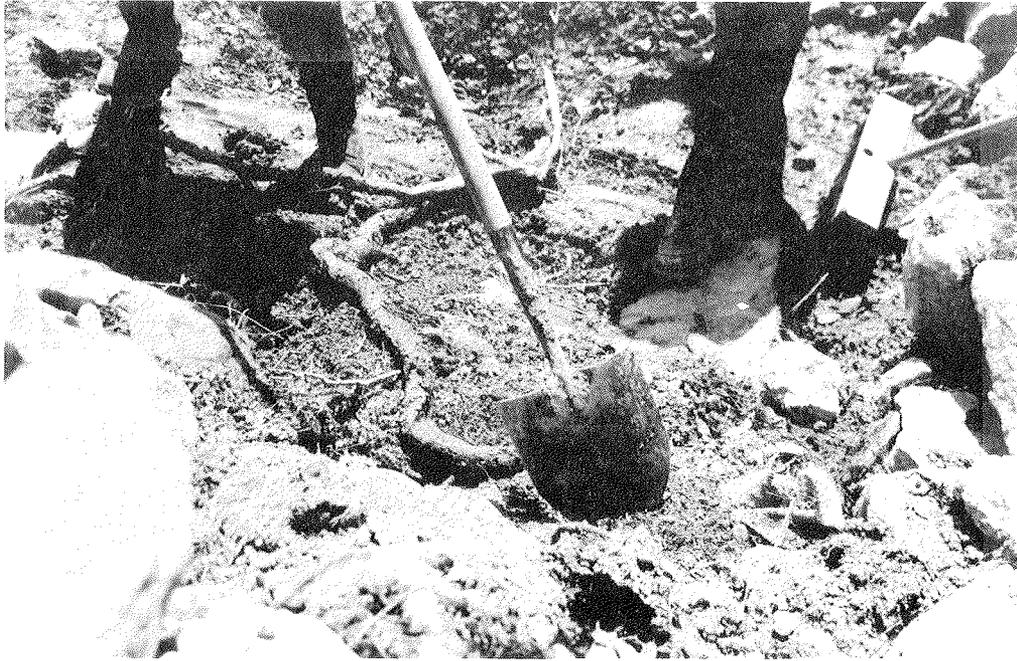
Figure 34. Excavation of riprap from around tree growing in slope protection, Divide Section, Tennessee-Tombigbee Waterway, Mississippi

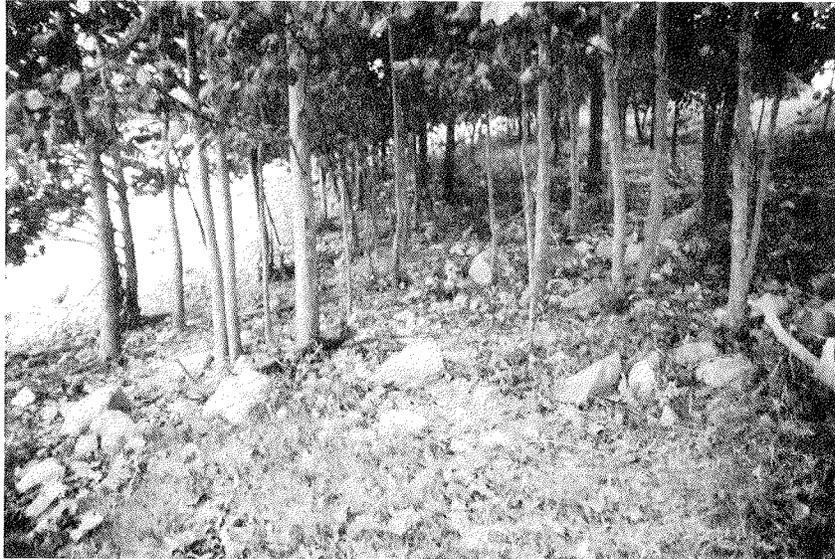
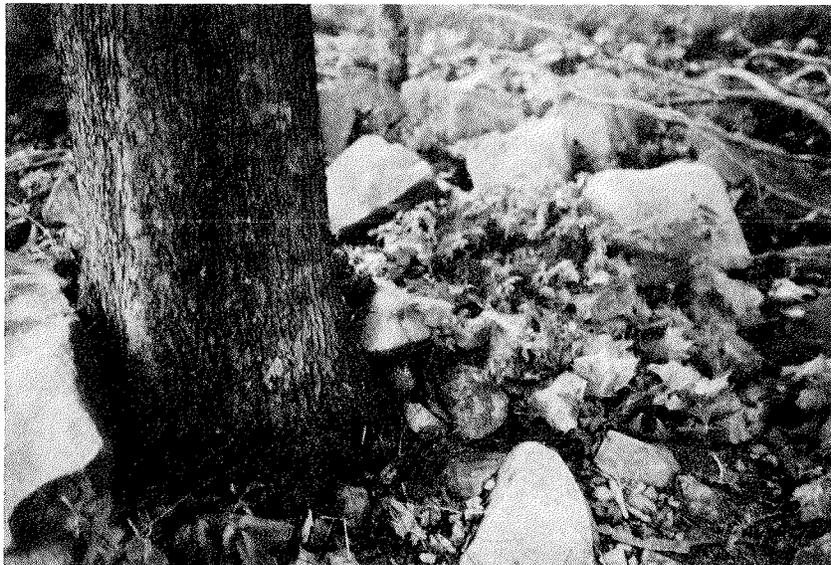
Figure 37. Large vegetation growing in riprap, Morameal Revetment, Red River, RM 256.1, October 1989
