Coastal Engineering Technical Note

SHORELINE RESPONSE TO THE REDINGTON SHORES, FL BREAKWATER

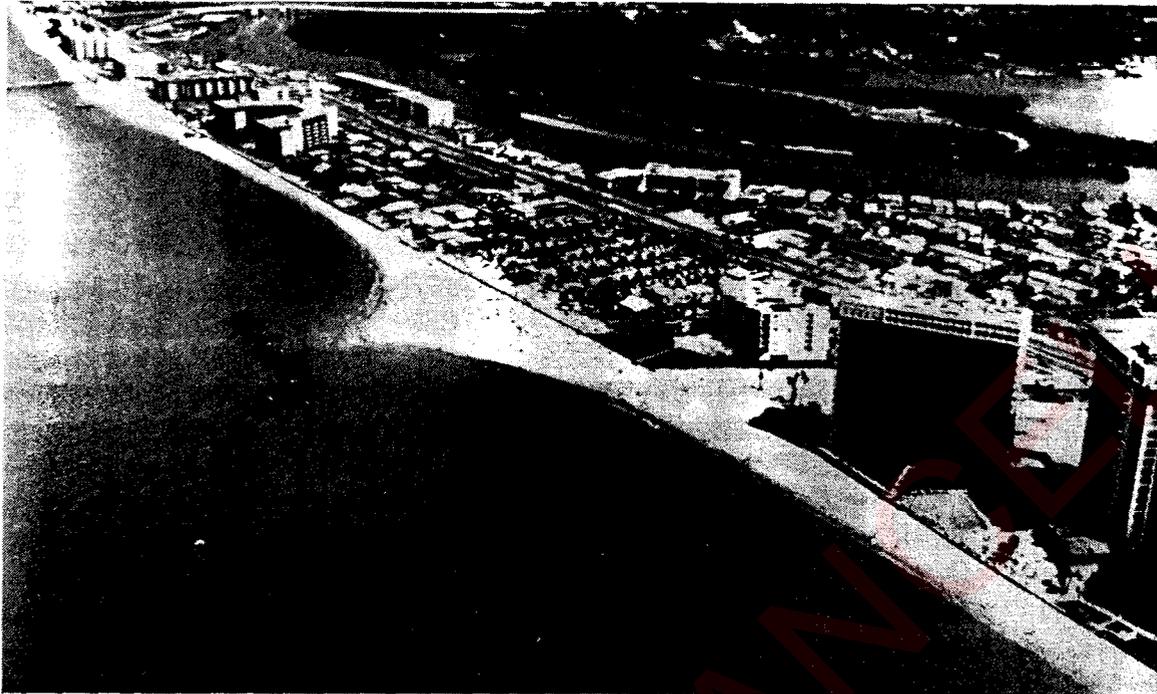
SHORELINE RESPONSE: Figure 3 is an aerial photograph of the project area just 4 months after breakwater completion. This photograph demonstrates the rapid tombolo formation which occurred in the lee of the breakwater and the effectiveness of the structure in attenuating wave energy.

Figure 3. Aerial photograph of Redington Shores breakwater: April 1986 (four months after construction).

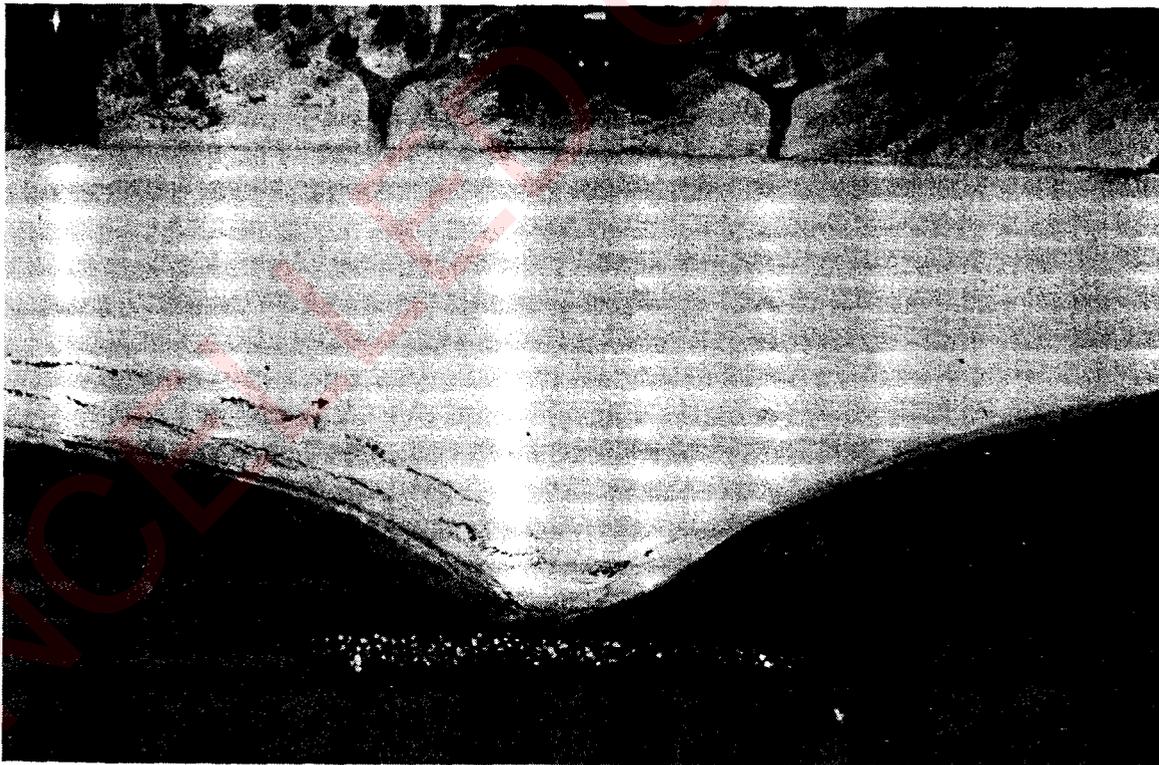
Figure 4. Aerial photograph of Redington Shores breakwater: October 1987.
