**U.S. Army Engineer Research and
Development Center:
Rapid Repair of Levee Breaches**

**FINAL REPORT:
Rapid Repair of Levee Breaches**

July 28, 2011

**Project Co-Principal Investigators:
Donald Resio and Stanley Boc**

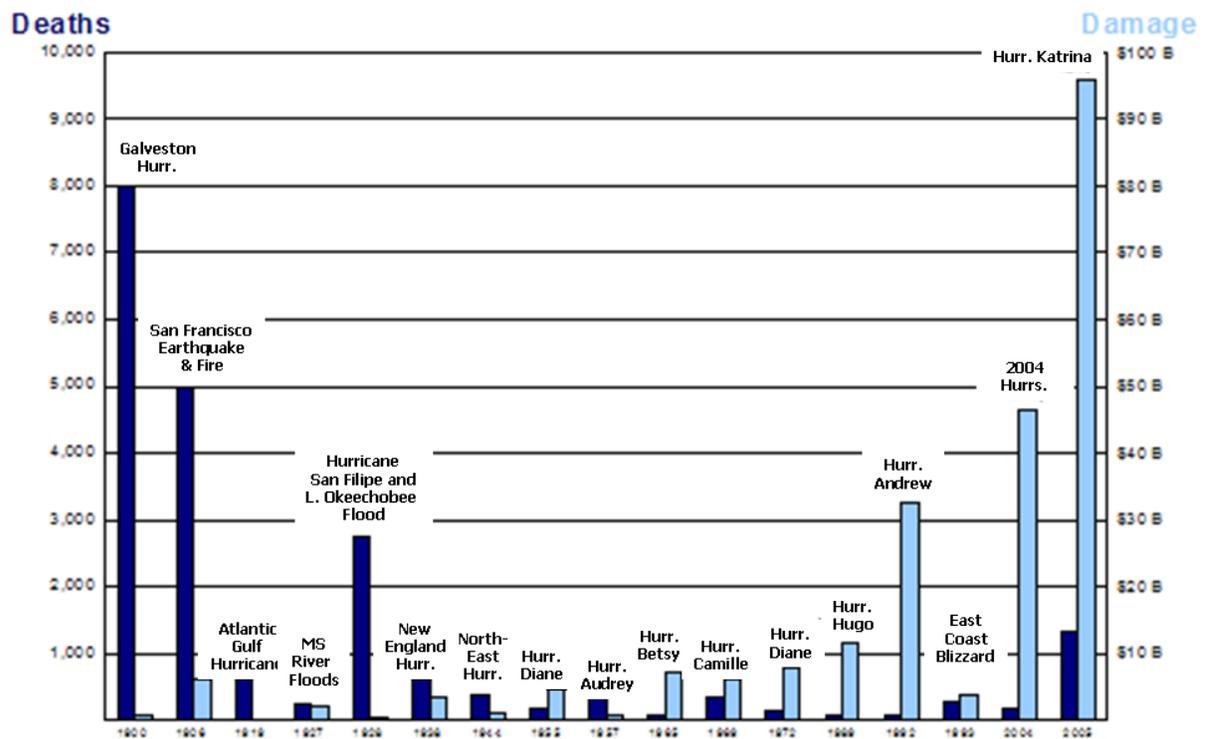
Figure 1. Disaster Fatalities and Property Losses in the U.S. from 1900 through 2005.

Based on a little over a century of disasters within the U.S., a strong case can be made that flooding caused by hurricanes is the major natural disaster leading to loss of life and property. Figure 1 from the U.S. Executive Office of the President (2006) shows that hurricanes represent a clear and persistent threat to the U.S. population and their livelihood. Moreover, inland flooding, such as the almost annual floods in the upper Midwest and the potential impact of floods in the Sacramento Delta area and Lake Okeechobee, add significantly to this overall threat level. Martin and Olgun (2011), consistent with the information in Figure 1, show that damages related to these natural hazards have continued to rise almost exponentially since the early part of the twentieth century. Given continued sea level rise, even if not enhanced by any changes in climate, and the continuing degradation of natural buffers in coastal areas within the U.S., this need is expected to continue to increase.

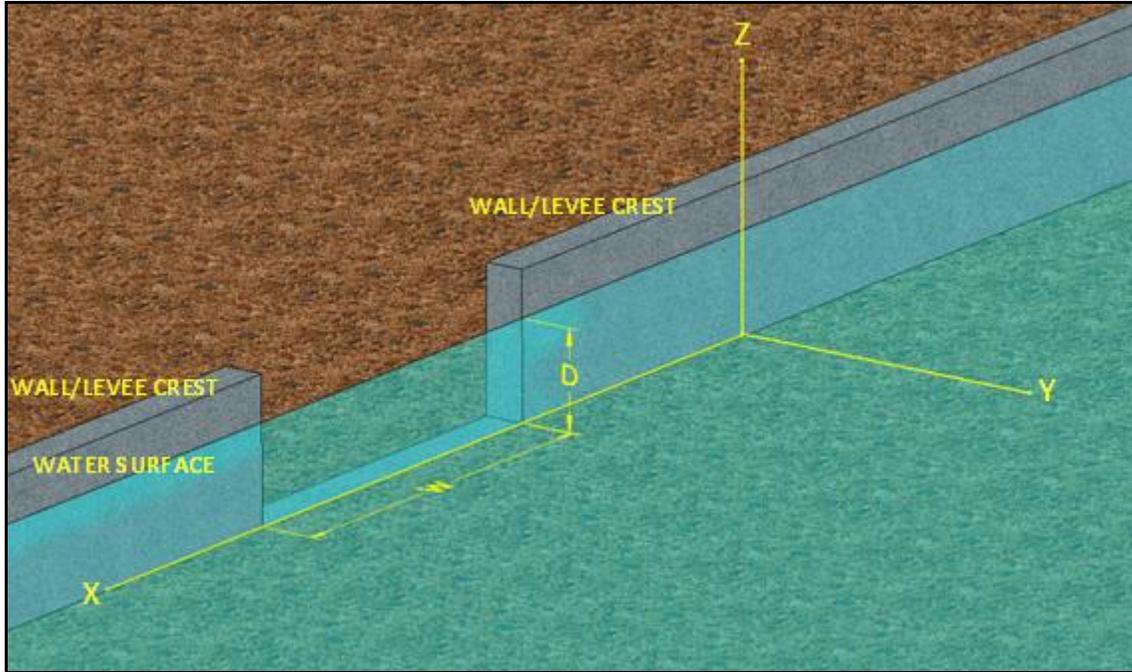
Figure 2. Coordinate system used in this report.

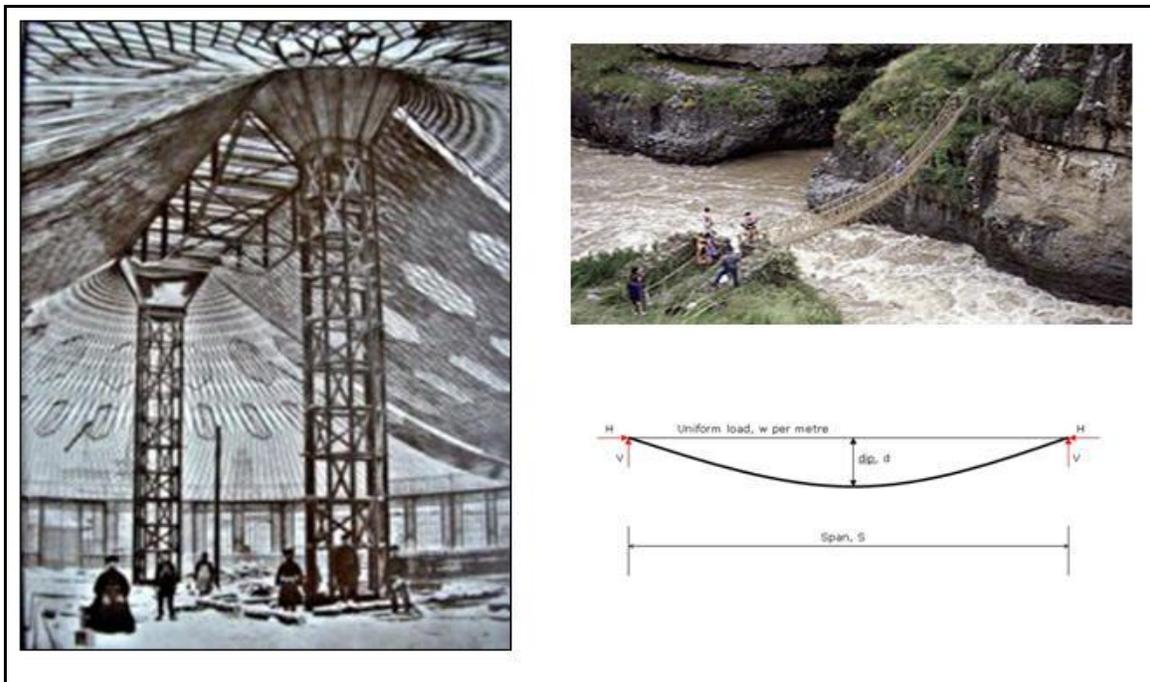
Figure 3. Examples of fabrics in construction. The left hand panel shows the Oval Pavilion from the 1896 World's Fair, while the right-hand panels show the simple idea of using a rope structure to carry a load across a span.

Fabrics have been used since ancient times as elements of expedient structures. The basic concept has remained the same through the ages – use the fabric to carry tensile loads, while allowing rigid (non-fabric) structural elements to bear the compressive loads as shown in Figure 3. In the left-hand panel the structural columns provide the support for the fabrics; while in the right-hand panel, the anchoring into the rock provides the support for the tension.

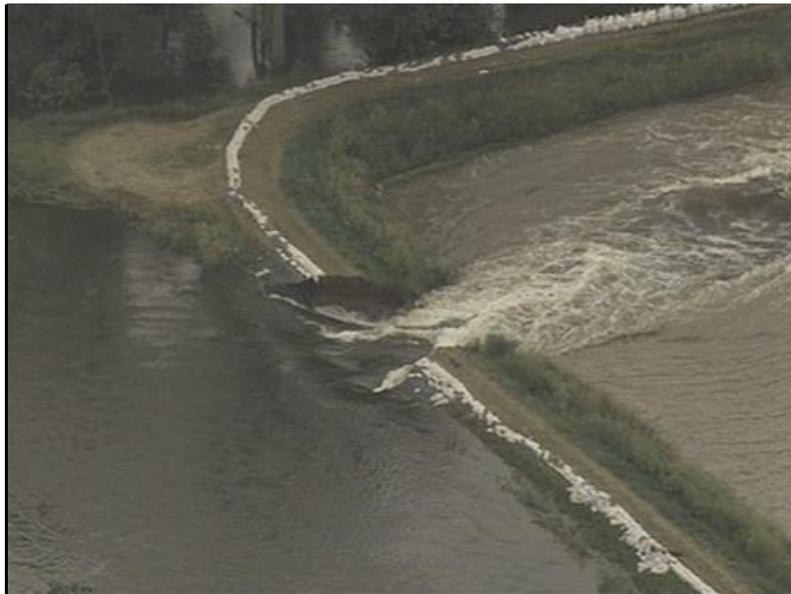
Figure 4. Failure of the Pin Oak levee in Midwest.

Note sand bags atop levee used to fight rising water levels.

Both natural and man-made levees have a long history of breaching in nature. Natural levees, built from sediment deposition when rivers overflow their banks, occasionally breach in what is termed a crevasse. Throughout the U.S., failures of natural and man-made levees have resulted in lives lost, destroyed infrastructure, and huge economic losses. One example is the Midwest portion of the U.S. containing the Upper Mississippi River, Missouri River, and their tributaries. The Midwest experiences flood events that result in levee failures. Figure 4 shows a levee failure on the Pin Oak levee in the Midwest. Figure 5 shows the Elm Point levee break from the Midwest.

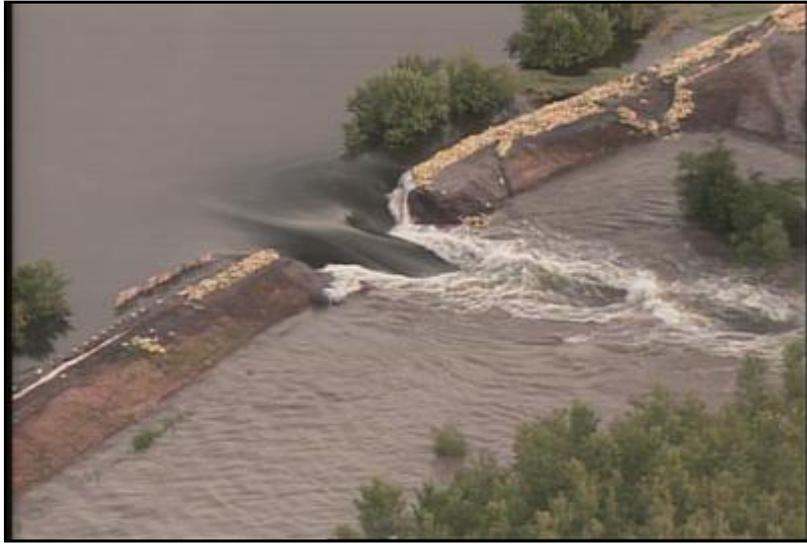
Figure 5. Failure of the Elm Point levee in Midwest.

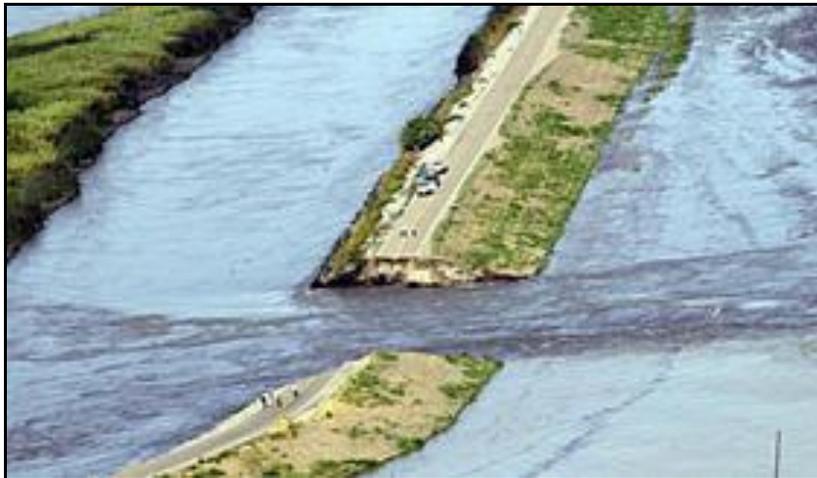
Figure 6. Upper Jones Tract levee Breach in the Sacramento-San Joaquin River Delta.

Another area where levee failures are of great concern is the Sacramento-San Joaquin River Delta area. Major flood events have occurred in 1950, 1955, 1964, 1986, and 1997. Mount and Twiss (2004) report that the projected subsidence of the Delta indicates that it will “become increasingly difficult and expensive to maintain the Delta levee system.” Some areas of the Delta are more than eight meters (m) below sea level. This large amount of subsidence greatly increases the chance of piping related levee failures that will be discussed subsequently. Piping related failures are the major concern in these levees. Figure 6 shows the 2004 breach in the levee at the Upper Jones tract in the Sacramento-San Joaquin River Delta.

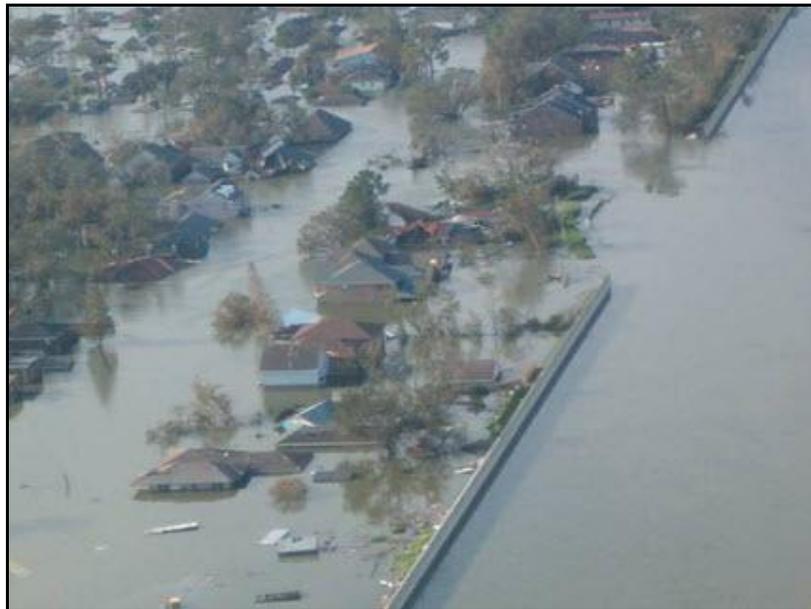
Figure 7. Floodwall failure on 17th Street Canal from Hurricane Katrina in New Orleans.

The current focus on levee breaches was brought about by the large number of levee and floodwall failures that occurred in the New Orleans area in 2005 as a result of Hurricane Katrina. The specifics of the failures are documented in the IPET report. These failures became the most costly disaster in the history of the U.S. During Katrina, levees and floodwalls failed as a result of most of the different causes that will be discussed in section 2.2.2. Figure 7 shows the floodwall failure on the 17th Street Canal.

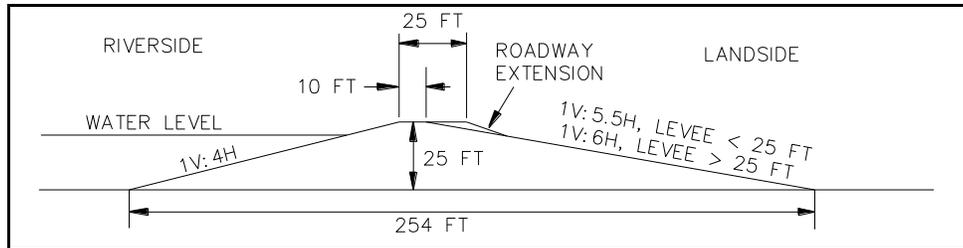
Figure 8. Typical levee cross section on Mississippi River in Memphis District.

- Mississippi River**—From the headwaters to the Gulf of Mexico, the levees along the Mississippi River vary in size and configuration. In the Memphis District, the typical levee section shown on the Memphis District website is shown in Figure 8.

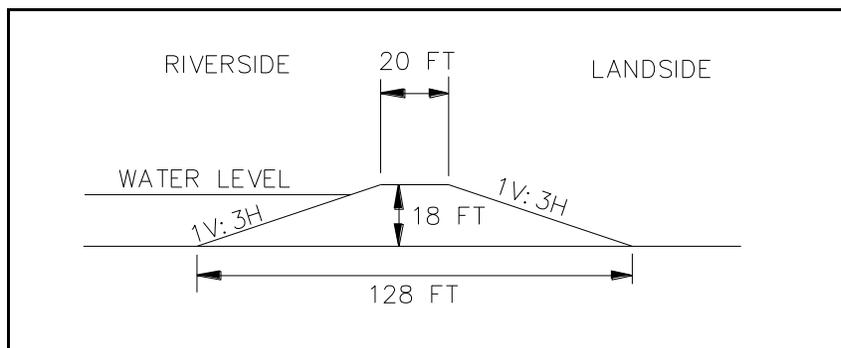
Figure 9. Typical levee cross section on Sacramento-San Joaquin River Delta.

- 7-26 ft levee height relative to landside toe,
- 1V:1H-1V:4.5H on riverside,
- 1V:1.5H-1V:5.5H on landside, and
- 11-38 ft crest width. Using averages of the data, the typical levee section used herein for the Sacramento-San Joaquin River Delta has a height of 18 ft, riverside and landside slopes of 1V:3H, and crest width of 20 ft as shown in Figure 9

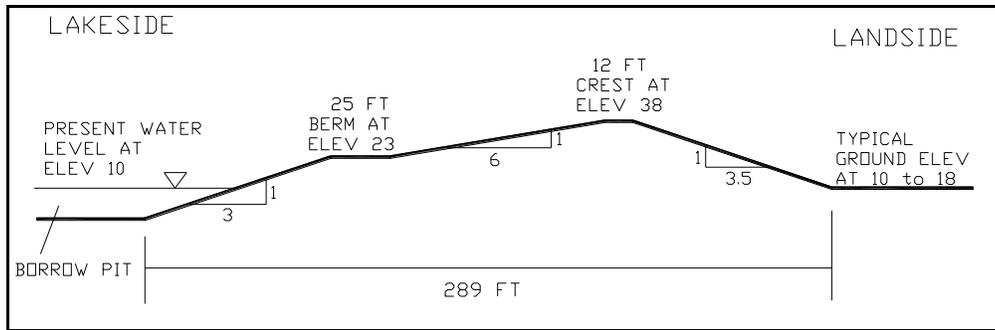
Figure 10. Typical levee section on Herbert Hoover Dike.

- Lake Okeechobee/Herbert Hoover Dike**—Based on “Report of Expert Review Panel, Technical Evaluation of Herbert Hoover Dike, Lake Okeechobee, Florida”, has a crest elevation of 32 to 46 ft with adjacent land elevation of about 10 to 18 ft. Lakeside slopes vary from 1V:10H to 1V:3H and landside slopes vary from 1V:5H to 1V:2H. Based on personal communication with Sam Honeycutt of the Jacksonville District, a typical levee section on the Herbert Hoover Dike is shown in Figure 10.

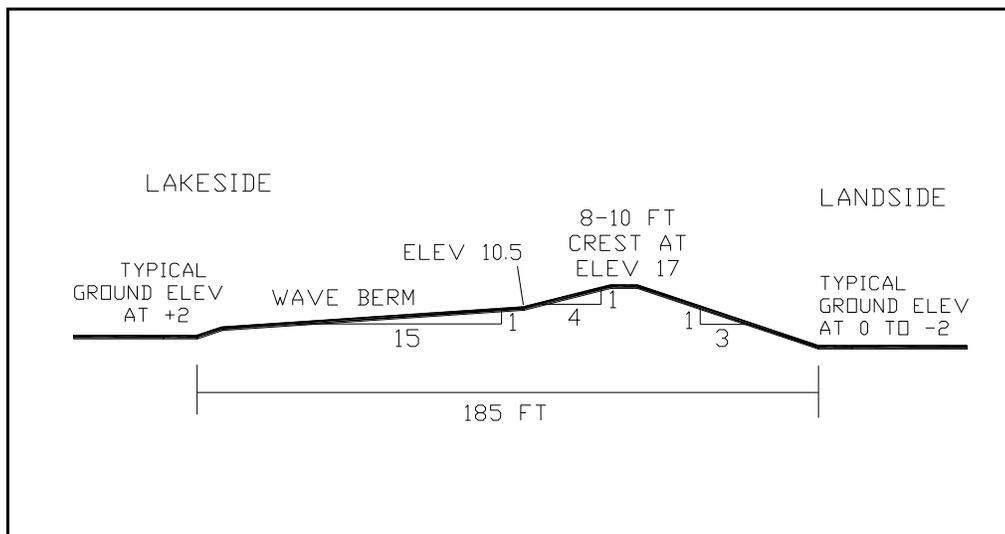
Figure 11. Typical levee section on Lake Pontchartrain in Jefferson Parish.

- Lake Pontchartrain at New Orleans**—Based on personal communication with Mr. Ellsworth Pilie of the U.S. Army Corps of Engineers (USACE) New Orleans District, the typical levee section for Jefferson Parish is shown in Figure 11.

Based on the typical sections presented, some have changing slope on the upstream face that will be a significant problem for sealing the edges of some rapid repair techniques such as barges sunk over the breach.

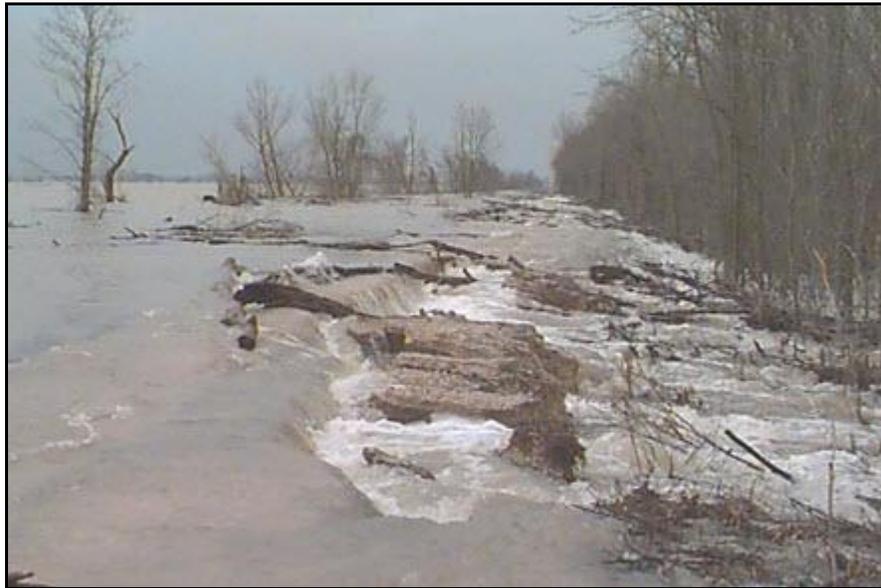
Figure 12. Overtopping of a levee over a wide area with a potential breach growing in foreground.

Overtopping occurs when the water level in the river exceeds the crest of the levee or waves spill over the levee. Because of the relatively steep landside slopes of levees shown in the previous levee cross sections, the water moves rapidly down the land side of the levee. If the height and duration of overtopping is small and the slope is covered by a good layer of grass or other protective material, the levee can survive overtopping. For large heights and durations of overtopping and no landside slope protection, a breach is likely to occur. The overtopping flow will find a locally low or locally weak spot at which erosion is initiated. Once initiated, the flow tends to concentrate the erosive forces and the breaching process accelerates. The stages of breach formation will be discussed subsequently. The Scientific Assessment and Strategy Team (SAST) (2007) reported that eyewitness accounts indicate that the majority of levee breaches during the 1993 flood on the Missouri River were caused by overtopping. Wave overtopping and breaching of the levee is similar to overtopping from excessive river water level except that a RRLB technique may have to be placed in waves and withstand wave forces. Figures 12 and 13 show a levee along a river being overtopped over a wide area.

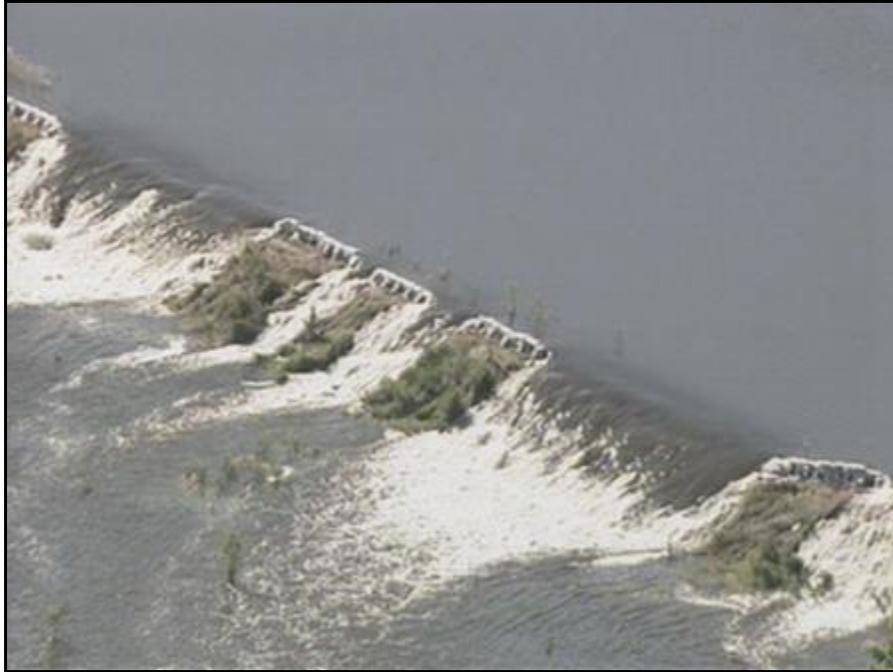
Figure 13. Overtopping of the Foley levee in the Midwest.

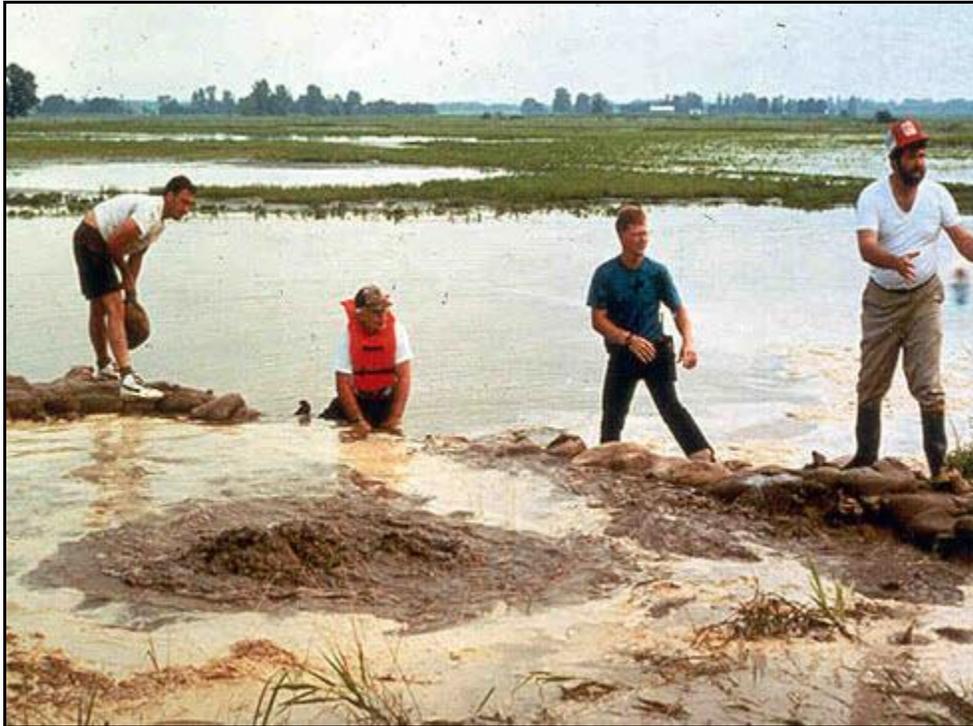
Figure 14. Sandbag levee around sand boil on Kaskaskia River.

to this picture, the ring levee had reduced the flow and stopped the movement of solid material. Suddenly, the levee foundation material started moving again as shown in the figure below. Efforts to further raise the sand bag levee and stop the material movement were unsuccessful and the full breach formed as shown in Figure 15.

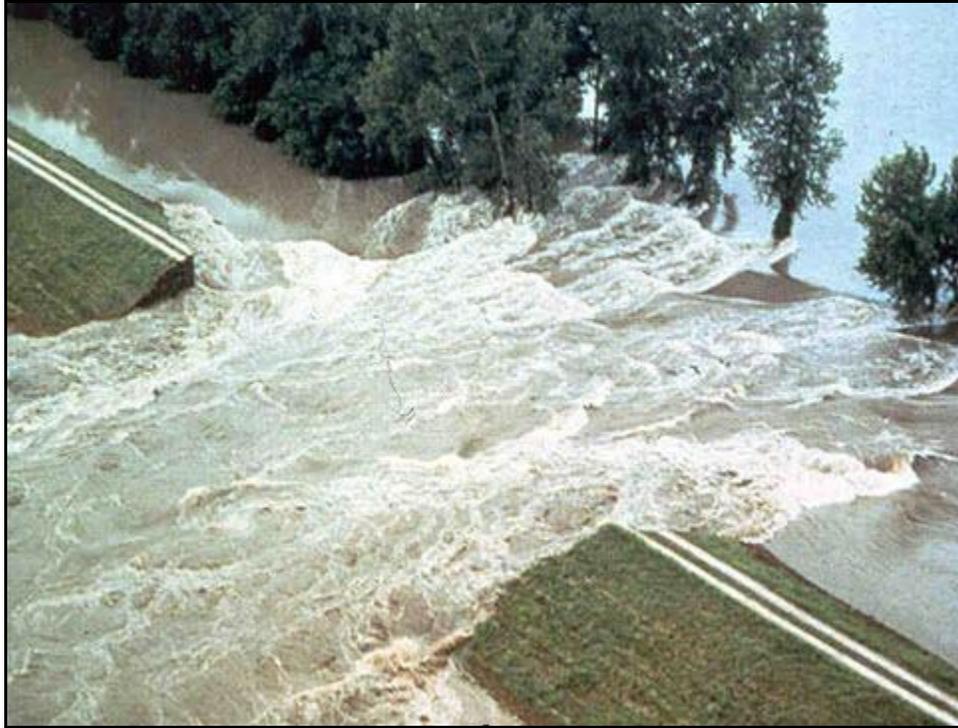
Figure 15. Kaskaskia River levee breach at location of sand boil.

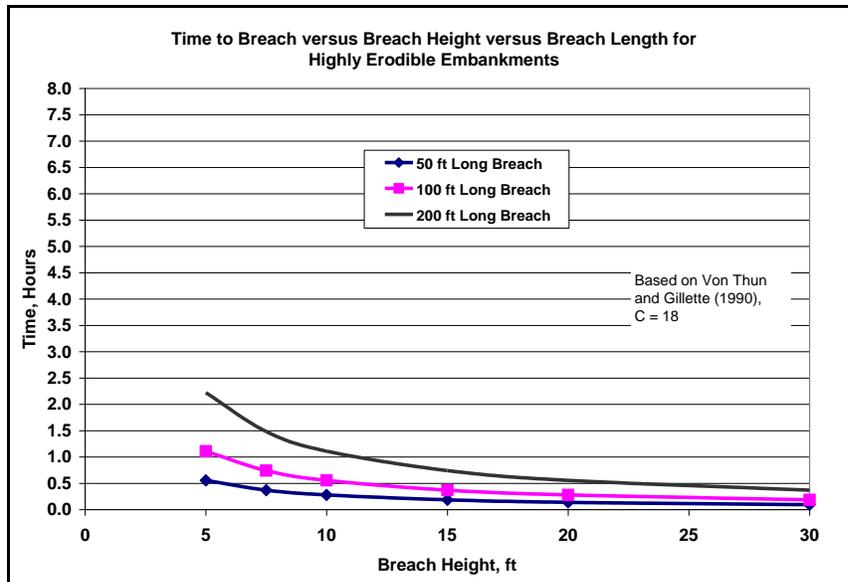
Figure 17. Breach time for highly erodible embankments.

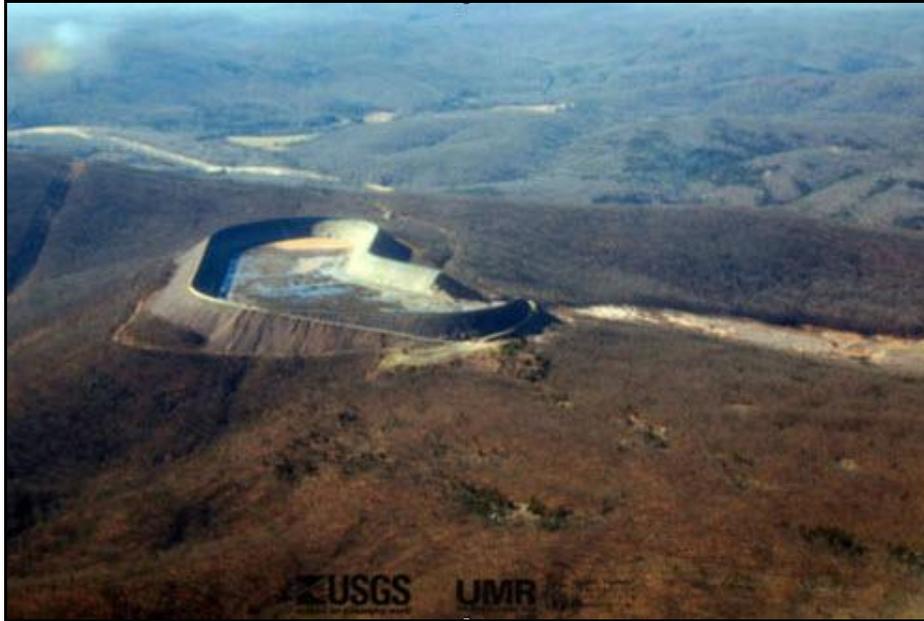
Figure 18. Aerial photo of the Taum Sauk Upper Reservoir, just after breach in December 2005.

Normally a breach forms slowly by overtopping, scouring, or piping; but that is not always the case as exemplified by the failure of the Taum Sauk Upper Dam, Missouri, in December 2005. Figure 18 shows a general view of the Taum Sauk Upper Reservoir near Ironton, Missouri (MO) just after the breach.

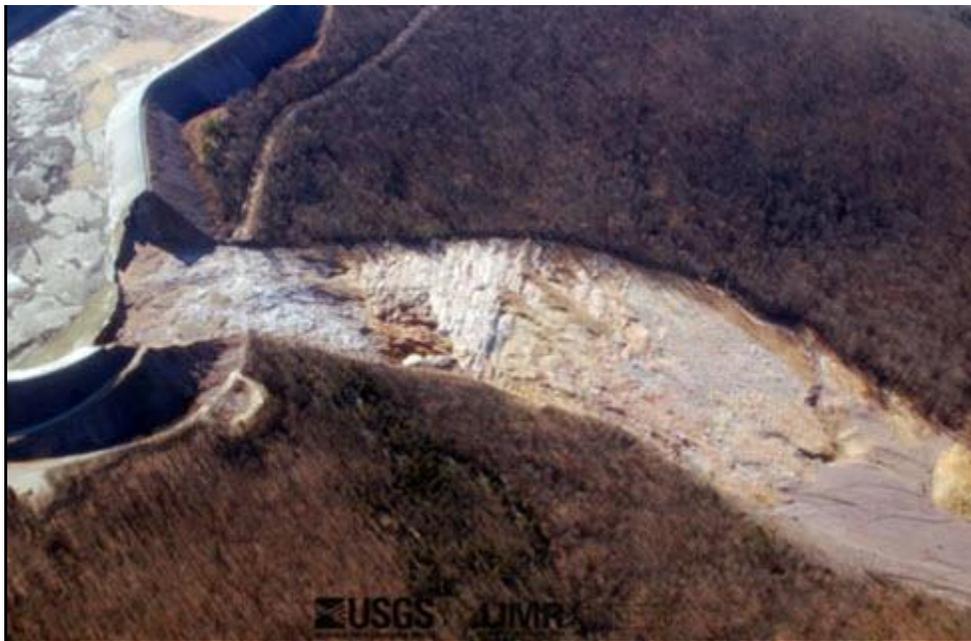
Figure 19. View of emptied lake and vicinity.

Figure 19 shows a closer view of the emptied lake and breach vicinity. In this case the lake wall was overtopped and also suspected of being undermined by seepage. When it collapsed, the lake was emptied in 12 to 15 minutes. It is suspected that the 17th Street breach in New Orleans failed catastrophically after some initial period of overtopping as well. Knowing that such documented cases exist, for this study a worst case scenario was considered as an instantaneous removal of the levee wall, allowing flow to cascade out of the breach.

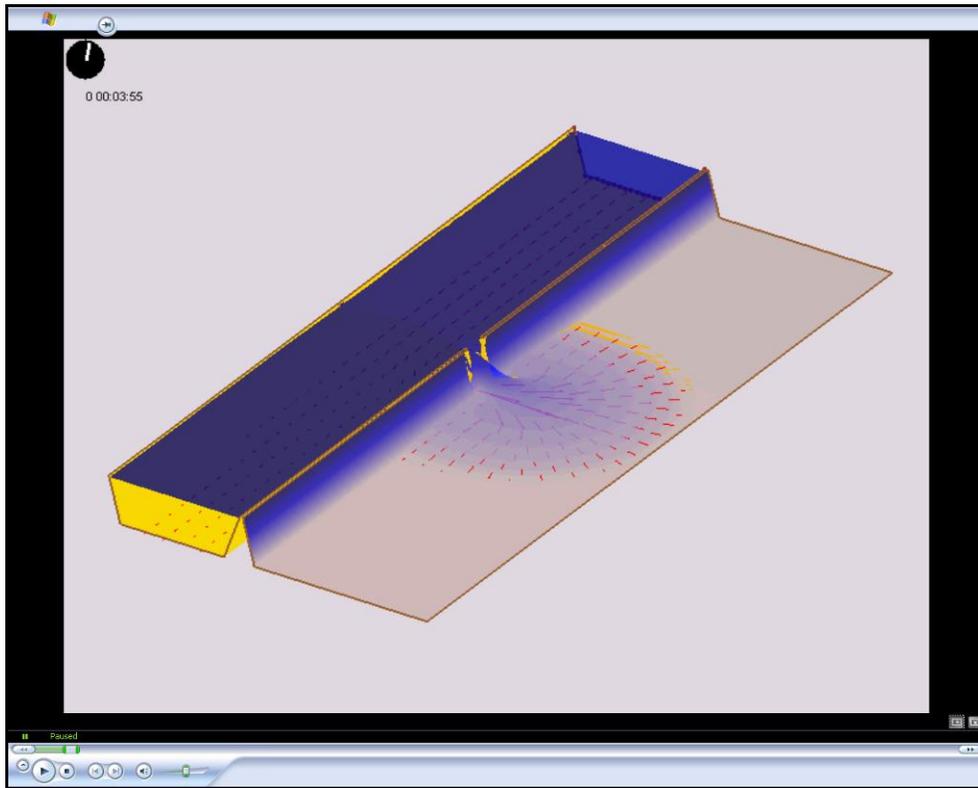
Figure 20. Schematic diagram of computer model of idealized breach.

A conceptual model was staged as water flowing down the Mississippi River. A levee with dimensions similar to large Mississippi River levees is on one side of the model. Opposite the levee is a basin into which the flood waters will flow. Figure 20 shows this situation.

The model is 6200 ft long and about 2760 ft wide. In Figure 20 the left side represents the river and the right side with the grey-brown floor represents an empty and dry basin into which the water from the breach will flow. The bottom of the simulated river and the ground elevation of the basin are made the same in this model. The simulation initial conditions were set with appropriate discharge in the river to maintain water at a depth of about 24.5 ft. The simulation starts when a 200-ft section of the levee is instantaneously removed. Water falls 24.5 ft across the breach onto the dry ground of the basin. The numerical grid for this simulation is shown in Figure 21 as an oblique view with a 5 vertical to 1 horizontal distortion. There are 14,134 two dimensional triangular elements in the grid and 7,369 nodes.

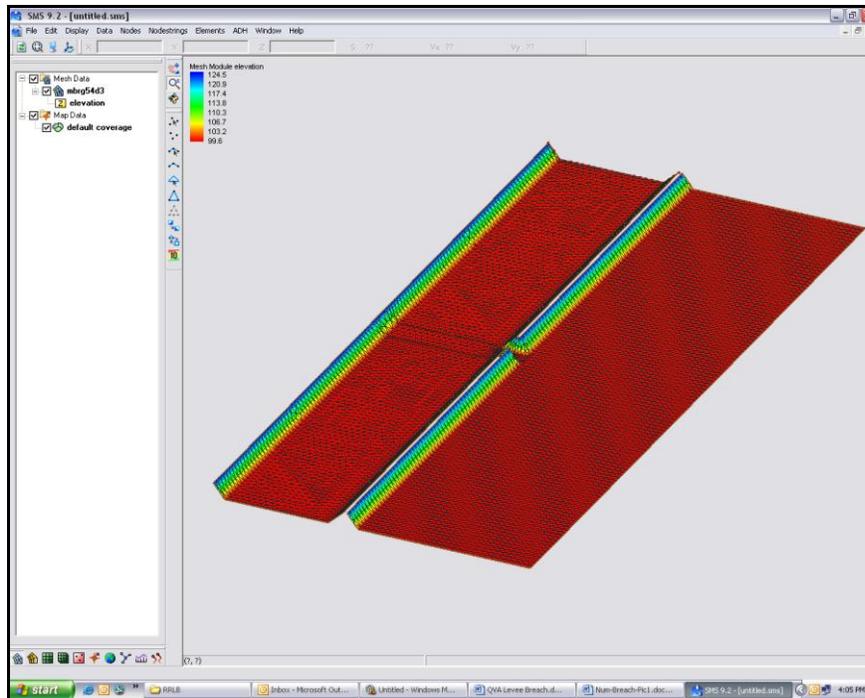
Figure 21. Illustration of nodes used in the idealized breach simulation.

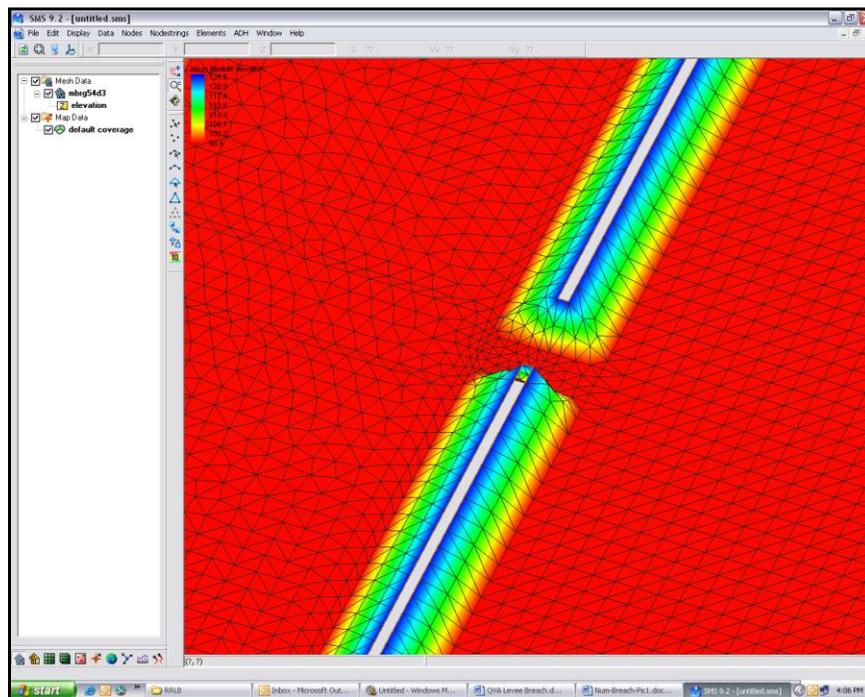
Figure 22. Close-up diagram of nodes in the vicinity of the idealized breach.

Flow is into the river at the top and out at the bottom, with lateral flow into the basin. The basin is fully enclosed to model the effect of filling on the breach discharge. Figure 22 shows a closer view of the 200-ft wide breach opening in the levee wall.

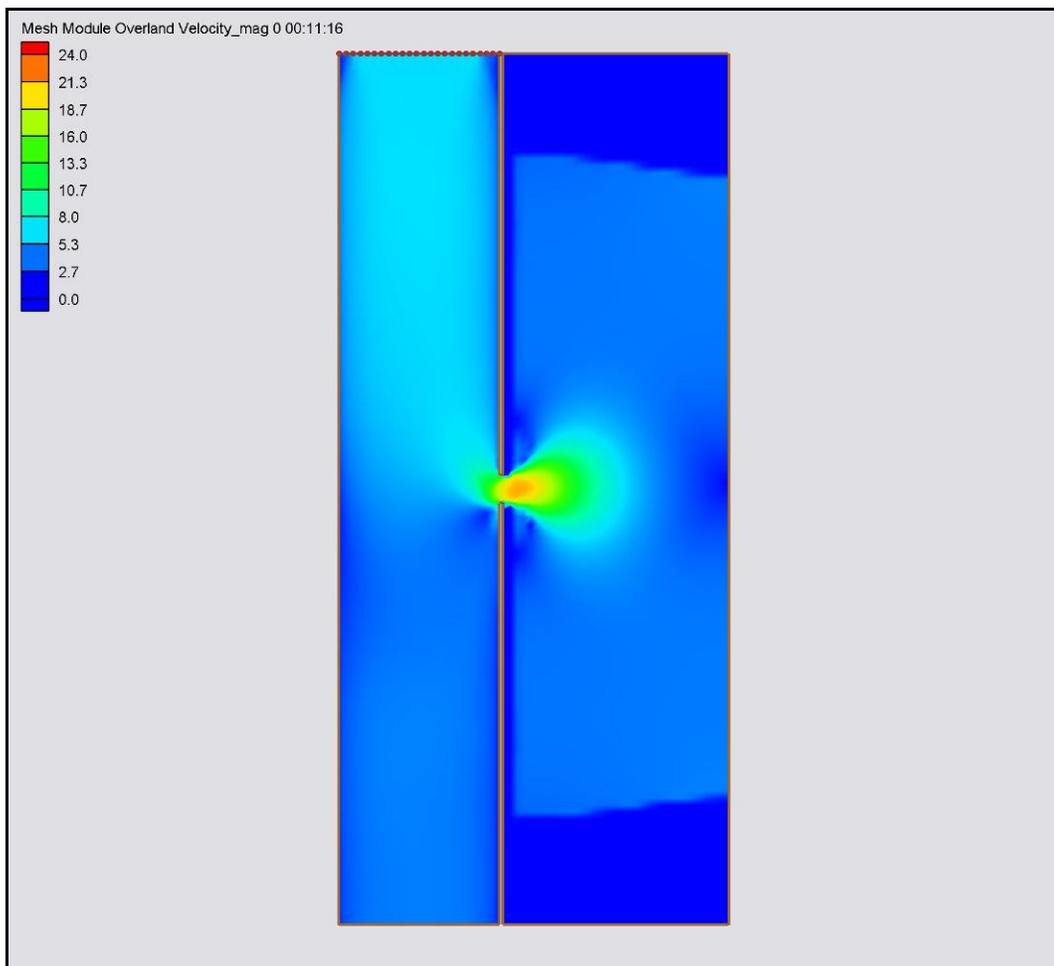
Figure 23. Velocity contours for flows modeled in idealized breach simulation.

The simulation results show that a maximum velocity of about 22 fps occurred over a period of nearly 12 min into the simulation and was located approximately 50 to 250 ft downstream of the levee longitudinal centerline. Figure 23 shows a graphic of these results. Figure 24 shows a computation of the forces that would be exerted on a flat plate per foot of length for any similar object placed in the flow field at a given location.

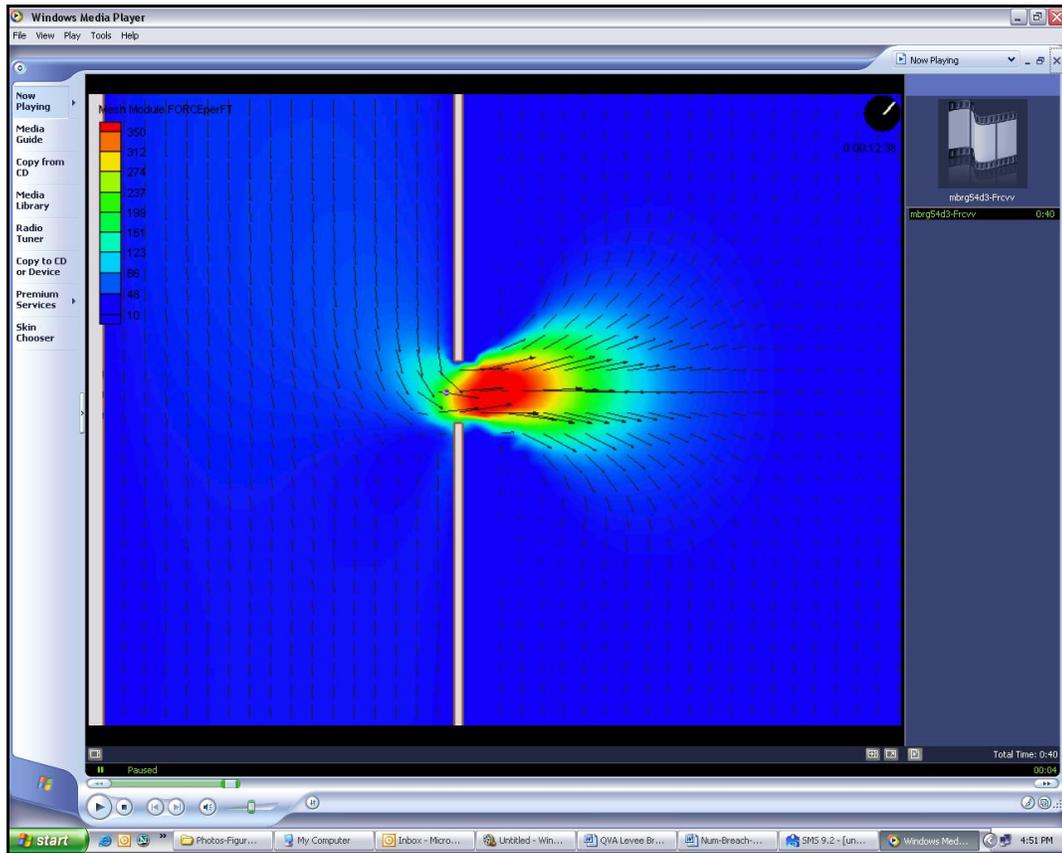
Figure 24. Modeled forces on a flat plate subjected to flows in vicinity of idealized breach.

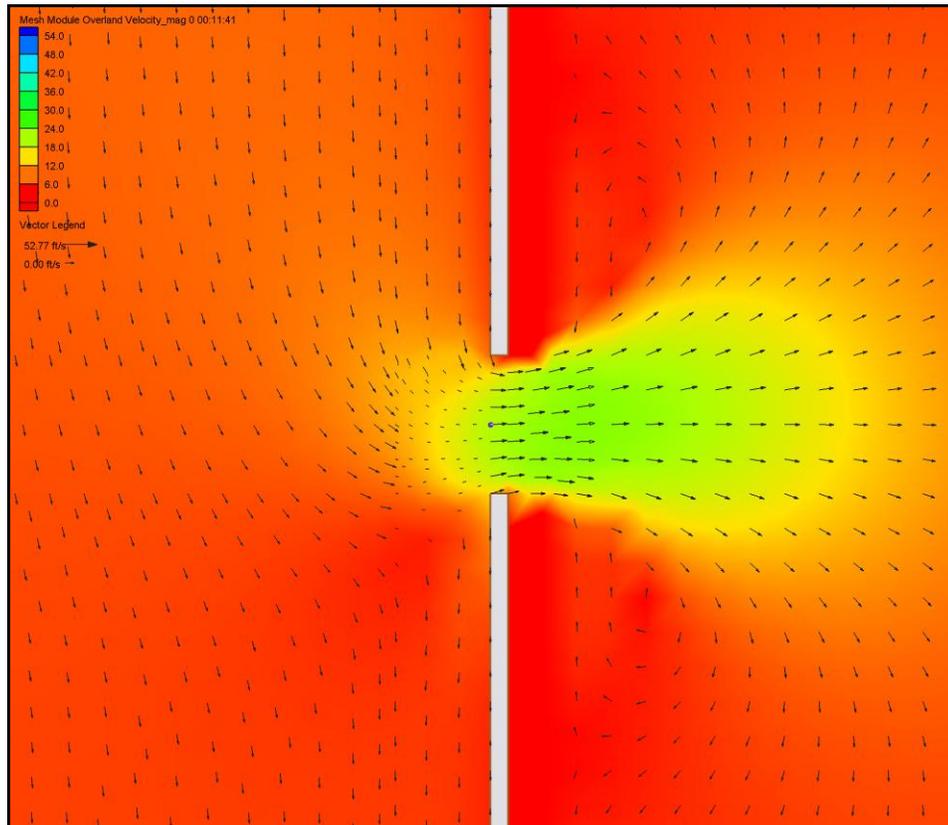
Figure 25. Force vectors (assuming a drag coefficient value of 2) for flow through an idealized breach.

100 ft in the streamwise direction and being 150 ft away from the levee crest, the velocity components change from 66 percent (%) streamwise and 33% breach-direction, to 66% breach-direction and 33% streamwise. This shows clearly that the streamwise components of velocity cannot be ignored when considering the logistics of moving a closure device into place, which will become an important topic when discussions for the concepts of operations (CONOPS) for deployment are being developed.

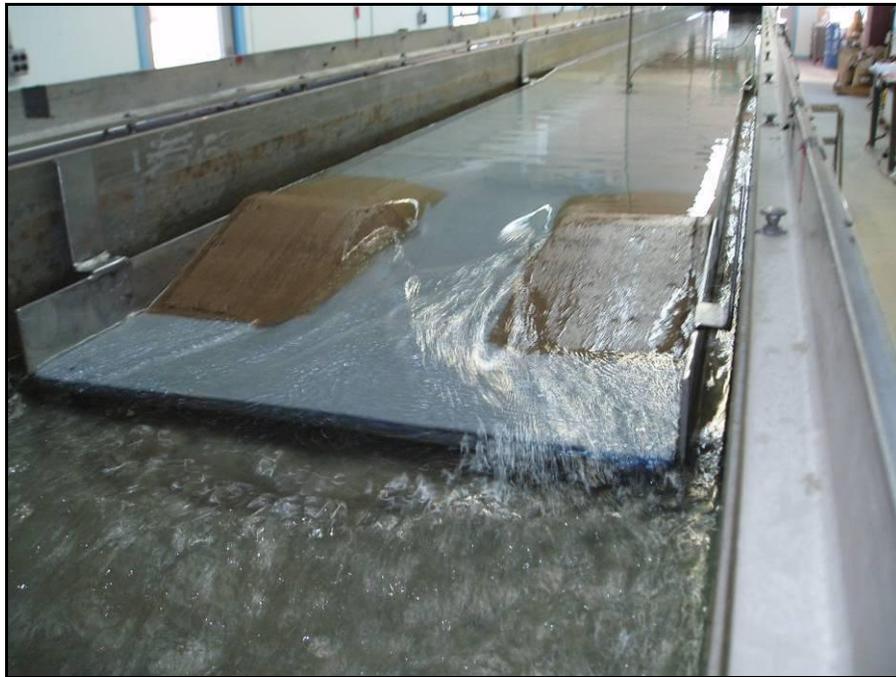
Figure 26. Photo of flow through small-scale (1:50) breach.

An 80-ft long tilting flume was used to provide a simulated levee breach and flow for testing of various closure methods discussed above. The flume cross section is 3 ft wide and 1 ft deep. The facility has pumps that can supply up to 5.5 cfs of flow capacity. To maintain a constant water level during the closure tests, a special side-weir-overflow device was constructed to fit within the flume. A simulated levee was constructed separately, but made to fit exactly within the confines of this overflow device. The flume, overflow device and simulated levee are all shown in Figure 26.

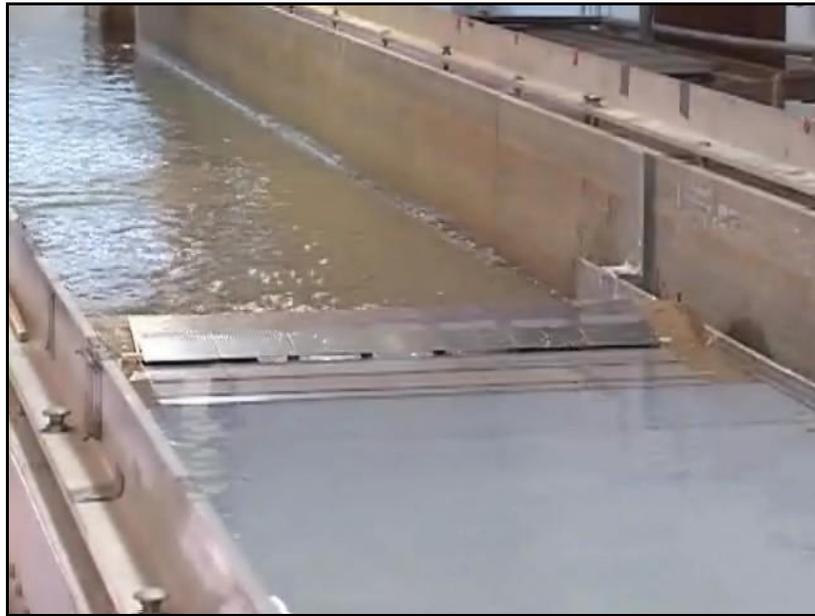
Figure 27. Photo of gated structure test in 1:50 scale flume.

- Rectangular gated structure floated into place, with and without a tarp. Figure 27 shows the gated structure just after placement with gates still open. After gate closures, significant flow continued along the device perimeter. A tarp was used in combination with the gated structure to see how this would work in conjunction with it. The slow residual velocities allowed positioning of the tarp, and actually helped move and seal the tarp against the structure. The result was an almost complete reduction of flow through the breach as shown in Figure 28.

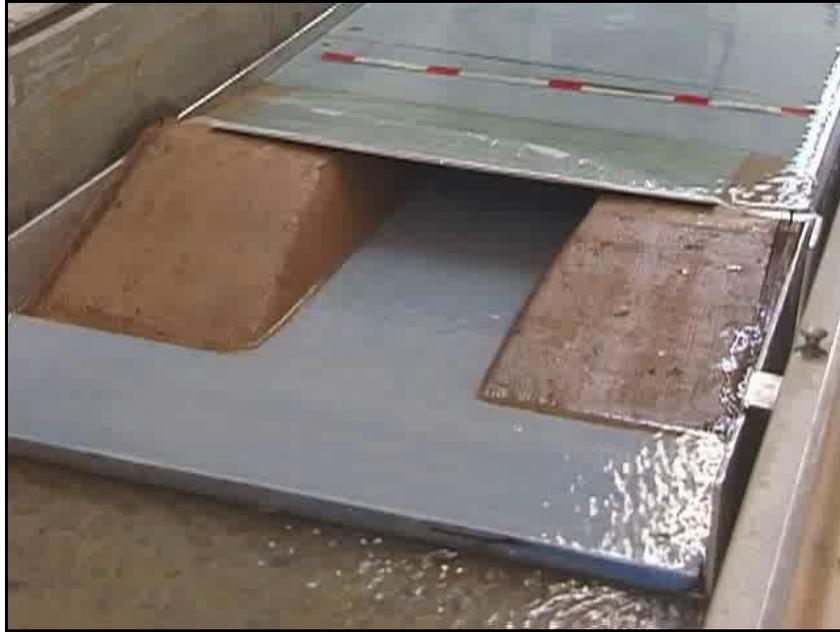
Figure 28. Test of a gated structure combined with a tarp showing almost no residual flow.

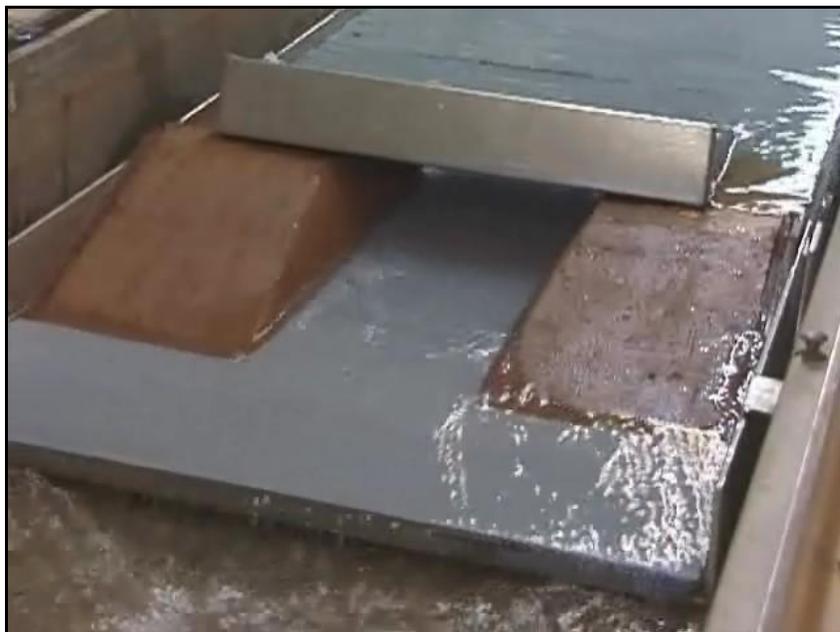
Figure 29. Idealized barge floated into position on small-scale levee and ballasted with water.

- Barge floated into place with ballast on one side. A sealing fabric bag was added on the upstream side of the barge. Figure 29 shows barge driven up the levee embankment and having a simulated fabric bag placed against its upstream side. Significant flow reduction occurred.

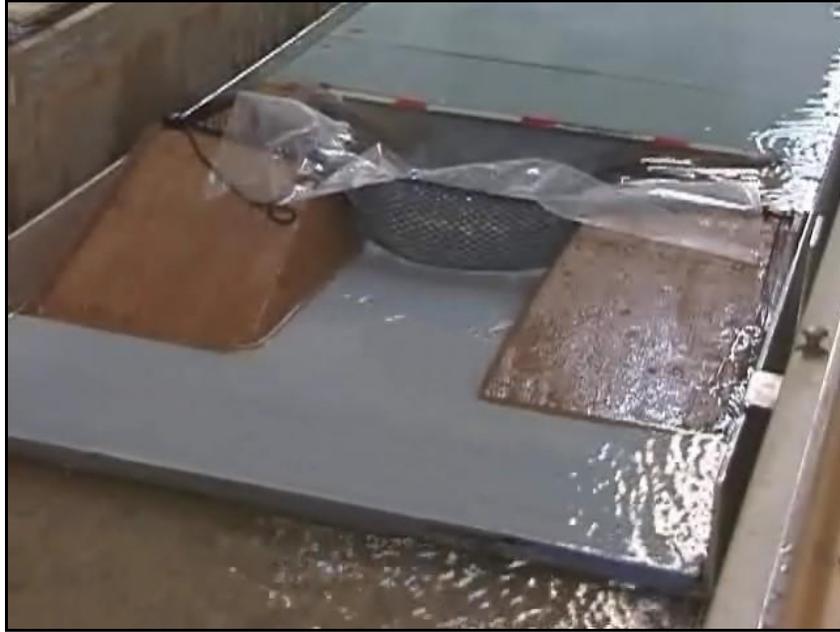
Figure 30. Photo of performance of a net anchored on either side of a breach combined with a tarp in the 1:50 scale model.

- Simulated cable net placed over the breach with tarp placed upstream of the breach. This is shown in Figure 30.

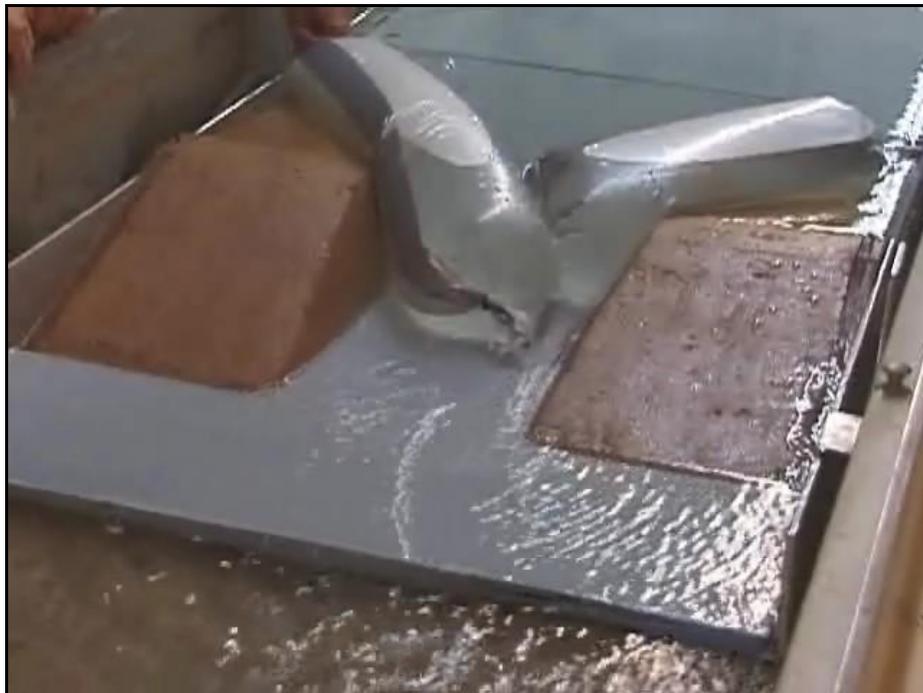
Figure 31. Photo of water-filled tube concept utilizing two tubes anchored to either side of a breach in the 1:50 scale model basin.

- Geo-textile fabric bags filled with water. For these tests, water-filled plastic bags were tested in anchored and un-anchored configurations. Bags anchored on each end and filled in place are shown in Figure 31.

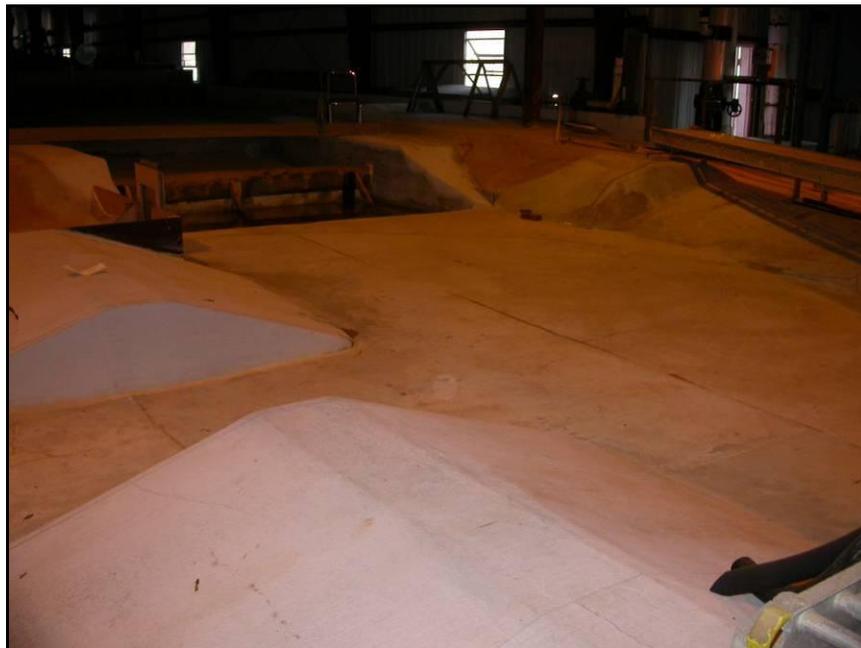
Figure 32. Test basin for 1:16 scale physical model tests.

The early phase of this project investigated a wide range of ideas of potential value to rapid levee repair; but many of those ideas were soon recognized as either impractical or beyond the state of the science that exists today. We knew that we could not continue to devote extensive amounts of time to all of these different ideas and still meet our specified timelines for large-scale demonstrations. To assist us with our down-selection, we knew that it would be extremely useful to have a physical basin that was substantially larger than the 1:50 scale flume described previously in this report. An existing physical model facility within ERDC was identified as having the best potential for providing a suitable basin for such testing of RRLB concepts. This basin was modified from its initial purpose to provide a flow capacity consistent with a 1:16 scale along a levee section (Figure 32). The model levee was constructed at an undistorted scale and represents a levee with a crest elevation of 20 ft (note: all dimensions are reported in prototype scale unless otherwise stated), side slopes on both faces of 1:3 (vertical:horizontal), and a crest width of 16 ft. The breach was 80 ft wide with 2:1 side slopes the full depth of the levee. Both the model basin and the levee were constructed of a concrete cap poured over a sand fill with inset aluminum templates to ensure the accuracy of the bathymetry and topography.
