**U.S. Army Engineer Research and
Development Center:
Rapid Repair of Levee Breaches**

**FINAL REPORT:
Rapid Repair of Levee Breaches**

July 28, 2011

**Project Co-Principal Investigators:
Donald Resio and Stanley Boc**

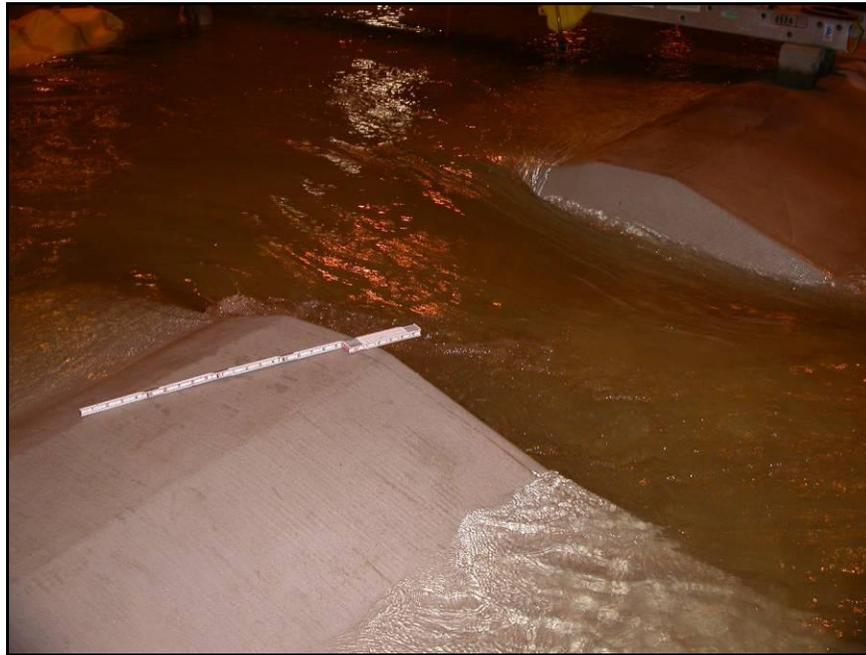
Figure 33. Flow through the breach with upstream depth at 18.7 ft.

This model represents a fairly extreme test for breach closure, since the breach is 80 ft wide and 20 ft deep, the still water level is 18.7 ft deep, and there is as a significant riverine current flowing along, past, and through the breach (Figure 33).

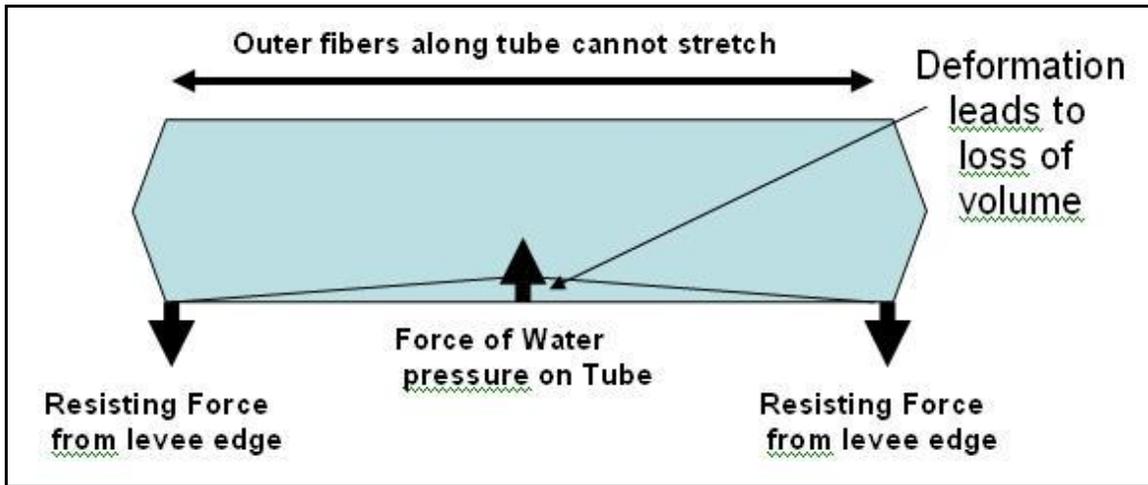
Figure 34. Idealized forces on a tube at a breach.

To illustrate this concept, consider the deformation of a simple cylinder with flat, non-deformable rigid ends as shown in Figure 34. Hypothetically, the tube's interior volume is filled with 100% water, the volume of the tube cannot be increased without a net increase in the surface area of the fabric (i.e., the fabric stretches). Conversely, if this tube is bent along the axis of the cylinder and the fibers along the outer curve are assumed to be incapable of stretching, such a deformation will require a buckling of the fabric on the interior curve, leading to a loss in volume. However, since water is essentially incompressible, the volume cannot decrease. Thus, the tube would resist deformation. Of course, actual fabrics do stretch and there will be some elongation (stretching) of the fibers along the outer curve. This elongation will be consistent with the total pressure force pushing outward on the surface of the fabric. This stretching of the fiber on the outside curve will allow a slight deformation in the overall shape of the cylinder, leading to bending. If the material can be stretched easily, an initially straight cylinder can be curved to any degree desired; however, if we use typical construction fabrics are used, the amount of stretching will be only about 5-7% before the fabric fails (tears).

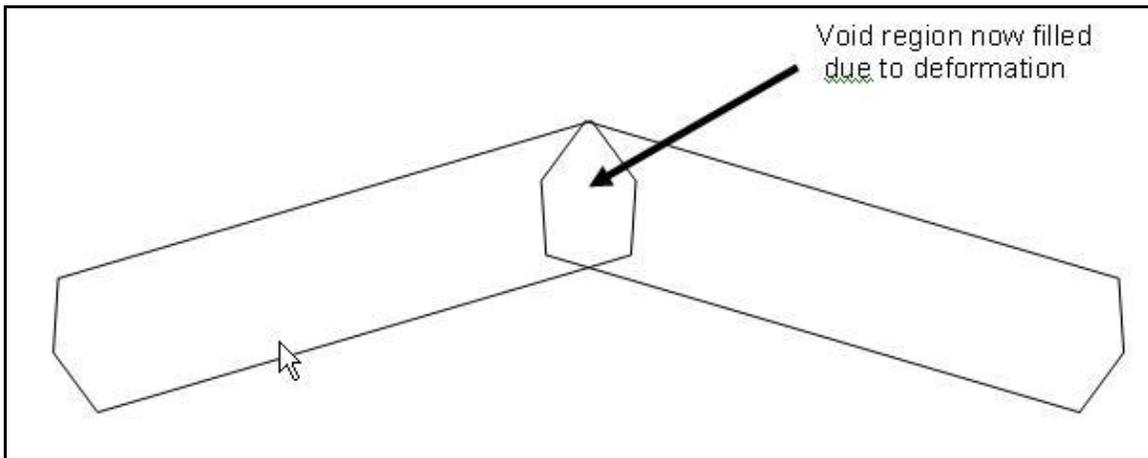
Figure 35. Deformation of a tube leading to loss of volume.

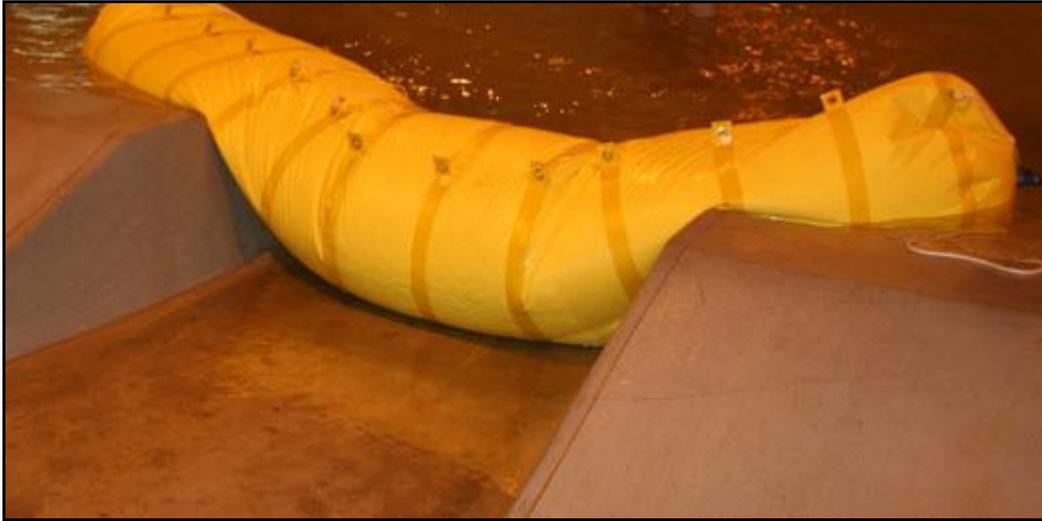
Figure 36. Deep-breach closure with large tube filled to 60% fill volume.

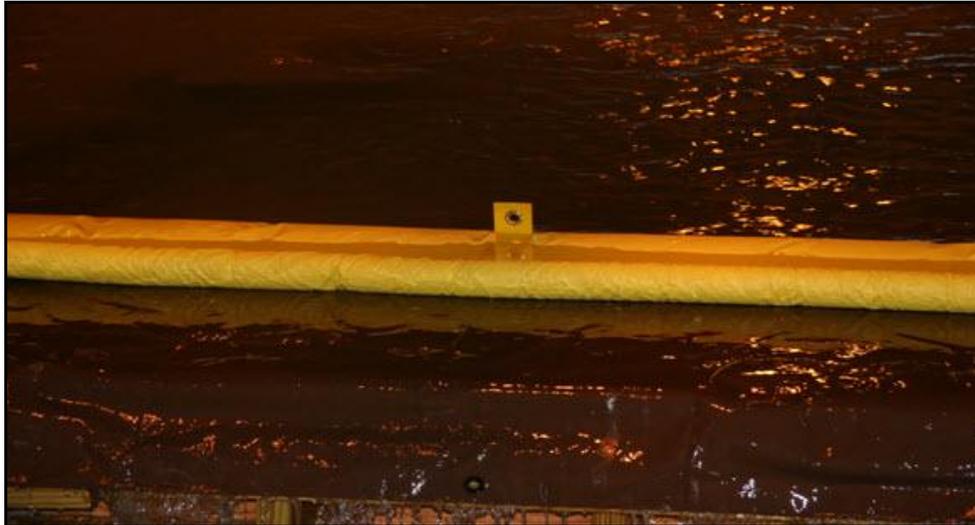
Figure 37. Performance of a very long water-filled fabric tube in a wide, shallow breach test in the 1:16 scale model.

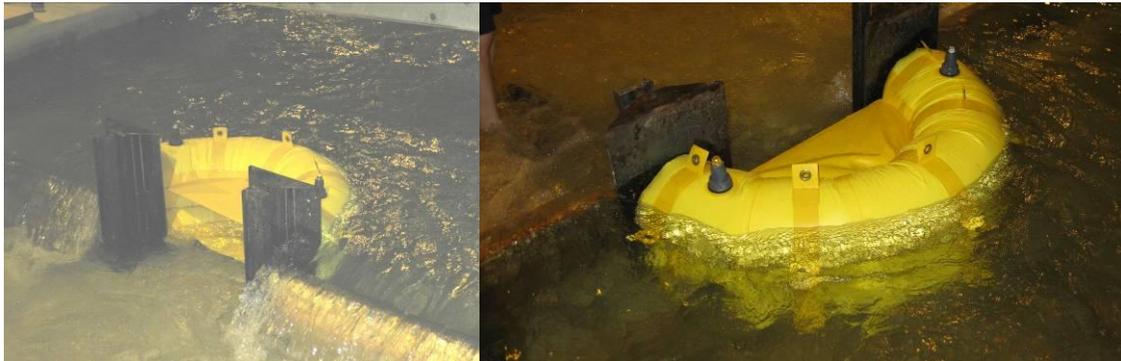
Figure 38. Successful laboratory tests of a two-arch system for blocking flow through a simulated “gate” opening. Actual distance between spanned by ARCH in these tests is about 1.5 ft.

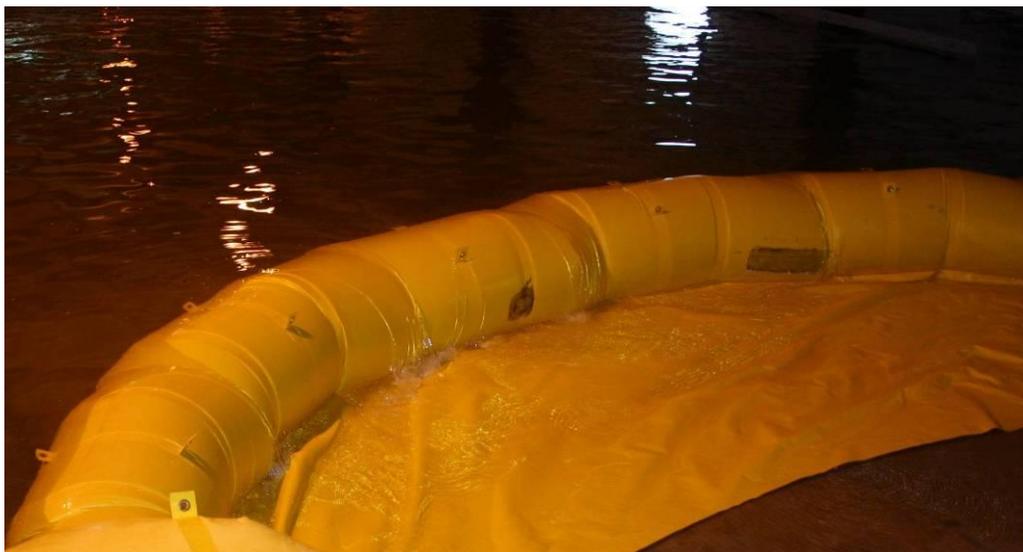
Figure 39. Successful small-scale test of a single-arch system for blocking flow across a large open area. Actual distance spanned by the ARCH in this test is approximately 25 ft.

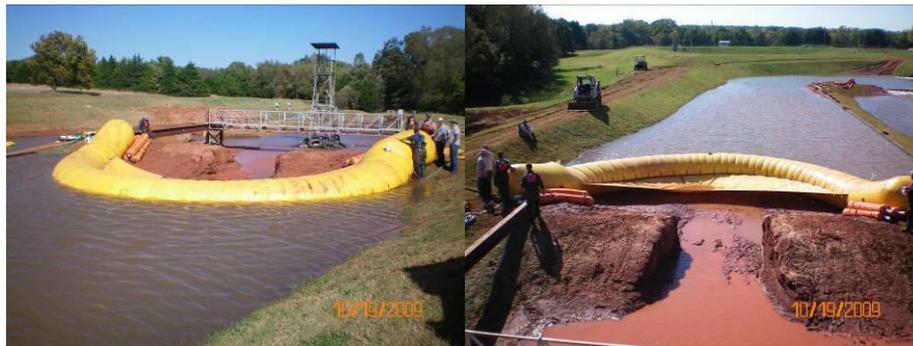
Figure 40. Early tests of the ARCH showing its capability to seal the area around a breach to allow the PLUG to be emptied and removed before permanent repairs commence.

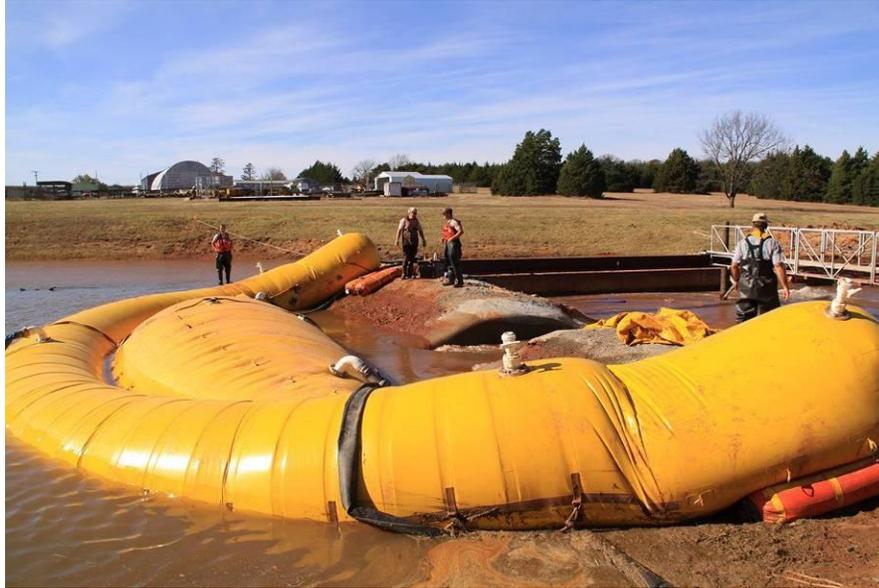
Figure 41. Test of the modified ARCH system at Stillwater, OK in November 2009. The ballast tank seen behind the apex of the ARCH improved its ability to resist deformation under very high water levels.

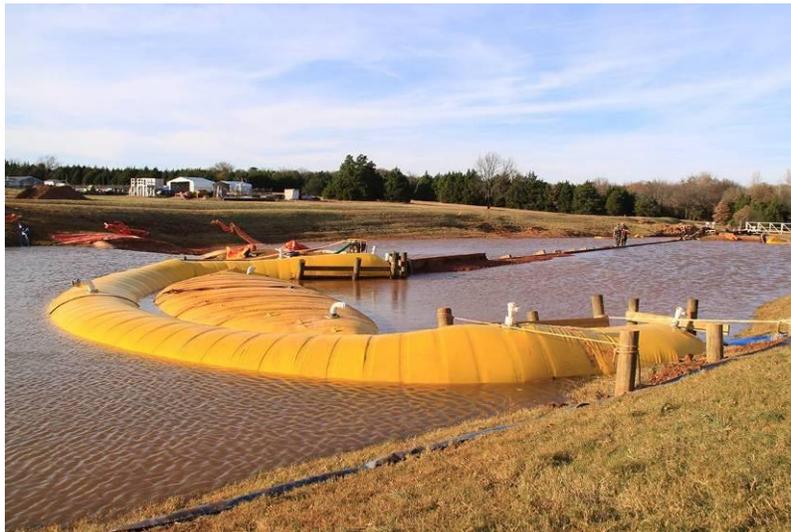
Figure 42. Test of the modified ARCH in Stillwater, OK in November 2009 showing its ability to block water from flowing into a channel approximately 40-feet wide with a water depth of approximately 4 feet.

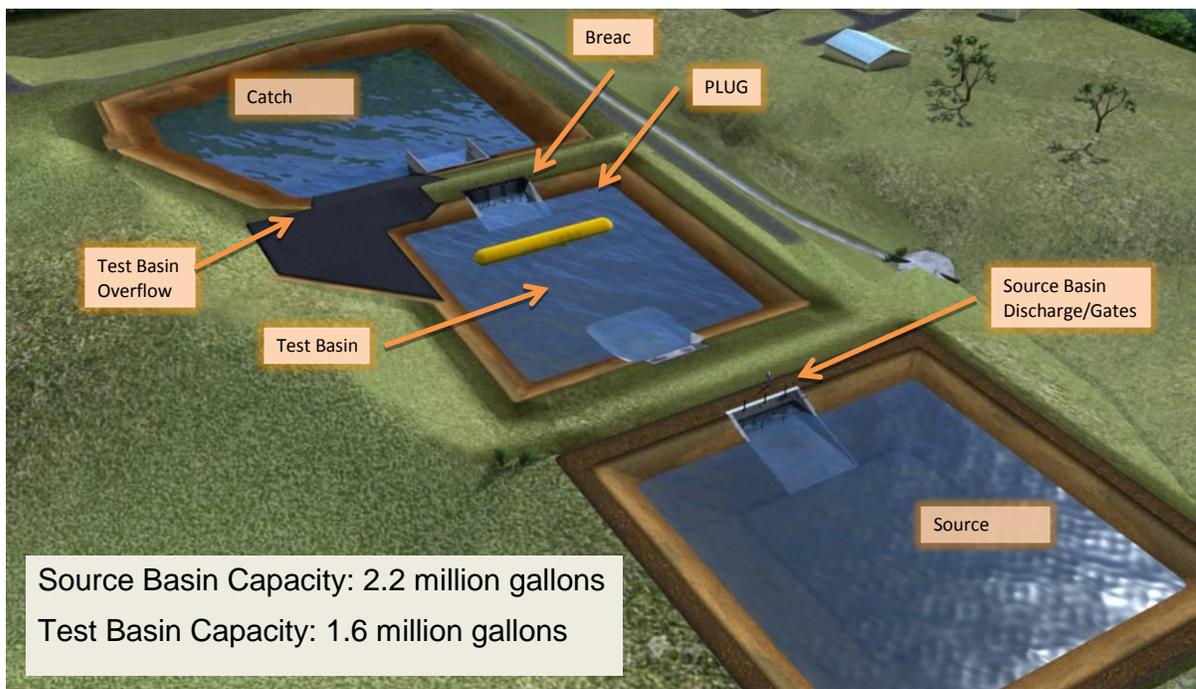
4 Figure 43. Artist’s rendition of the three-basin full-scale test facility. RRLB EFFORT: YEAR 3

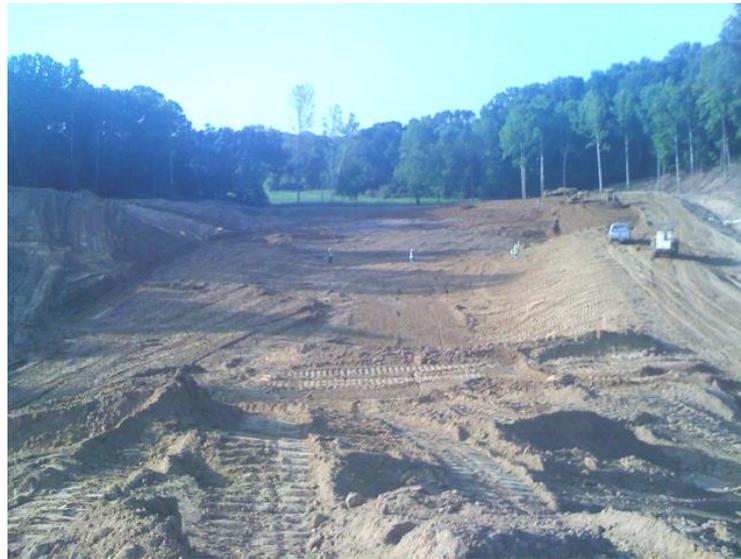
Figure 44. Early stage of construction July 2010.

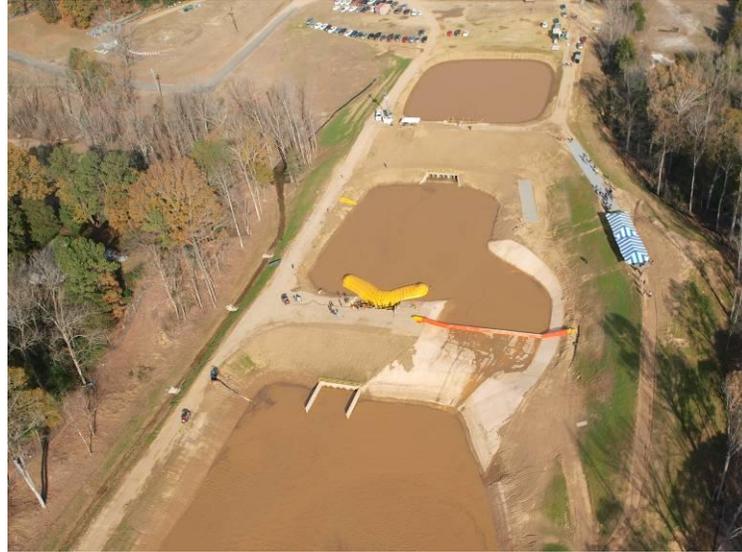
Figure 45. Aerial Photograph of Full-Scale Test Basin – 15 December 2010.

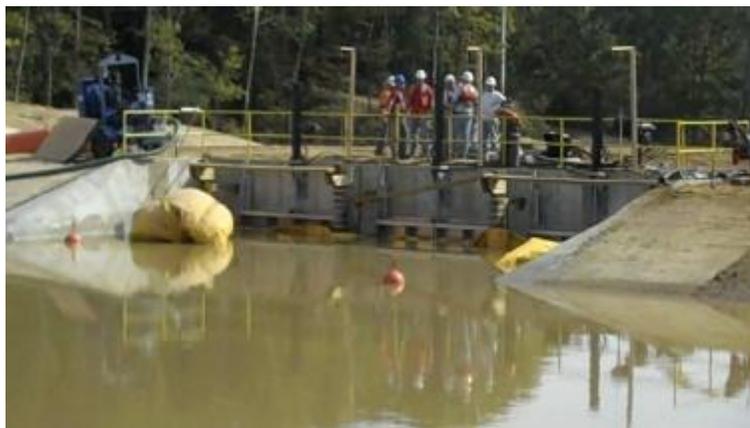
Figure 46. First PLUG test culminated in a failure, with substantial damage to the gate protection system and tears to the PLUG.

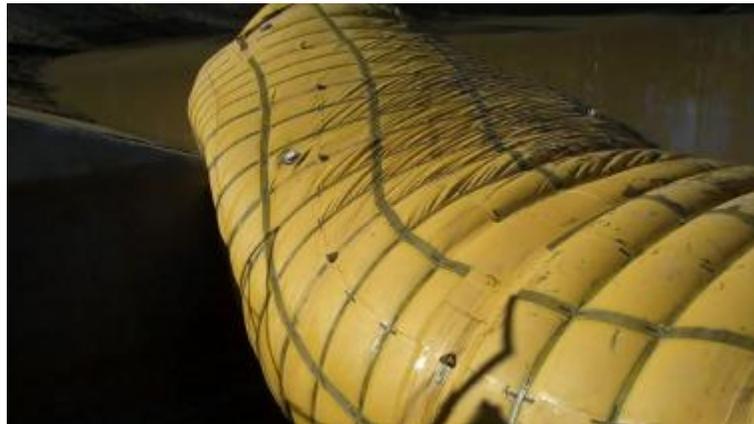
Figure 47. Successful test of the PLUG that achieved almost 100% stoppage of flow. The view in this figure is from the downstream side of the breach, with the water that is being held back from the breach shown in the upper right.

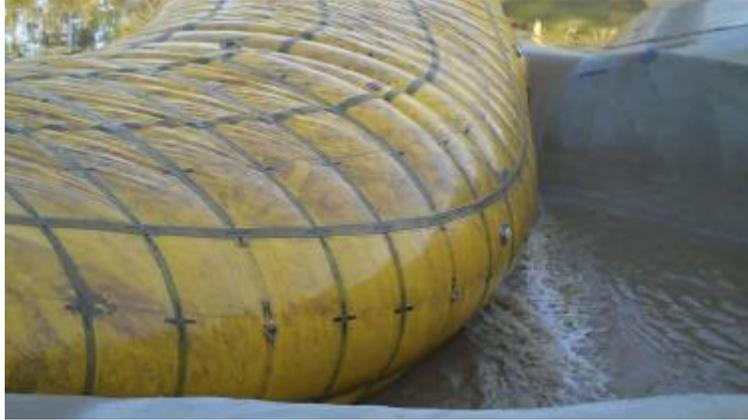
Figure 48. Photograph of the same test result as shown in Figure 47, except that it is taken from the opposite side of the breach. The curvature of the tube is very well seen along with rotational distortion in the longitudinal straps.
