# Flood-Fighting Structures Demonstration and Evaluation Program Interim Report

## Introduction

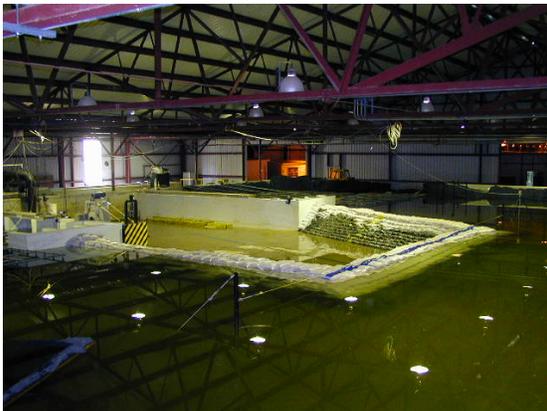
Sandbags – Static Loading Test

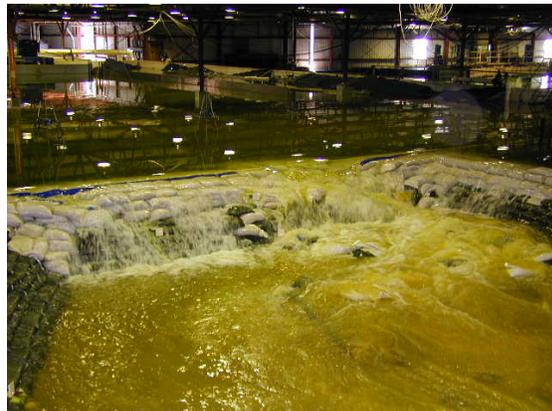
Sandbags - Overtopping

<b>Table L-3. Structure Damage During Laboratory Testing</b>	
<b>Structure</b>	<b>Observed Damage</b>
Sandbags	Repeatedly Damaged By Waves Failed During Overtopping
Hesco Bastion	Minor Sand Settling and Washout Some Bending of Wire During Debris Impact
RDFW	Minor Sand Settling Significant Washout Along Edges and Toe Toe Damaged During Large Waves or Overtopping 10% of Structure Broken
Portadam	Impermeable Liner Torn During Debris Impact

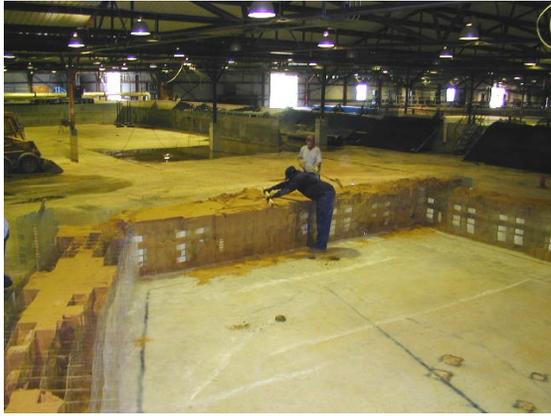
RDFW – Under Construction

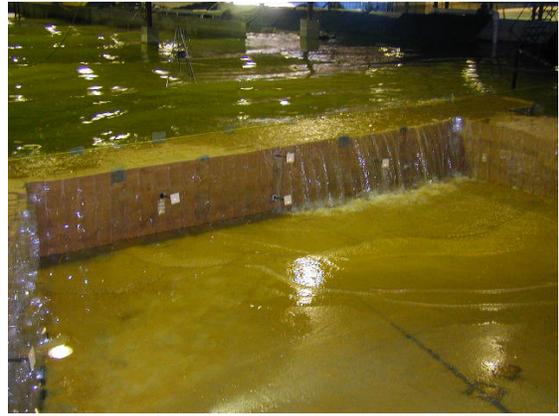
RDFW – Wave Test

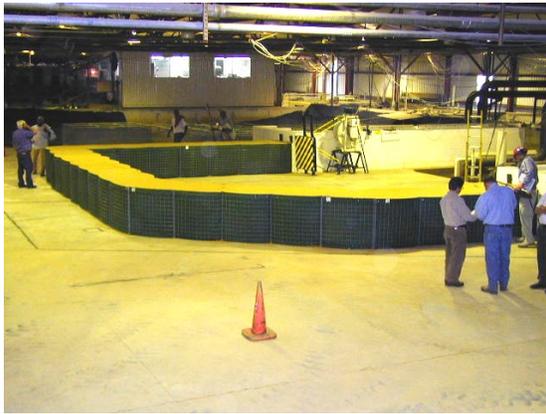
Hesco Bastion – Construction Complete

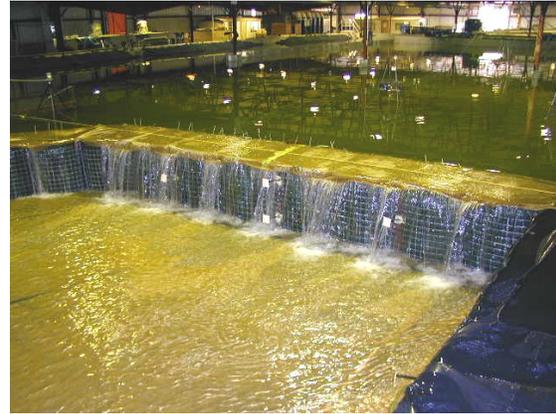
Hesco Bastion – Overtopping Test

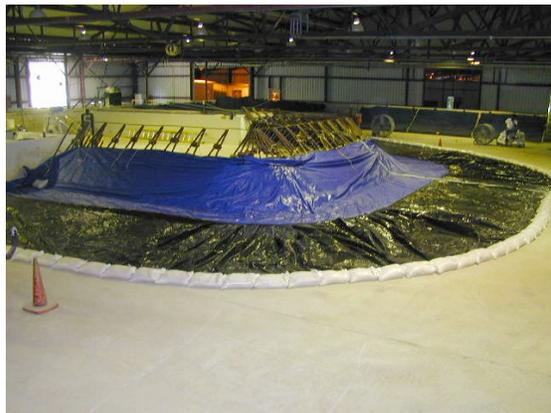
Portadam – Construction Complete

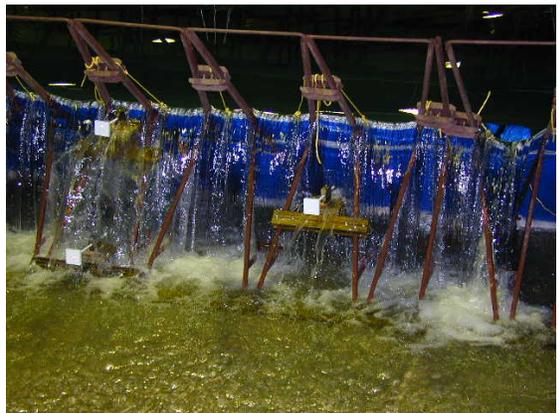
Portadam – Overtopping Test

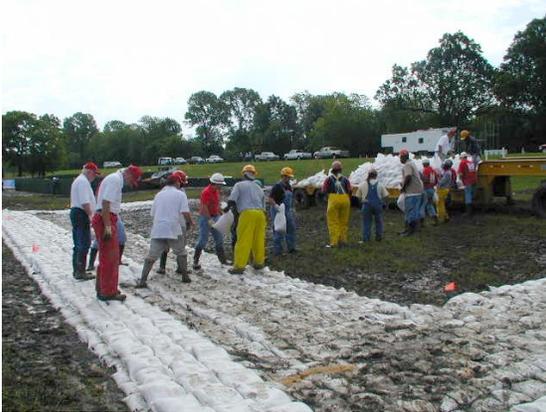
Sandbags – Construction

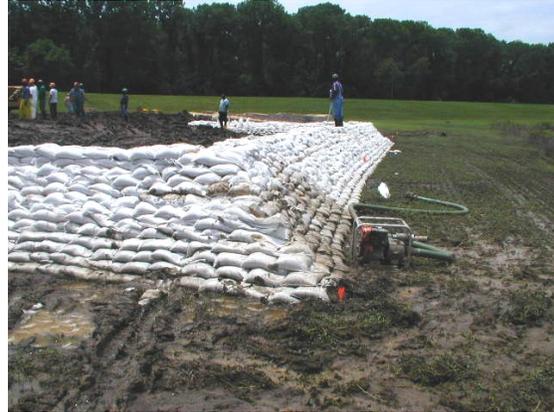
Sandbags – Construction Complete

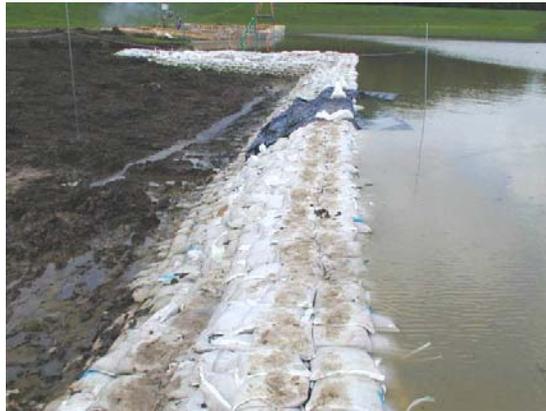
Sandbags – Prior To Overtopping

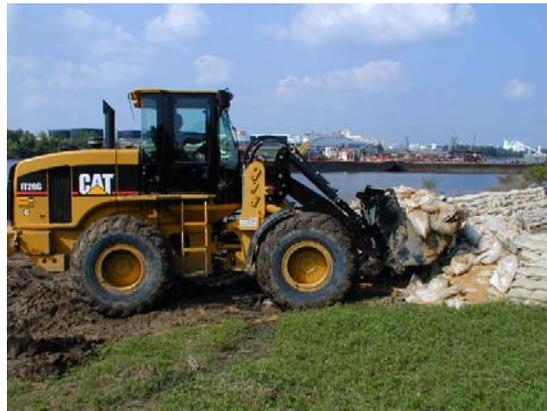
Sandbags – Removal

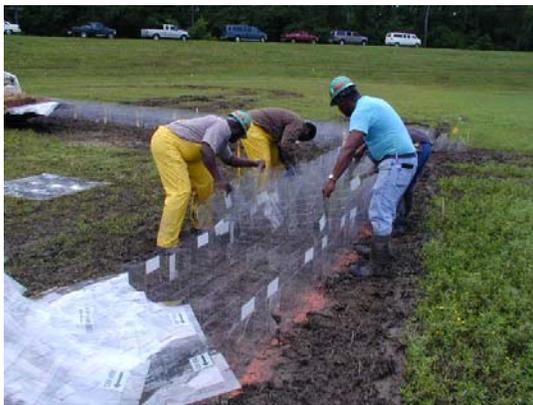
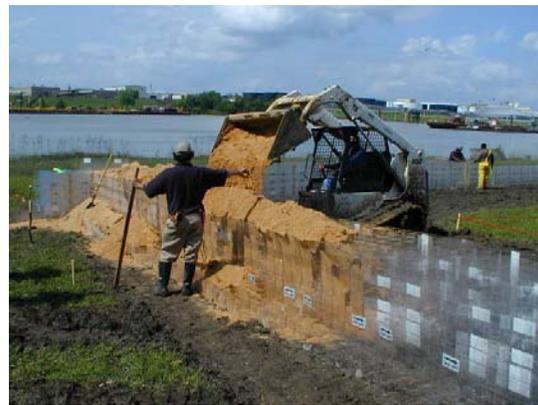
RDFW – Construction

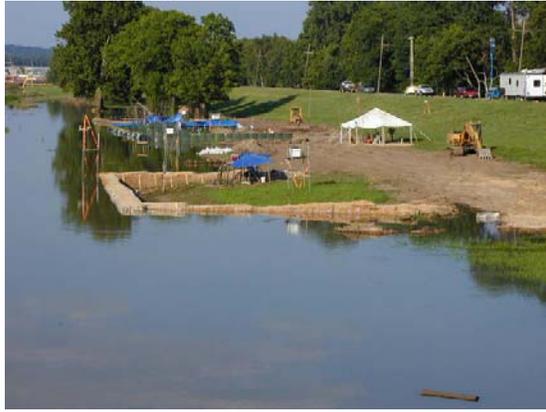
RDFW – Prior To Overtopping

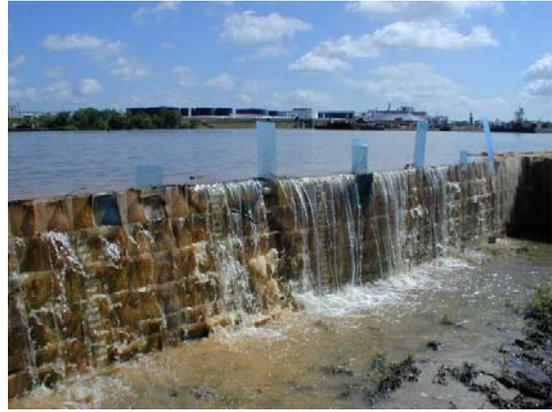
RDFW – Overtopping

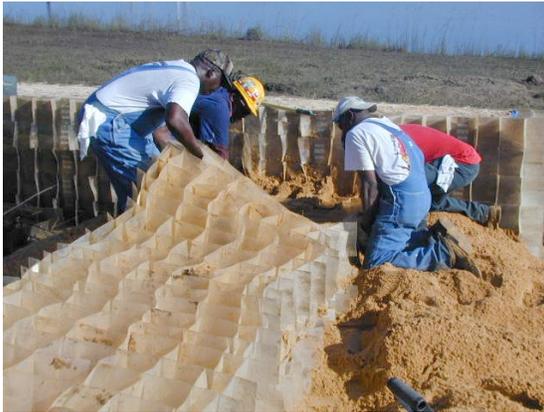
RDFW – Removal

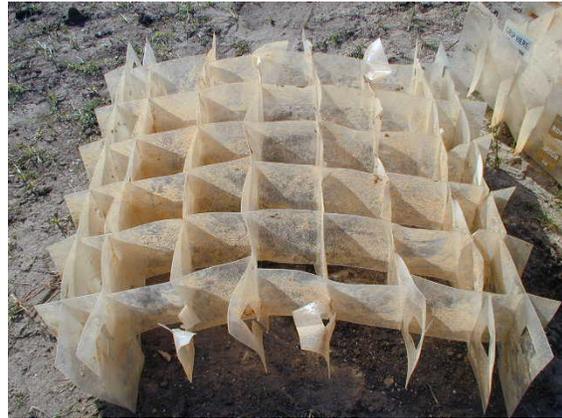
RDFW – Removed 4'x4'x8" Unit

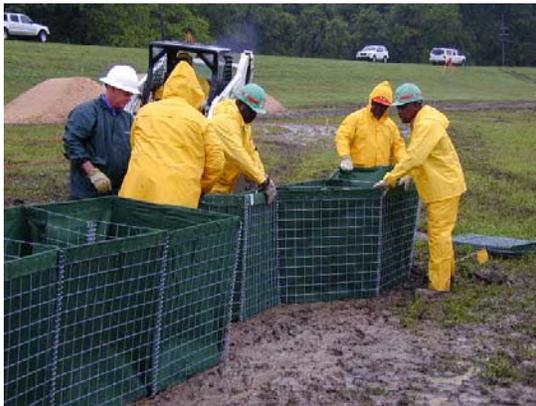
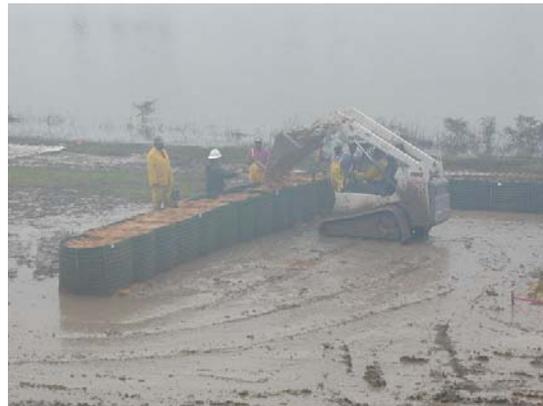
Hesco Bastion – Construction

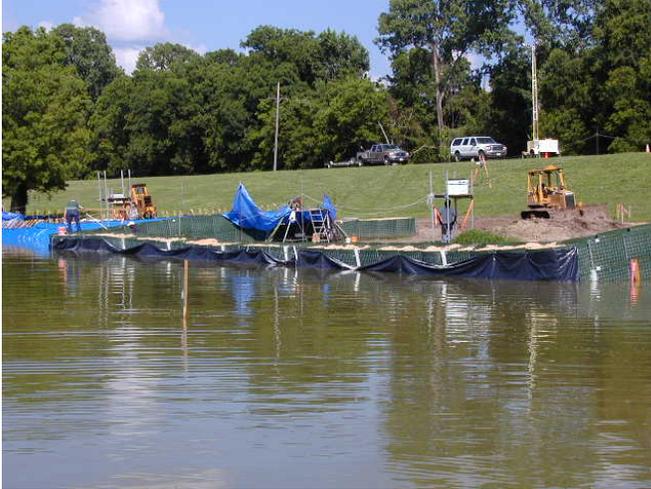
Hesco Bastion – Testing

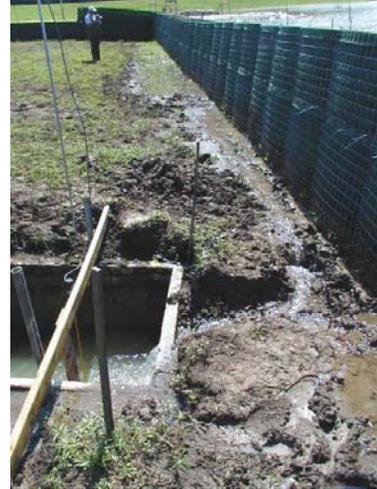
Hesco Bastion – Seepage

<b>Table F-2. Seepage Rates</b>				
<b>Wetted Area of Structure square feet)</b>	<b>Seepage Rate (Gallons / Hour)</b>			
	<b>Sandbags</b>	<b>Hesco Bastion</b>	<b>RDFW</b>	<b>Portadam</b>
100	0	300	50	200
200	0	2300	200	300
300	50	3900	700	500
400	300	6000	900	550
500	800	---	1500	600
600	3200	---	---	600

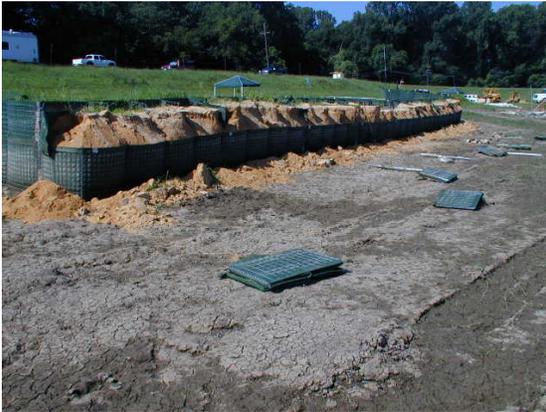
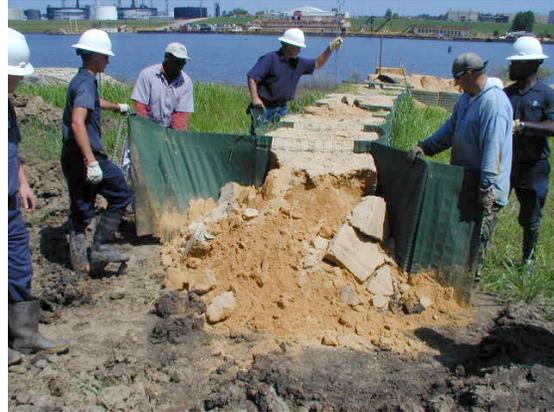
Hesco Bastion – Removal

Hesco Bastion - Removal

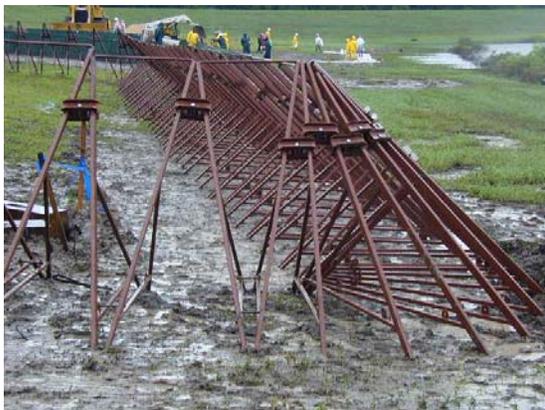
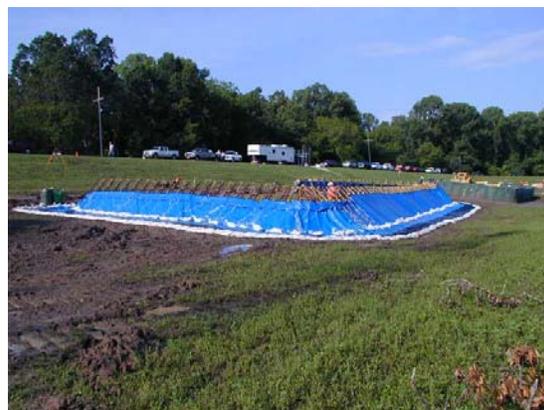
Portadam – Construction

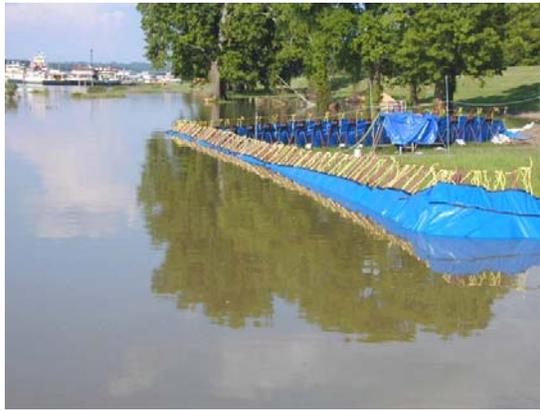
Portadam – Prior To Overtopping

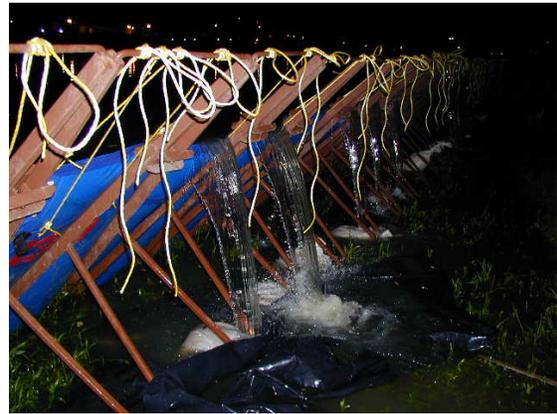
Portadam – Overtopping

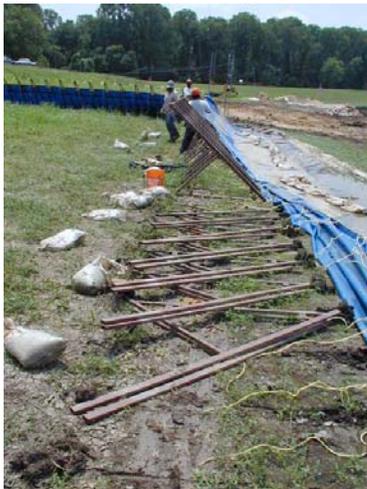
Portadam – Disassembly

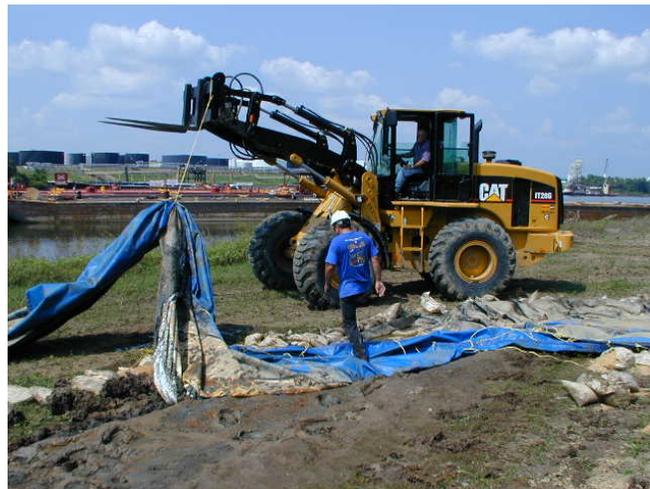
Portadam – Removal of Liner
