Contract Report CHL-97-1  
March 1997

## **Interaction of Seawalls and Beaches: Eight Years of Field Monitoring, Monterey Bay, California**

Institute of Marine Sciences and Department of Earth Sciences  
University of California, Santa Cruz  
Santa Cruz, CA

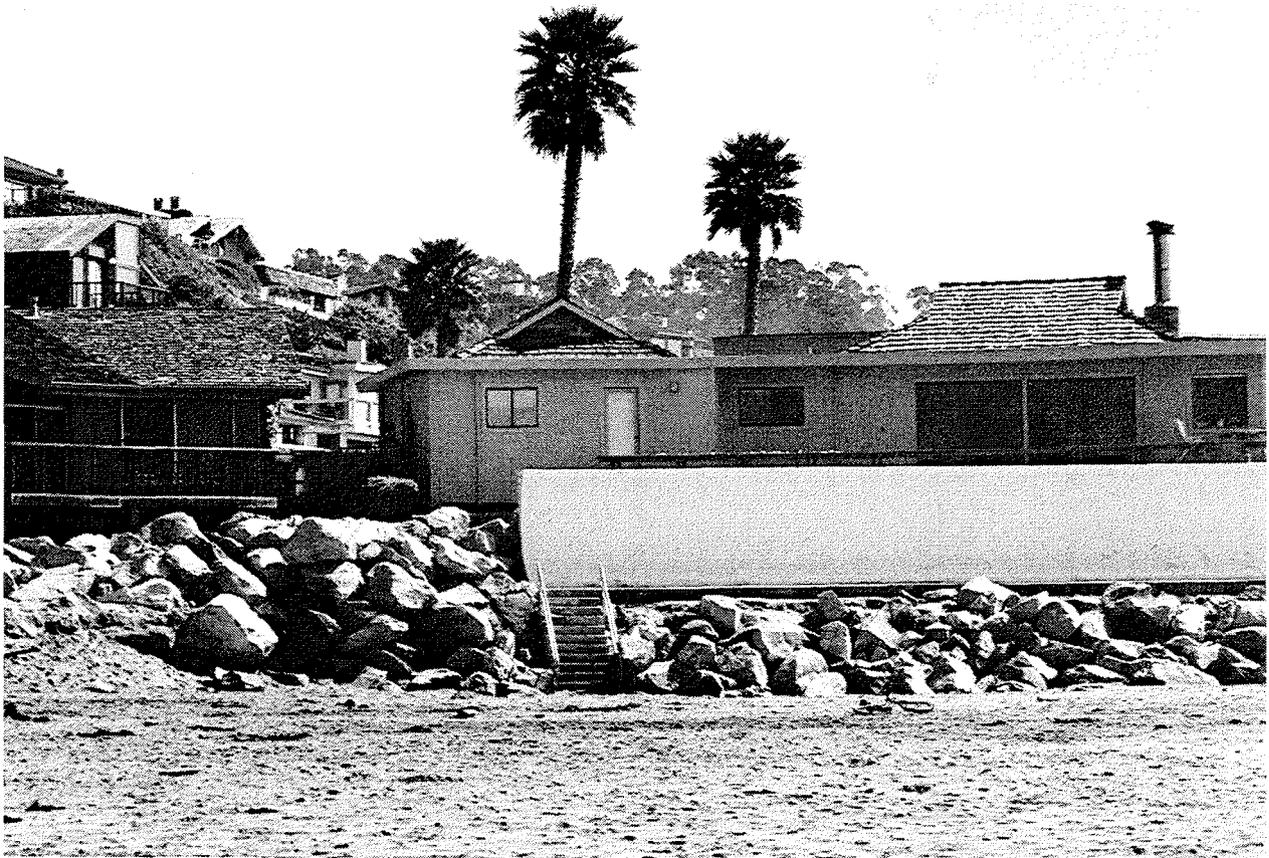
Figure 13. Stairs at north end of Aptos Seascapes seawall after the storms of January 1995

**Profiles.** At the Aptos Seascapes seawall study site, the primary beach responses to the storms of 1995 were a rapid change in profile shape, a significant decrease in beach elevation due to frontal scour, and erosion of approximately 115 m<sup>3</sup> of sand for every alongshore meter of beach. Several indicators of substantial beach elevation change were apparent to observers familiar with the study site. For example, the stairs on the northern flank of the seawall, usually buried in the beach, were completely exposed as the beach eroded (Figure 13). In addition, the access stairs fronting the seawall, which usually extend below sand level, were left dangling meters above the newly scoured beach (Figure 14).

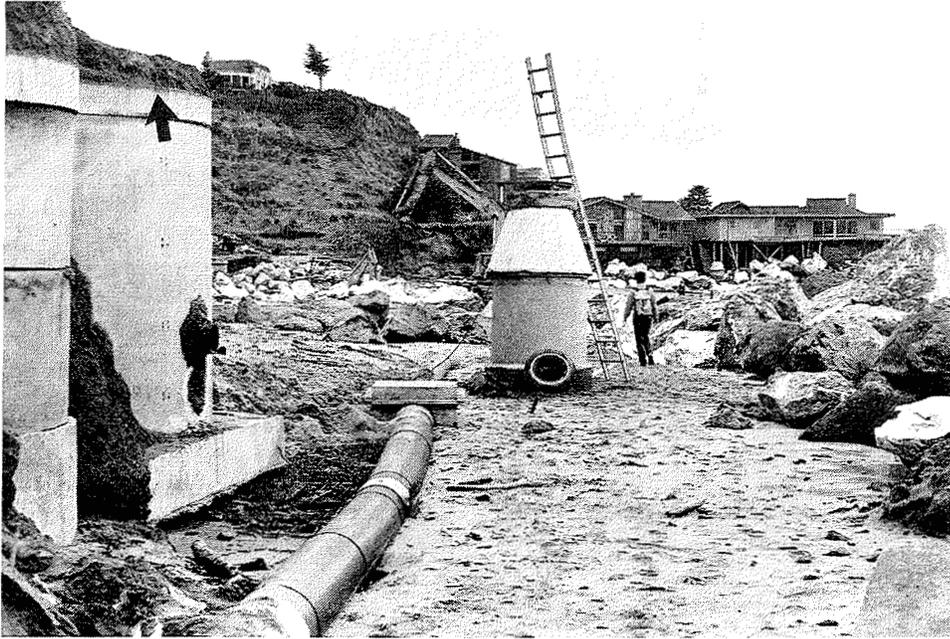
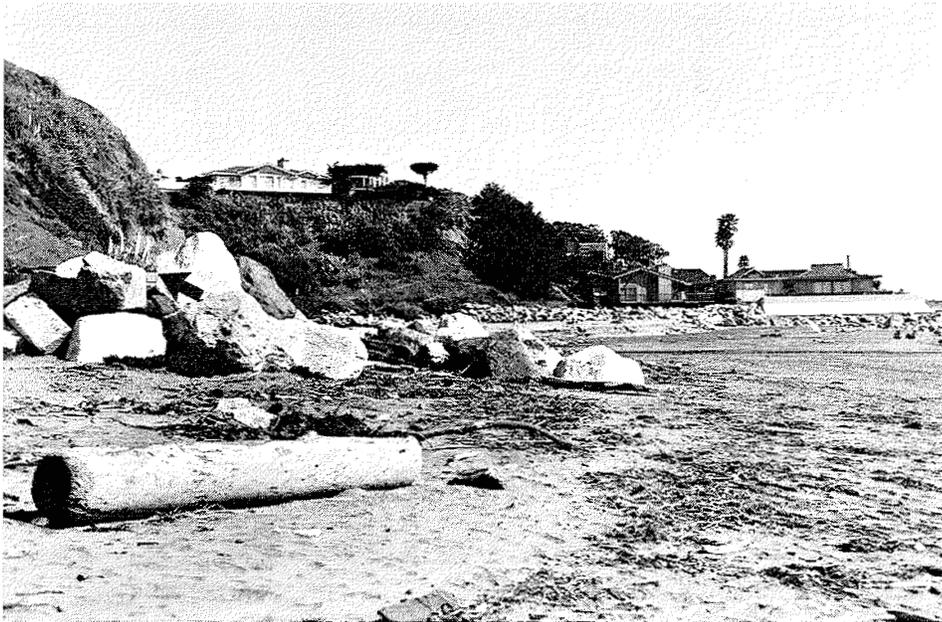
These extreme changes in beach level were reminiscent of the changes associated with the 1983 winter storms. However, despite obvious erosion, photographic comparison of the north control beach after the 1983 and 1995 events reveals that sand loss in 1995 (Figure 15b) was significantly less than it was in 1983 (Figure 15a).

a. 1983

b. 1995
