Technical Report HL-93-9
July 1993

Flood Control Structures Research Program

Flow Impingement, Snake River, Wyoming

*by Stephen T. Maynard
Hydraulics Laboratory*

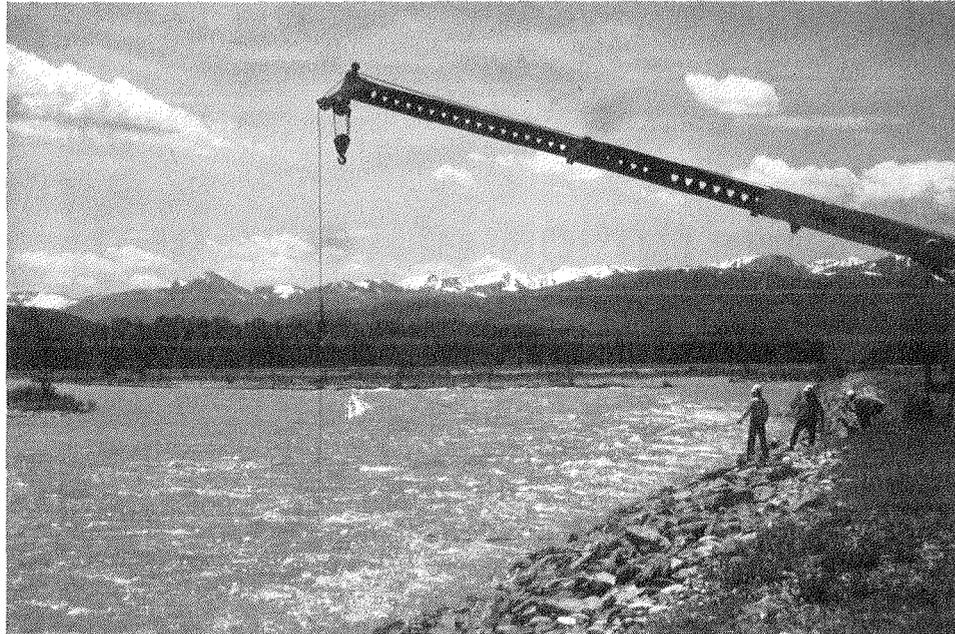
Figure 3. Crane at velocity site B-4, looking downstream

Price and electromagnetic velocity meters were mounted on lead fish and supported by an extendable boom crane that could reach up to 40 ft from the bank line, as shown in Figure 3. Even though the electromagnetic velocity meter could measure velocity in two directions, only the velocity parallel to the orientation of the lead fish was used in this investigation. Initially, a

100-lb lead fish was used, but this was swept too far downstream and a second lead fish weighing 140 lb was attached below the first one.

Future studies should use a single 200- to 250-lb lead fish for the high velocities encountered in this study. When near the bank line in shallow depths, the lead fish exhibited erratic side-to-side movement, which made velocity and depth measurements difficult. A graduated tape was attached both horizontally and vertically to the cable supporting the meter to determine the position of the meter. Bottom position was noted when the fish hit bottom and the cable deflected. Future studies should consider some type of electronic depth meter. The velocity meter had to be frequently raised to prevent damage to the velocity meter from debris. The cable supporting the velocity meter should not be strong enough to pull the crane over if large debris hangs up on the meter.

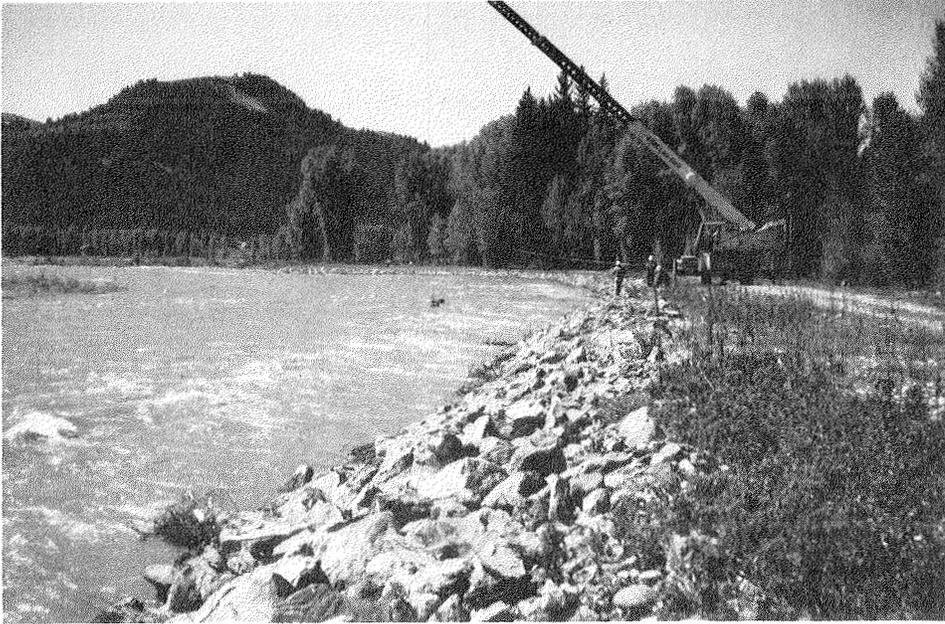
Figure 4. Site A-1, looking downstream

The two types of impingement sites that were observed on the Snake River were dependent on the alignment of the levee. Velocity sites A-1, A-2, B-4, D-1, D-2, and E-1 were impingement sites where the levee was straight. Velocity sites B-1 and E-2 were sites in a curved part of the levee having a outer bank line radius of 300-500 ft. In most cases the typical site had a wide, shallow approach channel that gradually converged toward the impingement site. The angle of the approach flow ranged up to 70 deg. Plates 3-10 show schematics of the impingement sites. Figures 4-8 show impingement sites.

- c. *Site A-1 (7 and 10 June 1991).* Most of the flow in the river was against the levee at this site, but some flow was in channels in the middle of the levees. The impingement angle was about 45 deg and flow was also entering the impingement site from a second channel parallel to the levee on 7 June with a lesser amount on 10 June. Surface float velocities about 30 ft from the bank line averaged 11 ft/sec between sta 4+00 and 6+00. Velocities and water-surface elevations were similar on 7 and 10 June, but some scour occurred between 7 and 10 June at sta 4+00. Measurement of riprap size at site A-1 showed an average W_{50} of about 150 lb. Riprap size was not measured at other locations, but surveys by the U.S. Army Engineer District, Walla Walla, in 1987 show the average size to be less than 100 lb.
