# Hatteras Breach Closure

Mike Wutkowski

**Hurricane  
Isabel  
18 Sep 2003  
Category 2**

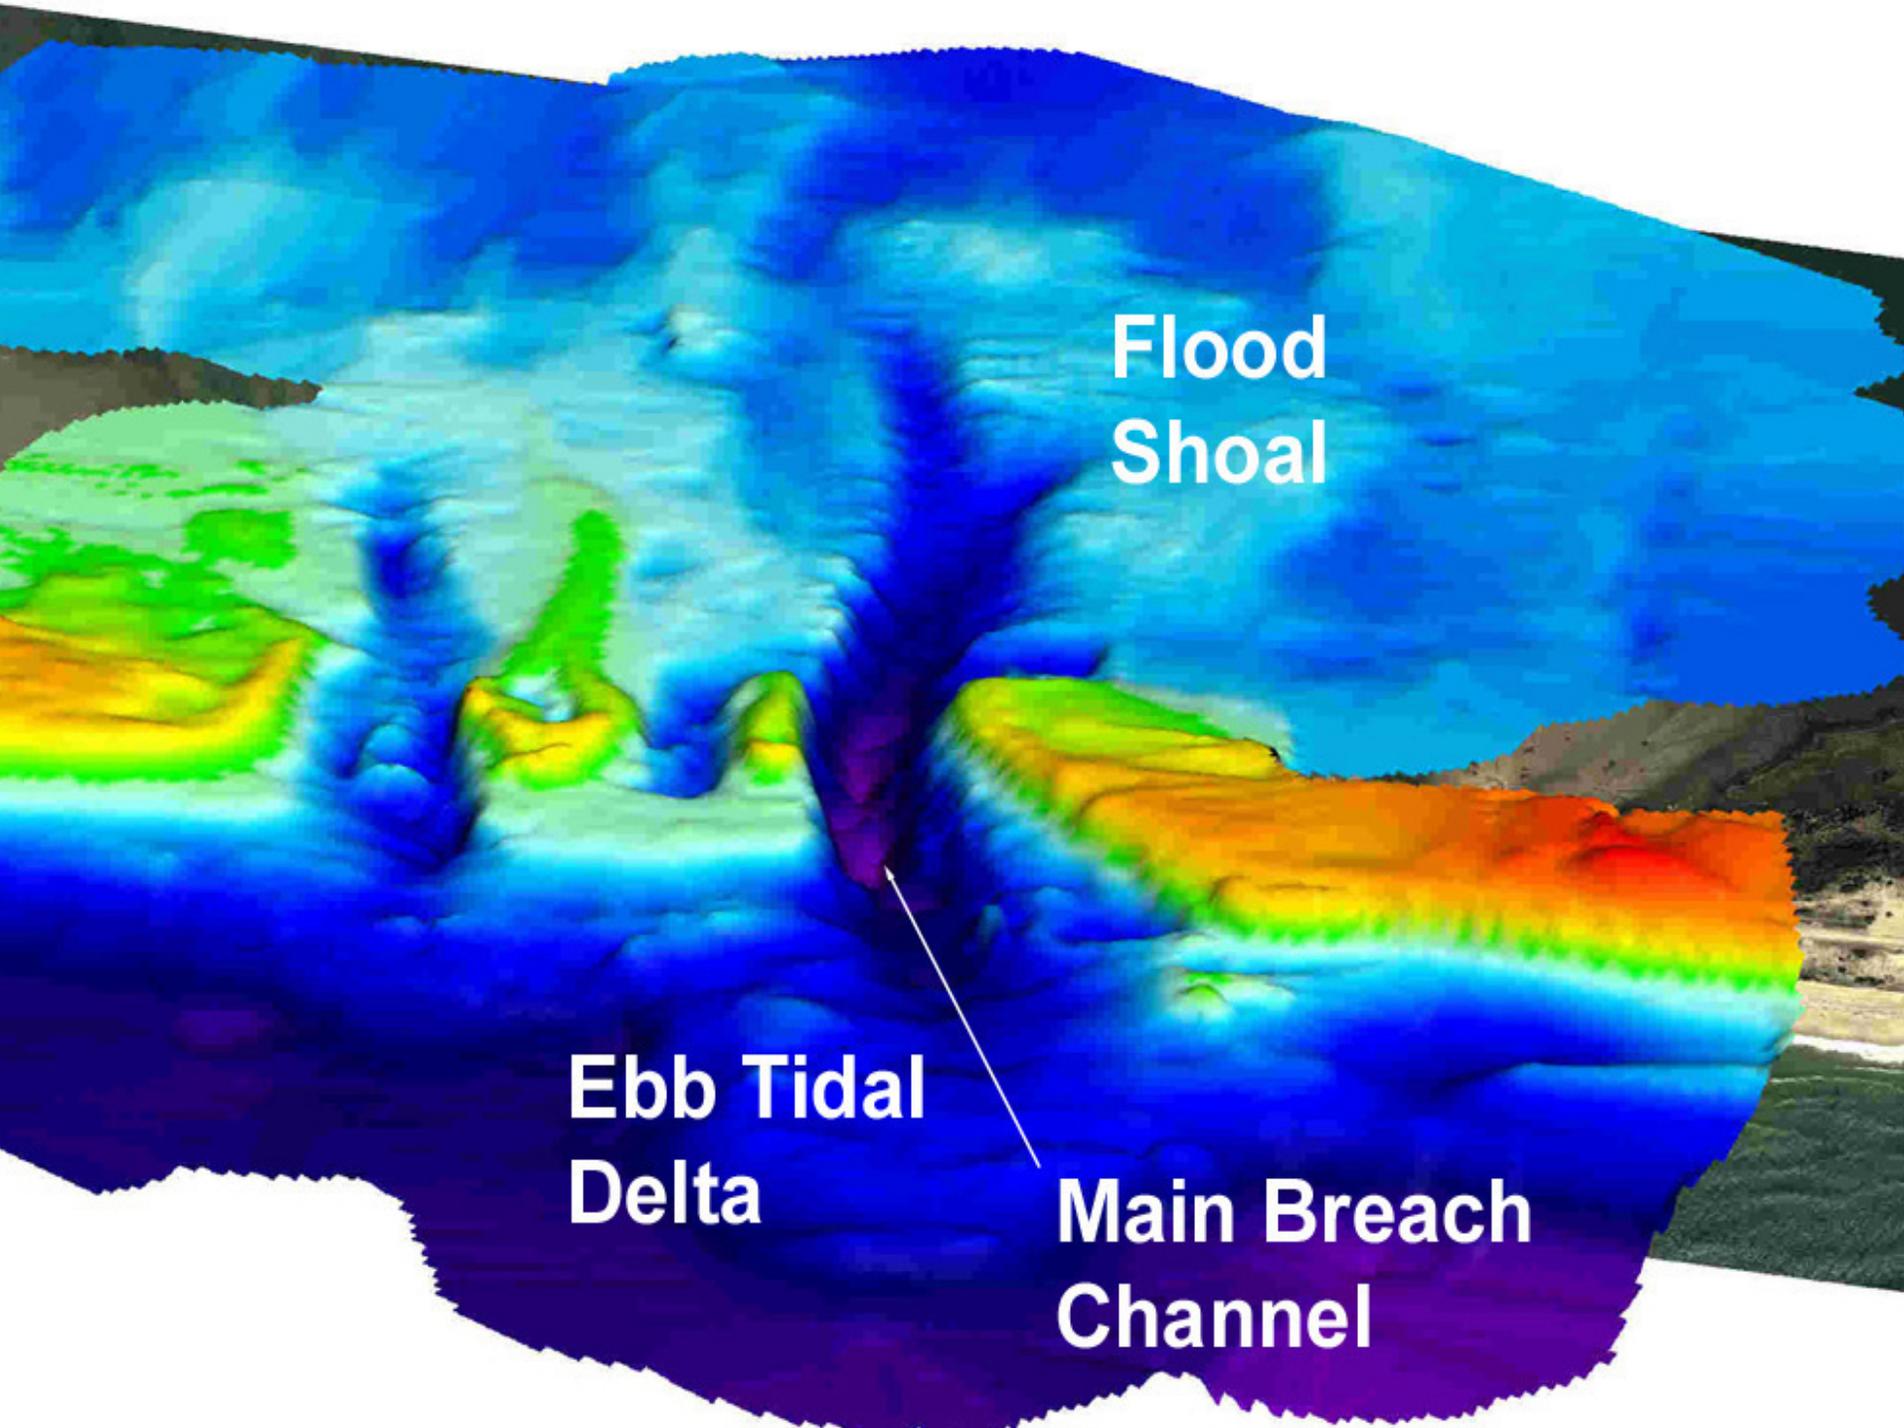
**Flood  
Shoal**

**Ebb Tidal  
Delta**

**Main Breach  
Channel**

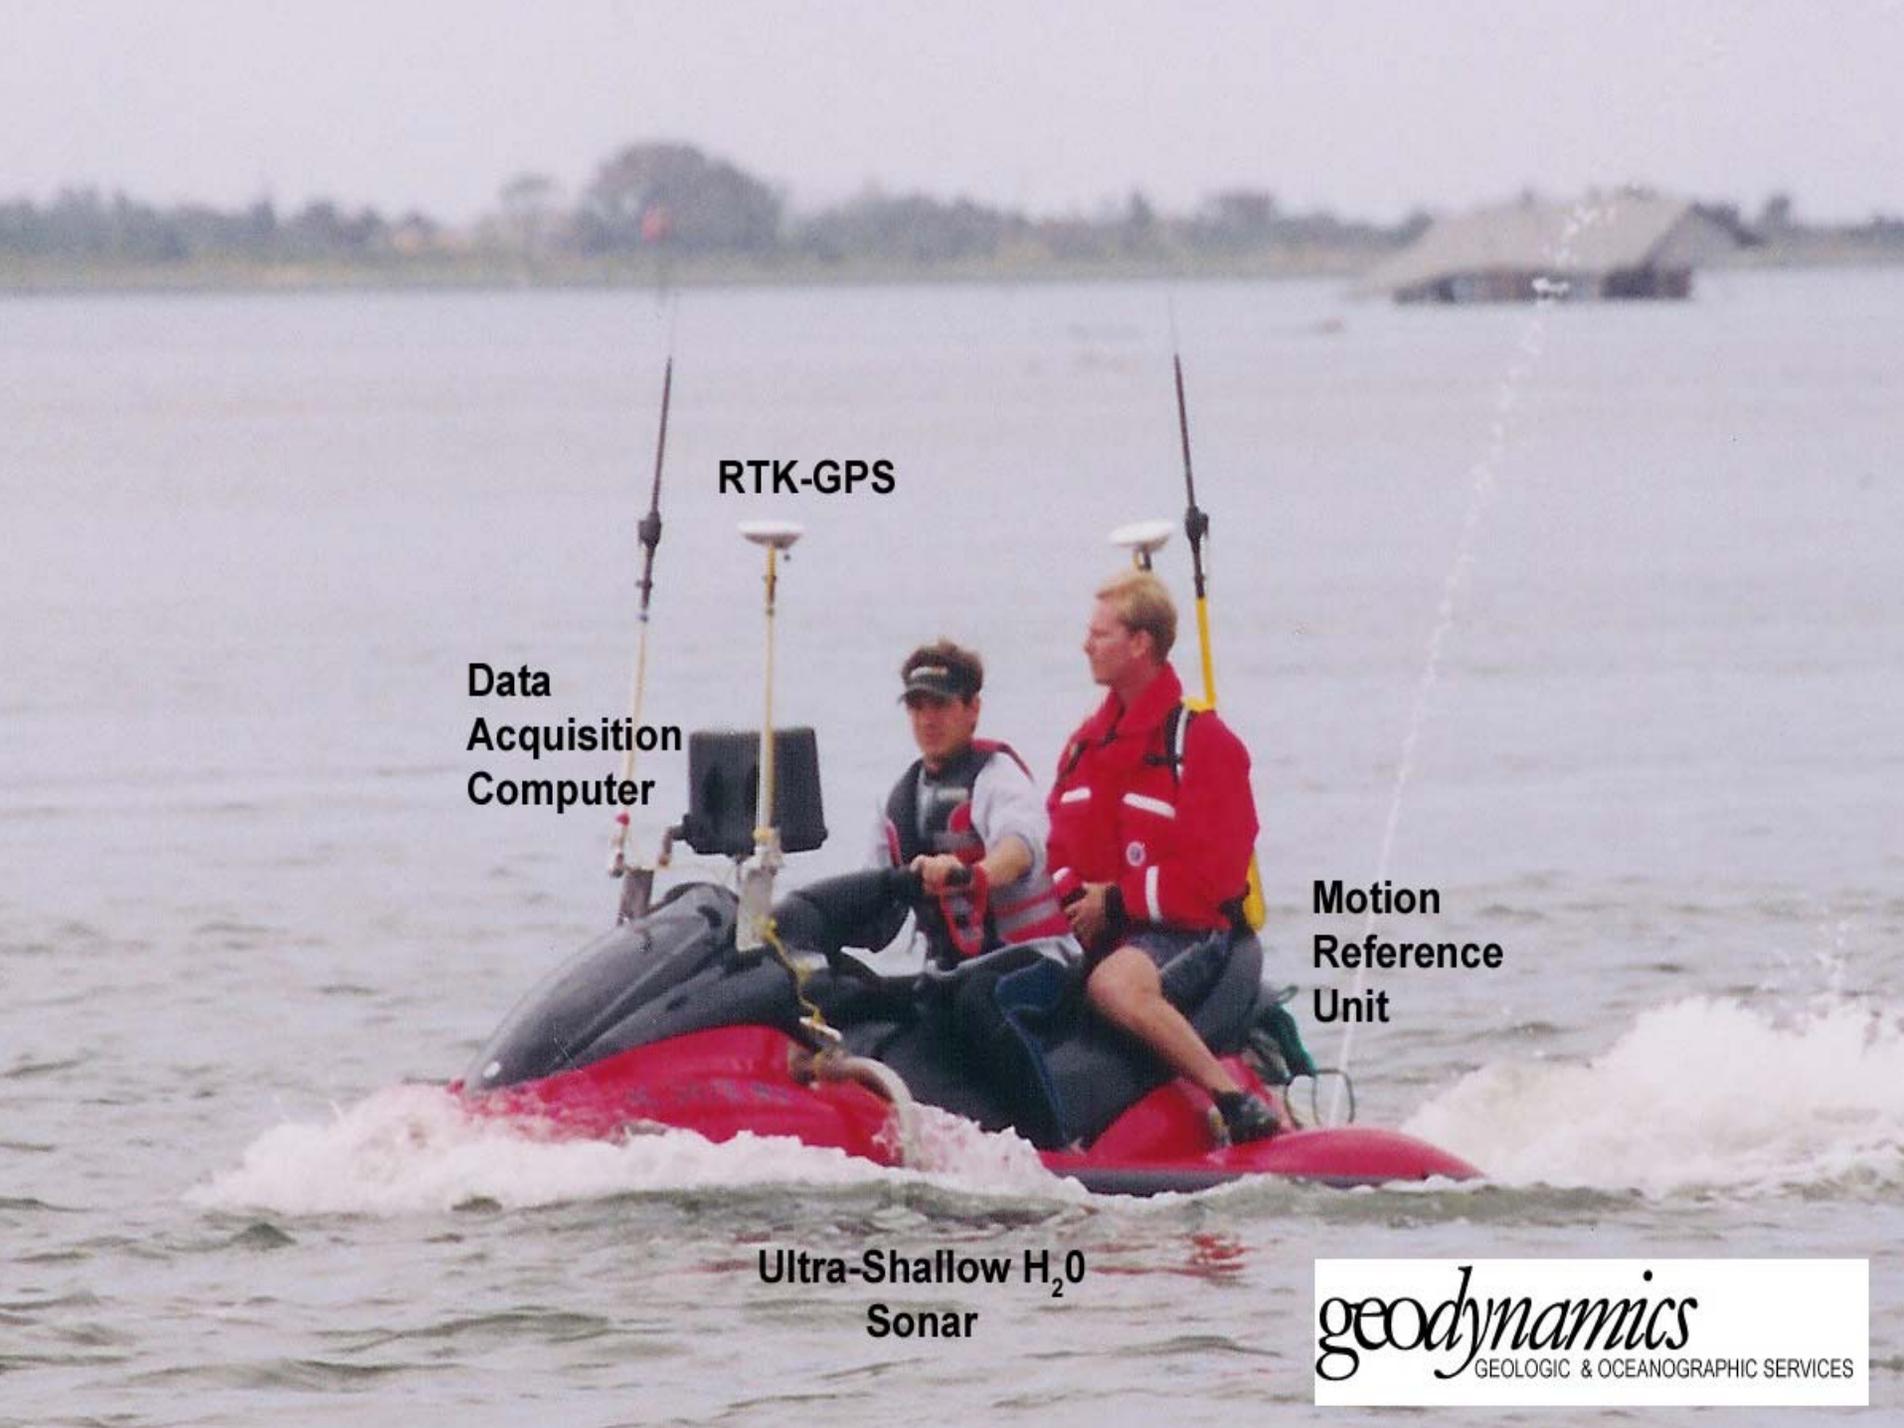
RTK-GPS

Data  
Acquisition  
Computer

Motion  
Reference  
Unit

Ultra-Shallow H<sub>2</sub>O  
Sonar

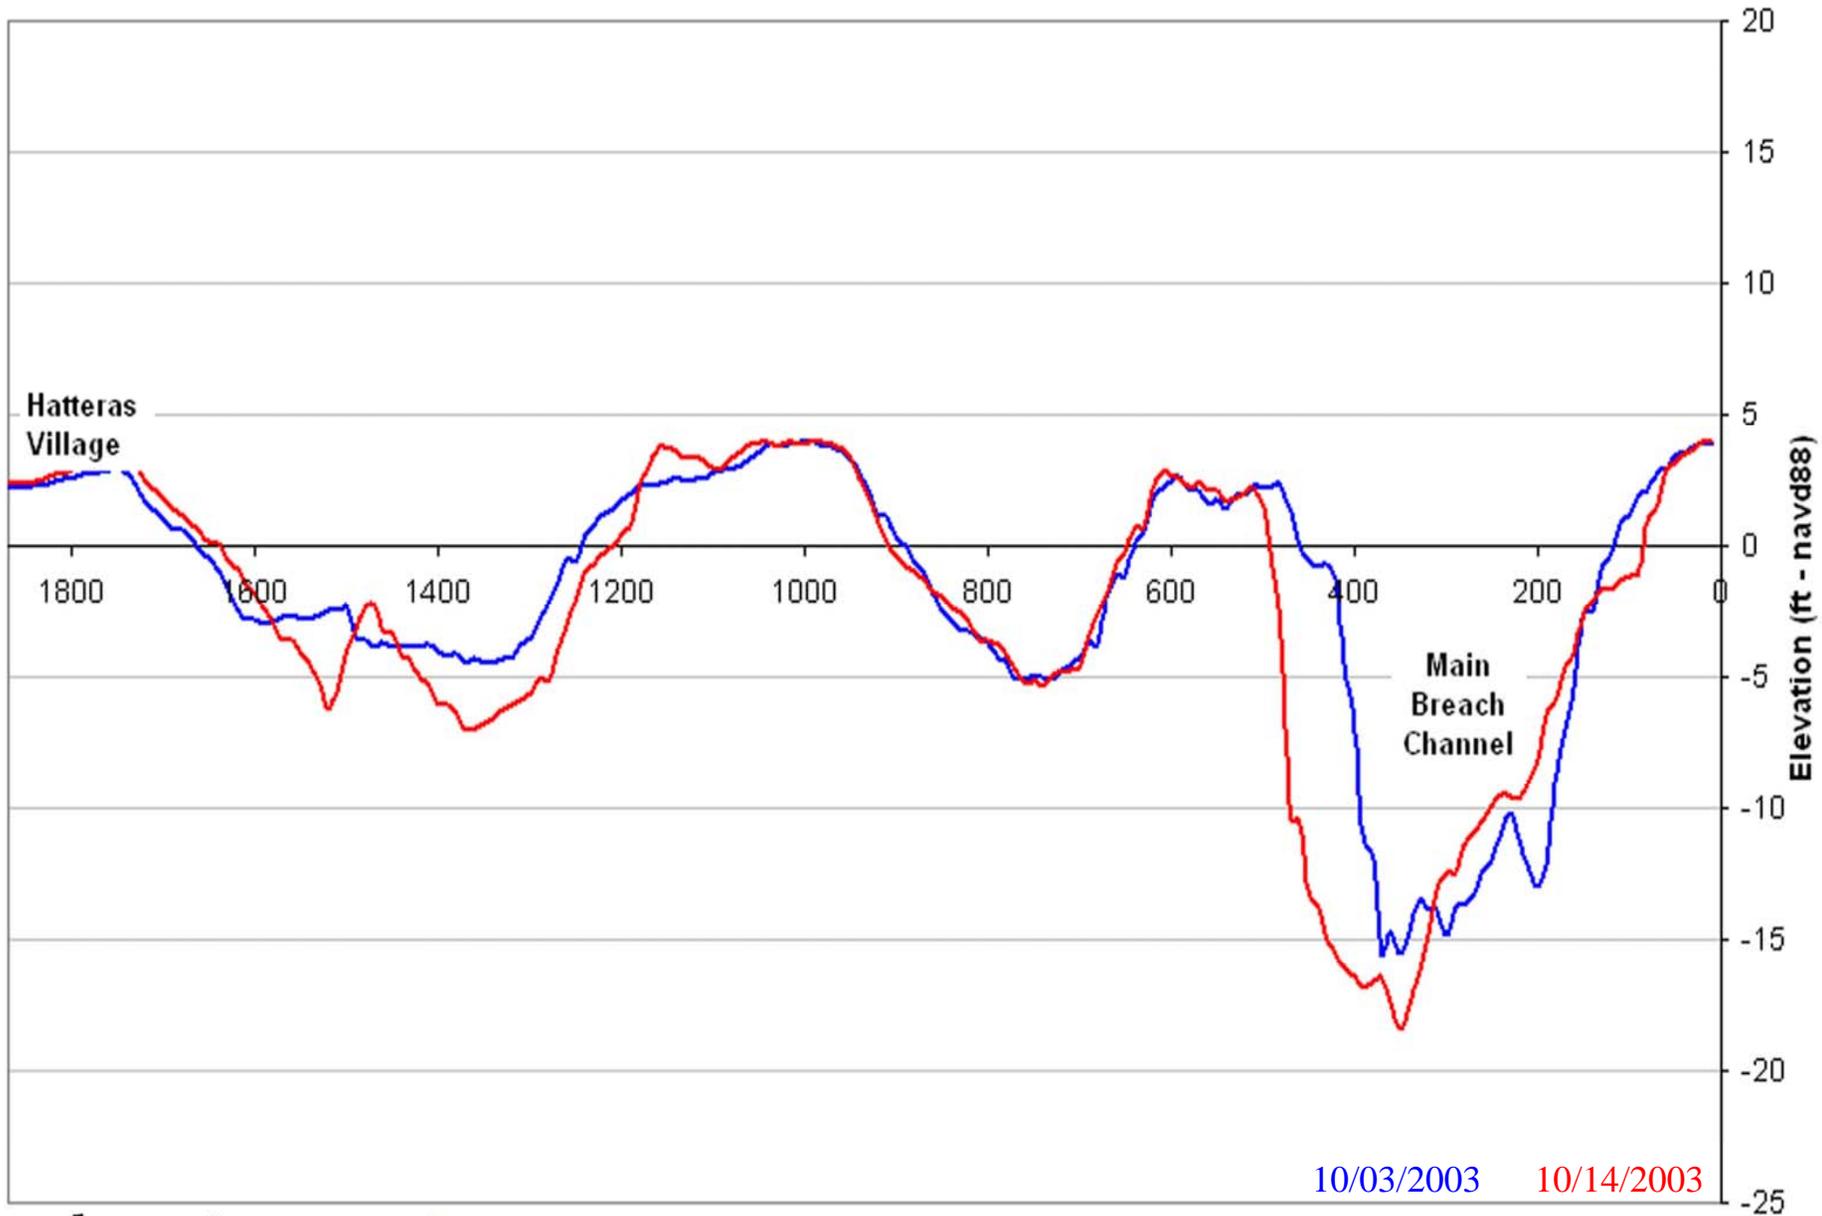
# Hatteras Breach Cross Section

10/03/2003 10/14/2003

Distance Along Profile (ft)

Survey1 Survey2

**Max surface current speed ~ 7.0 fps.**

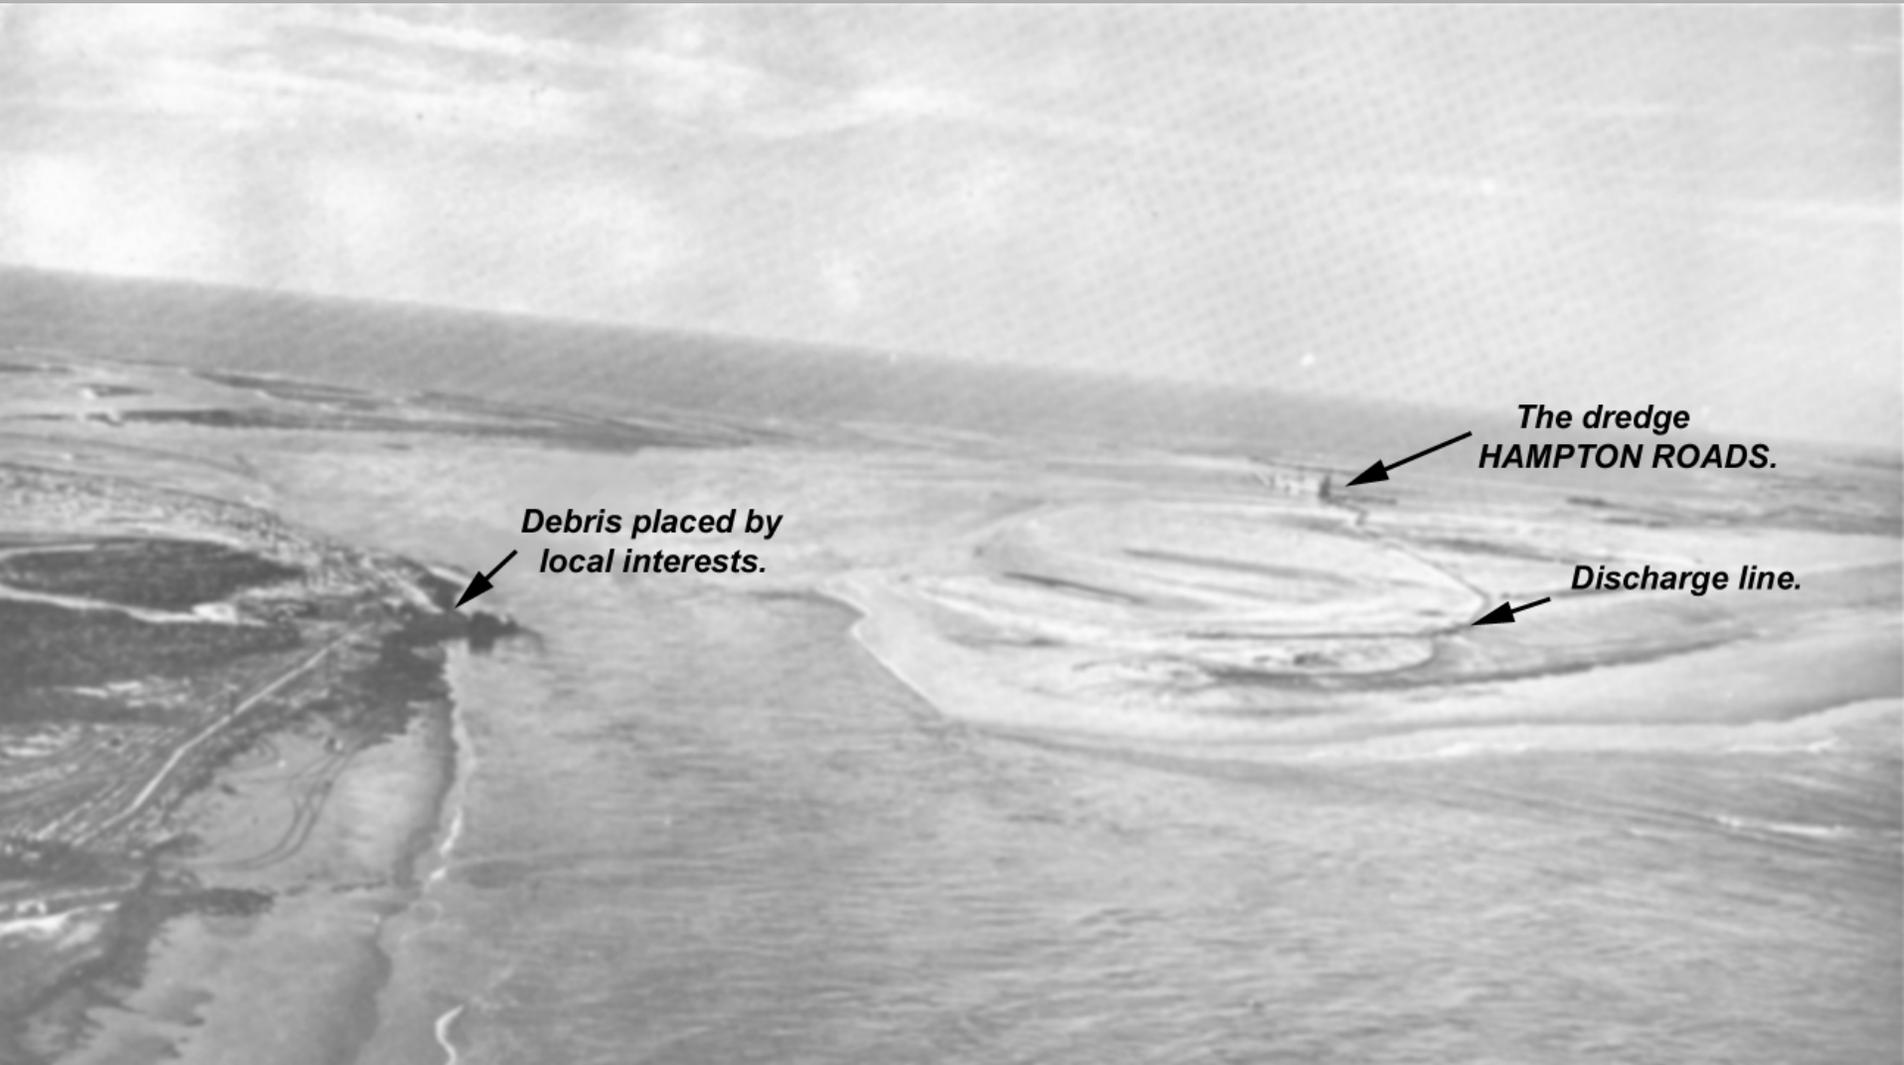
*Debris placed by  
local interests.*

*The dredge  
HAMPTON ROADS.*

*Discharge line.*

**Buxton Breach**  
1,650 ft wide  
12 feet deep

Two 16 inch dredged  
1,160 hp, 1,600 hp

9,000 cyds/day each  
1 dredge 55 days  
2 dredges 3 days

588,000 cyds  
At closure

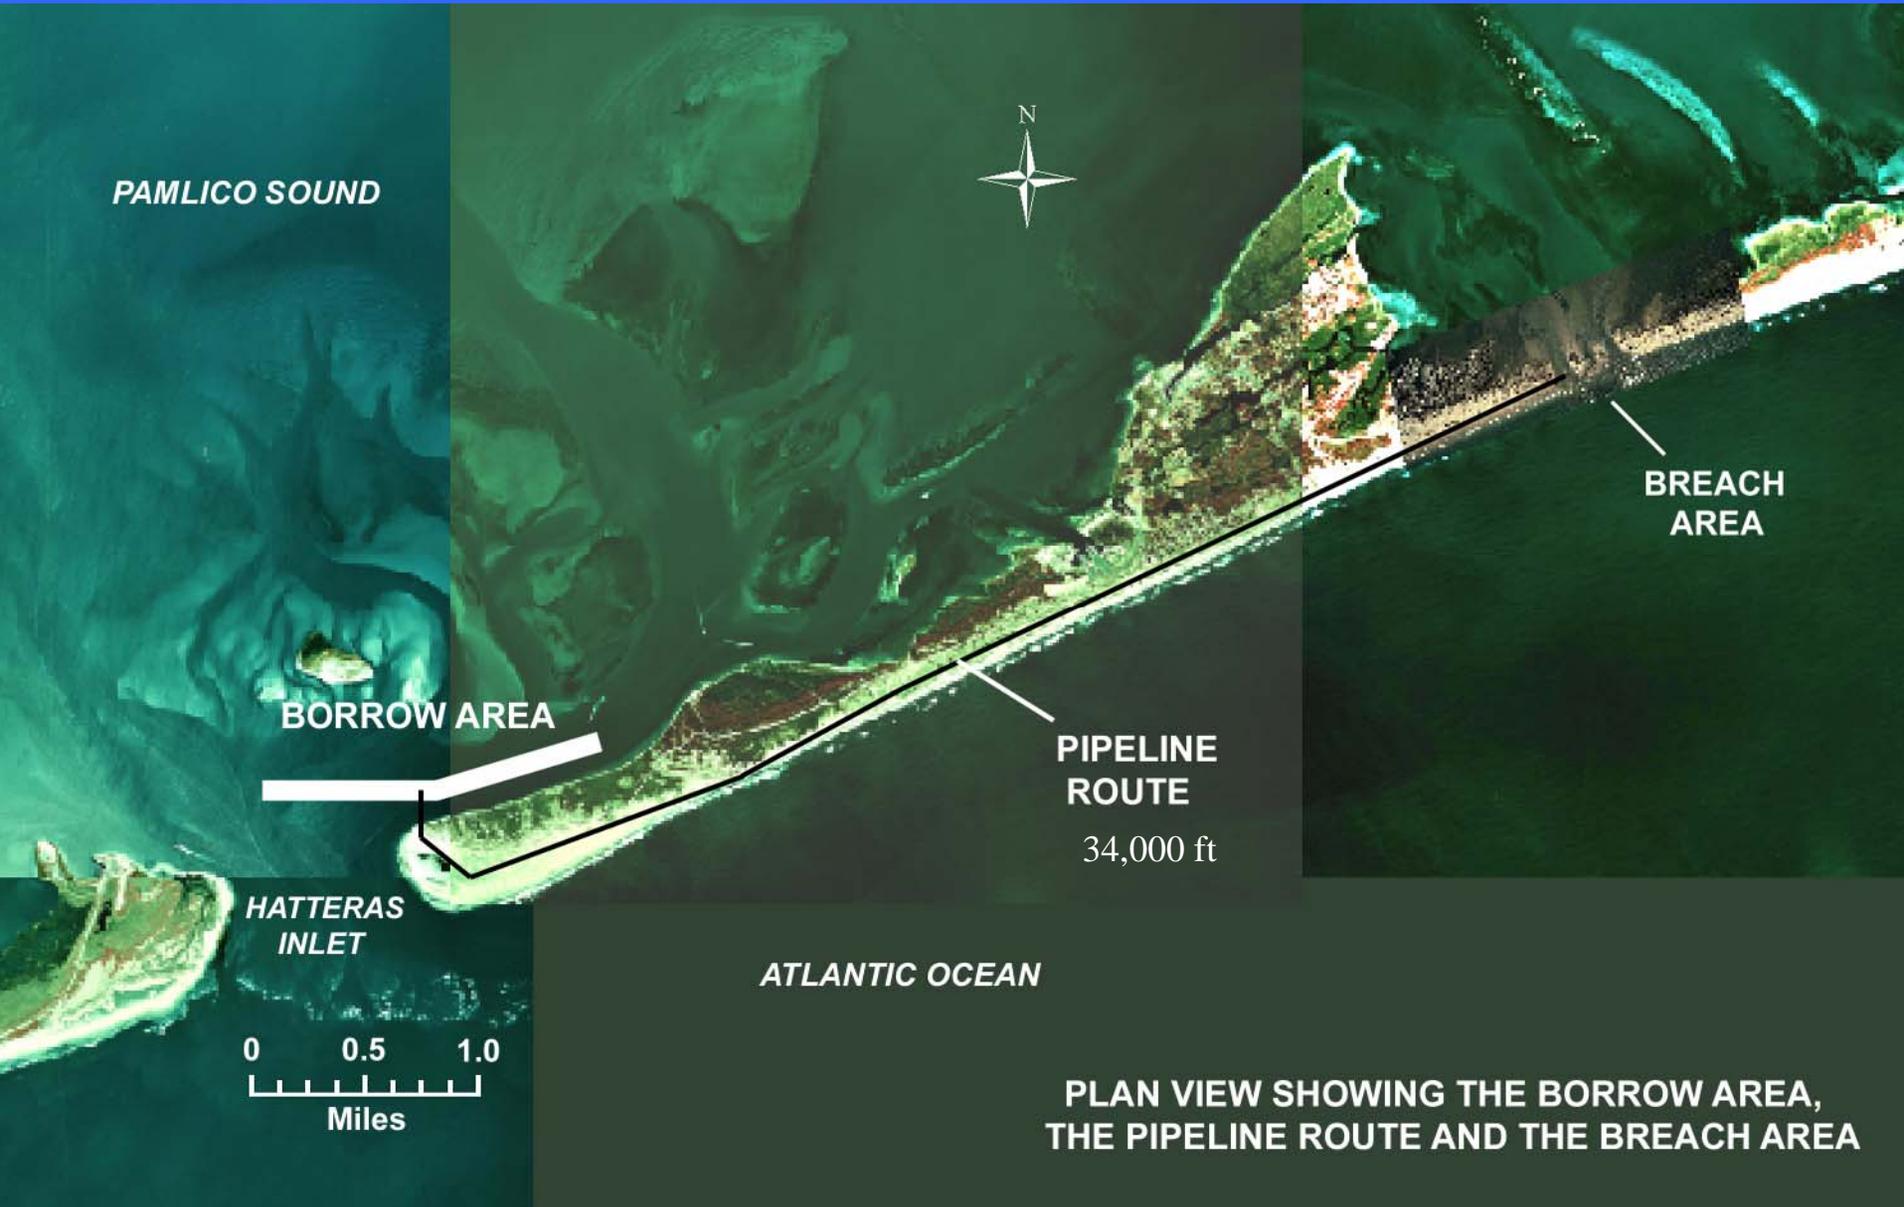
PLAN VIEW SHOWING THE BORROW AREA, THE PIPELINE ROUTE AND THE BREACH AREA

PAMLICO SOUND

BORROW AREA

BREACH AREA

PIPELINE ROUTE

34,000 ft

HATTERAS INLET

ATLANTIC OCEAN

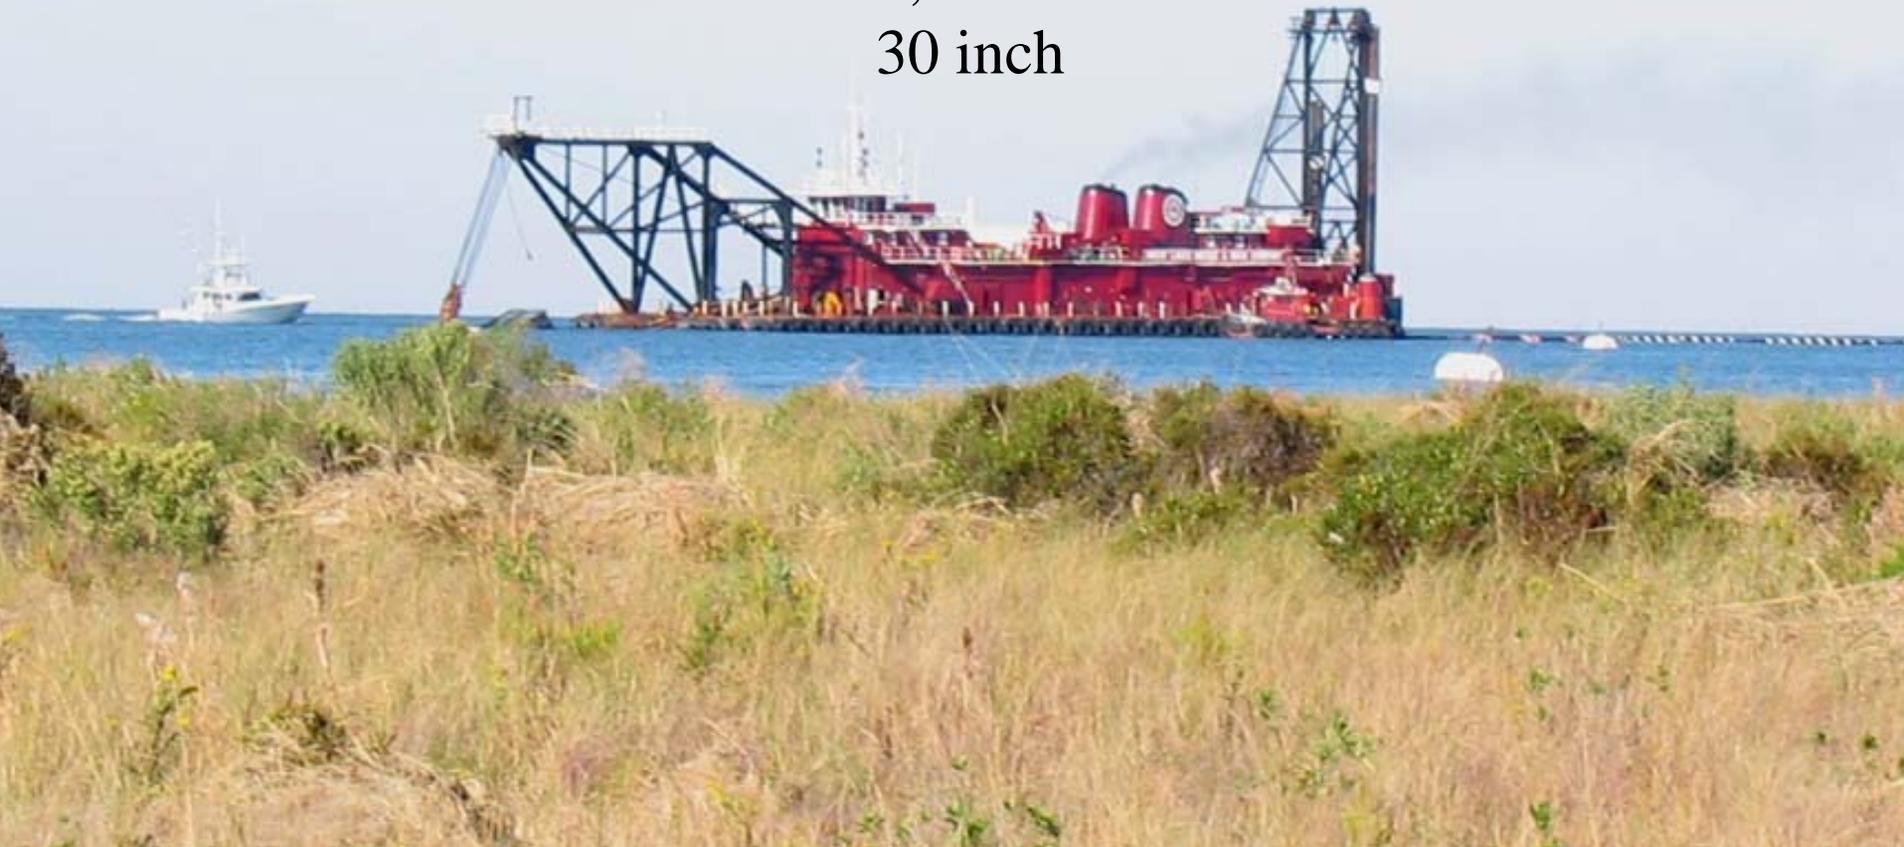
# *Illinois*

11,300 HP

30 inch

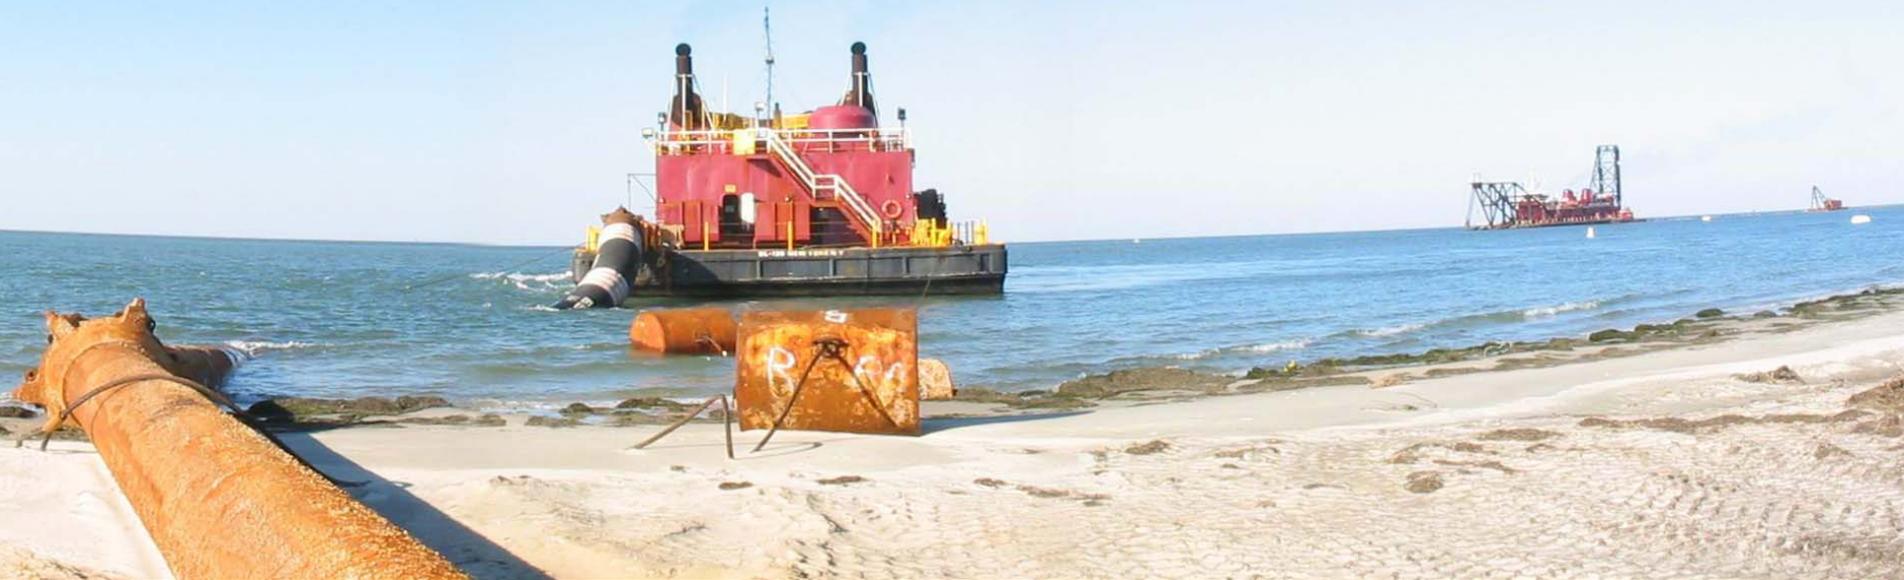
7,200 HP  
Booster

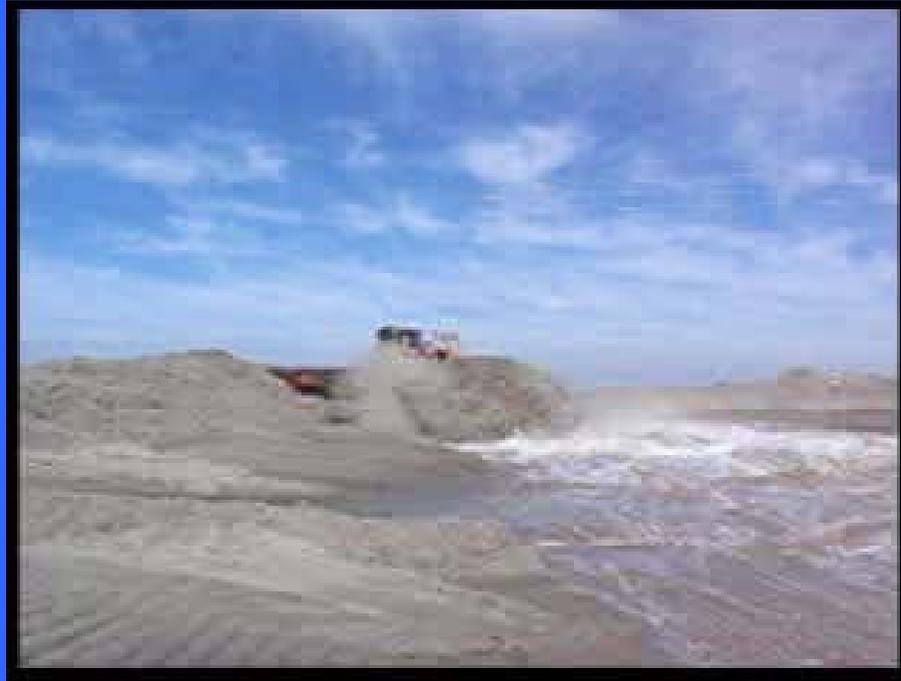
Started 17 October 2003  
15 days, 15 hrs/day, 22,000 cyds/day, 41,000 cyds/day max

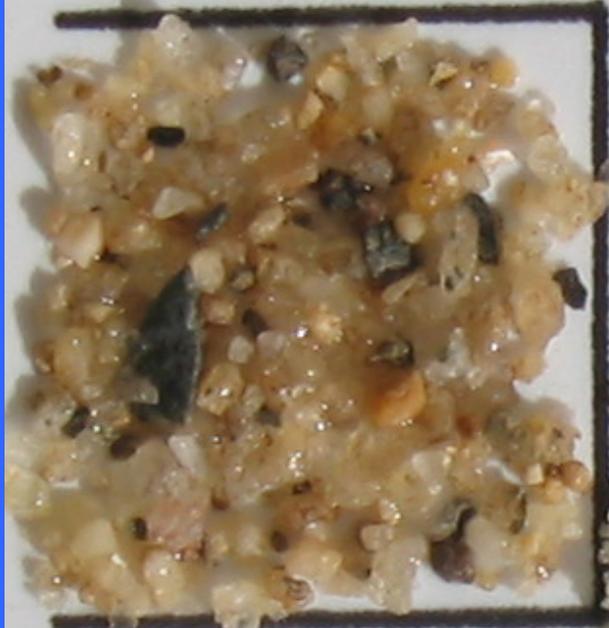
**coarse sand**

**1/2-1.0mm**

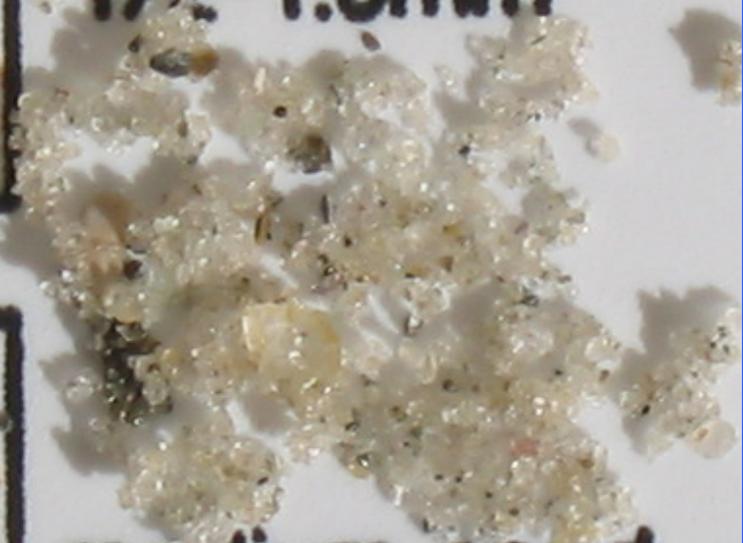
**medium sand**

**1/4-1/2mm**

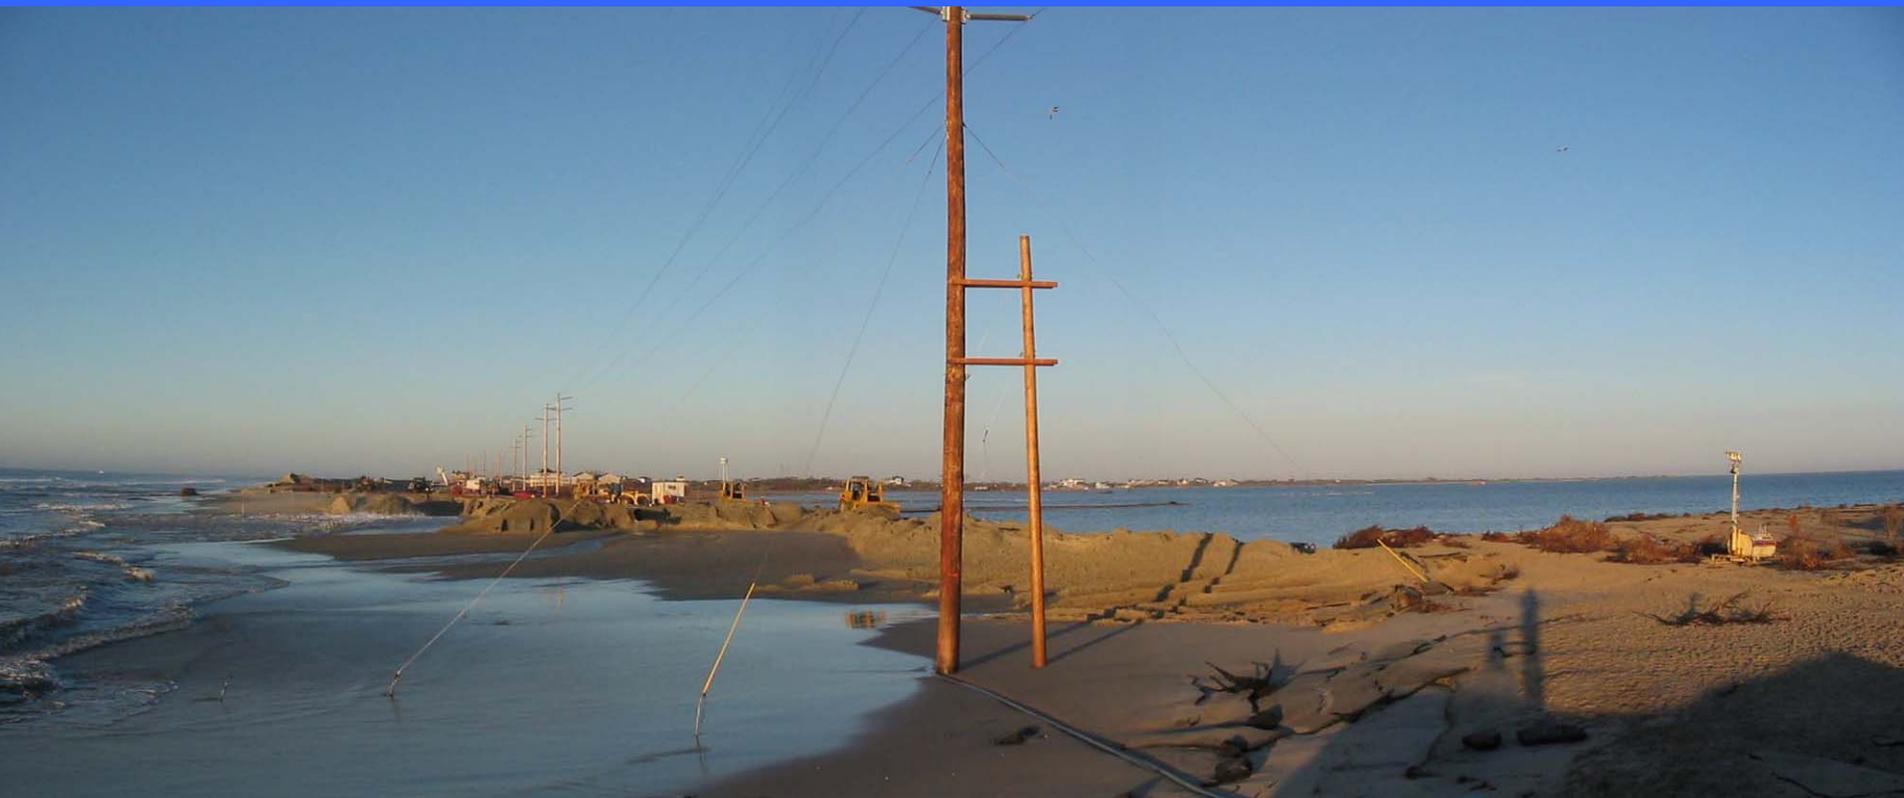
300,000 cubic yards dredged at closure
