# Effect of Armoring a Cohesive Nearshore with a Thin Cobble Lag, Shoreham, Michigan

*by Mohammad Dibajnia, James Selegean, and Andrew Morang*

**PURPOSE:** This Coastal and Hydraulics Engineering Technical Note (CHETN) summarizes monitoring results of the 1995 lake bed paving project conducted at Shoreham, MI, on Lake Michigan by the U.S. Army Engineer Research and Development Center (ERDC), in collaboration with The U.S. Army Engineer District, Detroit. The CHETN also discusses the effectiveness of lake bed paving in reducing cohesive lake bed downcutting and mitigation of bluff erosion. The lake bed paving concept was examined as an innovative alternative to traditional revetment construction to protect the shoreline.

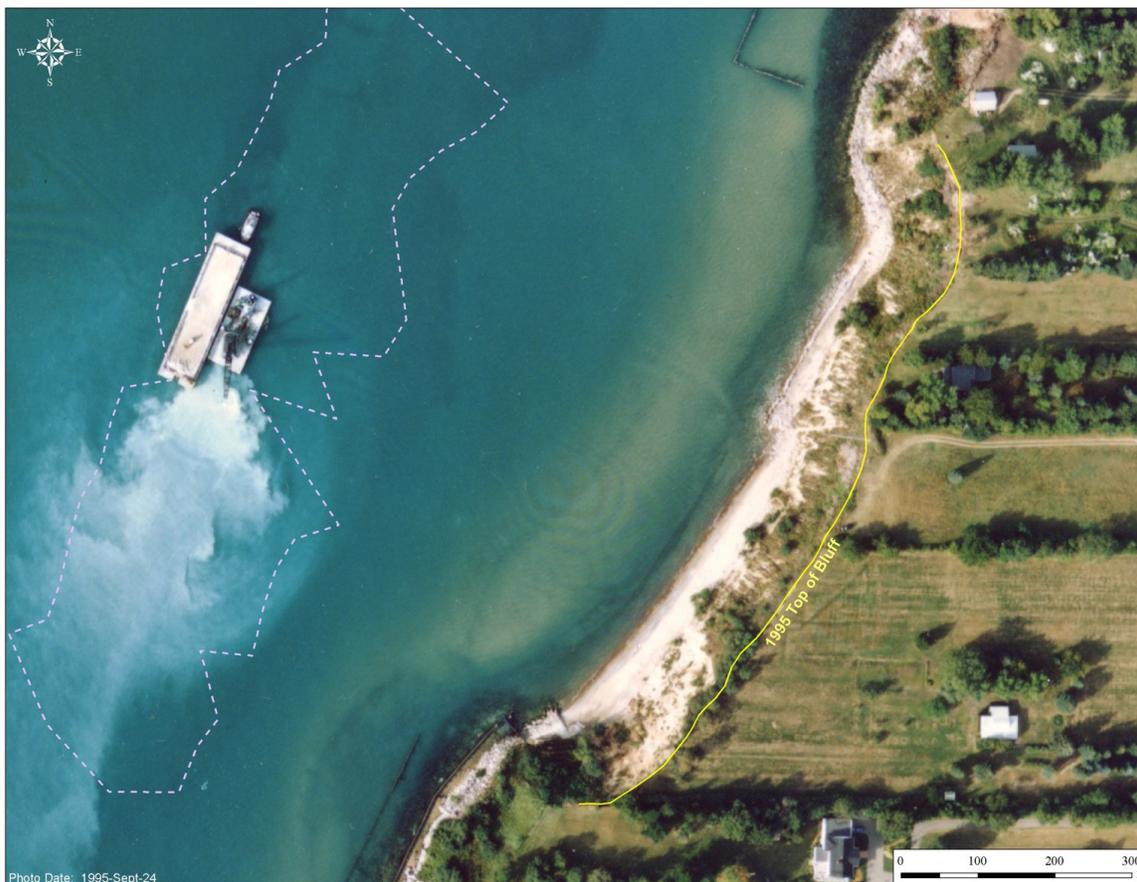
Figure 2. Stone placement captured in the September 1995 aerial photograph.

In September–October 1995, the Detroit District placed approximately 45.7 cm (18 in.) of stone on the lake bed near Shoreham, MI (Figure 2). The purpose of this study was to demonstrate that downcutting of the lake bed could be arrested with a relatively thin layer of cobble armor. A reduction in downcutting of the nearshore should ultimately lead to a reduction in bluff recession (Parson, Morang, and Nairn 1996). The stone placement encompassed an area roughly 335 m (1,100 ft) long, commencing at the 3.7-m (12-ft) contour (IGLD 1985 datum) and extending 152 m (500 ft) lakeward. Forty-three survey lines were taken at the site following the placement of the stone in 1995. These original survey lines were reoccupied in 2005.

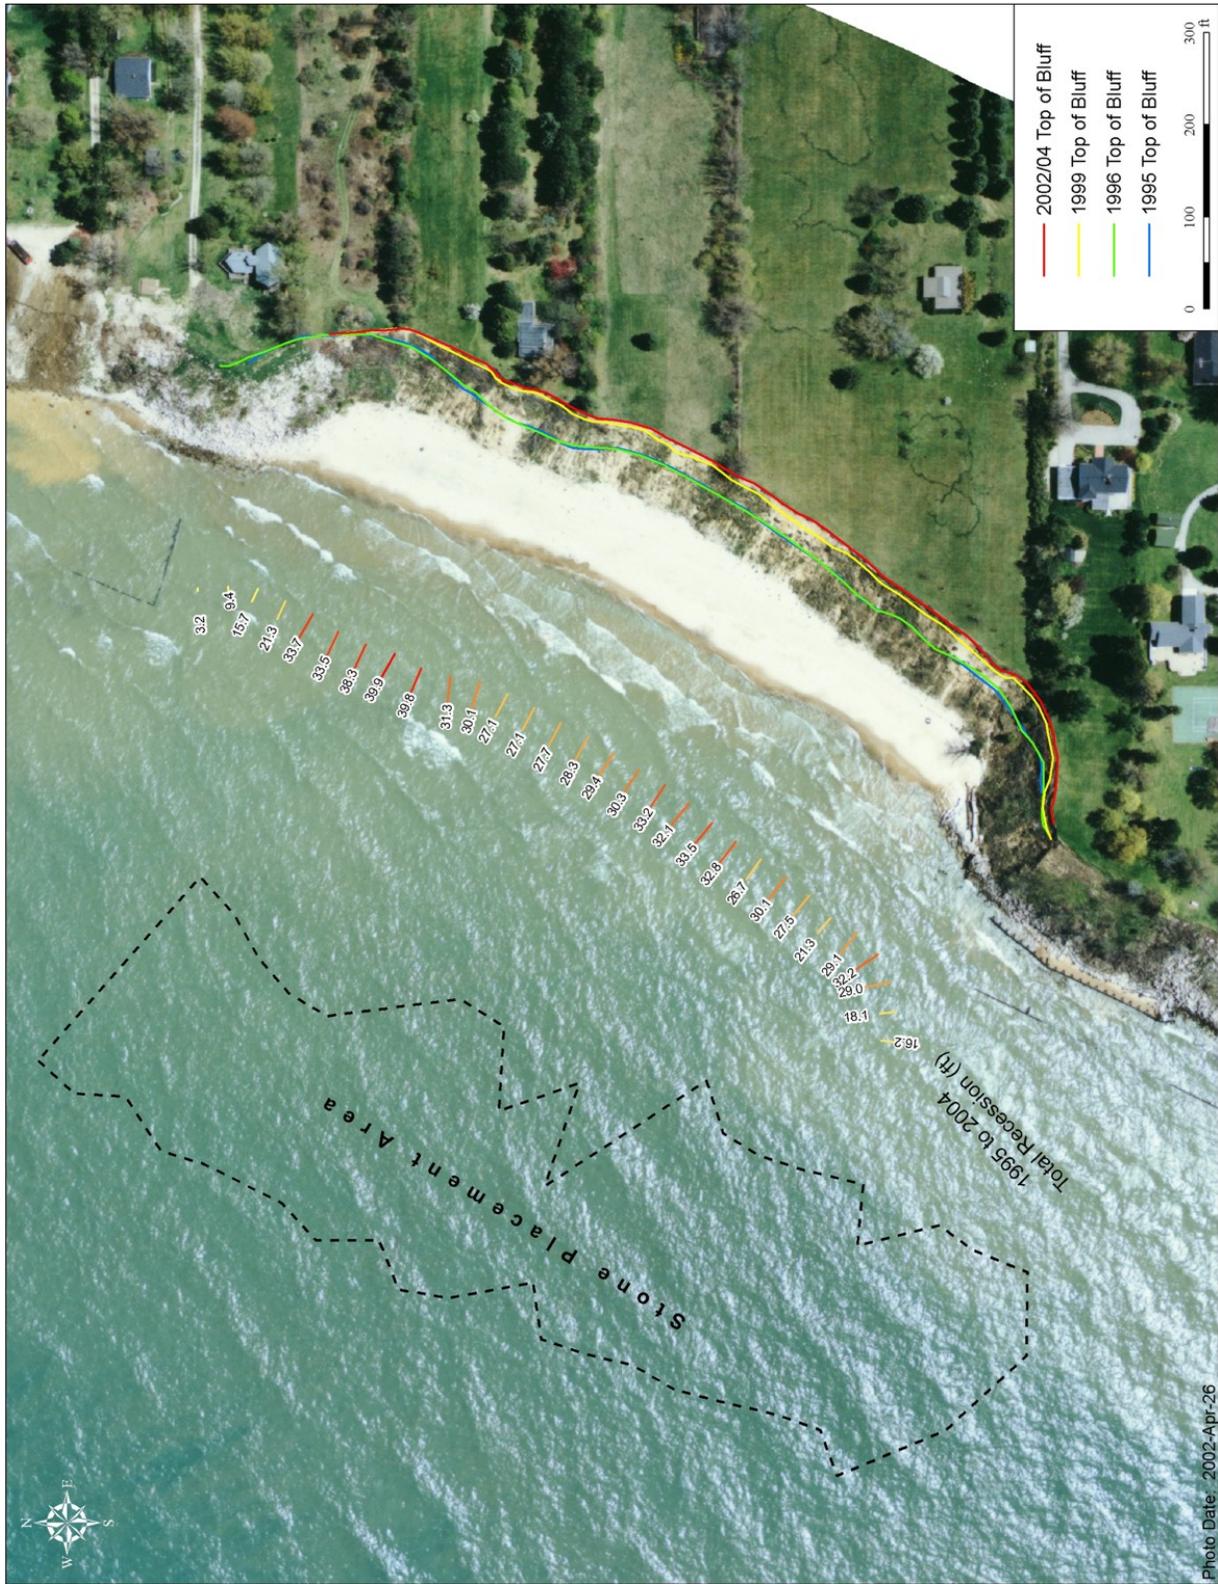
Figure 5. Bluff recession at Shoreham, MI, between 1995 and 2004.

Figure 5 shows bluff recession details since completion of stone placement project to present. Total recession between 1995 and 2004 for every 10 m (32.8 ft) along the Shoreham bluff are also given in this figure. Average total recession is 8.4 m (27.6 ft), which translates to a recession rate of about 0.9 m/year (3 ft/year) close to its long-term average. In this figure, the 2002 and 2004 lines are identical, i.e., there was no bluff erosion between these years likely because of recent low lake levels. During low lake levels there is little or no direct wave attack on the bluff face, which explains the growth of vegetation on the bluff face. During periods of high lake levels the bluff face is much steeper with little or no vegetation.
