# Coastal Barrier Breaching, Part 1: Overview of Breaching Processes

*by Nicholas C. Kraus, Ty V. Wamsley*

**PURPOSE:** The Coastal and Hydraulics Engineering Technical Note (CHETN) herein provides information about the causes of breaching of coastal barrier islands and spits, with emphasis on breaching near inlet navigation projects and measures to prevent breaching. Subsequent technical notes in this series will present case studies and models under development in the Coastal Inlets Research Program (CIRP) for predicting the inception and evolution of breaches.

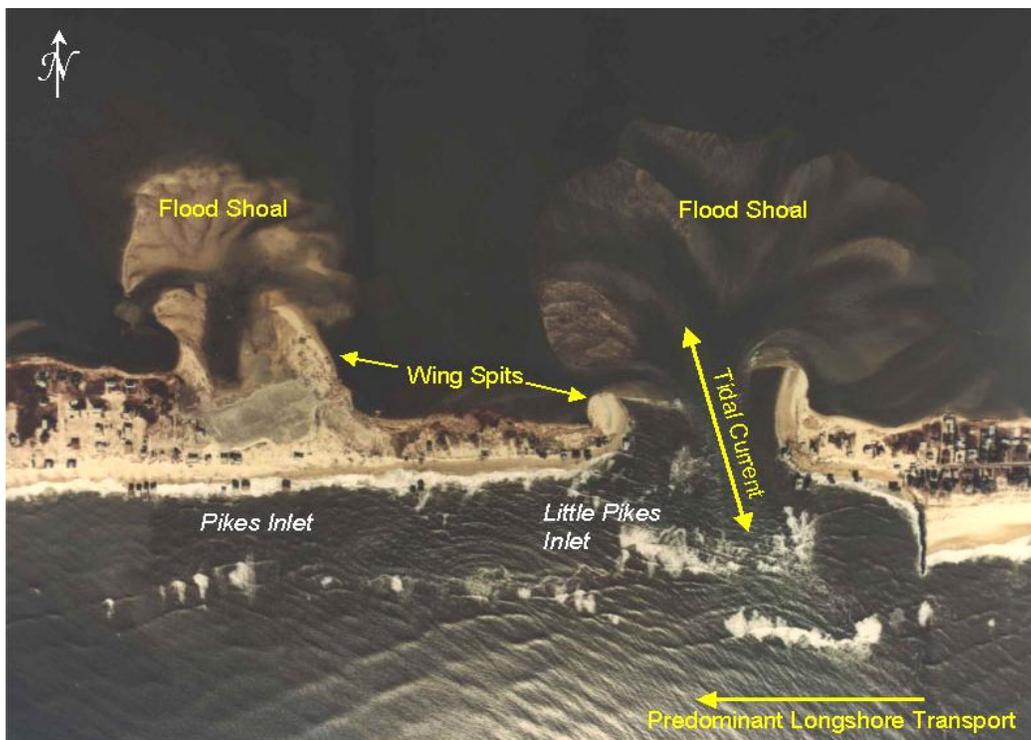
The destructive forces of breaching and constructive forces of breach filling are illustrated by reference to Figure 1, which shows two breaches at Westhampton, Long Island, NY, facing the Atlantic Ocean. This barrier section was breached from the ocean side during the subtropical storm of 11-13 December 1992 (Terchunian and Merkert 1995; Bocamazo and Grosskopf 1999). The initially larger breach opened at a location that was later called Pikes Inlet, creating wing spits and a flood shoal in the bay. Pikes Inlet attained more than 304.8-m (1,000-ft) width. At the same time, a shallow 30.48-m- (100-ft-) wide breach that could be walked through opened to the east at a location subsequently called Little Pikes Inlet. This small breach was initially prevented from growing by underlying peat deposits, which resisted erosion. The U.S. Army Engineer District, New York, closed Pikes Inlet in January 1993 by placement of 60,000 cu yd of material dredged from the nearby Intracoastal Waterway. Pikes Inlet had tended toward closure because of the littoral sand supply located to the east. In contrast, winter storms and lack of sediment supply caused Little Pikes Inlet to grow to more than 914.4 m (3,000 ft) in width, creating small wing spits and a large flood shoal. Tide range and salinity in the back bay increased while the breaches were open. The two breaches cut the access road to houses and the county park located on their west side.

Figure 1. Breaching of barrier island at Westhampton, Long Island, NY, December 1992. Photograph taken 7 March 1993 and furnished courtesy of First Coastal Corporation, Westhampton

Little Pikes Inlet became a semipermanent inlet because the longshore supply of sand was reduced by the Westhampton groin field located to the east and directly updrift (Nersesian, Kraus, and Carson 1992), so that scour by the tidal current could overcome the weak amount of infilling from longshore sand transport. The New York District initiated breach closure in May 1993 that was completed in November 1993 by hydraulic placement of approximately 1.6 million cu yd from two offshore borrow sites (Bocamazo and Grosskopf 1999). Subsequently, the New York District and New York State developed a breach-contingency plan for a 91.7-km (57-mile) reach of Long Island barrier islands. The breach contingency plan involves maintenance of stockpiles of sand (obtained from channel dredging) for reinforcing barrier dunes and reducing breach potential during storms. The plan has protocols for assuring rapid communication lines to coordinate actions between New York State and the New York District, which can be found at (<http://www.nan.usace.army.mil/fimp/>).

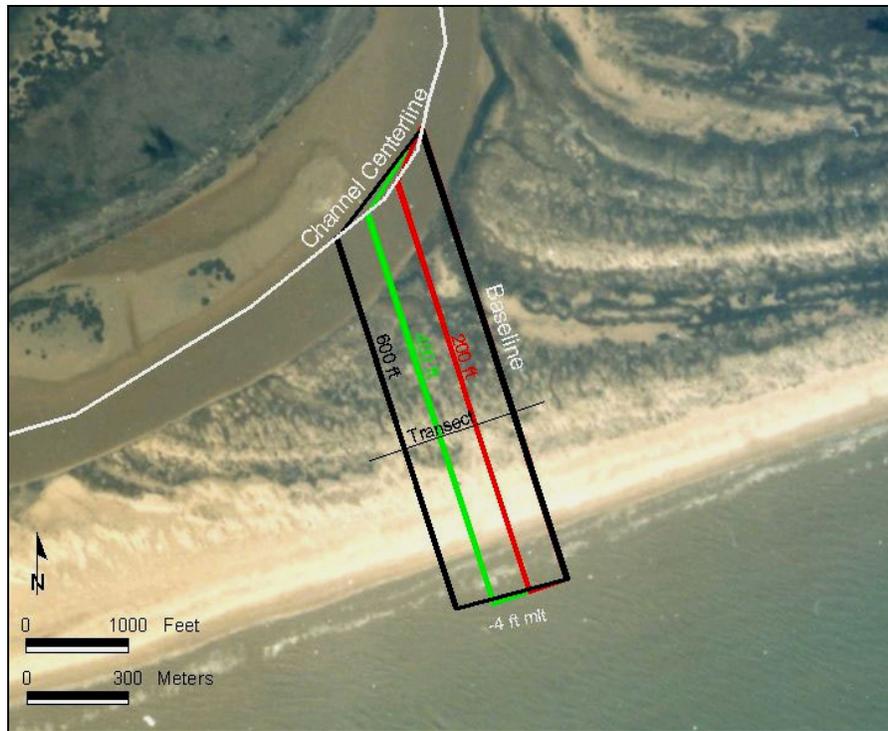
Another reason for breaching a barrier is to relocate an inlet or river mouth that has migrated alongshore. The U.S. Army Engineer District, Galveston, is considering relocating the mouth of the San Bernard River, TX (Figure 2), which empties into the Gulf of Mexico. The spit has grown westward under longshore sand transport, and the migrating river mouth has become inefficient, raising concern about flow patterns and navigation in the Gulf Intracoastal Waterway that intersects the river about a mile above (north of) its mouth. Breaching of the spit to return the river mouth to its original location will promote efficient flow to the Gulf of Mexico (Kraus and Lin 2002). Numerical and physical models of spit growth at inlets are discussed by Kraus and Seabergh (2002), and FitzGerald, Kraus, and Hands (2001) describe conceptual morphologic models of spit growth at inlets and rivers.

Figure 2. Alternatives for location and width of proposed relocated river channel mouth (breaching of coastal spit), San Bernard River, TX

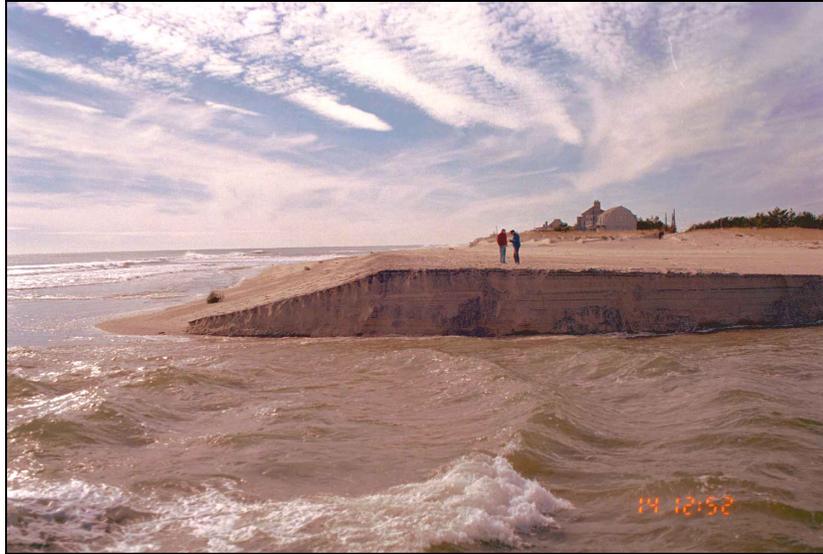
Photographs in Figure 3 were taken several hours after a breach was cut by hydraulic excavator at Mecox Pond, facing the Atlantic Ocean on the south shore of Long Island, NY. Without almost-annual artificial breaching, water level rises in the pond, and basements of bordering residences flood. The breach is left unattended to close under littoral processes, as documented by Smith and Zarillo (1988). Artificial breaching is conducted at several California river entrances such as the Carmel River, Russian River (Rice 1974), and Salinas River for such purposes as improvement of water quality, mitigation of flooding, and opening of migration paths for anadromous fish.

a. Looking east at breach cut through beach berm, Atlantic Ocean to left

Figure 3. Mecox Pond, breached on morning of 14 February 1998  
(photographs taken in afternoon of February 14)

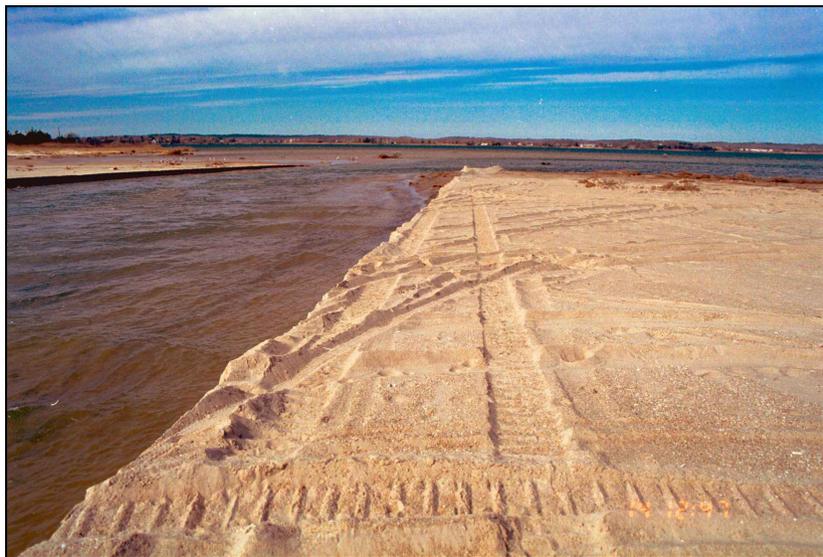
b. Looking north toward Mecox Pond

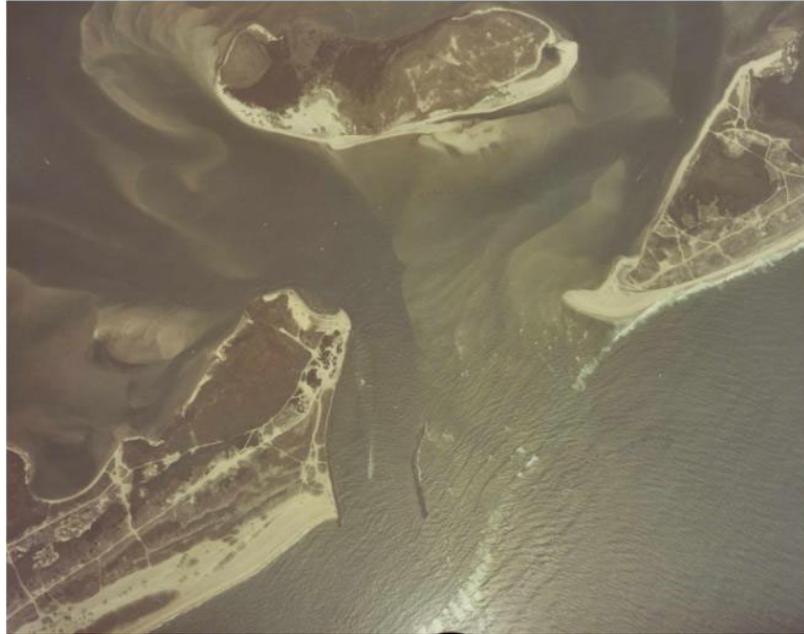
**Breach at Moriches Inlet, NY, January 1980.** Moriches Inlet (Figure 4) is one of six federally maintained inlets on the south shore of Long Island, NY, and connects Moriches Bay to the Atlantic Ocean. Inlets to Moriches Bay have been semipermanent and migratory (Sorensen and Schmeltz 1982)<sup>1</sup>. In 1952-1953, rubble-mound jetties 213.4 m (700 ft) apart were constructed “in the dry” at an updrift location, and mechanical cutting of the channel was augmented by a minor storm in September 1953 to open the inlet. The net longshore drift on this coast is predominantly from east to west (right to left in Figure 4). Although the east jetty is on the updrift side of the inlet, the barrier beach narrowed because the strong ebb current directed at and along the easternmost section eroded the shore on the back side of the barrier.

a. 21 September 1980, 9 months after January 1980 breach

Figure 4. Moriches Inlet, NY. Atlantic Ocean at bottom of figures

During 16-18 January 1980, a severe extratropical storm cut the barrier at its narrowest section, and the breach expanded (Figure 4a) from an estimated 91.4-m- (300-ft-) width and 0.61-m- (2-ft-) depth on 16 January to 883.9-m- (2,900-ft-) width and average depth of 3.0 m (10 ft) by October 1980. Moriches Inlet primarily serves shallow-draft recreational vessels, and the New York District monitored the breach without immediate action. Local interests expressed concern about increased exposure to storm-induced flooding in the bay areas and changes in bay salinity on the shellfish industry. The New York District proceeded to close the breach prior to the next storm season. Sorensen and Schmeltz (1982) describe the engineering actions taken. Approximately 1.2 million cu yd of material was required for the breach closure, half obtained from dredging in the back bay and half trucked from a nearby quarry. After closure of the breach, the State of New York and Suffolk County constructed a 487.7-m- (1,600-ft-) long riprap revetment on the bay side of the beach adjacent to the east jetty (Figure 4b). The adjacent beach is part of a county park and popular for bathing and fishing.

In summary, the breach at Moriches Inlet resulted from narrowing of the barrier island, mainly through erosion on the bay side. Seabergh (2002) describes the processes and possible remedial measures for bayside erosion at inlet entrances. Because the barrier near the east jetty was narrow and low, a severe storm overwashed the weakened barrier, triggering the breach.

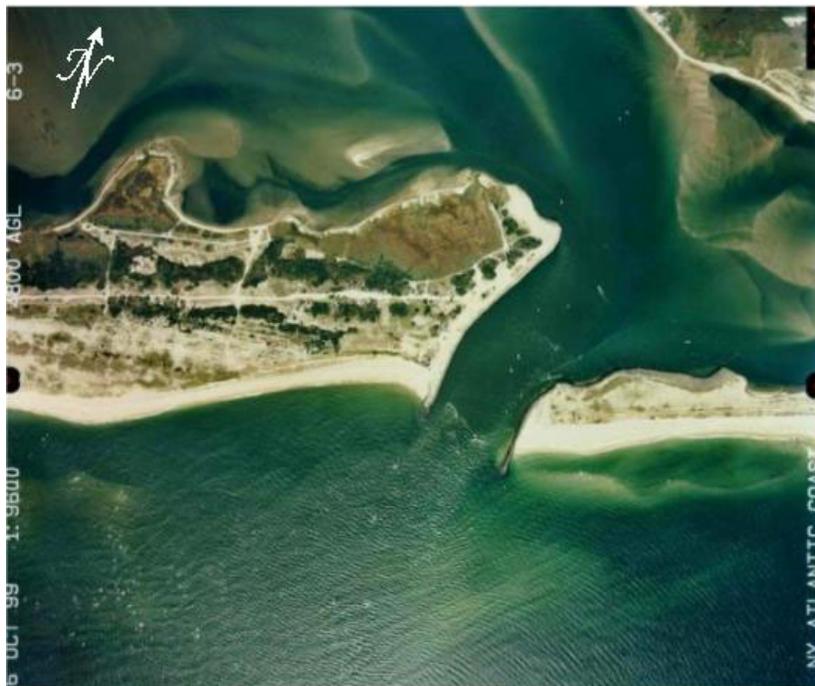
b. 6 October 1999, showing the revetment along eastern bay side

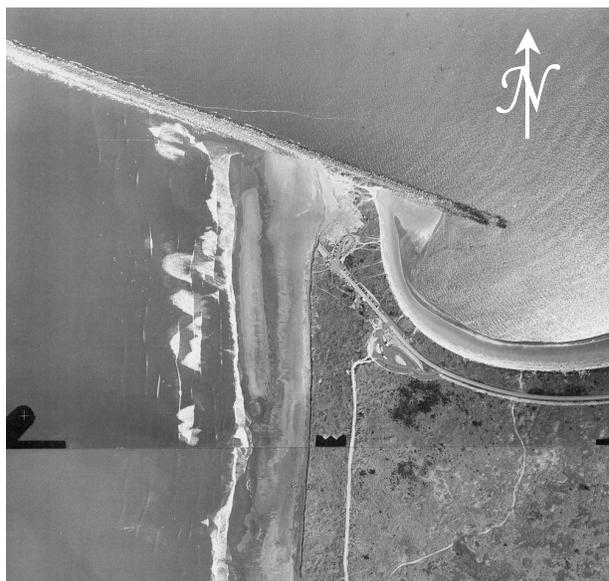
**Breach at Grays Harbor, WA, December 1993.** Grays Harbor is a large bay facing the Pacific Ocean (Figure 5). Two jetties constructed 2.4 km (1.5 miles) apart protect a deep-draft channel and stabilize the entrance. Grays Harbor has one of the largest tidal prisms in the United States. The tidal range exceeds 2 m, and the average annual wave height is greater than 2 m, with deepwater storm waves reaching heights of 8-10 m annually. Large wave heights and long wave periods, typically in the 12-20-sec range, contribute to large setup and runoff during storms.

a. May 1993, 7 months before breaching

Figure 5. South jetty, Grays Harbor, WA

At Grays Harbor, the predominant direction of regional longshore transport is from south to north. The beach on the bay side of the south jetty began to erode when the jetty elevation was raised in the mid-1930s. After the south jetty was sand-tightened in the 1970s, the back bay shoreline eroded further, creating what is now called Half Moon Bay (Figure 5a). The south beach gradually narrowed, and a storm on 12 December 1993 breached the barrier spit next to the jetty (Figure 5b). A considerable amount of sand was transported into the Half Moon Bay area by a strongly flood-dominant current flowing through the breach, as compared to the entrance between the jetties, which was ebb dominant. Local interests in the city of Westport, located to the east of the entrance and just behind the breach, grew concerned about loss of land, loss of water wells and increased exposure to waves and currents. There were also concerns that further erosion would threaten the stability of the south jetty and that the eroded material may shoal the entrance channel. The Seattle District closed the breach in the fall of 1994 by placing 600,000 cu yd of sand dredged from the channel.

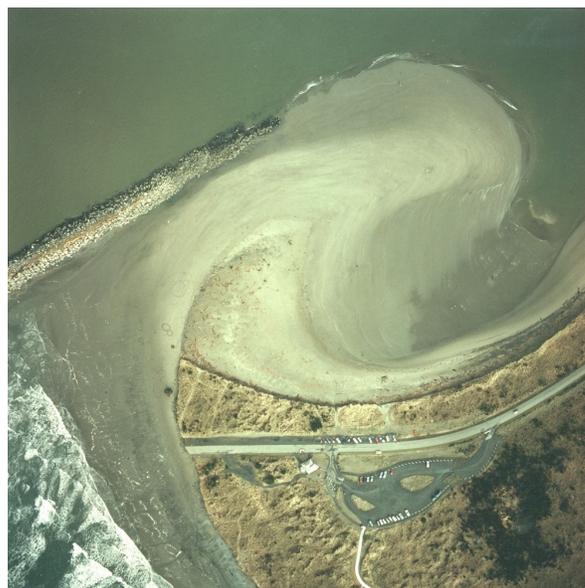
b. February 1994, 1 month after breaching

In summary, breaching at Grays Harbor during a storm in December 1993 was caused by a narrowed and lowered barrier spit. The beach had eroded both from the bay side and the ocean side. Placement of an adequate volume of sand in the breach and cobble on the bay side shoreline to reduce erosion proved effective under multiple storms. The lessons learned was that heavy precipitation could create gullies and weaken the berm fill. Therefore, planting of vegetation on the berm was considered a means for holding sand and collecting additional wind-blown sand to maintain or increase beach and dune volume.

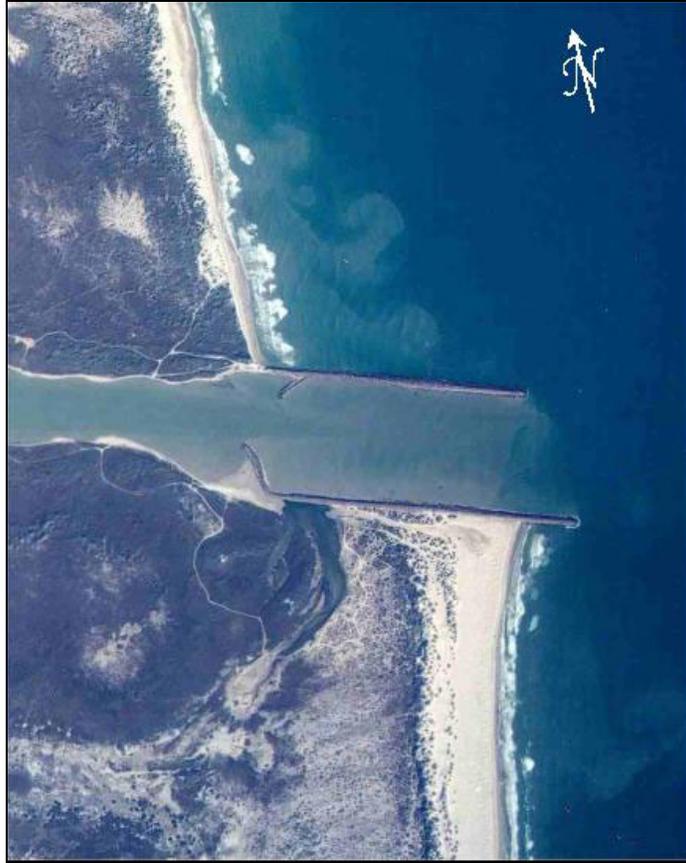
**Mansfield Pass, TX.** Mansfield Pass is an inlet located along the southern coast of Texas. Breaching potential exists at both the north and south jetties. As seen in Figure 6, the net direction of transport is strongly to the north. Formerly a harbor of refuge, Mansfield Pass presently provides access for shallow-draft recreational vessels and small commercial fishing boats. Maintenance dredging has decreased, and material dredged from the channel is placed on the beach of the Padre Island National Seashore adjacent to the north jetty. Insufficient volume of dredged material has

Figure 6. Mansfield Pass, TX, December 2001

required the Galveston District to consider fail-safe alternatives to prevent a breach along the north beach, adjacent to the north jetty. The alternatives include (a) a geotube or a stone revetment buried in the dune to be unobtrusive unless uncovered, (b) landward extension of the jetty, (c) placement of beach-quality material available from nearby disposal sites landward of the north jetty, and (d) combinations of (a) to (c).

The Galveston District has also noted a runnel (small channel) located along the beach next to the south jetty, apparent as a narrow strip of white sand cutting through the vegetation line in Figure 6. The runnel is probably created by surge and waves piling up water at the jetty during storms, as well as by runoff from the beach during heavy rain. This problem is remedied by dune rehabilitation and re-routing and dispersion of water pathways.

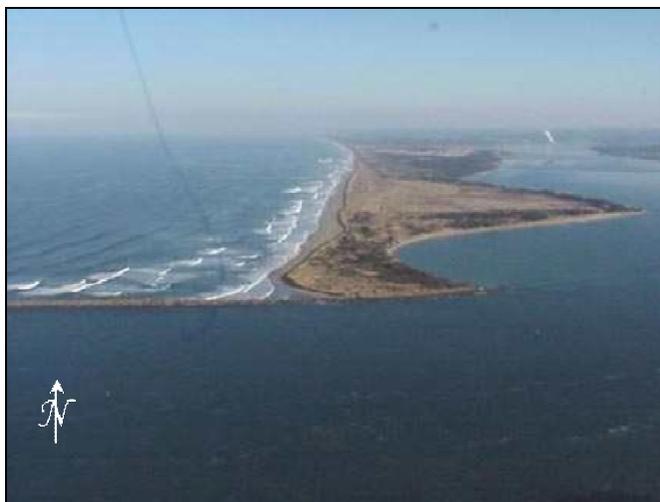
**Coos Bay, OR.** The north jetty at Coos Bay (Figure 7a) was constructed during 1892-1894, including a substantial effort at stabilizing the beach and sand dunes of the north spit. The 1998-1999 storm season resulted in significant shoreline recession adjacent to the north jetty. Approximately 103.6 m (340 ft) (35 percent) of the beach width was lost. In addition, a runnel or hydraulic flow path was established adjacent to the north jetty, the focusing effects of which are evident in the accelerated shoreline erosion of the vegetation line shown in Figure 7b. The combination of beach width loss and runnel creation made the back section of the jetty vulnerable to

a. View of north jetty and barrier spit, looking north

Figure 7. North jetty, Coos Bay, OR (December 2002)

overtopping; this section of jetty had a crest elevation that was 2.7 m (9 ft) lower than the seaward section. The more than 100-year-old jetty was subsequently severely damaged during a severe Pacific Ocean storm in November 2002 that removed stone near its connection to the beach (Figure 7b). The opening was approximately 30.5 m (100 ft) wide (Figure 7b), and the repair section is 152.4 m (500 ft) long. Repairs were accomplished from December 2002 (Figure 7c) to January 2003 as an emergency action. The lower crest elevation near to the shore prevents sand accumulation or impoundment at the jetty, narrowing the barrier, and increases the potential for a breach to open next to the jetty. In addition, wave energy from the channel side has increased with wider and deeper navigation channels, allowing significant wave attack from the channel side. Although this particular breach occurred in the jetty itself, there is also concern about breaching through the coastal dune into the inner embayment seen in Figure 7a.

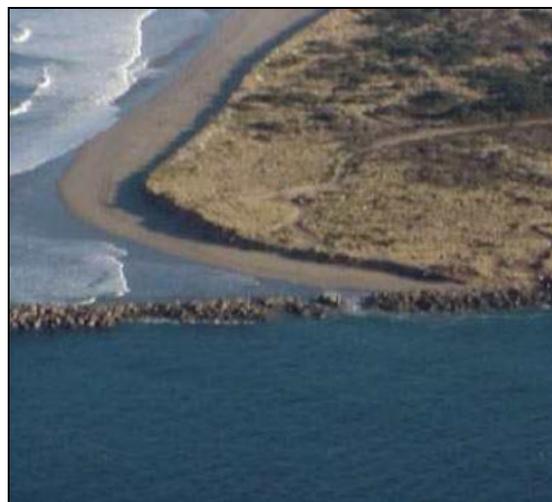
b. Close view of gaps in north jetty near the land tie-in

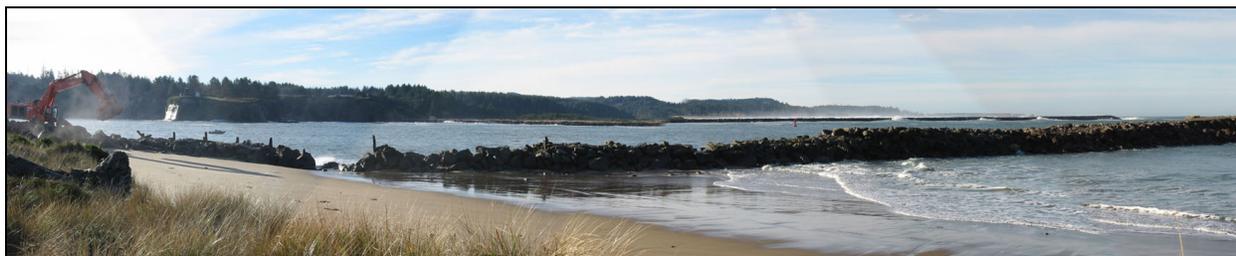
c. Panorama of jetty under repair

Subsequent to the jetty breach, approximately 50,000 cu yd of sediment was transported through the jetty breach and into the navigation channel. After the jetty breach was repaired, 50,000 cu yd of sand was replaced on the beach side of the breach area. This was considered essential not only to shore up the repaired jetty section but also to build back the beach which is a protective feature preventing a shoreline breach into the inner bay.
