ERDC/CHL CHETN-III-66
June 2003

Periodic Inspections of Concrete-Armored Coastal Structures

by Robert R. Bottin, Jr.

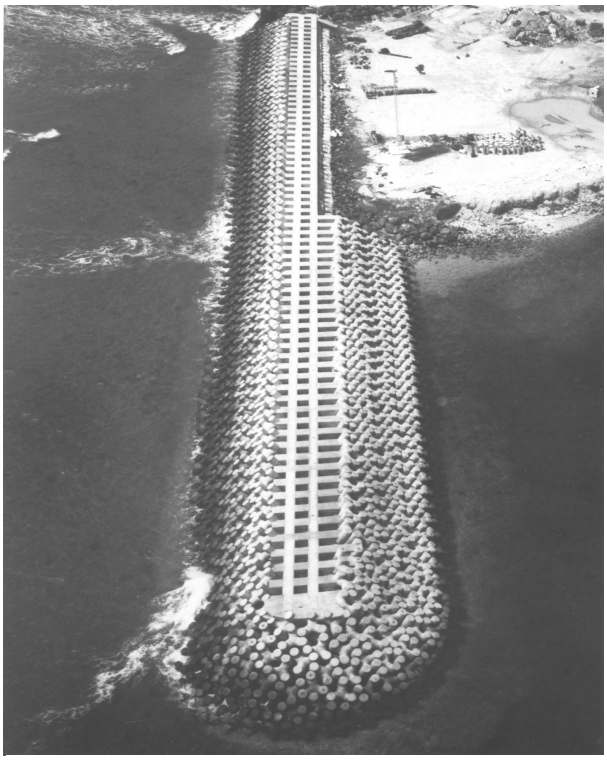
Figure 1. Ofu Harbor breakwater

The breakwater (Figure 1) is armored with a single layer of uniformly-placed 4,082.33-kg (4.5-ton) concrete tribar units. It has a concrete rib cap system on the crest to stabilize and buttress tribars at the upper sea- and harbor-side slopes. The structure has a crest elevation (el) of +4.57 m (+15 ft), and side slopes of 1V:1.5H. Due to the nonavailability of local stone, the structure was built utilizing a unique concrete design for the underlayer units. Basically the design entailed using various sized concrete units for breakwater construction as opposed to stone. Most of the underlayer consisted of 1,632.93-kg (1.8-ton) concrete units approximately 1.22 × 1.22 × 0.61-m (4 × 4 × 2 ft) with 5.08-cm (16-in.) holes in their centers and 22.86-cm (9-in.) semicircular holes on each side. When placed on the breakwater slope, the underlayer units, with the holes, resemble a slice of Swiss cheese and have been labeled Swiss cheese blocks. In addition, both 2,267.96-kg (2.5-ton) and 510.29-kg (1,125-lb) concrete units were formed by pumping high-strength, fine aggregate concrete into geotextile bags. The 2,267.96-kg (2.5-ton) units were used as a rib cap underlayer and placed along the harbor side of the structure near its origin. The 510.29-kg (1,125-lb) units were used as an underlayer for the tribars around the breakwater head since the Swiss cheese blocks could not be placed in this area due to the tight radius.

During the initial photogrammetric survey of October 1996, selected tribars were targeted (three targets each) and precise positions of these units were obtained as well as centroid data and orientations of the targeted armor units. A walking survey of the structure revealed no broken armor units, however, one sea-side tribar was slightly separated from the rib cap. In addition, it was noted that some of the Swiss cheese block underlayer units along the slope had slightly separated in a vertical direction. The maximum separation was about 20.32 cm (8 in.) The geotextile bags had deteriorated and some spalling along the edges of the 510.29-kg (1,125-lb) high-strength concrete underlayer units was also noted around the head of the structure. In general, the breakwater appeared to be in excellent condition.

The August 2002 photogrammetric survey of the breakwater revealed negligible movement of the concrete armor units relative to the 1996 survey. Maximum movement of the targets established on the tribar armor units in the horizontal and vertical directions, respectively, were 0.14 m (0.45 ft) and 0.106 m (0.35 ft); and the average movements of all horizontal and vertical targets were 0.012 m (0.04 ft) and 0.021 m (0.07 ft), respectively. Maximum movements of the target armor unit centroids were 0.088 m (0.29 ft) and 0.073 m (0.24 ft) in the horizontal and vertical directions, respectively, while average movements were 0.012 m (0.04 ft) and 0.024 m (0.08 ft) in the horizontal and vertical directions. Seventy-three percent of all vertical movements and 93 percent of horizontal movements were 0.03048 m (0.1 ft) or less. Changes in rotation angles of the armor units varied from 0.0 to 4.03 deg with an average of 0.64 deg. A walking inspection of the structure in 2002 revealed no broken tribars. Fifteen sea-side tribars were slightly separated from the rib cap as opposed to one in 1996. On the entire sea side of the structure, it was noted that the Swiss cheese block underlayer units had separated along the slope between the third and fourth rows (down from the crest). Typical separations ranged from 2.54 to 10.16 cm (1 to 4 in.), and the maximum was 20.32 cm (8 in.). Some underlayer separations 2.54 to 10.16 cm (1 to 4 in.) were also noted on the harbor side of the structure. Separations between the cheese block underlayer units were more widespread as opposed to the 1996 inspection. The 510.29-kg (1,125-lb) high-strength concrete underlayer units around the head of the structure looked the same as the previous inspection. Even though slight movement in the breakwater's underlayer armor units had occurred, the breakwater appeared to be in excellent condition. It has not been subjected, however, to a major tropical storm, typhoon, or hurricane since its construction.
