ERDC/CHL CHETN-VII-10
August 2010

Innovative Streambank Protection in an Urban Setting, Accotink Creek, VA

by David L. Derrick and Meg M. Jonas

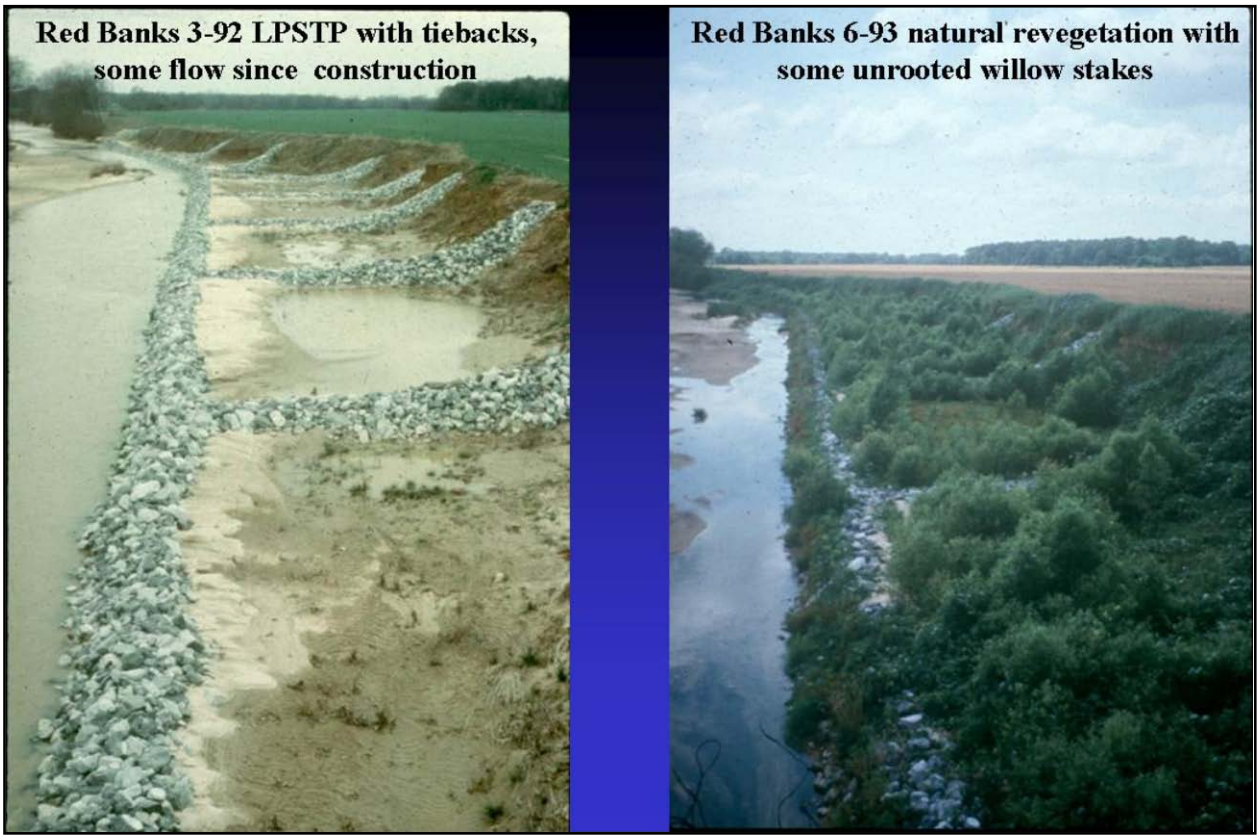
Figure 4. Longitudinal peaked stone toe protection built to provide a false bank line.
