Table 21
Whitefish Point Harbor Breakwaters
Whitefish Point, Michigan

Date(s)	Construction and Rehabilitation History
1968	Construction of a 507-ft-long south breakwater and a 587-ft-long north breakwater was completed at the site (Figure 56). The south breakwater consisted of a 323-ft-long steel sheet-pile cantilever wall and a 184-ft-long sand-filled cellular steel sheet-pile structure (Figure 56). The cells were 25.5 ft in diameter and were capped with reinforced concrete. Riprap was placed on each side of the cells, The entire breakwater was constructed to a +8 ft lwd el. The north breakwater was constructed with sand-filled cellular steel sheet-pile structures that were also capped with reinforced concrete. The shoreward cells were 25.5 ft in diameter, while the lakeward cells had a diameter of 30.2 ft (Figures 56 and 57). Riprap was placed on each side of the structure, and the crest el was +8 ft lwd.
1969	A 270-ft-long interior breakwater was constructed (Figure 56) for wave absorption. This structure consisted of steel sheetpiling installed at an el of +8 ft lwd and riprap installed at 0.0 ft lwd on each side of the structure (Figure 57). The weight of the riprap ranged fr

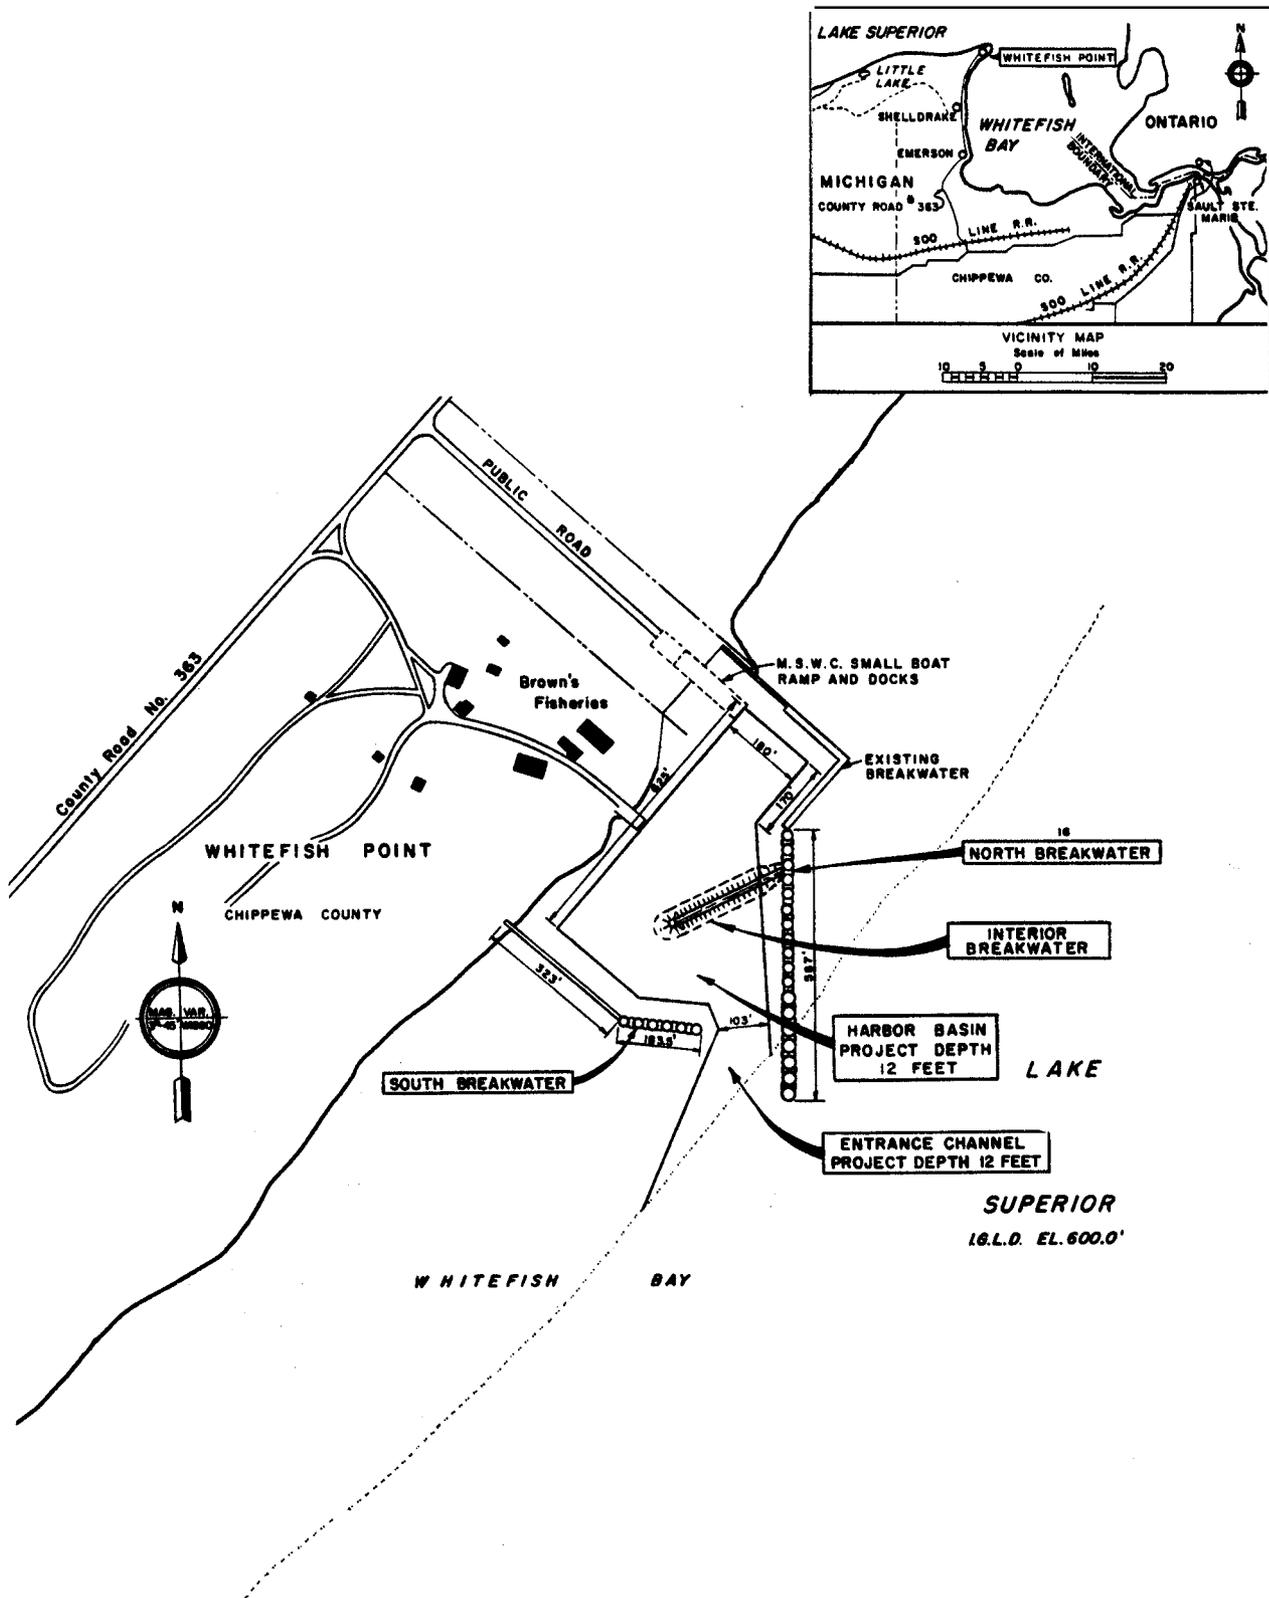
Figure 56. Whitefish Point Harbor, Michigan

1986	The breakwaters appear to be functioning well and presently are in good condition. An aerial view of Whitefish Point Harbor breakwaters is shown in Figure 58.

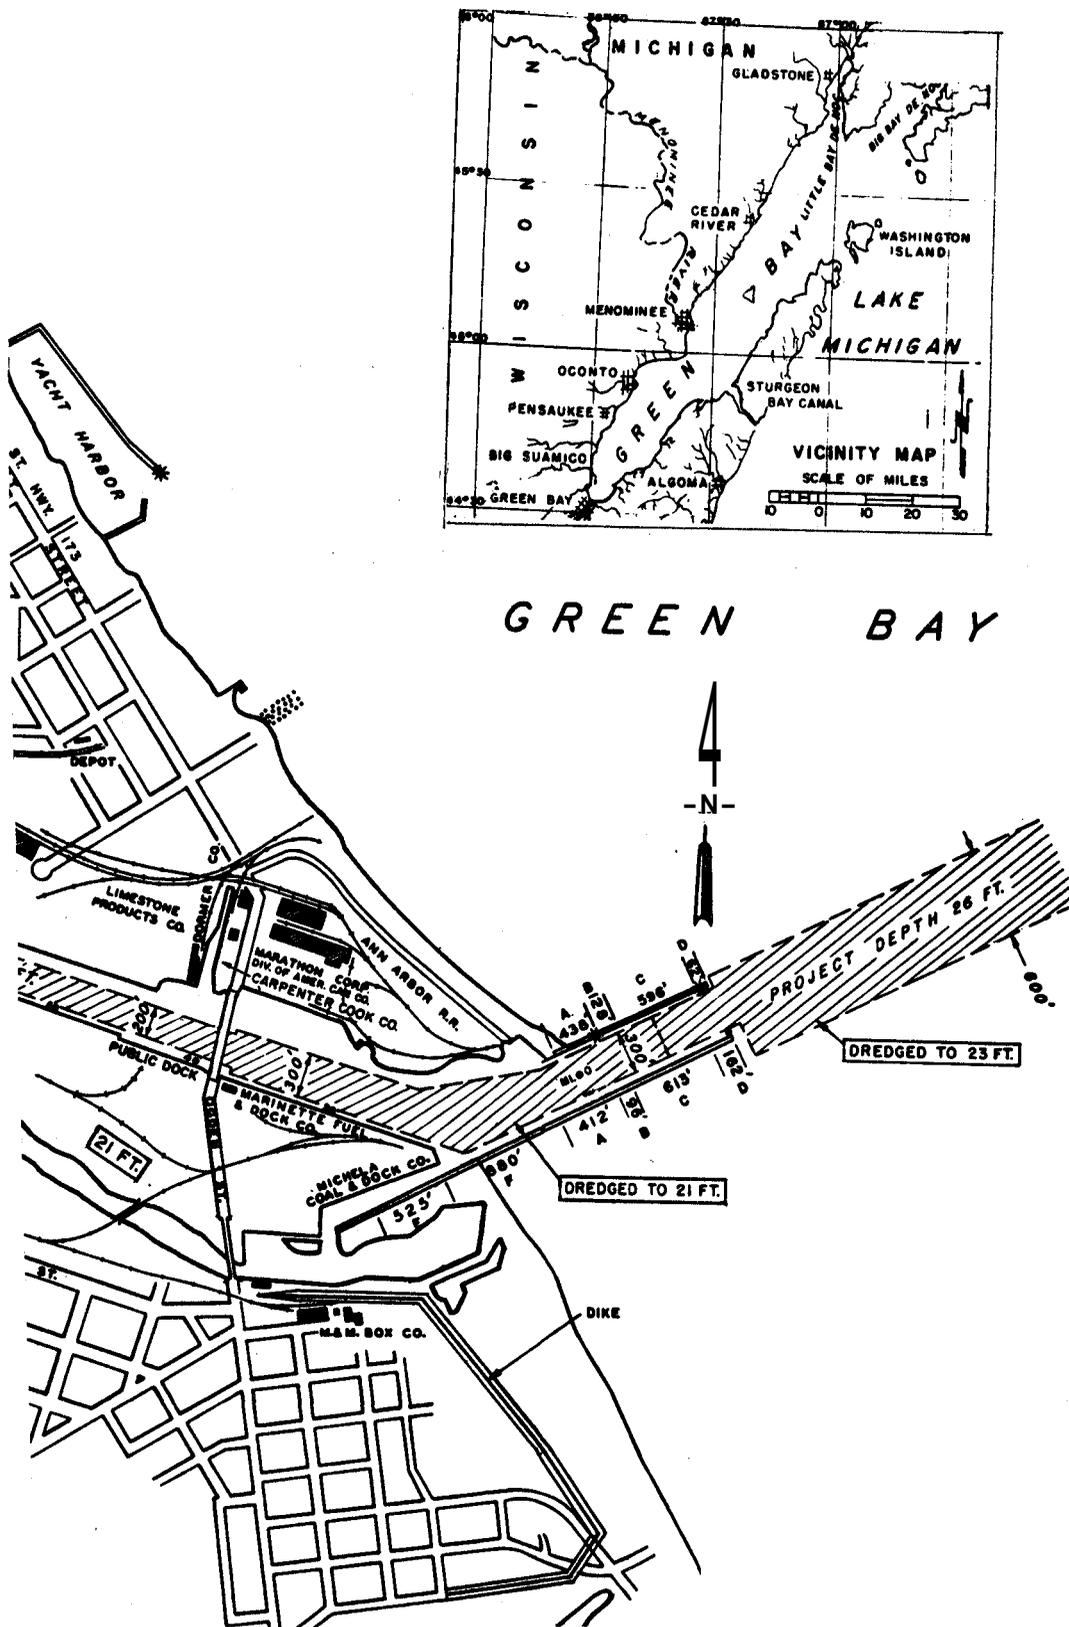
Figure 63. Menominee Harbor, Michigan

1954	The cellular sheet pile at the lakeward end of the north pier was repaired (Figure 63, Section D).
1955	A 613-ft-long section of the south pier was repaired (Figure 63, Section C).
1963	Repairs were made to a 508-ft-long section of the south pier (Figure 63, Sections A and B) and a 1,164-ft-long portion of the north pier (Figure 63, Sections A, B, and C).
1965	An 880-ft-long portion of the south pier was repaired (Figure 63, Section F).
1974	The cellular sheet-pile north pierhead was again repaired (Figure 63, Section D).
1977	The lakeward end of the south pier (Figure 63, Section D) experienced some settlement and was observed slightly leaning toward the channel. Additional riprap placement was completed in the area.
1982	A site inspection of the structures indicated that the north pier was in very good condition and that the south pier was generally in good condition. The settlement of the lakeward end of the south structure (Figure 63, Section D) appeared to have stabilized since placement of the riprap in 1977. The concrete superstructure of the portion of the pier needed maintenance however.

1986	The piers have experienced reconstruction, repairs, and maintenance during their lifetime, and they presently are considered in good condition.

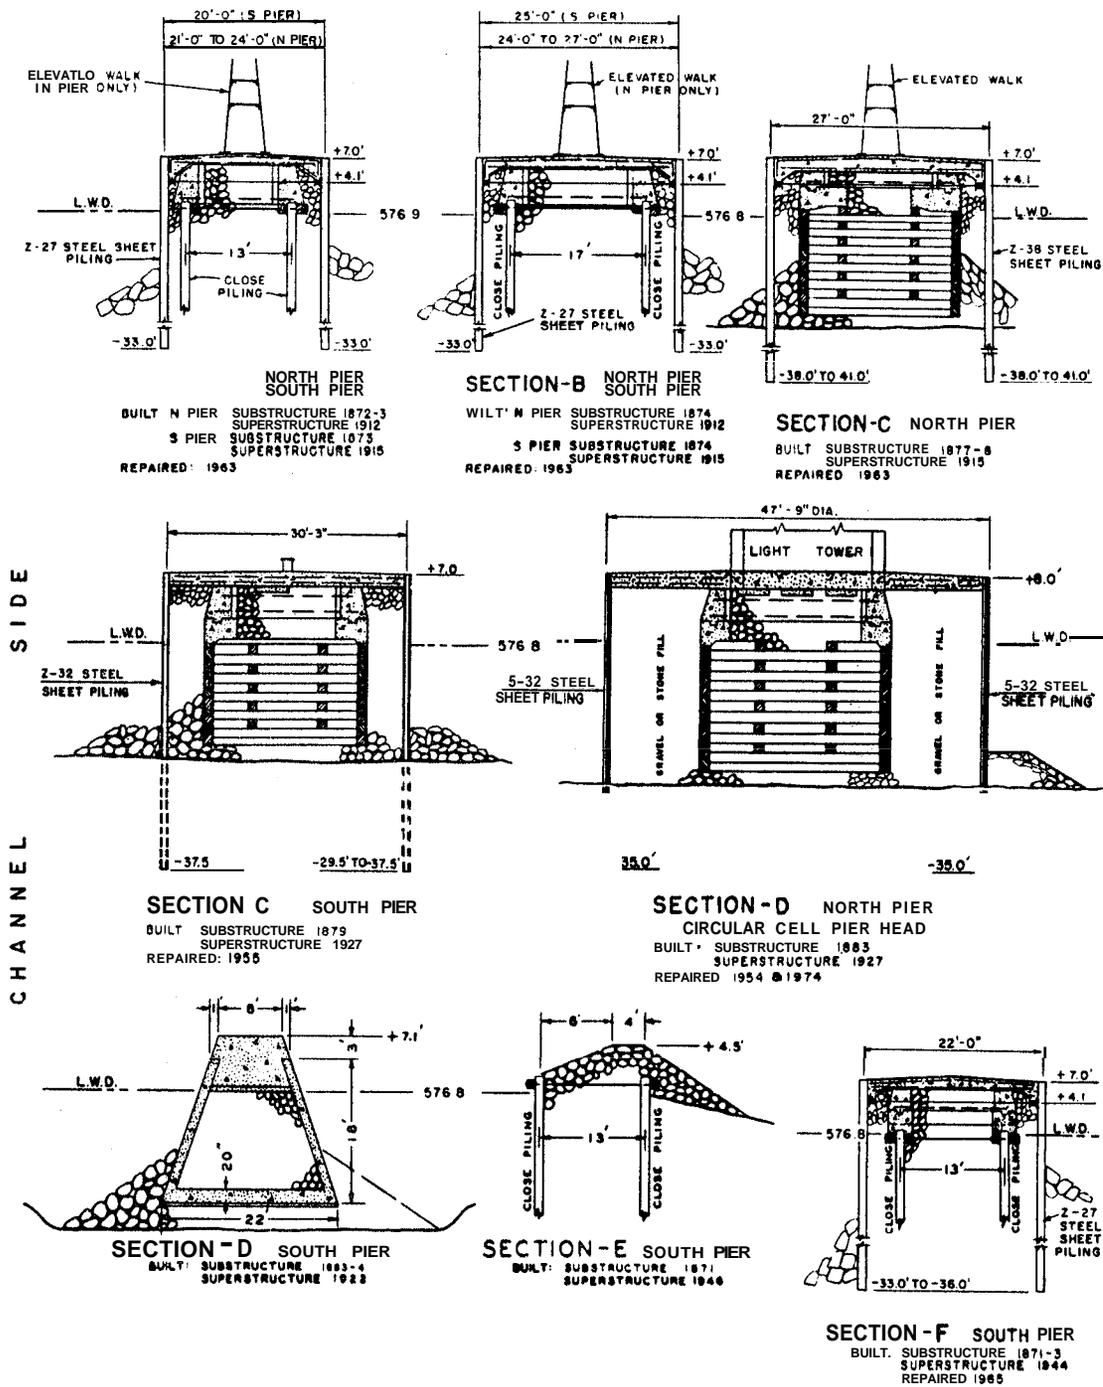
Figure 64. Typical pier cross sections, Menominee Harbor, Michigan

1912	The shoreward 566-ft portion of the north pier was reconstructed, (Figure 63, Sections A and B). Steel sheetpiling was installed that resulted in pier widths ranging from 21 to 27 ft. The structures were stone filled and capped with a concrete superstructure at an el of +7.0 ft lwd (Figure 64, Sections A and B). Riprap toe protection also was installed.
1915	A 508-ft-long portion of the south pier (Figure 63, Sections A and B) and a 596-ft-long portion of the north pier (Figure 63, Section C) was reconstructed in a manner similar to that in 1912. Steel sheetpiling was installed, filled with stone, and capped with a concrete superstructure to an el of +7.0 ft lwd (Figure 64, Sections A, B, and C). A 412-ft portion of the south pier had a 20-ft width (Section A) and the remaining 96-ft portion a width of 25 ft (Section B). The north pier portion (596 ft long) had a width of 27 ft (Section C). Riprap toe protection also was placed on each side of both piers.

1922	The 162-ft-long lakeward end of the south pier was modified (Figure 63, Section D). A rock-filled concrete superstructure was built on the existing rubble-mound pier. The superstructure had a crest el of +7.1 ft lwd with an 8-ft width (Figure 64, Section Q).
1927	A 613-ft-long portion of the south pier (Figure 63, Section C) and the 62-ft-long lakeward end of the north pier (Figure 63, Section D) were reconstructed. Steel sheetpiling was placed a width of 30.3 ft apart on the south pier (Figure 64, Section C). The voids were filled with stone, and a concrete superstructure with a crest el of +7.0 ft was installed. Riprap toe protection was also installed. Steel sheetpiling was installed on each side of the north pier which

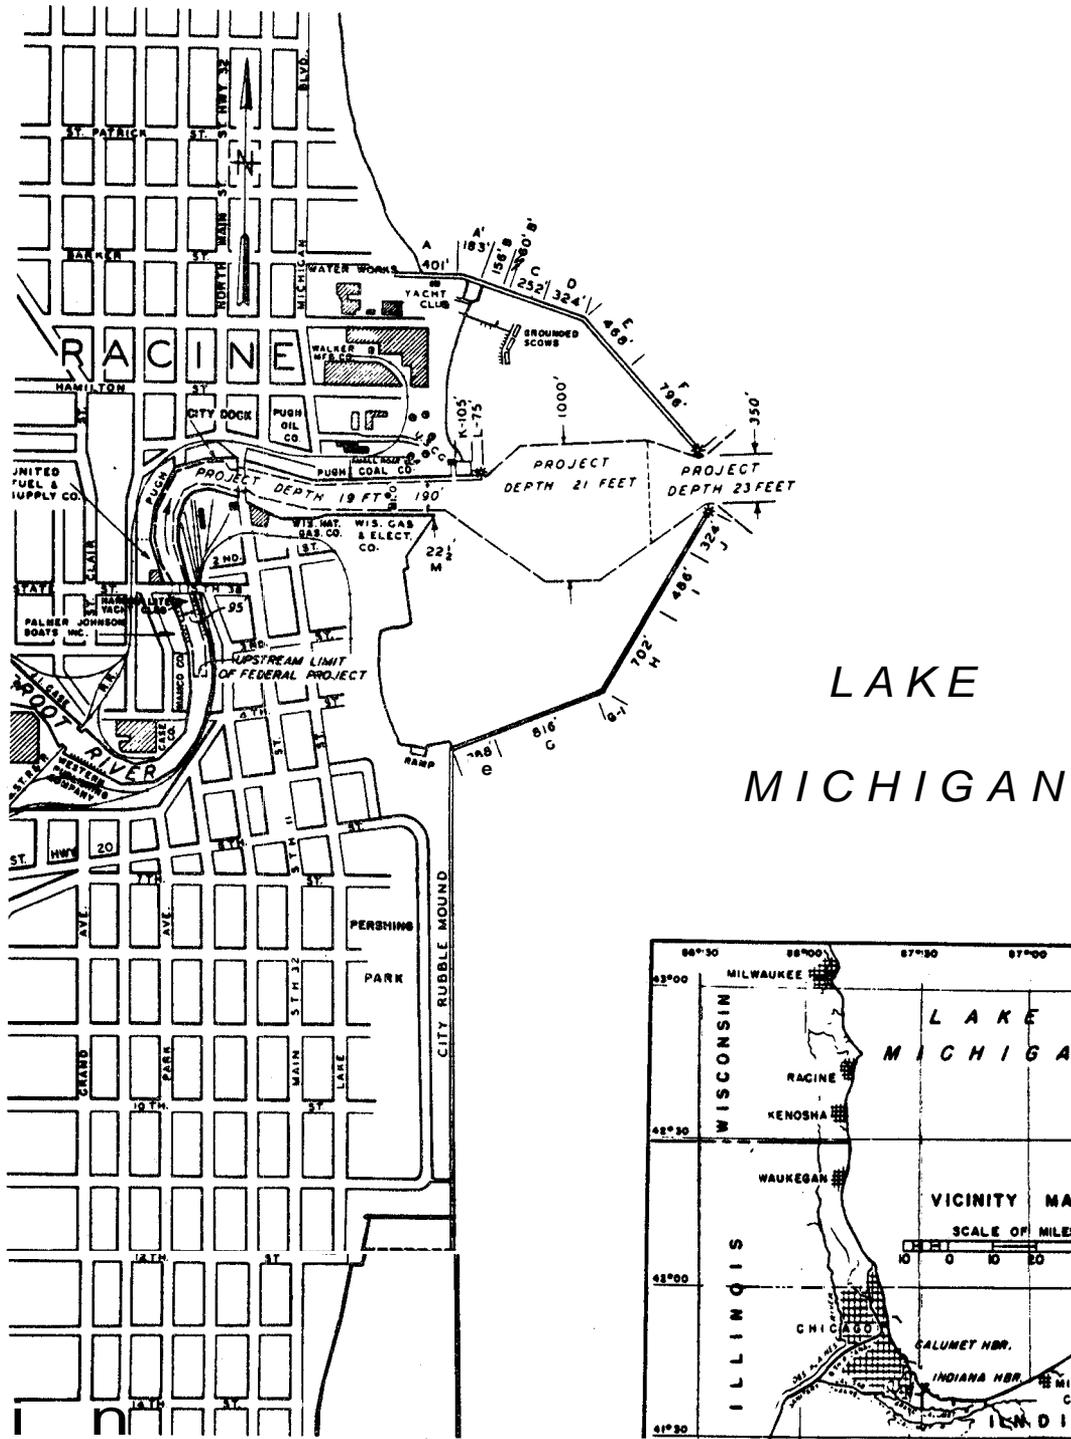
Figure 88. Racine Harbor, Wisconsin

1973	The lakeward 796-ft-long portion of the north breakwater was repaired (Figure 88, Section F). Riprap was installed on each side of the structure (Figure 89, Section F) to an el of +4 ft lwd. The riprap was placed with side slopes of 1V:1.5H .
1974	Two sections of the north breakwater (Figure 88, Sections A' and B') were rebuilt. Steel sheetpiling was driven on the lakeward side of the 183-ft-long portion of Section A' (Figure 90). Filling the voids with stone and capping the breakwater with concrete resulted in a breakwater section that was 17.5 ft in width with a crest el of +7.5 ft lwd. The 60-ft-long portion of Section B' (Figure 90) was covered with stone. It had a 15-ft-wide crest with an el of +7.1 ft lwd. Concrete was poured between the stones on the crest to form a walking surface. The existing concrete superstructure was removed because of its deteriorated condition prior to placement of the stone. Side slopes of the structure were 1V:1.5H .

1986	The structures have undergone repair and maintenance during their lifetime; however, they are presently in good condition. The President signed an act to deauthorize the project at Racine, and the title to any facilities constructed by the United States has been transferred, without consideration, to Racine County.

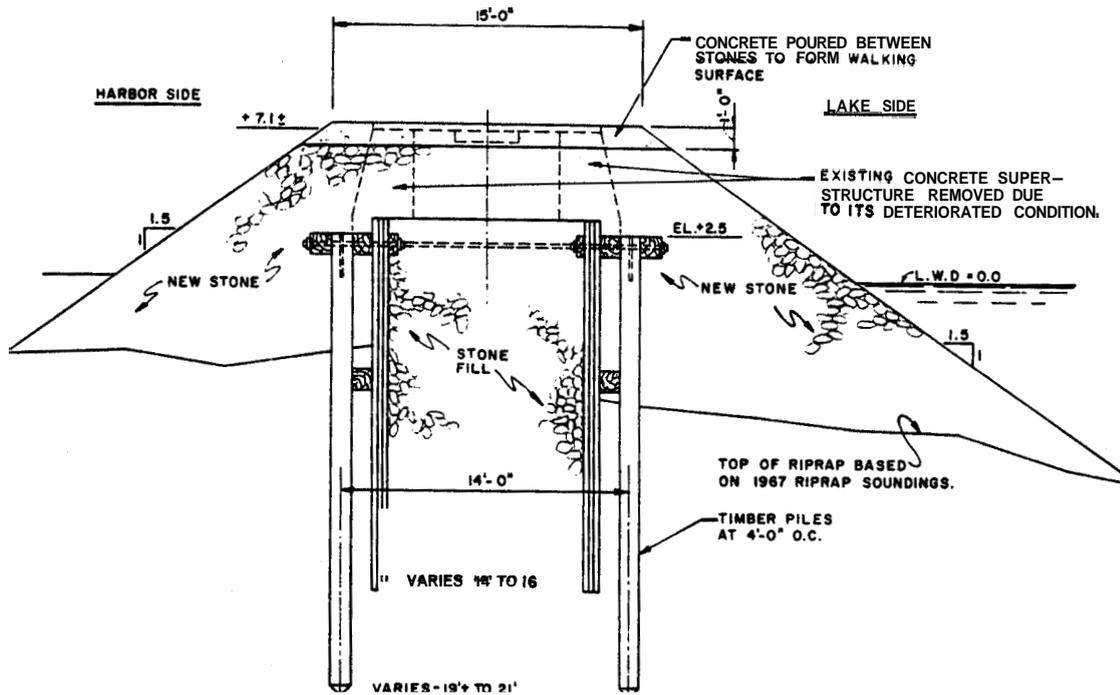
SECTION - B'

BUILT: SUB-STRUCTURE 1912-13
 SUCCI-STRUCTURE 1912-13
 RE-BUILT 1974

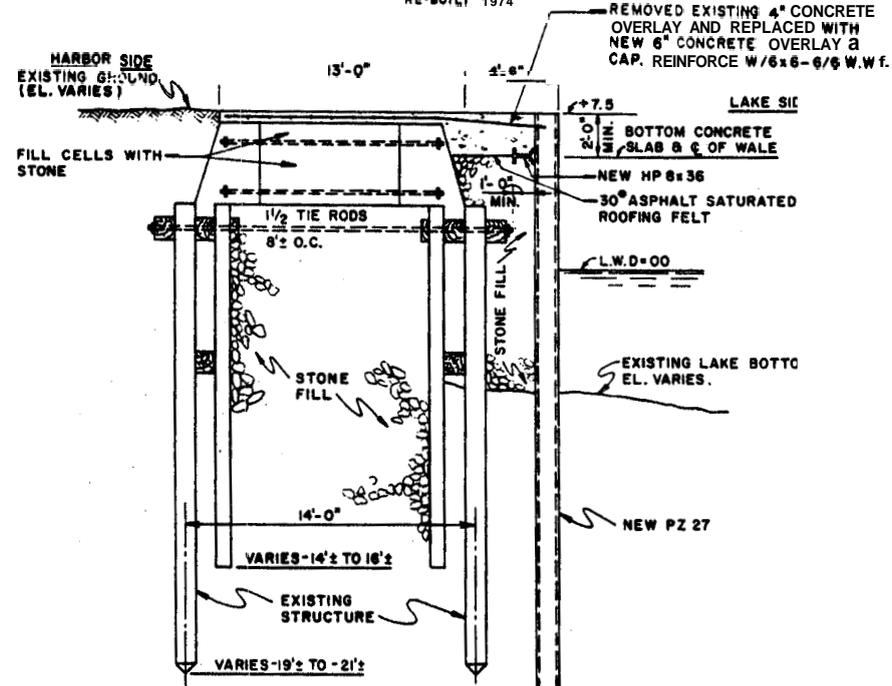
SECTION - A'

BUILT: SUB-STRUCTURE 1912-13
 SUPER-STRUCTURE 1912-13
 RE-WILT 1974

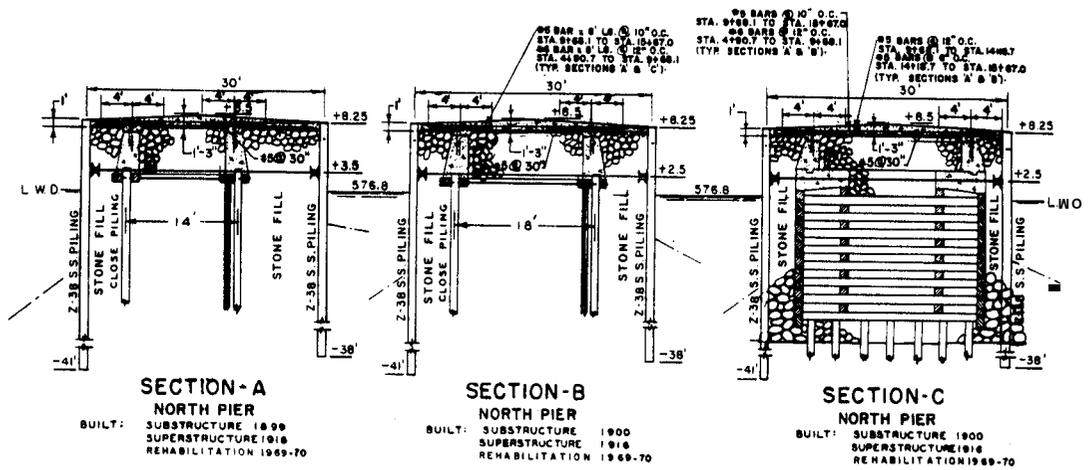
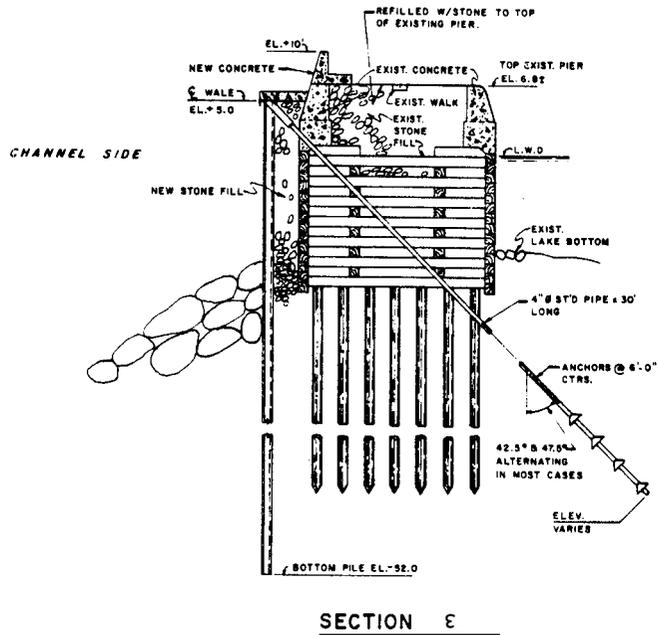
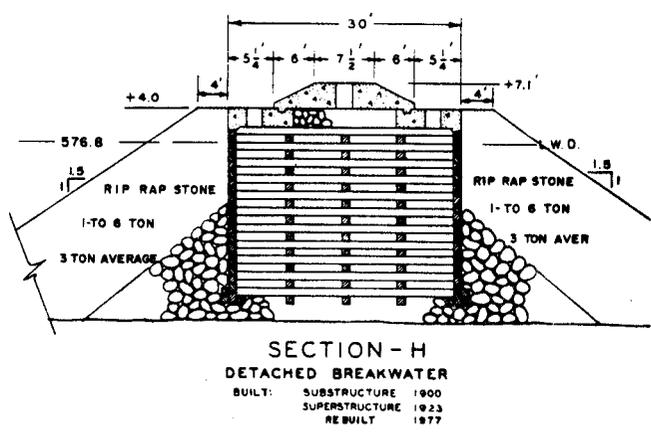
Figure 92. Typical structure cross sections, Kenosha Harbor, Wisconsin

1969- 1970	The north and south piers were rehabilitated during this time (Figure 92, Sections A, B, C, and E). Steel sheetpiling was driven on each side of the north pier resulting in a structure 30 ft wide. Voids were filled with stone, and a concrete cap was installed at a crest el of +8.5 ft. Riprap was installed on each side of the structure. Steel sheetpiling was installed on the lakeward side of the south pier. The void and the existing pier were filled with 50-lb stone. A parapet wall was installed on the lakeward side of the structure to an el of +10 ft lwd. (This was adjacent to a confined dredging disposal area).
1977	The detached breakwater (Figure 92, Section H) was rebuilt, and 1- to 6-ton (3-ton average) riprap stone was placed on each side of the structure to an el of +4 ft lwd. Side slopes of the riprap were 1V:1.5H.
1980	A site inspection of the structures revealed them to be generally in good condition. Spalling of concrete was noted in several areas; however, the problem was not critical at that time.

1986	The structures presently are considered to be in fair condition.

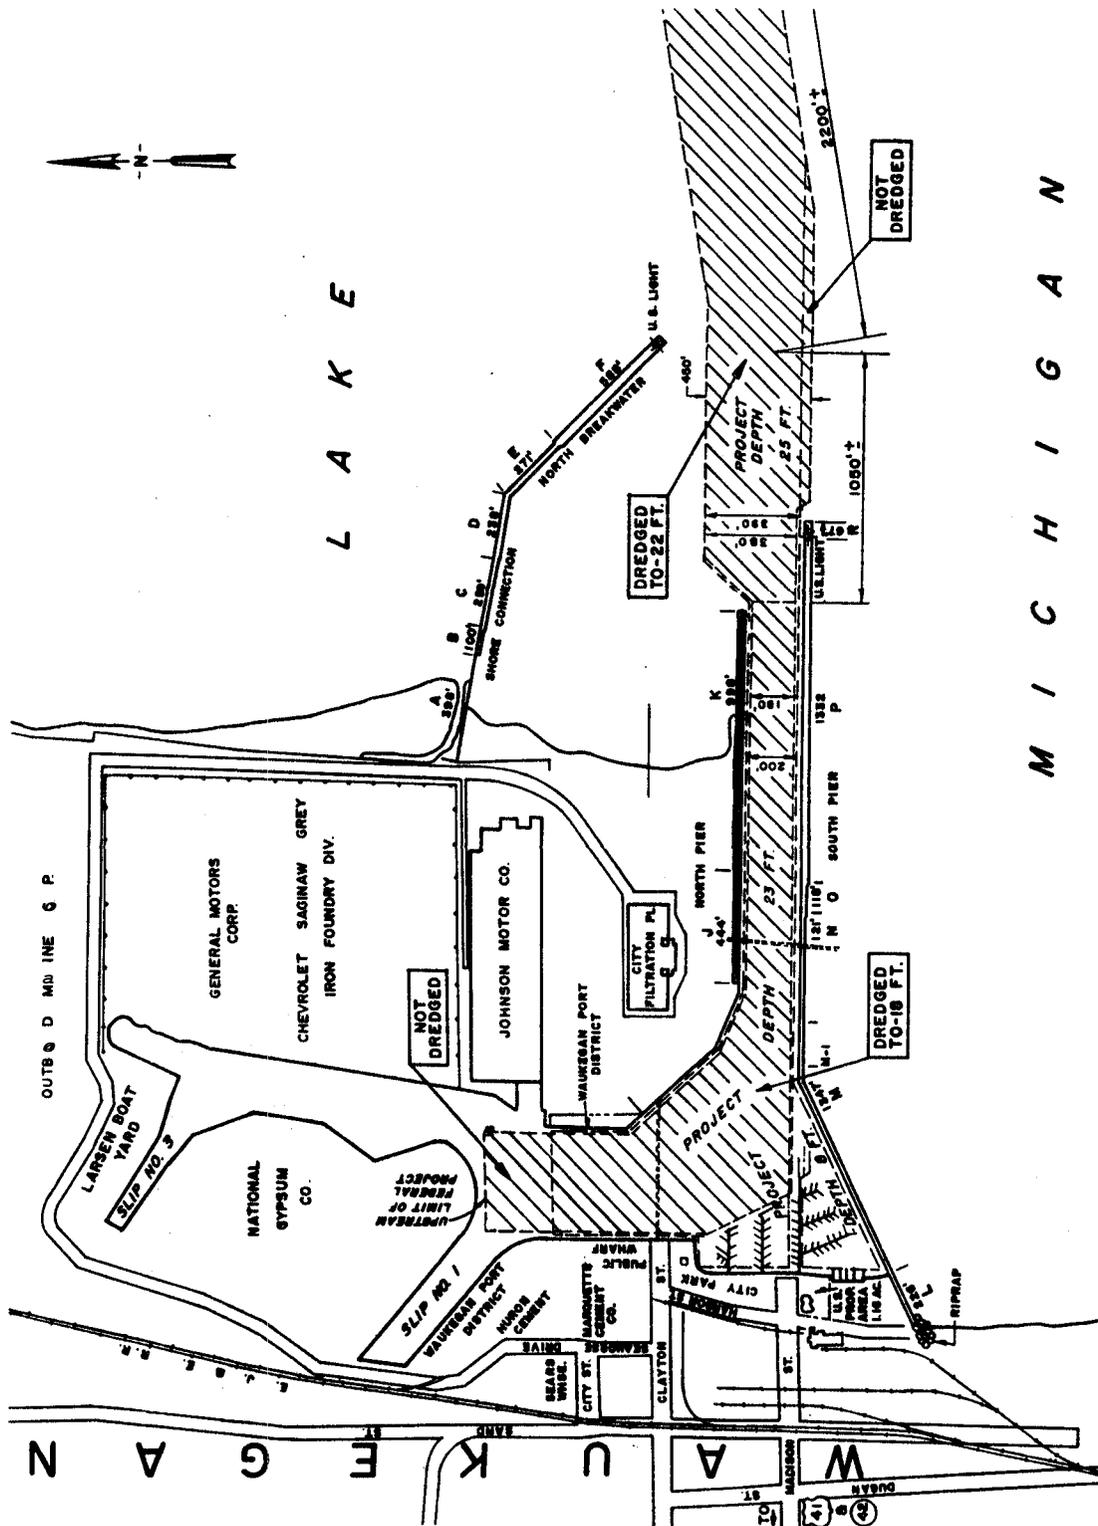
Figure 93 Waikewan Harbor, Illinois

Date(s)	Construction and Rehabilitation History
	+7.1 ft lwd on the channel side (Figure 95, Section K). The south pier superstructure had crest els ranging from +7.6 to 8.85 ft lwd (Figure 94, Sections N, O, P, and R).
1960	A portion of the south pier (Figure 93, Section M-1) was repaired. Steel sheet piles were driven on each side of the existing structure. The voids were filled with stone, and the pier was capped with concrete at an el of +7.85 ft lwd (Figure 94, Section M-1). Stone toe protection was placed on each side of the structure.
1961	The shoreward portion of the north pier (Figure 93, Section J) was removed and rebuilt. Steel sheetpiling was installed at an el of +7.1 ft lwd and backfilled with earth fill (Figure 95, Section J). Riprap toe protection was also installed on the channel side of the pier.
1977	Portions of the south pier (Figure 93, Sections M and O) were rebuilt.
1978	An underwater intersection was made along the north pier which indicated that the structure was intact with the exception of construction joints. There were holes and gaps about 5 in. across at each construction joint along the wall. It was also noted that wood had rotted underneath the concrete cap at several locations. Maintenance repairs were made subsequent to the inspection.

1981	A superstructure condition survey indicated that the structures were in good condition.
1986	The structures have undergone rehabilitation and maintenance during their lifetime; however, they are presently considered to be in good condition. An aerial photograph of the harbor structures is shown in Figure 96.

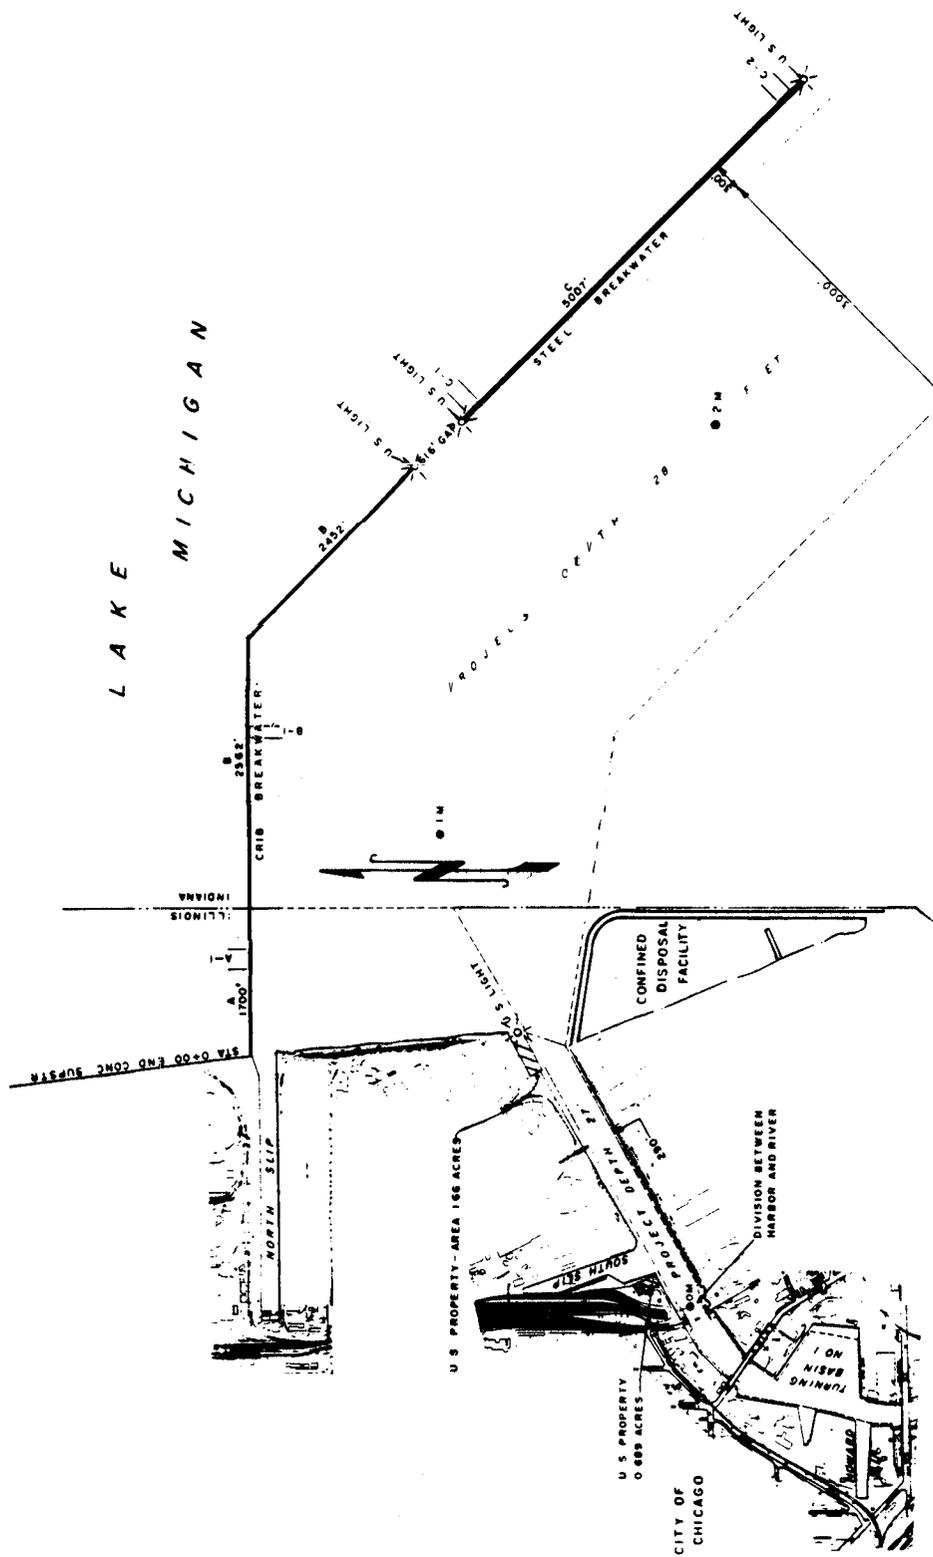
Figure 100. Calumet Harbor, Illinois and Indiana

1957	Portions of the detached breakwater (Figures 100 and 101, Sections C-1 and C-2) were repaired. Heavy riprap stone was placed on each side of the structure at the northern end (Section C-1) and on the lakeside of the breakwater on the southerly end (Section C-2).
1961- 1962	Portions of the attached timber crib breakwater (Figures 100 and 101, Sections A-1 and B-1) were repaired. Riprap protection was placed on the lakeside of the breakwater at Section A-1 and on the harbor side at Section B-1.
1984	A severe storm occurred in February with estimated wave heights of 15 ft. Two cells at the southern end of the detached breakwater failed, and the fill stone was lost under the impact of the storm waves. Stones ranging from 6 to 23 tons were placed on the ends of the damaged cells in October to stabilize them and prevent damage to adjacent cells. A total of 3,938 tons of stone was used during these repairs. During November a site inspection of the attached timber crib structure revealed damaged concrete with exposed rebar, spalling, concrete deterioration, fractured concrete, voids, and erosion of some cribs on the harbor side.

1985	A reconnaissance report for breakwater rehabilitation was published by NCC recommending conversion of the attached breakwater to a rubble-mound structure as an attempt to preserve the detached breakwater with rubble-mound berms installed on each side.

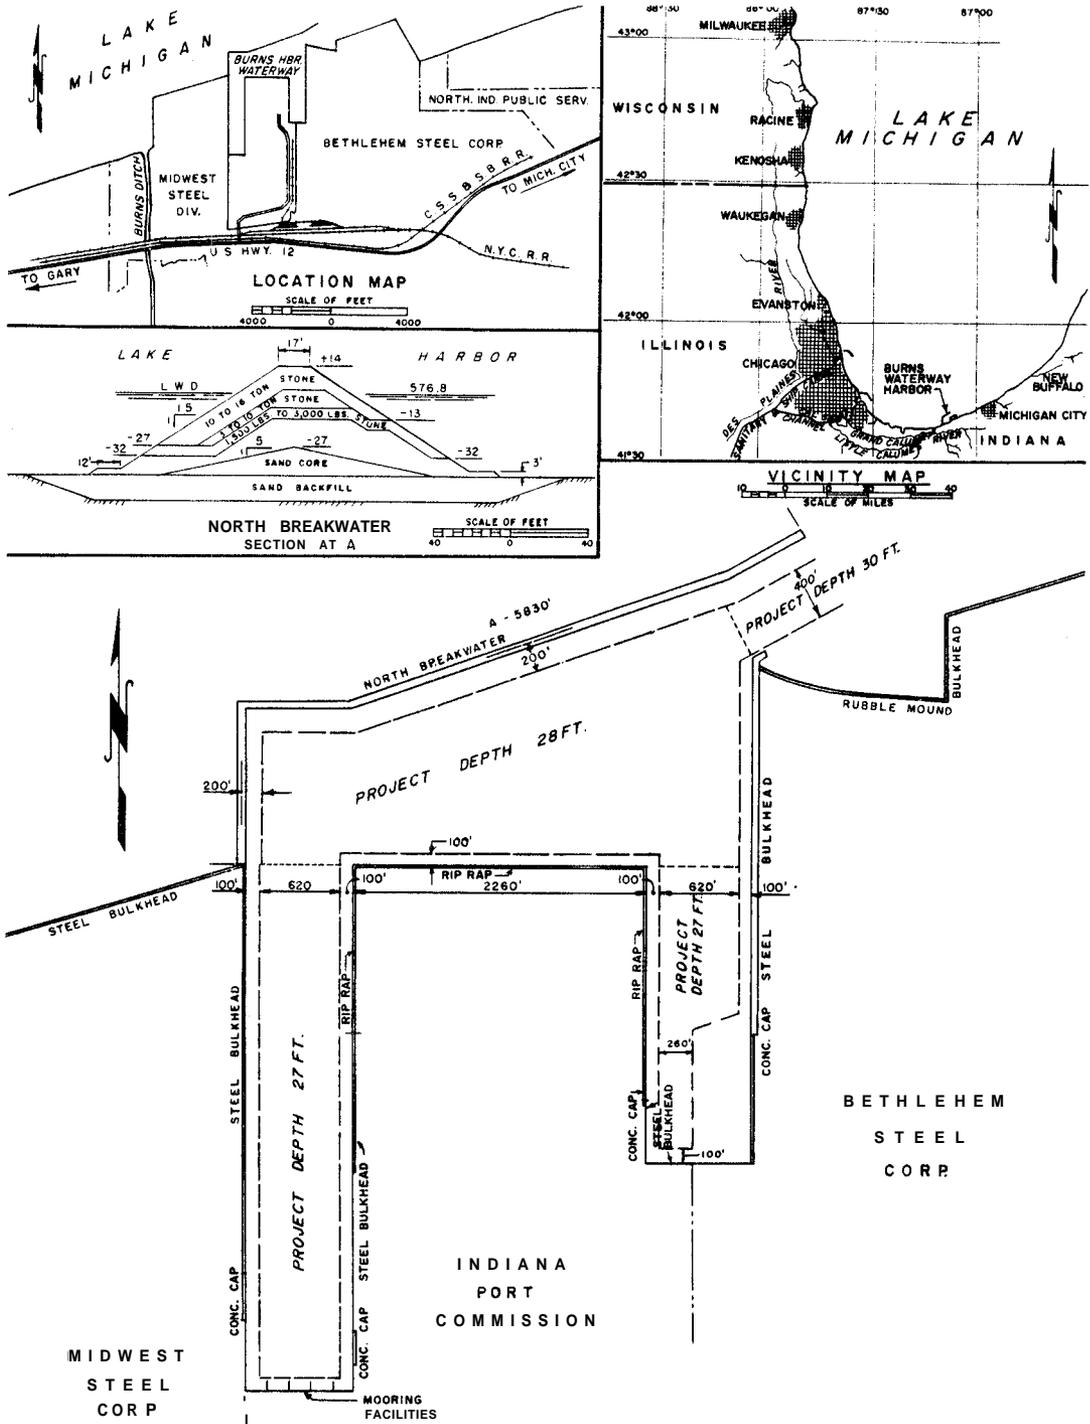
Figure 104. Burns Harbor, Indiana

1978	A total of 14,340 tons of stone ranging from 3 to 16 tons (9-ton average) was placed on the breakwater.
1980	A total of 47,334 tons of stone ranging from 3 to 16 tons (9-ton average) was placed on the breakwater.
1984	A storm in March caused damage to the breakwater dislodging armor stone in many areas and the overall integrity of the above-water stone placement.
1986	The breakwater has undergone extensive maintenance and rehabilitation since its construction because of structure slumping. The exact cause of the slumping is not known. A study is presently being conducted to identify the cause of the problem where remedial measures can be taken.

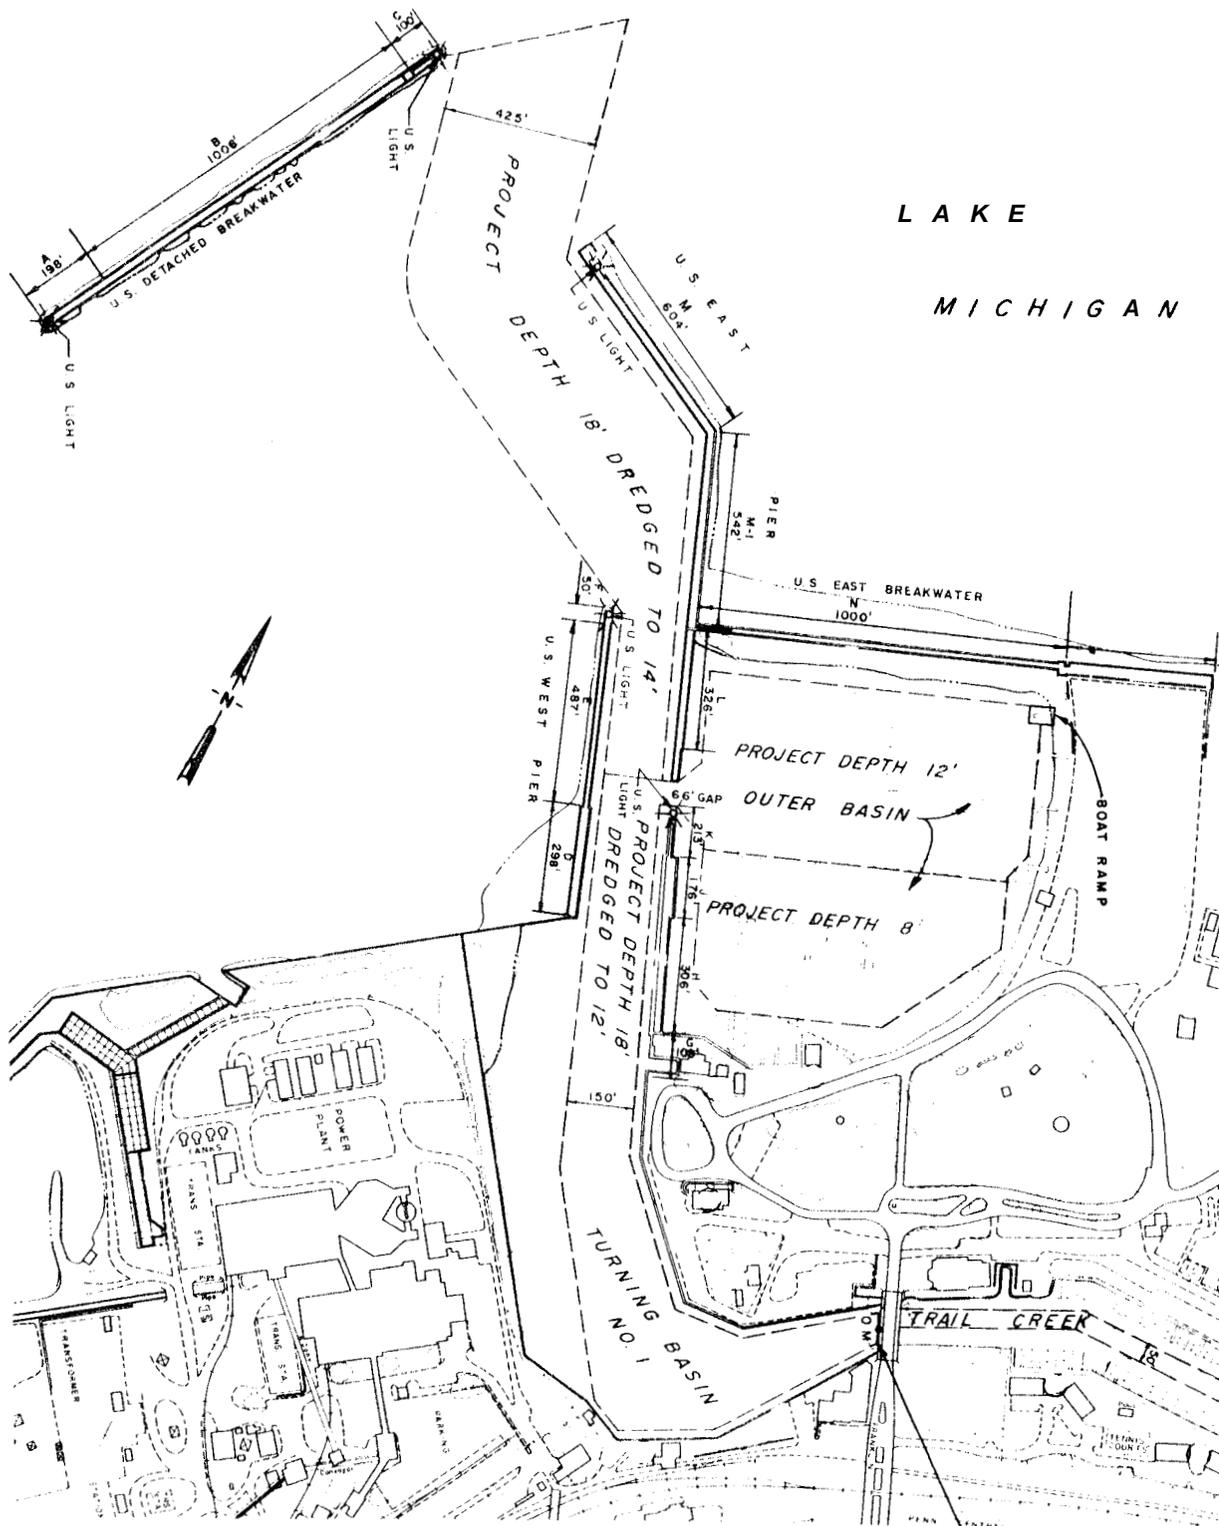
Figure 105. Michigan City Harbor, Indiana

1972	The shoreward portion of the west pier (Figure 105, Section D) and a portion of the east pier (Figure 105, Sections H and J) were rehabilitated. Steel sheetpiling was driven on each side of the existing piers, and the voids were filled with stone. The west pier (Figure 107, Section D) was capped with concrete with a crest el of +7 ft lwd and a new width of 28 ft. The east pier (Figure 106, Sections H and J) consisted of a concrete and stone cap installed at a cost el of +7.85 ft lwd. The inner portion (Section H) was 34 ft in width and remaining portion (Section J) was built 38 ft wide.
1978	The concrete cap on the shoreward end of the detached breakwater (Figures 105 and 107, Section A) was rebuilt.
1979	An inspection of the structures indicated that the east breakwater was in fair condition and the other structures generally were in good condition. Riprap on the lakeside of the detached breakwater was low in areas, and the concrete cap on the east pier had deteriorated in areas. Subsequent maintenance repairs have been performed.

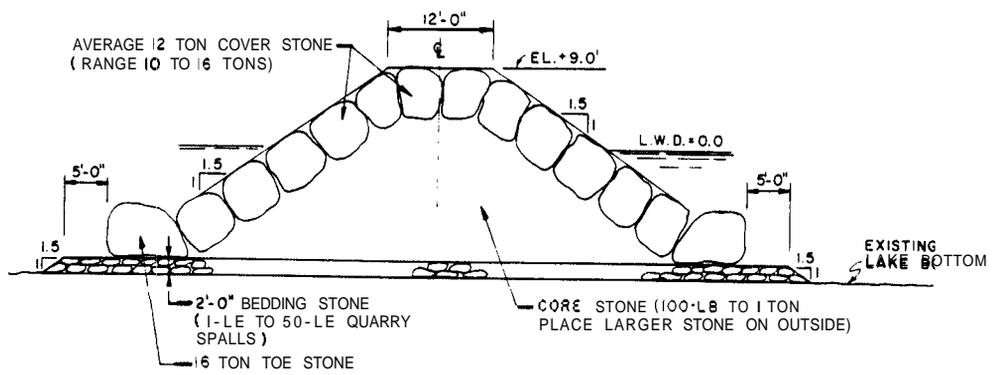
REACH A
BUILT 1975

1980	<p>An inspection of the structures at the site indicated that voids existed in the outer reach (Reach A) of the north breakwater and minor Settlement had occurred, particularly around the head of the structure adjacent to the navigation lights. The remaining portion of the rubble-mound north breakwater also consisted of many voids with some stones deteriorating (cracking or crumbling into smaller pieces). The outer portion of the south breakwater (Reaches B and C), although in better condition than the north structure, also had experienced some settlement and contained some gaps where waves washing through the structure was noted. The inner portion of the breakwaters was in good condition.</p>
1983	<p>Stone was placed in the voids of the outer portions of each breakwater (Reaches A and B, north breakwater, and Reach B, south breakwater, Figure 108). A site inspection in the latter part of the year revealed that some of the smaller stone (used to fit the voids) had washed out. Voids in the trunk sections of the breakwater (Reaches C and D, north structure, and Reach C, south structure) still existed along with settlement of 1 to 2 ft in some areas.</p>

1986	<p>The structures are presently considered in fair condition. Maintenance repairs of the breakwater have been recommended but not yet implemented.</p>

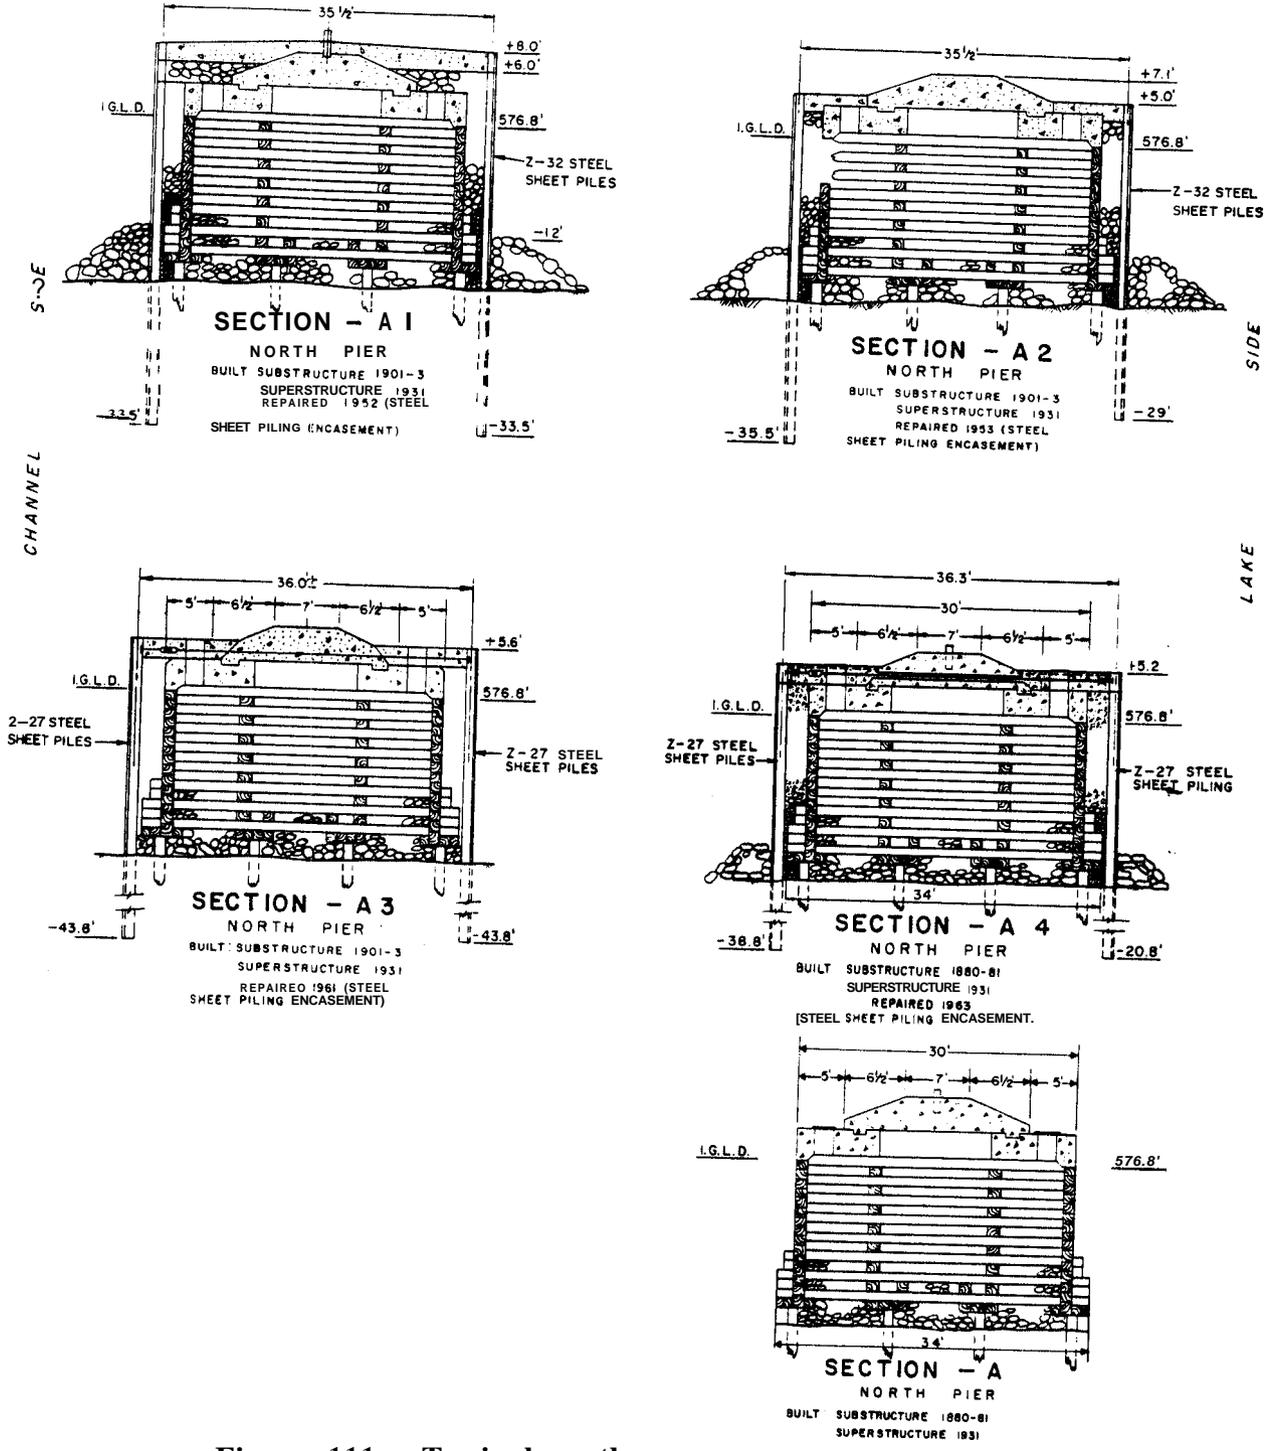
Figure 111. Typical north pier cross sections, Saint Joseph Harbor, Michigan

1952- 1953	Portions of the north pier (Figure 110, Sections A1 and A2) were repaired by enclosing the structure in a steel sheetpiling encasement (Figure 111, Sections A1 and A2). Voids were filled with concrete, and the pier was recapped with concrete. The outer portion (Section A1) had a crest el of +8.0 ft lwd and was 35.5 ft wide, while the other portion (Section A2) was +7.1 ft lwd with a width of 35.5 ft. Riprap toe protection was also installed on each side of the piers adjacent to the new sheet-pile walls.
1961	Additional portions of the north pier were repaired (Figure 110, Section A4, C, D, and E) by using steel sheetpiling. The shoreward portions of the pier were repaired by installing sheetpiling on the channel sides of the existing structures (Figure 112, Sections C, D, and E) and 'backfilling the voids with stone prior to capping the area with concrete. The el of this portion of the pier was +7.0 ft lwd. The remaining portion of the pier was repaired by enclosing the structure in a steel sheet-pile encasement (Figure 111, Section A3). Voids were filled, and the structure was capped with concrete to an el of about +7.6 ft lwd. The pier width was approximately 36 ft.

1963	A portion of the north pier (Figure 110, Section A4) and a portion of the lakeward end of the south pier (Figure 110, Section F) were repaired by enclosing the structures in steel sheetpiling encasements (Figure 111, Section A4 and Figure 112, Section F). Voids between the sheetpiling were filled with stone, and the piers were capped with concrete. The structures were about 36 ft wide and had crest els of approximately 7.0 ft lwd after repairs were made. Riprap toe protection was also installed on each side of the piers.
