Table 21
Whitefish Point Harbor Breakwaters
Whitefish Point, Michigan

Date(s)	Construction and Rehabilitation History
1968	Construction of a 507-ft-long south breakwater and a 587-ft-long north breakwater was completed at the site (Figure 56). The south breakwater consisted of a 323-ft-long steel sheet-pile cantilever wall and a 184-ft-long sand-filled cellular steel sheet-pile structure (Figure 56). The cells were 25.5 ft in diameter and were capped with reinforced concrete. Riprap was placed on each side of the cells, The entire breakwater was constructed to a +8 ft lwd el. The north breakwater was constructed with sand-filled cellular steel sheet-pile structures that were also capped with reinforced concrete. The shoreward cells were 25.5 ft in diameter, while the lakeward cells had a diameter of 30.2 ft (Figures 56 and 57). Riprap was placed on each side of the structure, and the crest el was +8 ft lwd.
1969	A 270-ft-long interior breakwater was constructed (Figure 56) for wave absorption. This structure consisted of steel sheetpiling installed at an el of +8 ft lwd and riprap installed at 0.0 ft lwd on each side of the structure (Figure 57). The weight of the riprap ranged fr

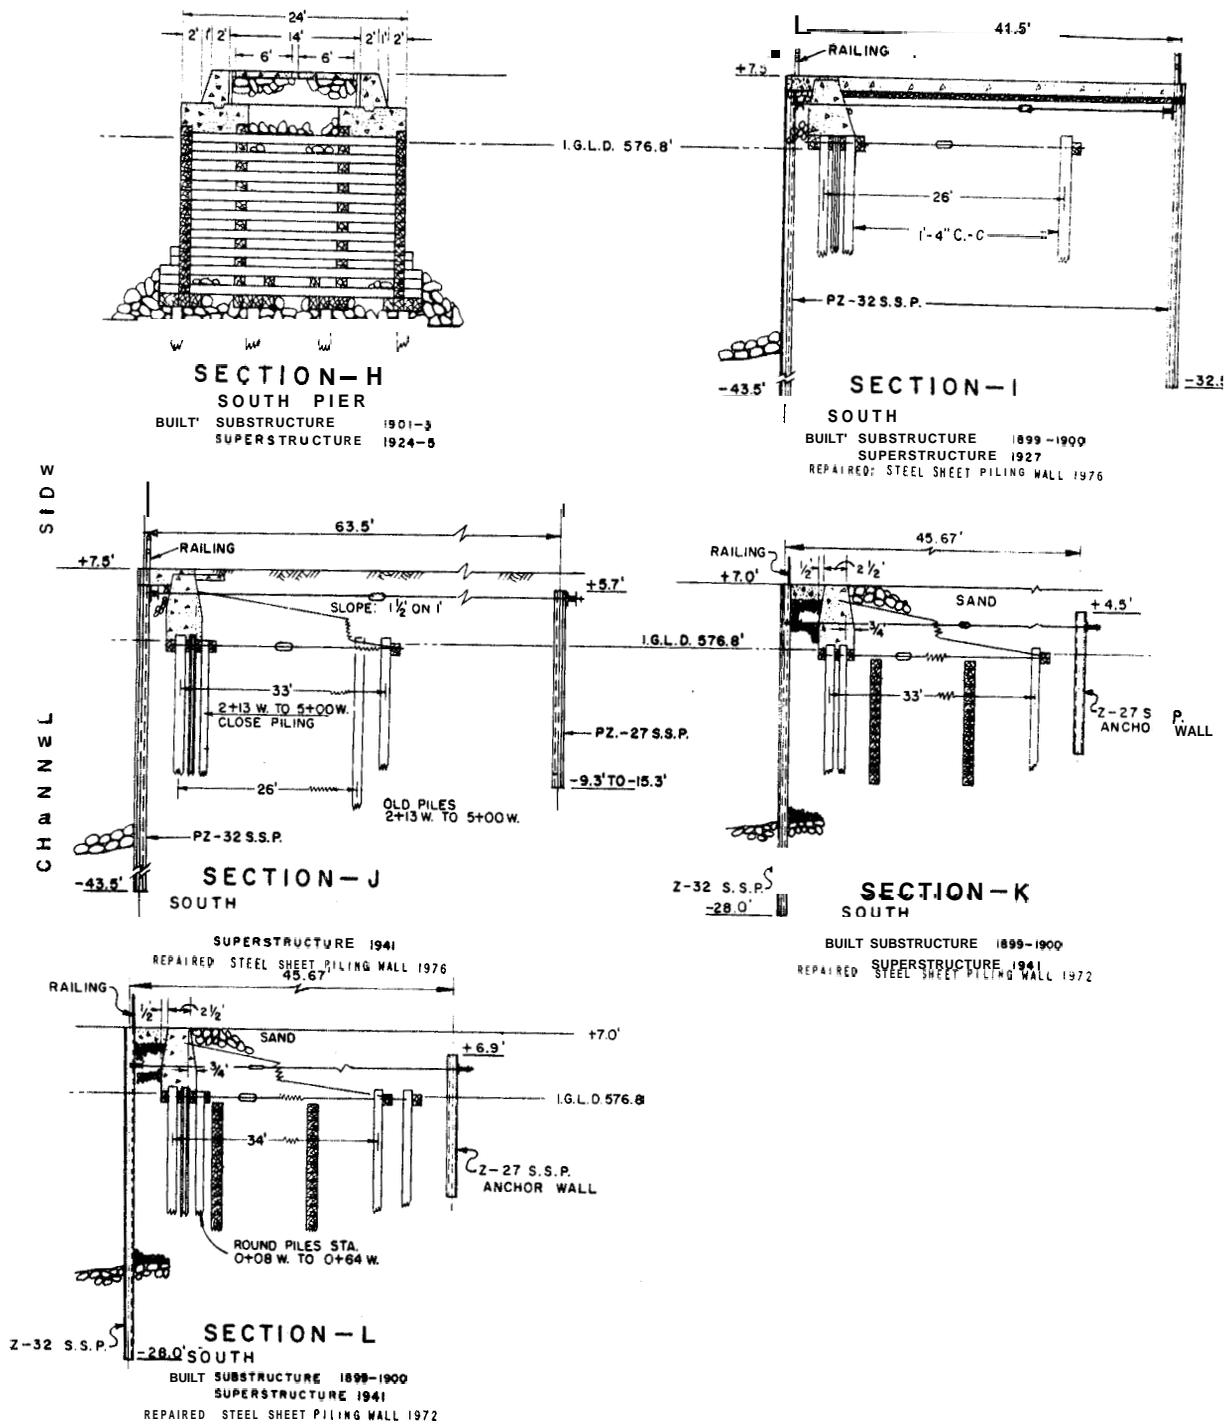
Figure 113. Typical structure cross sections, Saint Joseph Harbor, Michigan

1889- 1900	Construction of the inner 819 ft of the south pier (Figure 110, Sections I, J, K, and L) was completed during this time frame. The pier was constructed of woodpilings spaced from 26 to 34 ft apart and filled with earth and stone (Figure 113, Sections I, J, K, and L).
1901- 1903	Construction of the lakeward 709 ft of the north pier (Figure 110, Sections A1, A2, and A3) and the lakeward 1,784 ft of the south pier (Figure 110, Sections F, G, and H) was completed during this period. Both piers were constructed of stone-filled timber cribs built on a stone base. The entire north pier extension consisted of timber cribs that were 30 ft in width (Figure 111, Sections A1, A2, and A3). The south pier extension was 30 ft wide at its lakeward end (Figure 112, Section F) and 24 ft wide where it extended shoreward (Figure 112, Section G and Figure 113, Section H).
1911	The lakeward portion of the south pier (Figure 110, Section F) was capped with a concrete superstructure (Figure 112, Section F).

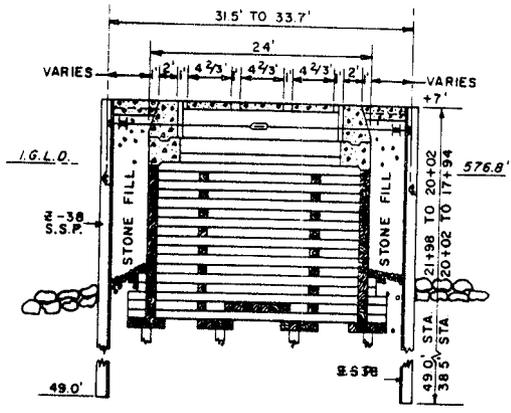
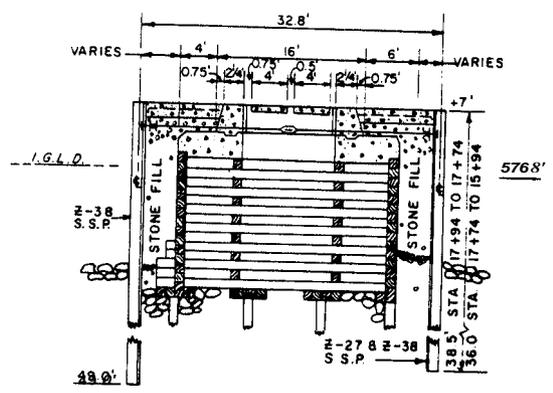
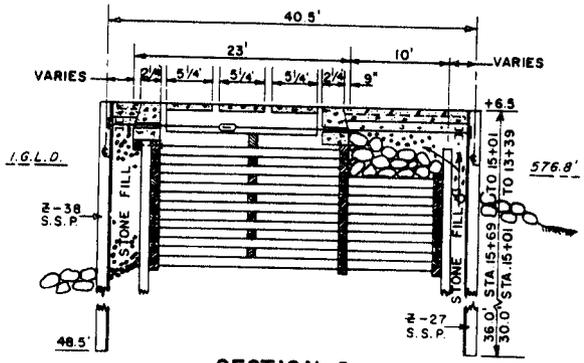
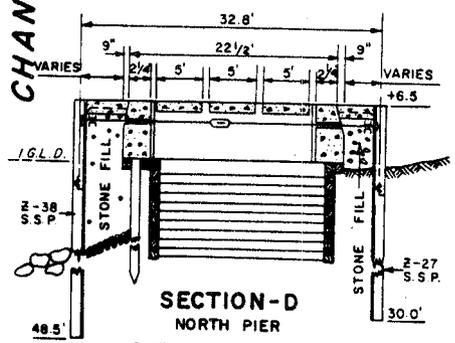
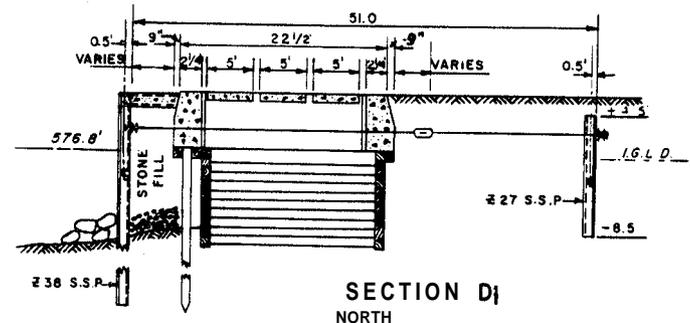
Figure 115. Typical north pier cross sections, South Haven Harbor, Michigan

1888	Construction of the shoreward 320 ft of the north pier (Figure 114, Sections D and D1) was completed. These structures were 20-ft-wide stone-filled timber cribs (Figure 115, Sections D and D1).
1897- 1898	An additional 179-ft-long lakeward extension (Figure 114, Section J) of the south pier was constructed. The extension consisted of stone-filled wood-pilings spaced 25 ft apart (Figure 116, Section J).
1899	Another 200-ft lakeward extension of the north pier (Figure 114, Section H) was completed. The pier was built of a stone-filled timber crib structure which was 24 ft in width (Figure 116, Section H).
1900	A 200-ft lakeward extension of the north pier (Figure 114, Section B) was constructed. The pier was constructed of stone-filled timber cribs that were 24 ft in width (Figure 115, Section B).
1912- 1913	Construction of the lakeward portions of the north and south piers (Figure 114, Section A) was completed. Both these structures were 24-ft-wide, stone-filled timber cribs (Figures 115 and 116, Section A).

1924- 1925	The shoreward 784 ft of the south pier (Figure 114, Sections H, J, K1, K, K2, and L) was capped with a stone and concrete superstructure. The crest el of this structure ranged from +5.5 to +7.1 ft lwd (Figure 116, Sections J and H; and Figure 117, Sections K1, K, K2, and L).
1930- 1931	The shoreward 807 ft of the north pier (Figure 114, Sections B, C, D, and D1) was capped with a concrete superstructure. Crest els ranged from +6.5 to +7.0 ft lwd (Figure 115, Sections B, C, D, and D1).

Date(s)	Construction and Rehabilitation History
1940	The landward portions of the north and south piers (Figure 114, Section A) were capped with stone and concrete superstructures resulting in pier crest els of +7.0 ft lwd (Figures 115 and 116, Section A).
1962- 1963	The entire north pier (Figure 114) was repaired during this time frame. Repairs consisted of installing steel sheetpiling on each side of the existing structures, filling the voids with stone, and capping the structure with concrete. Widths of the pier ranged from 31.5 to 40.5 ft (Figure 115, Sections A, B, C, D, and D1).
1964- 1965	A 179-ft portion of the south pier (Figure 114, Section J) was reconstructed. Steel sheetpiling was installed on each side of the existing pier forming a 32.7 ft-wide structure (Figure 116, Section J). The voids were filled with stone, and a concrete cap was installed.
1970- 1972	Additional portions of the south pier (Figure 114, Sections H, K1, K, K2, and L) were repaired during this period. These piers were repaired similar to the earlier ones by the installation of steel sheetpiling on each side of the existing pier. Voids were again stone filled and the structure capped (Figure 116, Section H; and Figure 117, Sections K1, K, K2, and L). Widths of the rehabilitated structure sections ranged from 30 to 42 ft.

1981	Riprap ranging from 1 to 6 tons was placed along the lakeside face of the north pier (Figure 114, Section A). Approximately 1,788 tons of stone was used that extended from the head of the pier 600 ft shoreward. Also, 38 tons of 2- to 4-in. stone was placed under the caps to replenish fill stone.
1982	Approximately 1,029 tons of riprap was placed along the north pier (Figure 114, Sections A and B) and 2,054 tons along the south pier (Figure 114, Section A). Three- to sixteen-ton stone was used for the purpose. Additionally, 40 tons of 1- to 3-ft stone was placed under the caps of the south pier to replenish fill stone.
1983	About 600 tons of 6- to 12-ton riprap was placed along the lakeside of the north pier shoreward of the riprap placement of 1981 and 1982.
1985	An inspection of the structures revealed that the north pier was in good condition. The lakeward end of the south pier (Figure 114, Section A) appeared stable and in fair condition. Separation, settlement, and cracking of the superstructure was noted, and maintenance repairs have been recommended. The remaining portions of the south pier were in good to excellent condition. An aerial view of the South Haven Harbor piers is shown in Figure 118.

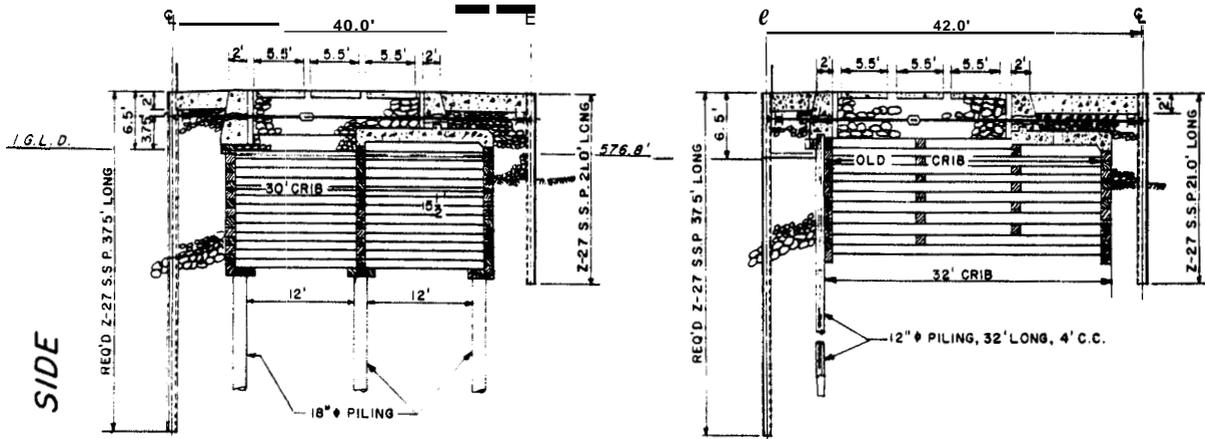
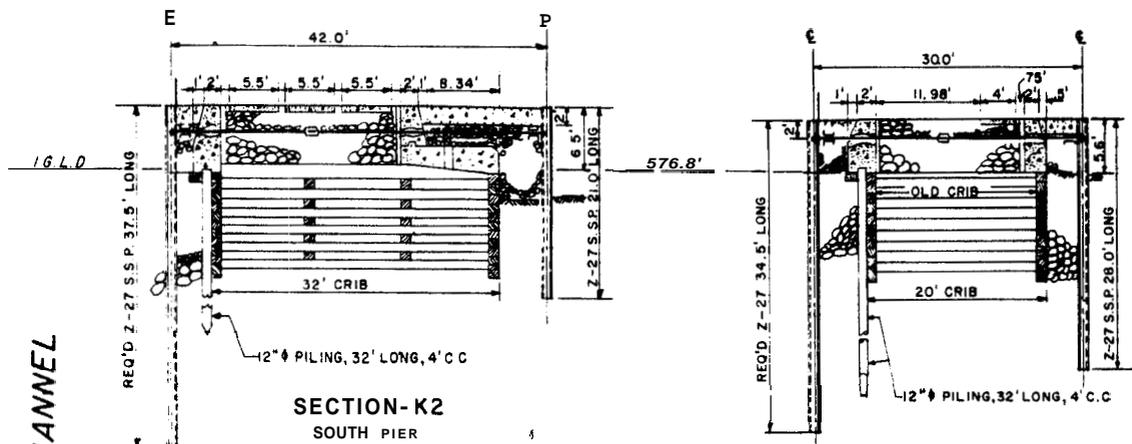
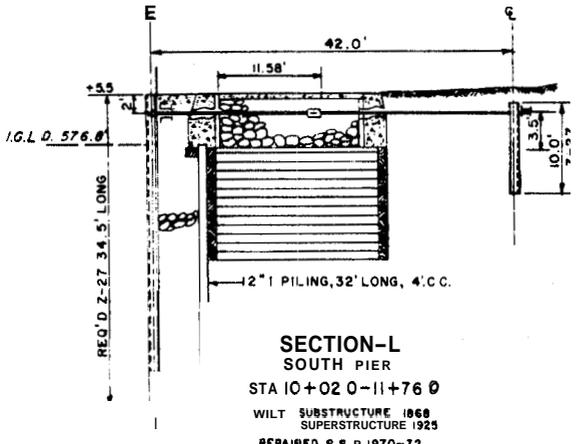
Figure 117. Typical pier cross sections, South Haven Harbor, Michigan

Date(s)	Construction and Rehabilitation History
1868	Construction of the shoreward portion of the south pier (Figure 114, Section L) was completed. (Figures 114, 115, 116, and 117 illustrate structures at South Haven Harbor.) The pier was built with stone-filled timber crib structures and was about 20 ft in width (Figure 117, Section L).
1870- 1874	Construction of a 287-ft-long portion of the north pier (Figure 114, Section C) was completed. The structure consisted of a stone-filled timber crib that was 23 ft in width (Figure 115, Section C).
1871- 1874	Extension of the south pier by 150 ft (Figure 114, Sections K and K2) was completed during this period. The pier extension consisted of a 32-ft-wide, stone-filled timber crib structure (Figure 117, Sections K and K2).
1887	An additional 50-ft extension of the south pier (Figure 114, Section K1) was completed. The extension consisted of a stone-filled timber crib structure that was 30 ft in width (Figure 117, Section K1).
