TECHNICAL REPORT REMR-CO-3

CASE HISTORIES OF CORPS BREAKWATER
AND JETTY STRUCTURES

Report 4

PACIFIC OCEAN DIVISION

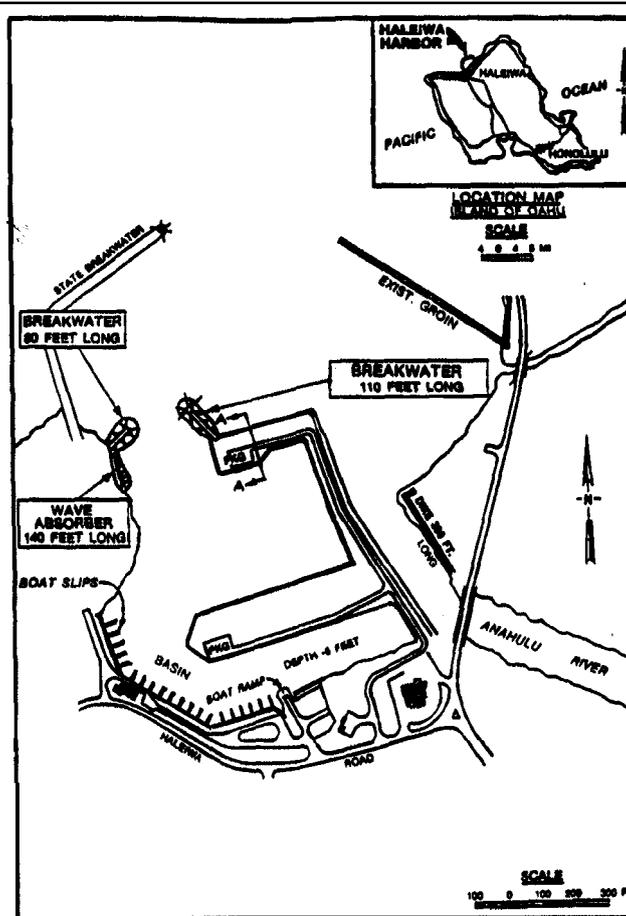
Figure 1. Haleiwa Small-Boat Harbor, Oahu, Hawaii

Date(s)	Construction and Rehabilitation History
1975	The 80-ft-long west and 110-ft-long east breakwaters were added to the existing project at a cost of approximately \$150,000 (Figure 1). The armor stone on the east and west breakwaters (Figure 2) was designed for 6- and 4-ft nonbreaking waves, respectively.
1978	The head of the west breakwater was rebuilt. Failure of the original head was thought to be due to the original structure toes not being placed on a firm foundation, thereby resulting in undermining of the toe and slippage of the armor stone layer. The head was rebuilt with the same size armor stone; but the sand was excavated, and the toe was placed on a firm coral bottom.
1984	Inspection of the stub breakwaters in July revealed that both structures were in good condition.

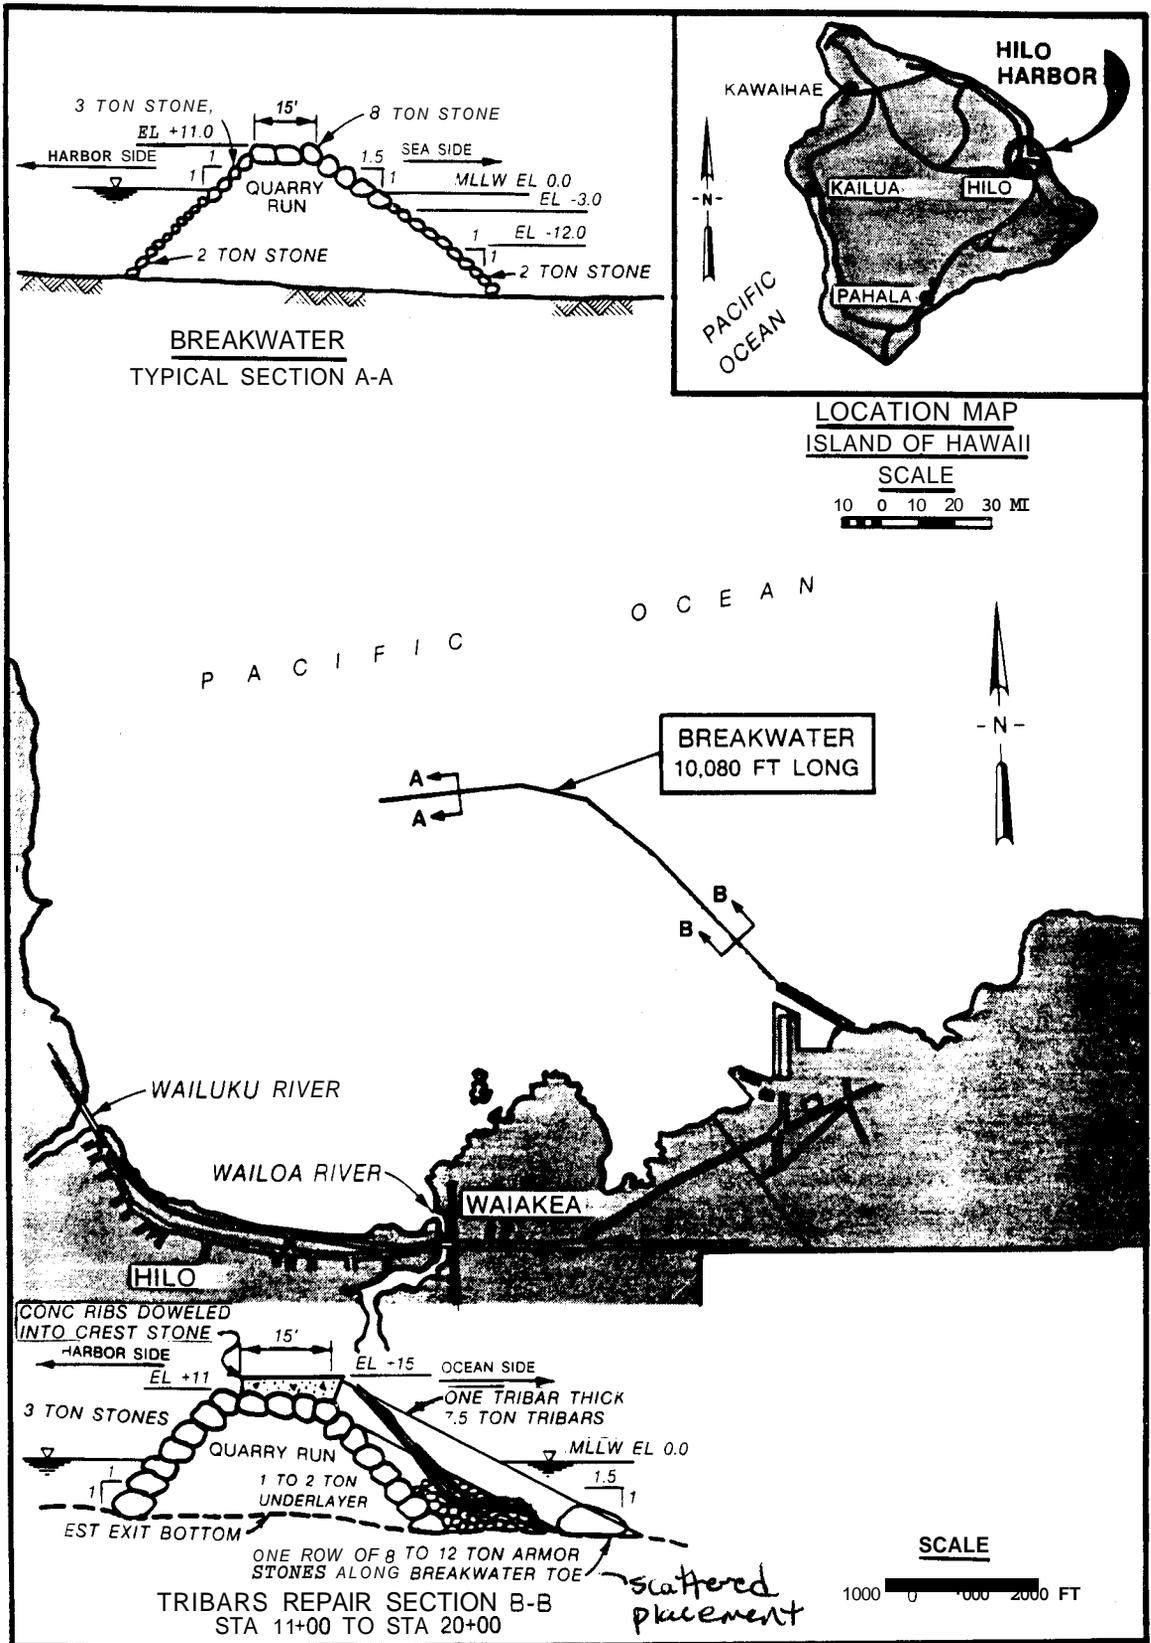
Figure 3. Hilo Harbor, Hawaii, Hawaii

<u>Date(s)</u>	<u>Construction and Rehabilitation History</u>
1930	The Corps completed the 10,080-ft-long rubble-mound breakwater (Section A-A, Figure 3).
1931- 1945	Only minor repairs were required to restore the original construction at an average annual cost of \$10,000 based on 1967 money.
1946	The tsunami of 1 April severely damaged 6,000 ft of the breakwater. Primary armor stone and core material were displaced both seaward and toward the harbor down to an average elevation of -3.0 ft mllw. A 1,100-ft-long breach occurred adjacent to the piers.
1946- 1948	Tsunami damage was repaired using original design criteria at a total cost of \$1,500,000.
1949- 1952	Storm waves of December 1951 caused damage to 13 areas (Figure 4). By October 1952 the structure had been repaired to the original cross section at a cost of \$76,000.
1954- 1957	Storm waves of March 1954 caused damage to several areas (Figure 4). By August 1957 the structure had been repaired to its original cross section at a cost of \$80,000. The structure was exposed to the tsunami of 9 March 1957 but sustained no damage.

1960	The tsunami of 1960 caused breakwater damage (Figure 4), but it was not as severe as that sustained by the 1946 tsunami. Less severe damage was attributed to the direction of wave attack. The 1960 approach was less direct than that of 1946; therefore, wave energy reaching the structure was less than what had occurred in 1946. Between 1946 and 1960 average annual maintenance costs were \$25,000. It was thought that the 1946-1948 repair work did not key the replacement armor into the existing structure, thus resulting in weaker cross sections in these repair areas.
1965	Storm waves of February 1965 caused additional damage at sta 15+00, 36+30, 73+40, 83+00, and 90+00.
1967	Between the 1960 and the 1967 tsunami, no repair work was done due to the possibility of total rebuilding of the breakwater as one leg of a proposed tsunami barrier for Hilo Harbor. The average annual cost of structure maintenance had been \$43,900 for the first 37 years of the project.

1976	Hurricane Kate produced overtopping waves at various lengths of the breakwater on 28 and 29 September. It also was noted that large amounts of water were passing through the structure between sta 6+00 and sta 20+00. An inspection on 5 November 1976 revealed sporadic, moderate damage on the upper sea-side slopes and the crown and harbor-side slopes, but no immediate repairs were recommended.
1977	Inspection on 4 October revealed some settlement of sea-side slope stone in a few areas exposing the crown stone to direct wave attack. In a couple of areas armor stone had been displaced up onto the crown or was missing. No immediate repairs were recommended.
1980	Inspection on 16 October revealed additional sporadic damage to the crown and upper sea-side slope. Damage was not severe but observed transmission through the structure between sta 1+00 and sta 16+00 during heavier seas was thought to be a possible cause of swell conditions in the berthing areas.

Date(s)	Construction and Rehabilitation History
1968	Repair work was completed in August. A total of 11 areas was repaired. Due to the severity of wave overtopping and the recurrence of damage in many areas, the armor stone weight used for repair of the crown was increased from a minimum of 8 tons to a minimum of 10 tons. The remainder of the repair work followed the original cross section design. The total cost of repair was approximately \$124,500.
1971- 1973	An inspection on 7 April 1971 revealed deterioration of the structure at various points along the entire length, but it was thought that immediate repair of 1,700 ft at the shoreward end of the structure was needed to protect the berthing area. Emergency repair work was completed in 1973 at a cost of \$184,000. The original cross section design was used for repair.
1975	Major repair of the breakwater was completed. Both new and reset 8- and 10-ton minimum weight armor stones were used to repair various areas along the entire length of the structure. The structure slopes and crown elevation were unchanged from the original design cross section. The total cost of the work was approximately \$591,000.

Date(s)	Construction and Rehabilitation History
1981	<p>The breakwater was repaired between sta 11+00 and sta 20+00. One layer of uniformly placed <u>7.5-ton tribars extended from sea-side toe to crown on a 1V:1.5H slope.</u> The tribar toe was buttressed with a single row of 8- to 12-ton stone, and concrete ribs were constructed on the crown (Section B-B, Figure 1). The design was based on a 15.5-ft water depth, a breaking wave height of 13.5 ft, and a K_D of 7.5. Excess tribars were stockpiled in a single layer on the seaside of the breakwater shoreward of the repair site.</p>
1984	<p>During a 2 August inspection by US Army Engineer Waterways Experiment Station (WES) personnel, it was noted that the tribars seemed to be on a steeper than 1V:1.5H slope in some areas. No broken armor units were seen during the inspection. Inspection only went to sta 40+00, but just beyond the tribar repair area damage to upper sea-side slope and crown armor stones was noted in a couple of areas. The tribar repair is in good condition. The old armor stone structure is in need of some repair and will continue to need repair as long as the repair work continues to be done with the original size armor stone. Although the maximum wave heights that the structure has seen are unknown, it is exposed to large wave conditions on a regular basis.</p>

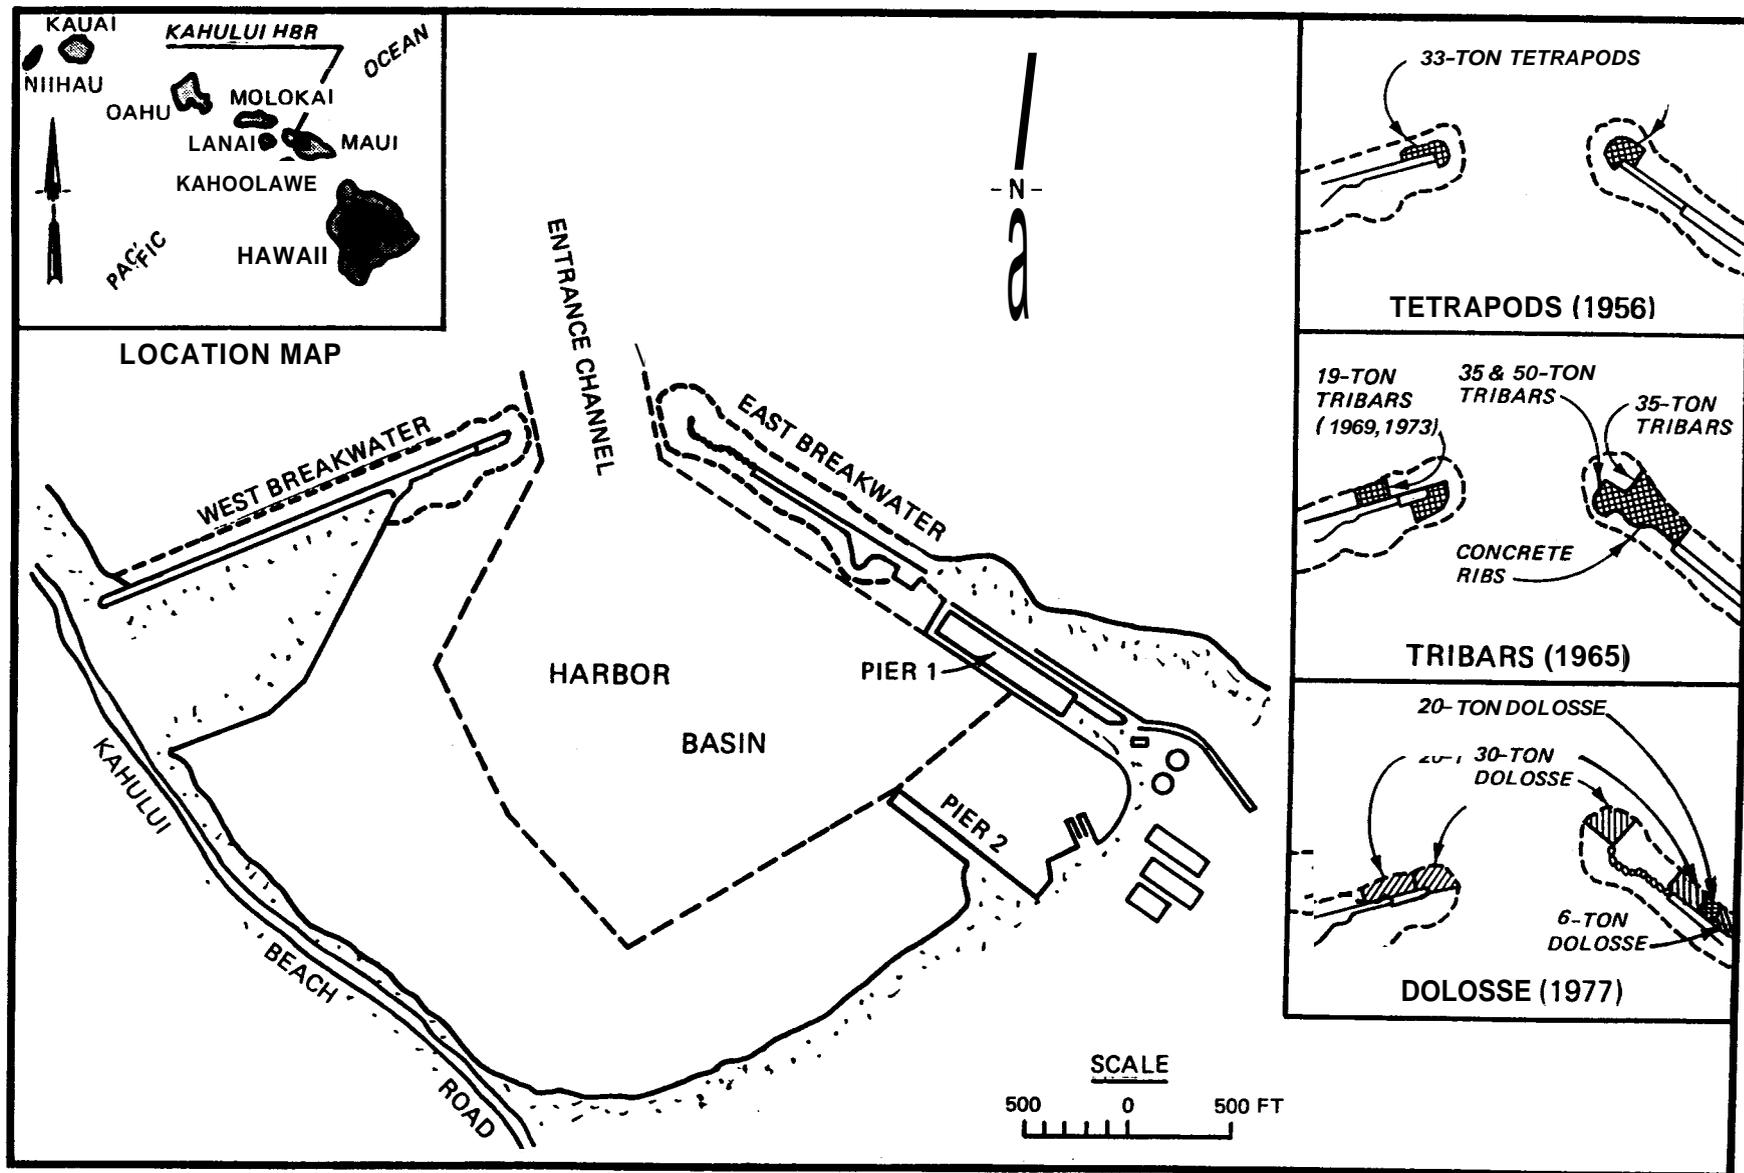
Figure 5. Kahului Harbor, Maui, Hawaii

<u>Date(s)</u>	<u>Construction and Rehabilitation History</u>
1900	The Kahului Railroad Company constructed the original harbor which consisted of a berthing area, a dredged channel, and a 400-ft-long east breakwater (Figure 5, location map).
1913	The first breakwater improvements constructed by the Corps of Engineers were completed (Figure 6). These improvements included a 400-ft-long extension of the east breakwater.
1919	The Corps constructed the west breakwater to a length of 1,950 ft.
1931	Extensions of the east and west breakwaters to lengths of 2,766 ft and 2,315 ft, respectively, were completed.
1931-1954	Maintenance costs exceeded \$1,000,000. Routine maintenance and repair involved approximate restoration of damaged breakwater sections to their original conditions.
	On 14-17 October 1943 the east breakwater was damaged. Approximately 45 tons of rock on the extreme east end were dislodged and washed into the inner harbor area. Approximately 150 ft shoreward of the east breakwater light a larger mass of stone was dislodged and washed into the harbor. This break was on the inside of the east breakwater and covered an area approximately 75 ft long and 20 ft deep. The Estimated repair quantity was 250 tons.

1977	<p>A 1973 breakwater inspection indicated considerable damage and settlement of the 33-ton tetrapods on the seaward quadrants of both breakwater heads. In addition, the 8-ton armor stone along both trunks was failing and required repair. In 1977 the following repairs were completed (Figure5): on the west breakwater, <u>257 30-ton reinforced dolosse were placed in two layers over the 33-ton tetrapods on the sea-side quadrant of the head; 291 20-ton reinforced dolosse were placed on the sea-side slope of the west breakwater trunk; on the east breakwater 61U 30-ton reinforced dolosse were placed in two layers over the 33-ton tetrapods on the sea-side quadrant of the head; 164 20-ton reinforced dolosse were placed in a double layer on the sea-side slope, of the trunk beginning at the shoreward end of the 35-ton tribars; and, beginning at the point where the 20-ton dolos ended and extending shoreward, two layers of 6-ton unreinforced dolosse (455units) were placed on the sea-side slope of the east breakwater trunk.</u> The total cost was \$3,290,000.</p>

1956	<p>Repairs of damage caused by the March 1954 storm were completed (Figures 5 and 7). Head repairs consisted of a double layer of <u>33-ton unreinforced tetrapods</u> on a <u>1-V:3-H</u> seaward slope and a <u>1-V:2-H</u> landward slope. Two layers of tetrapods also were extended 250 ft down the sea side of the west breakwater trunk, and the core of both was capped with 2 ft of concrete.</p> <p>A total of 400 tetrapods was placed. To prevent encroachment of the structures on the entrance channel, the breakwaters were shortened slightly, and a <u>1-V:2-H</u> slope was used on the inboard quadrant of the armor wraparound on the breakwater heads. The total cost of repairs was \$1,200,000.</p>

1965	During 2-3 February, 1 month after awarding the tribar-placing contract, a storm with hindcasted deepwater wave heights of 27 ft and period of 17 sec caused damage to the heads of both breakwaters.
1966	Major rehabilitation (Figures 5 and 9(a,b)) consisted of repair of both breakwater heads and the first 355 ft shoreward of the east breakwater head. On the inboard quadrants of the breakwater heads, <u>two layers of 35-ton tribars</u> were placed over the <u>lower third of the side slope</u> , and <u>two layers of 50-ton tribars</u> were placed over the <u>upper two-thirds</u> . Two layers of 35-ton tribars were placed on the sea-side slope of the east breakwater head and buttressed against the concrete rib cap constructed on the crest; 827 and 181 35-ton reinforced tribars were placed on the east and west breakwaters, respectively; and 43 and 173 50-ton reinforced tribars were placed on the east and west breakwaters, respectively. Except for the concrete rib cap, all repair work was model tested (Jackson 1964). The total cost of repair work was \$1,560,000.

Date(s)	Construction and Rehabilitation History
1969	<p>The damaged west breakwater trunk was repaired by placement of two layers of <u>19-ton reinforced tribars</u> (260units) on the sea-side slope, shoreward of the tetrapod area (Figure5). A concrete rib cap was added to the crest for buttressing of the tribars. The total cost was \$443,000,</p> <p>In November 1969 another severe storm hit with estimated breaking wave heights of 15-20 ft; damage occurred to the west breakwater <u>in the tribar-original armor stone transition area, presumably because of insufficient interlocking.</u> Approximately 25 19-ton tribars were moved shoreward as much as 300 ft.</p>
1973	<p>The November 1969 damage was repaired by placement of <u>80 19-ton reinforced tribars</u> (Figures5 and 10). The tribars and concrete crest ribs were extended shoreward another 80 ft down the seaside of the west breakwater trunk, and the landward end of the tribar armor section was buttressed by 25 35-ton tribar units. The total cost was \$262,000.</p>

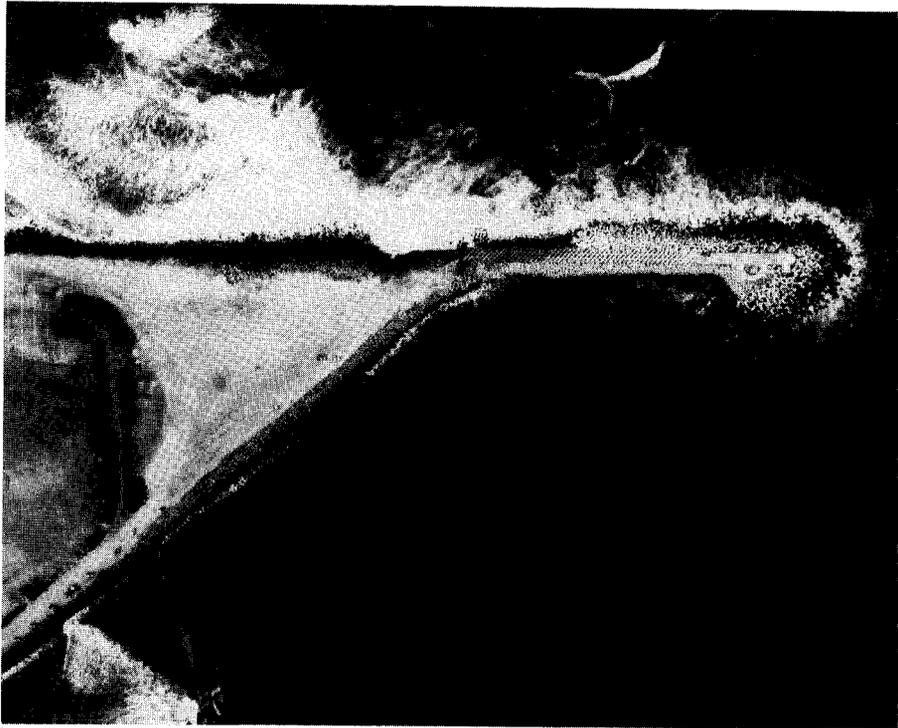
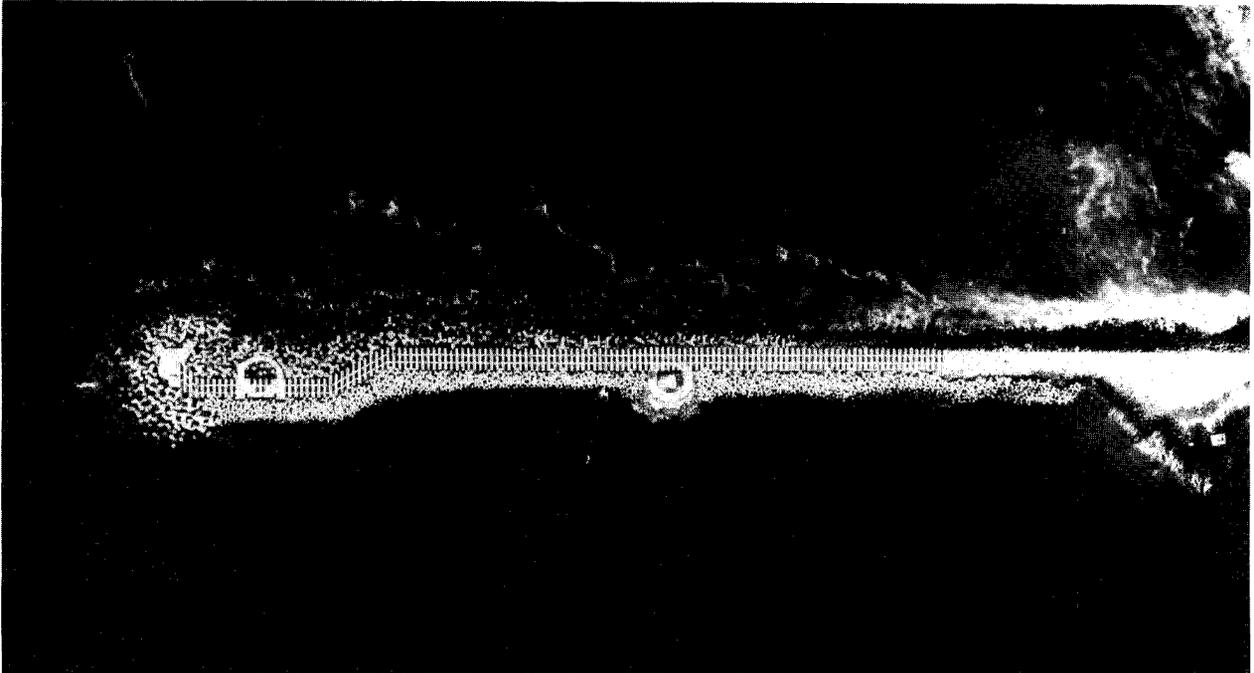
Figure 11. Aerial photographs of the Kahului breakwater, 1984

<u>Date(s)</u>	<u>Construction and Rehabilitation History</u>
1984 (cont.)	<p>were buttressed with 25-ton tribars. On the east breakwater one layer of 9-ton tribars was placed harborside between sta 23+80 and sta 27+15; also, from sta 19+50 to sta 23+80, one layer of 9-ton tribars was placed on the harborside, and a concrete rib cap was constructed (head at sta 27+66). A total of 540 6.5-ton, 755 9-ton, and 10 25-ton tribars was placed. In Figure 11(a,b) are aerial photographs of the east and west breakwaters taken in January. The estimated cost of repairs was \$6,000,000.</p>

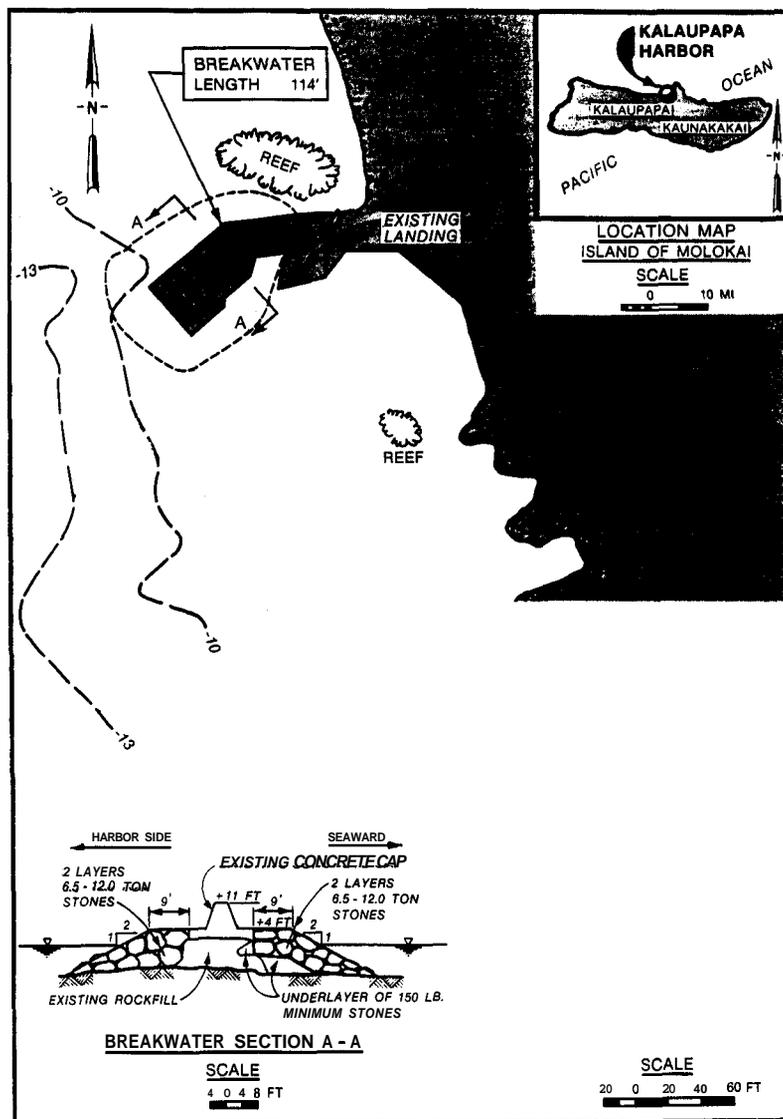
Figure 12. Kalaupapa Harbor, Molokai, Hawaii

An existing rock fill breakwater with a concrete cap was improved by widening the crown and armoring the structure slopes with 6.5- to 12-ton armor stone (Figure 12). The armor stone was designed for a 12-ft breaking wave in a water depth of 15 ft at the breakwater head. The breakwater modification cost approximately \$95,000. As of 1984, the structure has required no major maintenance.

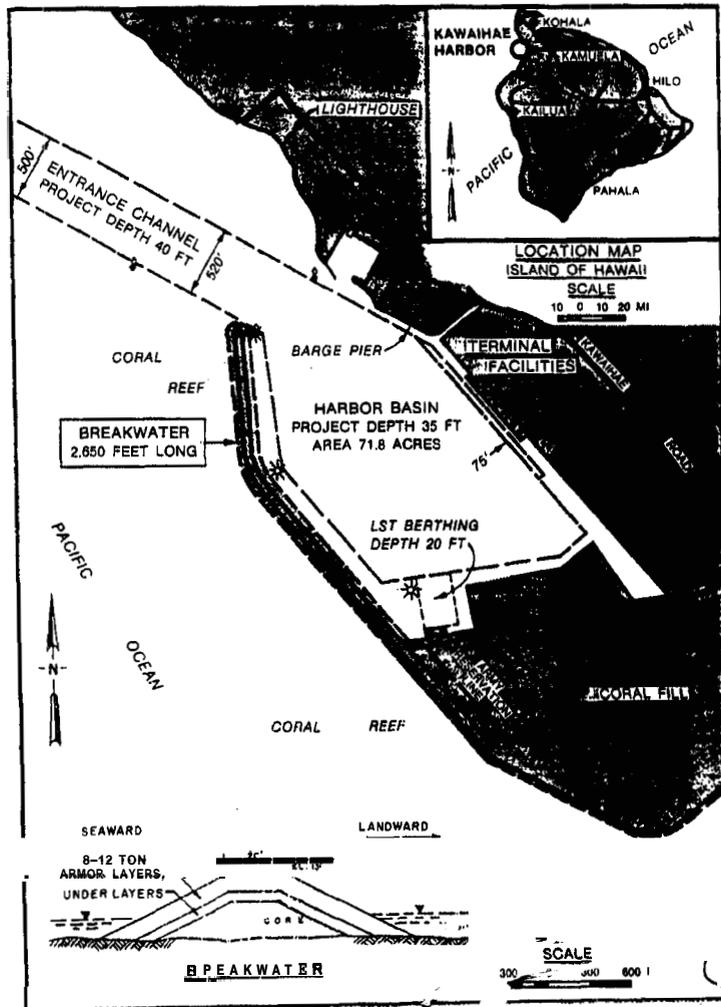
Figure 13. Kawaihae Deep Draft Harbor, Hawaii, Hawaii

<u>Date(s)</u>	<u>Construction and Rehabilitation History</u>
1962	A 2,650-ft-long armor stone breakwater was completed (Figure 13). Through 1973, the Corps spent just over \$6,000,000 for construction, enlargement, and maintenance of this deep-draft harbor. As of 1984, the structure had required no maintenance.

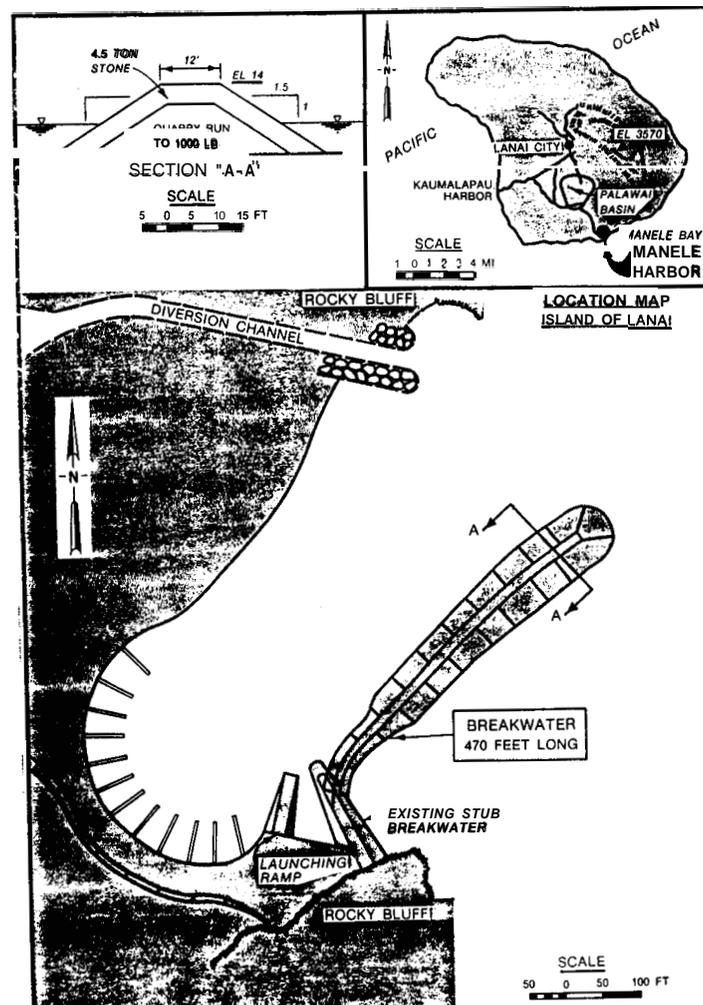
Figure 14. Manele Small-Boat Harbor, Lanai, Hawaii

Date(s)	Construction and Rehabilitation History
1965	A 470-ft armor stone breakwater extension was added to an existing stub breakwater. The breakwater was part of a light draft harbor project completed in 1965 (Figure 14). Total project cost was \$742,850. Along the breakwater's length the armor stone varied from 2 to 4.5 tons for design breaking-wave height ranging from 3 ft at the root to 10.1 ft at the head.
1984	Recent inspection of the breakwater revealed only minor damage that did not warrant immediate attention.

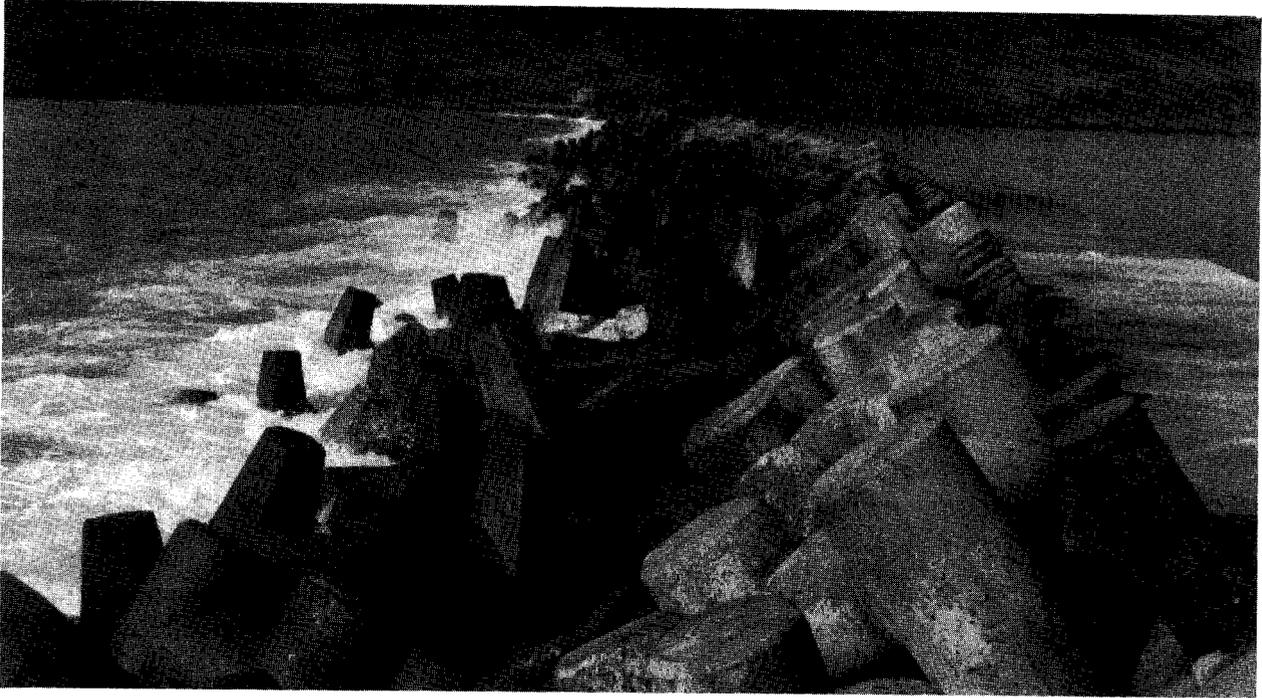
Figure 18. View from head of Nawiliwili breakwater, July 1984

1983	An underwater inspection was conducted on 9 August. This detailed inspection revealed that the underwater slope of the breakwater head was approximately 1V:1H, much steeper than it was thought to be. The inspectors recommended repair of the head to prevent a possible catastrophic failure of the head that could be initiated on steep underwater slopes.
1984	Figure 18 is a photograph of the breakwater taken from the head looking landward. A general design memorandum for the rehabilitation of the breakwater in 1985 was prepared. The proposed work was as follows: <u>one and two layers of randomly placed dolosse on the sea- and harbor-side slopes of the head; one layer of 11-ton dolosse on the sea-side slope between stations 18+35 and 20+45; one layer of uniformly placed, 6.5-ton tribars on the harbor-side slope between sta 12+00 and 15+00; and concrete ribs on the crown between sta 12+00 and 20+45.</u> Portions of this proposed work were model tested (Markle and Herrington 1983). The estimated first cost of this rehabilitation was \$3,500,000 based on January 1984 price levels.

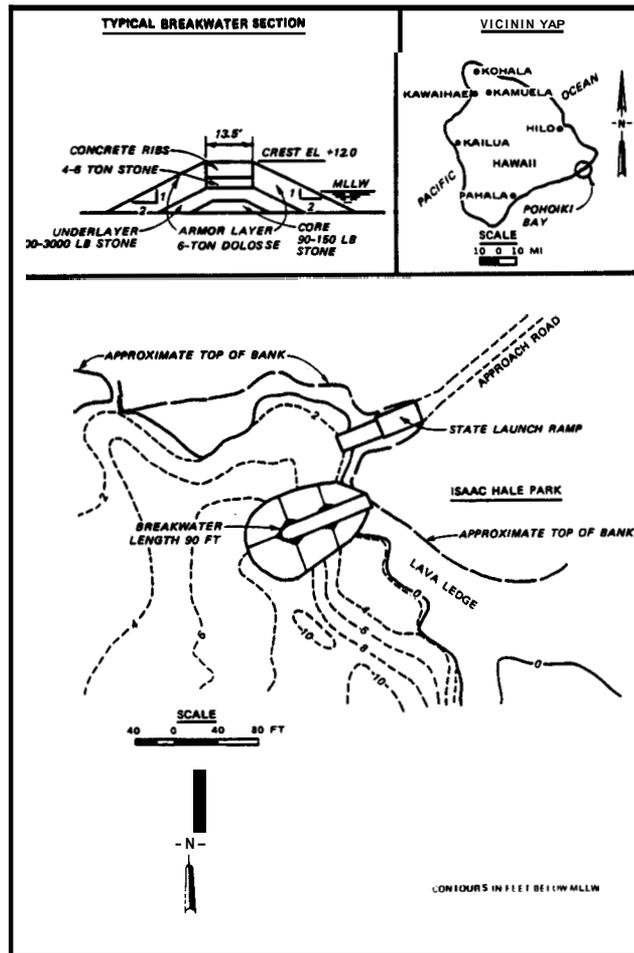
Figure 19. Pohoiki breakwater, Hawaii, Hawaii

A 90-ft dolos-armed structure with a concrete rib cap was constructed in 1979 at a cost of approximately **\$335,500** (Figure 19). The structure was designed for 12-ft depth-limited breaking waves at the structure. The wave condition has reportedly occurred on several occasions since completion of construction, and the structure shows no signs of deterioration. The 6-ton unreinforced dolosse (two layers) exceeded the needed weight for the design conditions but were found to be more economical than a lighter weight in that fewer units were needed. All existing dolosse breakage (5 units) occurred during construction and were left on the structure. Figure 20 is an aerial photograph of the breakwater taken in 1984.

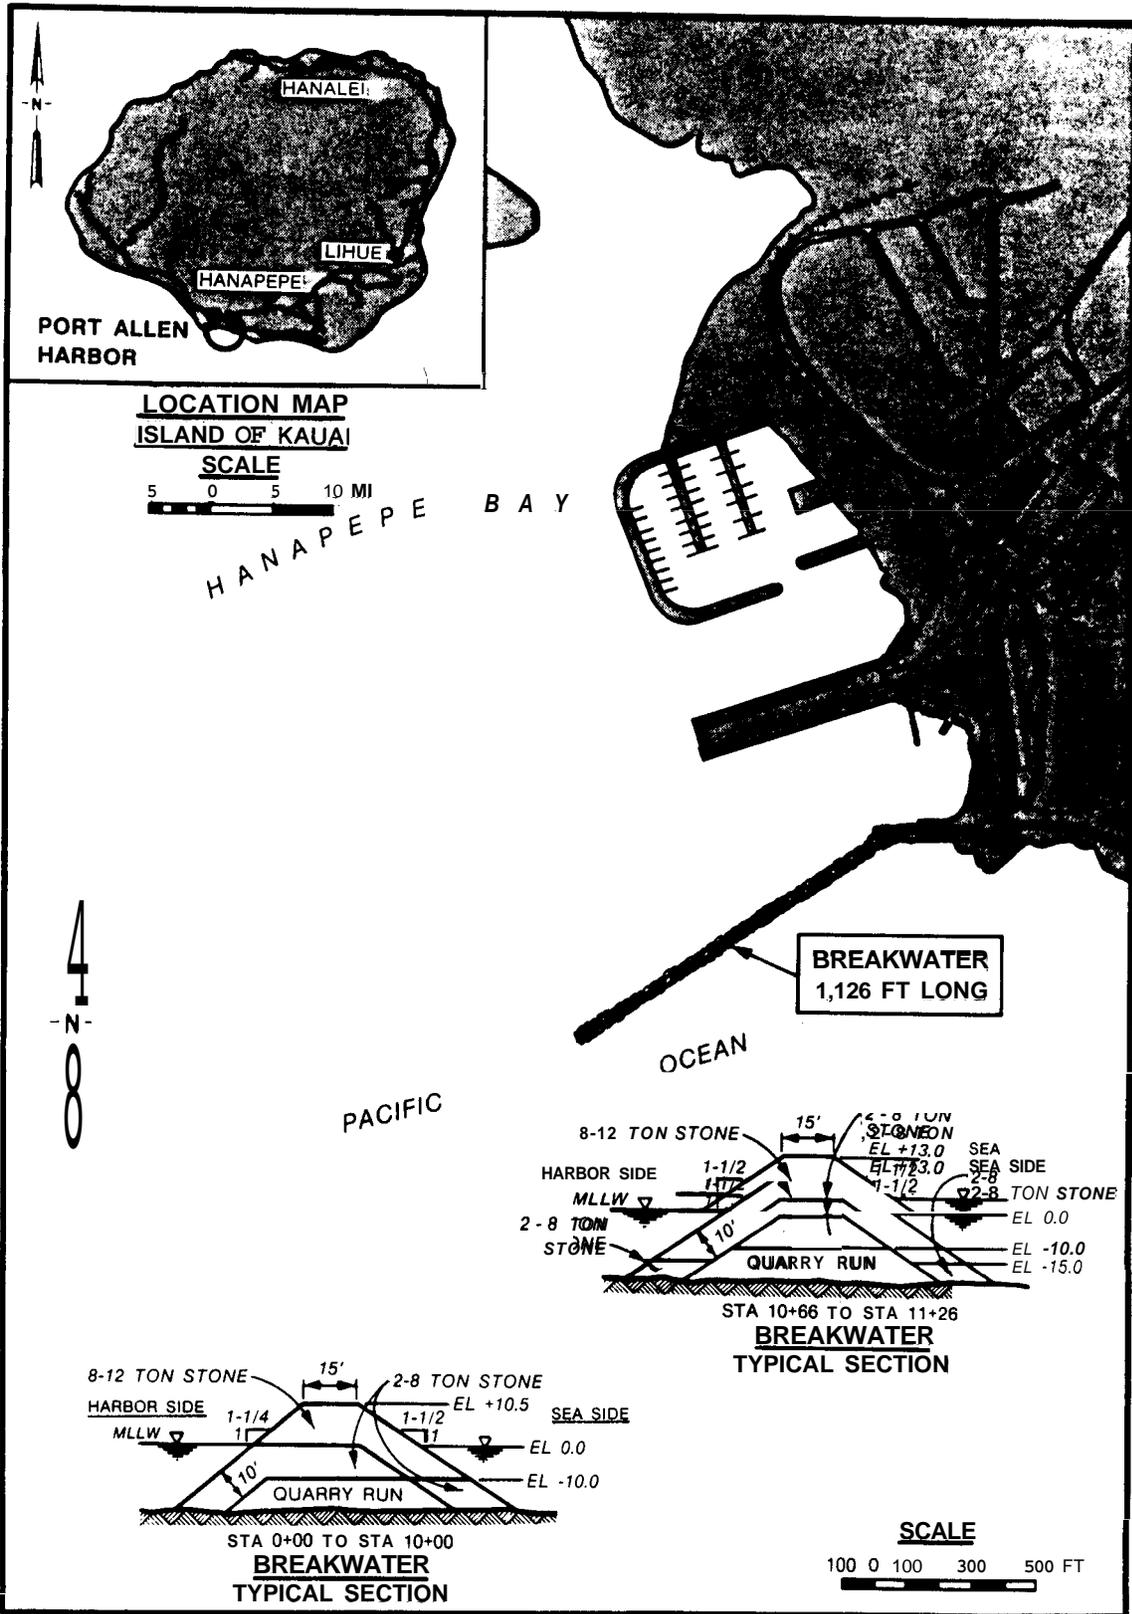
Figure 21. Port Allen Harbor, Kauai, Hawaii

<u>Date(s)</u>	<u>Construction and Rehabilitation History</u>
1935	The 1,200-ft-long structure was completed as an extension to a privately constructed breakwater (Figure 21).
1982	Until damaged by Hurricane Iwa of November 23, the old 8-ton keyed-and-fitted armor stone structure had no repair history. The breakwater light at the seaward end had been damaged and repaired several times (Coast Guard cost) prior to its present destruction. The estimated 20-ft breaking waves at the structure first dislodged the stones on the inboard crest which eventually resulted in the total destruction of the outer 130 ft of the breakwater. Overtopping waves also displaced crest stone and exposed under-layer stone on a 150-ft length at the extreme root of the structure. Minor damage also was sustained along the inboard slope.
1984	The head was rebuilt, and the minor damage on the inboard slope was repaired at a cost of \$178,000. The breakwater was shortened to a total length of 1,126 ft. The outer 74 ft was abandoned. The repair was accomplished by resetting stone remaining on the structure and by retrieving stone from the harbor and replacing it on the structure using the old keyed-and-fitted construction (Figure 22). The crown elevation on the last 80 ft of structure was increased to +13.0-ft mllw. This was done to improve the stability of the inboard slope by decreasing wave overtopping. The root of the breakwater was not repaired.

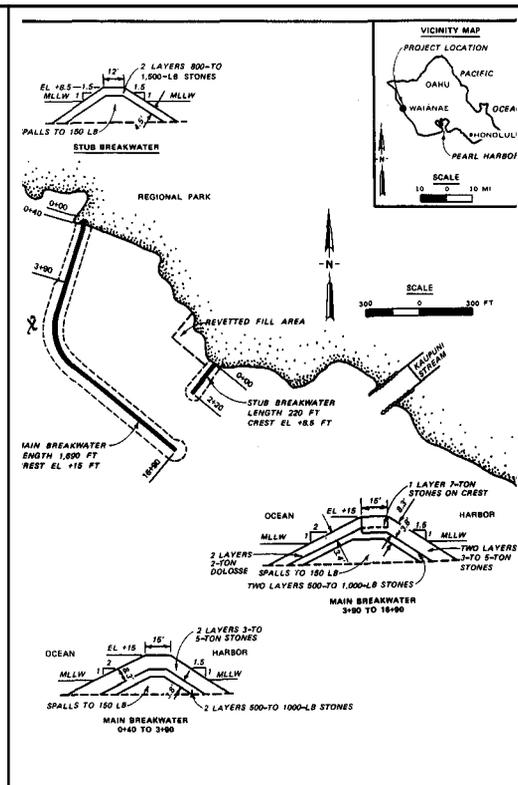
Figure 23. Waianae Small-Boat Harbor, Oahu, Hawaii

Date(s)	Construction and Rehabilitation History
1979	The 1,690-ft-long armor stone and dolosse-armored main breakwater and 220-ft-long armor stone stub breakwater were completed in January (Figure 23). The dolosse-armored portion of the main breakwater was model tested (Bottin, Chatham, and Carver 1976) for a design breaking wave height of 11.8 ft in a water depth of 16 ft.
1980	Inspection of the structure revealed that 203 of the 6,633 dolosse originally placed were broken. It is estimated that 47 of these were broken and left in place during construction.
1982	Inspection subsequent to Hurricane Iwa of November 23 revealed no additional breakage of dolosse, but it is thought that a section of dolosse around sta 4+00 may have slumped slightly.
1984	The structures looked in good condition during a 7 August 1984 inspection. Dolos breakage appeared unchanged from 1980, and the slump area referred to above did not appear to pose any immediate problem. There was no obvious need to implement breakwater repair.

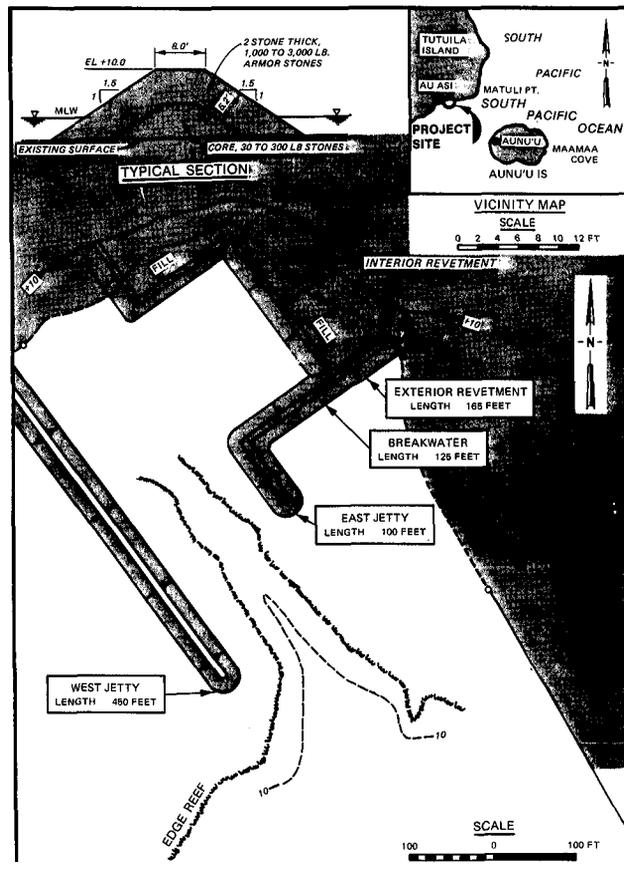
Figure 24. Auasi Small-Boat Harbor, Tutuila Island, American Samoa

A 125-ft armor stone breakwater and 100- and 450-ft east and west armor stone jetties, respectively, comprised a portion of the project completed in 1981 (Figure 24). Total cost of the project was approximately \$1,166,300. The structures were designed for depth-limited breaking wave heights of 4.8, 7.0, 5.6, and 6.0 ft for the breakwater, west jetty head, west jetty trunk, and entire east jetty, respectively. Water depths for these wave heights were 6.2, 7.2, 7.2, and 7.7 ft, respectively. The structures have no history of damage or repair. There is some evidence of armor stone breakage. Although quarried basalt armor stone appeared to be free of cracks when placed, internal stresses may be responsible for breakage. Testing by dropping from a 10-ft height onto a stone bed did not result in breakage during construction. The condition is not widespread and is not considered serious at present.

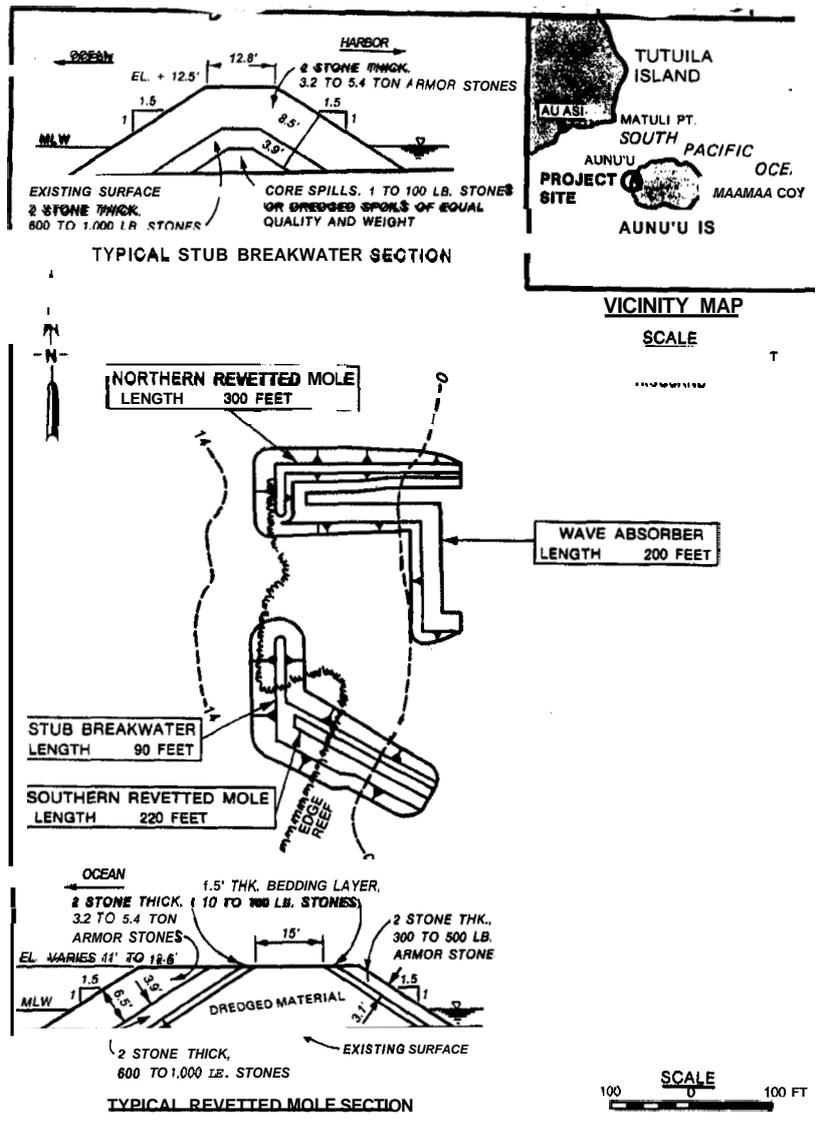
Figure 25. Aunu'u Small-Boat Harbor, Aunu'u Island, American Samoa

Date(s)	Construction and Rehabilitation History
1981	The 90-ft armor stone breakwater was a portion of the project completed in 1981 (Figure 25). The total project cost was approximately \$2,018,400. The breakwater section was designed for a depth-limited breaking wave height of 10.0 ft. The structure has had no documented damage or repair work since its completion.

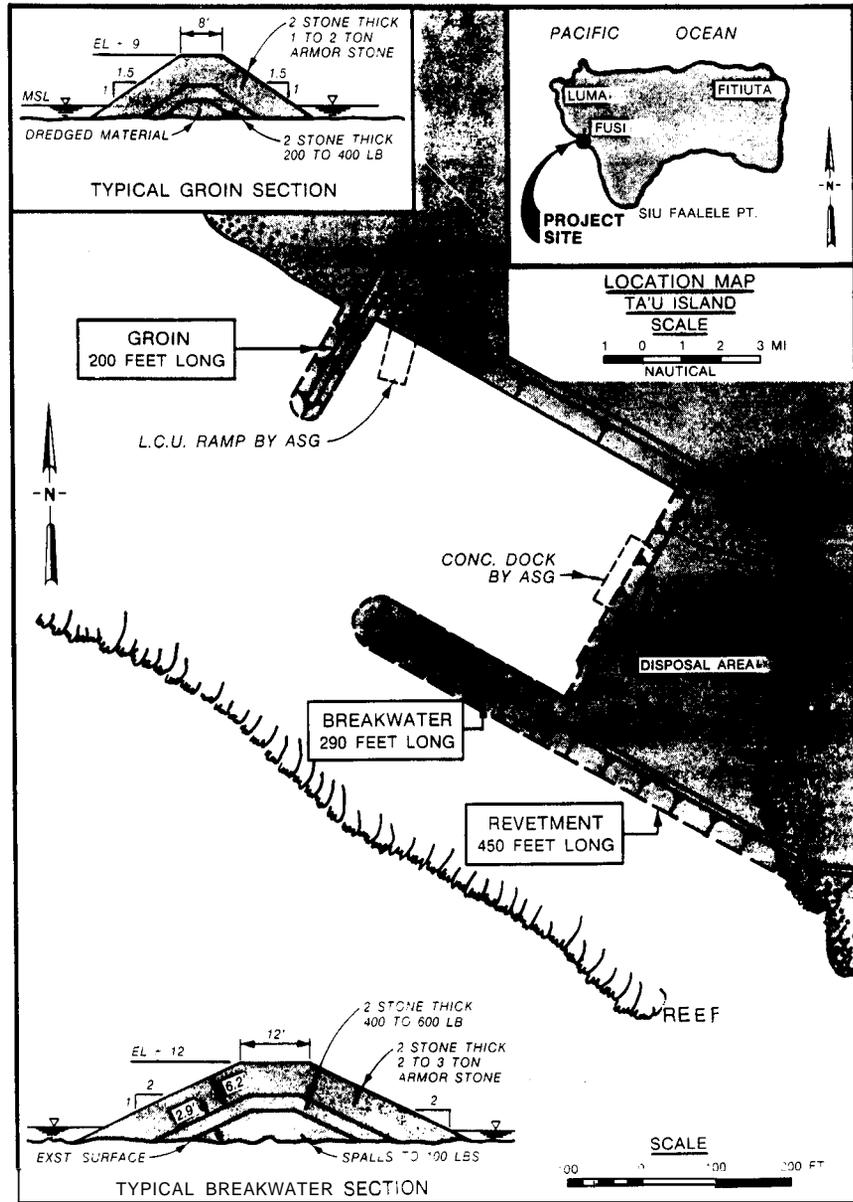
Figure 26. Ta'u Small-Boat Harbor, Ta'u Island, American Samoa

The 290-ft armor stone breakwater is part of the project which was completed in 1981 at a cost of approximately \$2,020,400 (Figure 26). The breakwater armor was designed for a 7.0-ft depth-limited breaking wave in a water depth of 9.0 ft. The structure has required no repair since completion.

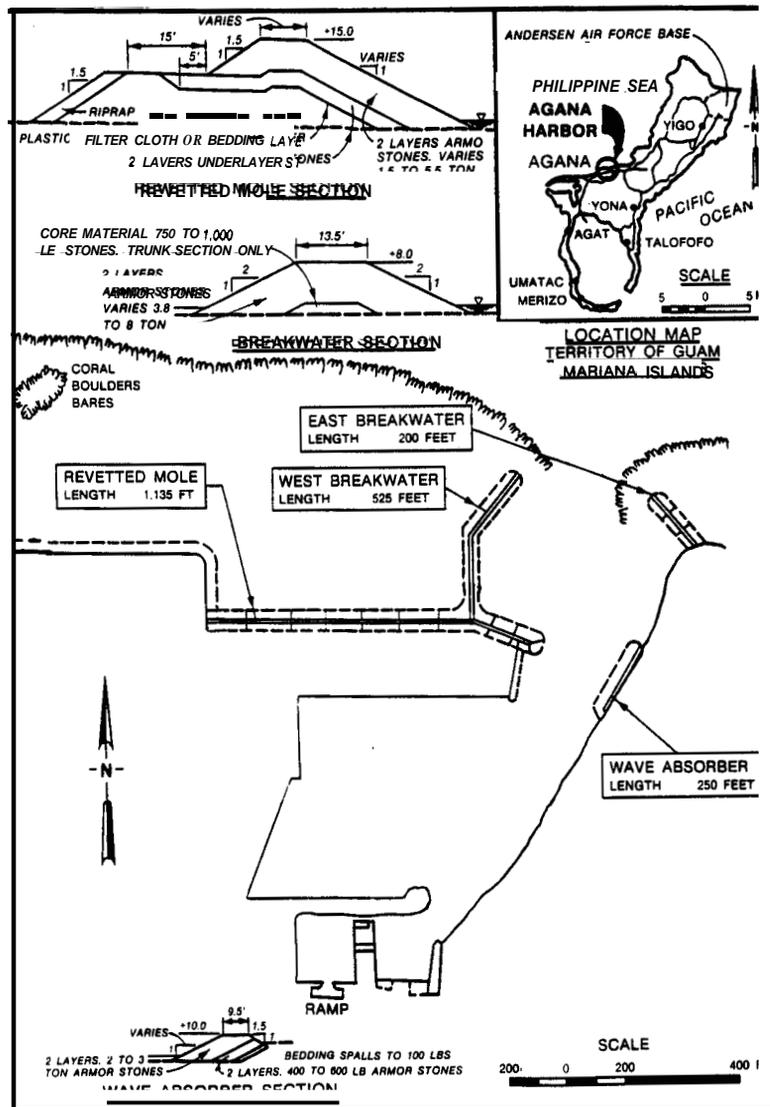
Figure 27. Agana Small-Boat Harbor, Agana, Guam

The 200-ft and 525-ft east and west armor stone breakwaters, respectively, were a portion of the project completed in 1977 (Figure 27). The total project cost was approximately \$1,220,550. The heads and trunks of the breakwaters were designed for 10- and 9-ft depth-limited breaking waves, respectively. The structures have no damage or repair history since their completion.
