TECHNICAL REPORT REMR-CO-3

**CASE HISTORIES OF CORPS BREAKWATER
AND JETTY STRUCTURES**

Report 9

SOUTHWESTERN DIVISION

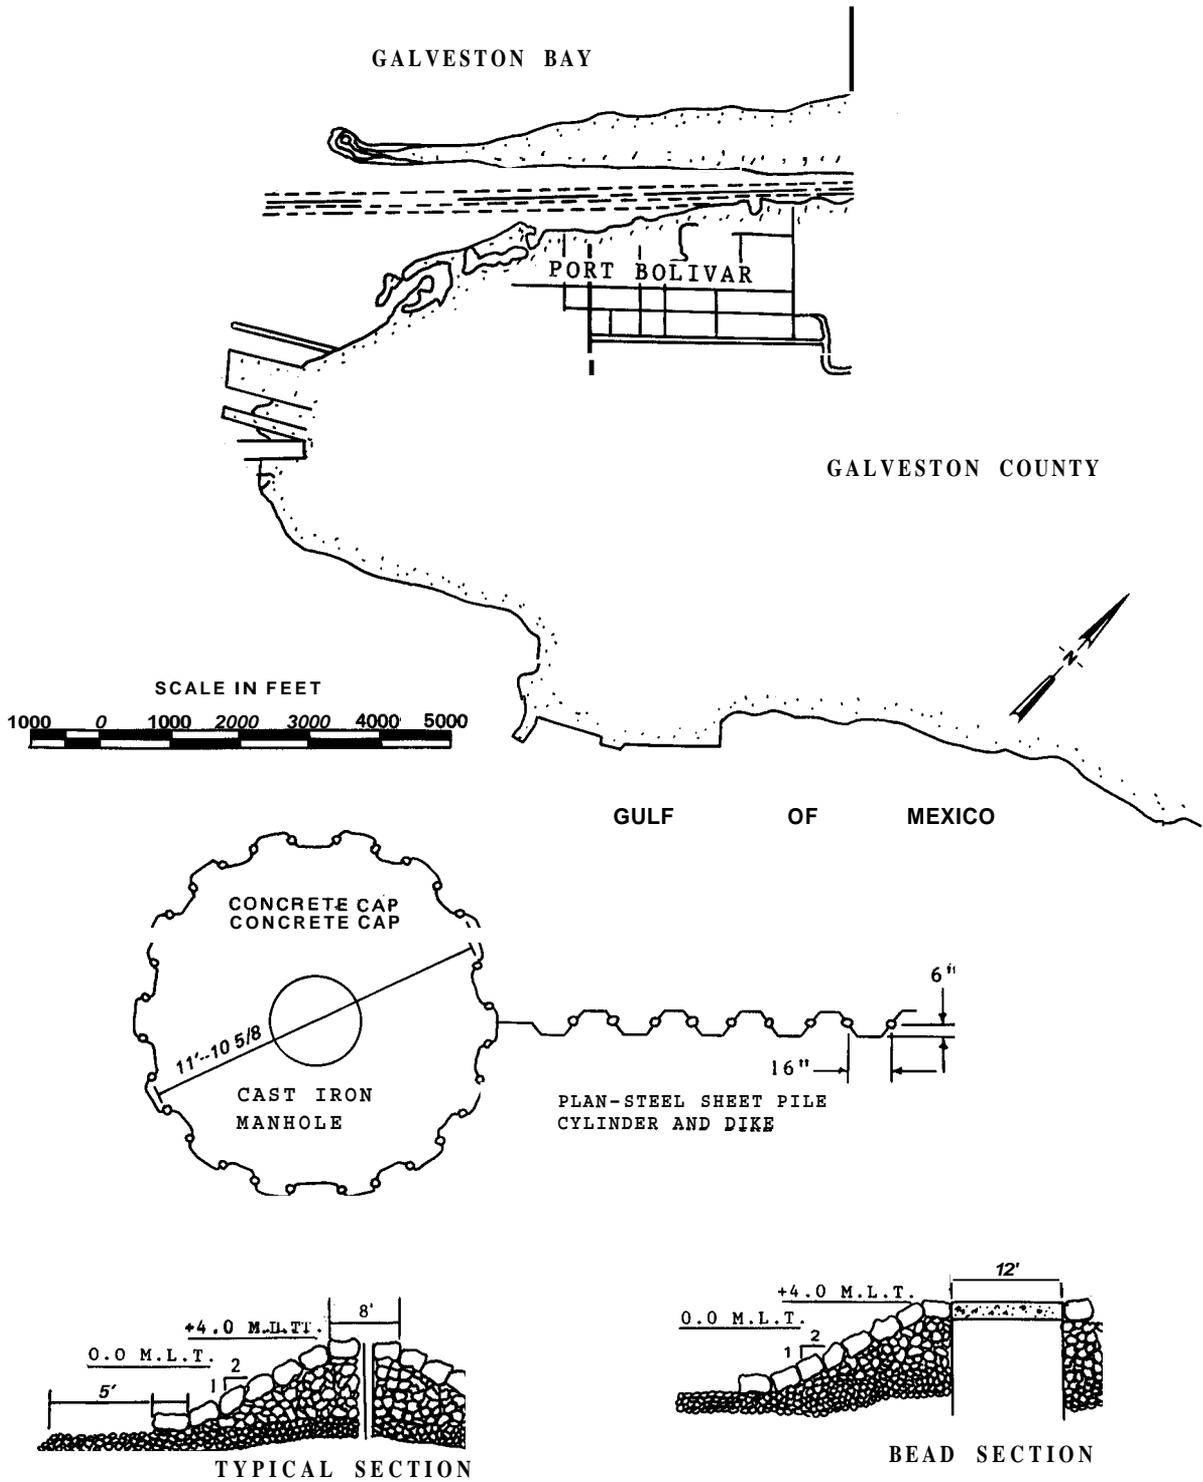
Figure 3. Location, plan view, and typical sections of Port Bolivar jetty

1985	The dike presently is considered to be in good condition.

Date(s) ,	Construction and Rehabilitation History
1933- 1934	A 1,700-ft-long steel sheet-pile dike was constructed to prevent shoaling in the Gulf Intracoastal Waterway at this location (Figure 3). The seaward end of the dike consisted of a 12-ft-diam sheet-pile cell, with a 2-ft-thick concrete cap (and underlying fill material), protected by a stone blanket at the toe of the cell. The top elevation of the sheet pile was +4 ft mlt. Existing water depths varied from -4 (landward) to -13 (seaward) ft mlt. A total of 47,500 sq ft of sheet pile and 6,670 tons of stone was used. Cost of the improvements was \$25,000.
1936- 1937	The landward end of the dike was repaired and extended 200 ft at a cost of \$7,050. Approximately 230 tons of stone was placed as scour protection at the seaward end at a cost of \$1,750.
1966	The outer 1,230 lin ft of sheet pile was supplemented with a rubble-mound section similar to the 1964-1965 Port O'Connor repairs. The dike was generally intact, with some damage to the piling at the outer end and a heavy coating of rust scale due to saltwater exposure. Existing ground elevations varied from -5 ft mlt near the seaward end to +4 ft mlt along the unrepaired landward segment (in general, an accretion of 6 to 8 ft had occurred since original construction). The outer sheet-pile cell, with a maximum water depth of -11 ft mlt, was the only section where localized scour was evident (but in this case not critical to structural integrity). The sheet-pile top elevation was generally from +3.5 to +4 ft mlt (within 0.5 ft of the design elevation). The rubble-mound design sections (Figure 3, inset), with the existing dike at the center line, had a crown elevation varying from +4 (seaward) to +6 (landward) ft mlt, a crown width of approximately 8 ft (2 cover stones wide) and 1V:2H side slopes. The sections were built upon a 2-ft-thick (3 ft at outer end) bedding layer of 0.5-in. to 200-lb stone. The bedding layer extended from 3 ft (landward) to 10 ft (seaward) beyond the toe of the cover layer and was covered with a 2-ft-thick layer of 200- to 1,000-lb apron stone. Similar sized stone were used as core stone, and the outer layer consisted of 1- to 6-ton stone. Filler stone (0.5 to 4 in.) also were placed with the core stone, in a section extending beneath the crown at 1V:1H side slopes. The general purpose of filler stone is to decrease permeability and reduce sediment transport through the structure. The cover stone size was selected based partly on Hudson's slope stability equation and partly for economic reasons. A total of 19,280 tons of stone was placed at a cost of \$164,700.

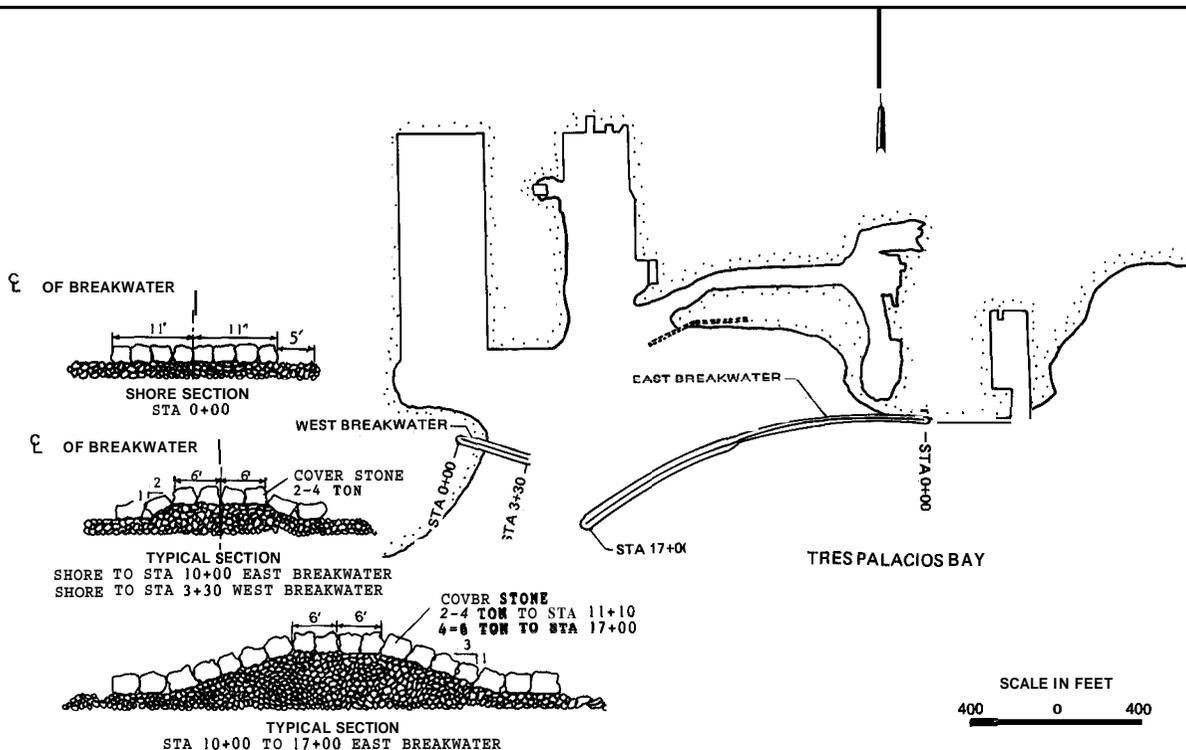
Figure 8. Plan view of Palacios Harbor and typical breakwater cross sections

1970	The shoreline, made up of clay banks, was eroding in the general vicinity of the west breakwater. Rubble stone was placed along the shoreline on either side of the breakwater. (No details are available.)
1983	The breakwaters were inspected and considered to be in good condition.

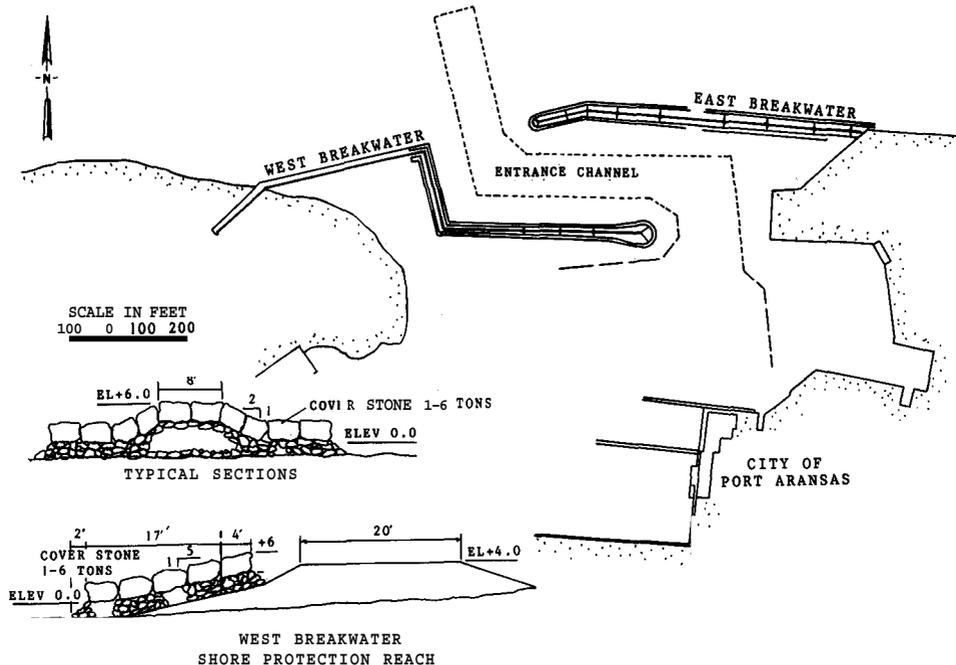
Figure 12. Port Aransas plan view and typical breakwater sections

1977	An inspection of the breakwaters indicated they were in good condition with the exception of the revetted section of the west jetty. Waves breaking over the shore protection had eroded the sand fill resulting in some minor settlement of the stone.
1984	The breakwaters were inspected and considered to be in good condition.
