Technical Report HL-93-7
August 1993

Scour Protection for Dam No. 2, Arkansas River, Arkansas

Hydraulic Model Investigation

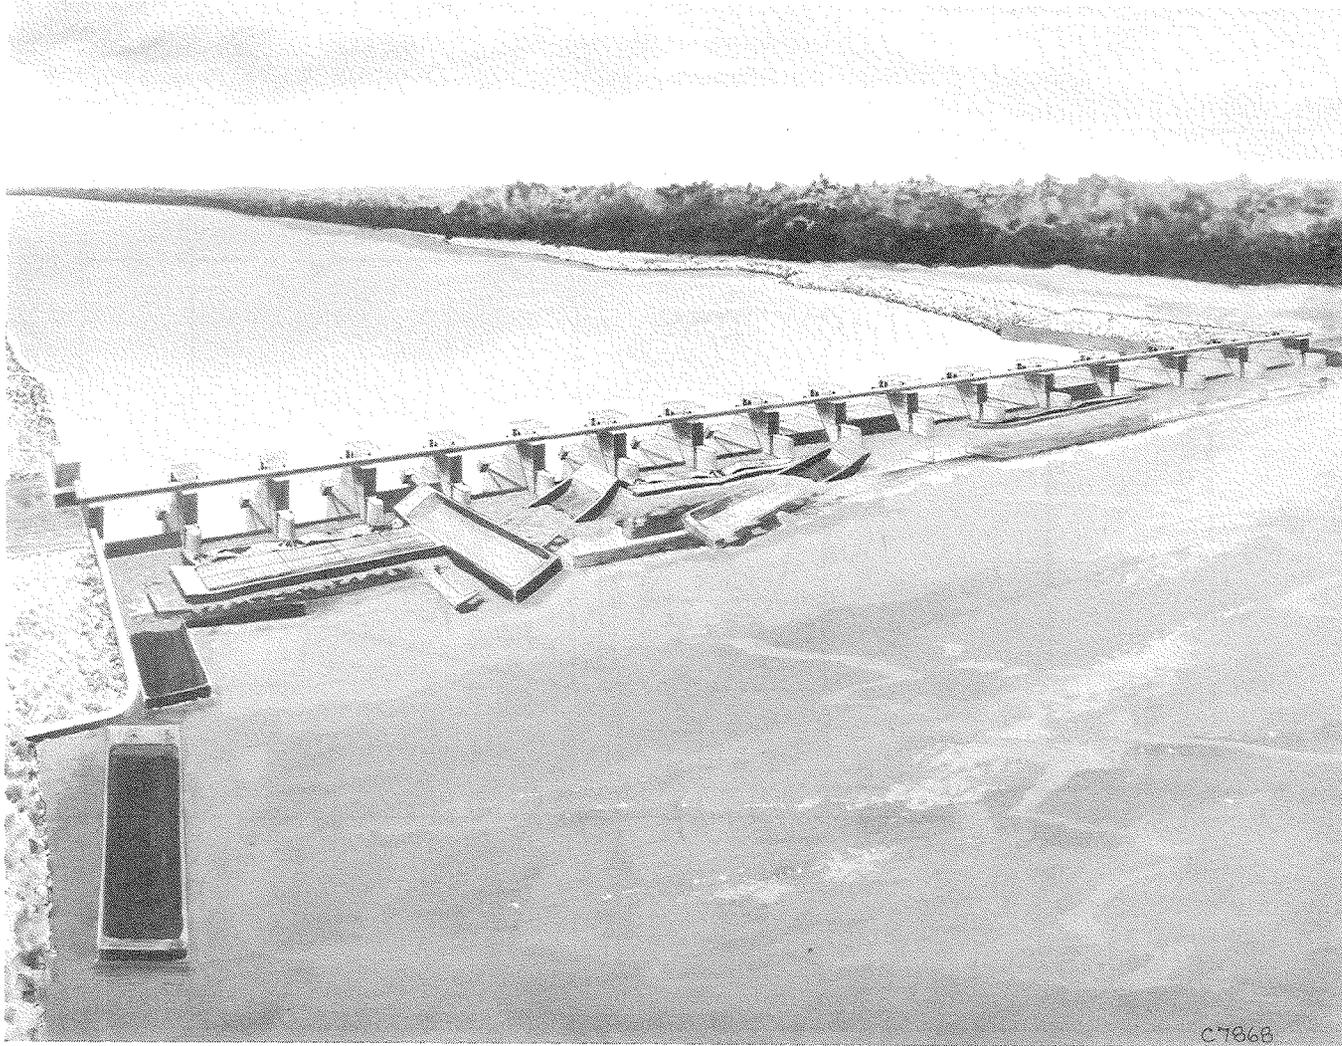
In December 1982, 38 barges broke loose from their moorings upstream of Dam No. 2. Sixteen barges drifted into the dam and ten barges subsequently sank against the spillway. Twelve of the sixteen gates were either partially or completely blocked as depicted in Figure 3. The discharge during this time varied from about 258,000 cfs to about 35,000 cfs. The maximum discharge through the open gates was estimated to be 39,400 cfs per gate, and because of the blockage, the upper pool was about 7 ft higher than for normal operation. The sunken barges, in addition to blocking flow, caused extreme turbulence and velocities both upstream and downstream from the dam. Extensive damage to the scour protection was caused by this extreme turbulence. The upstream scour protection stone and the concrete scour slab were destroyed from pier 3 to pier 10, a distance of about 480 ft. The stone protection downstream from the stilling basin was extensively damaged or completely destroyed in bay 7 and between piers 9 and 15. The remainder of the downstream stone protection received slight to moderate damage. The gates and the concrete portions of the structure also were damaged. Repairs were completed in July 1983 to ensure safe normal operating conditions at the project.

Figure 3. Artist's conception of barge accident

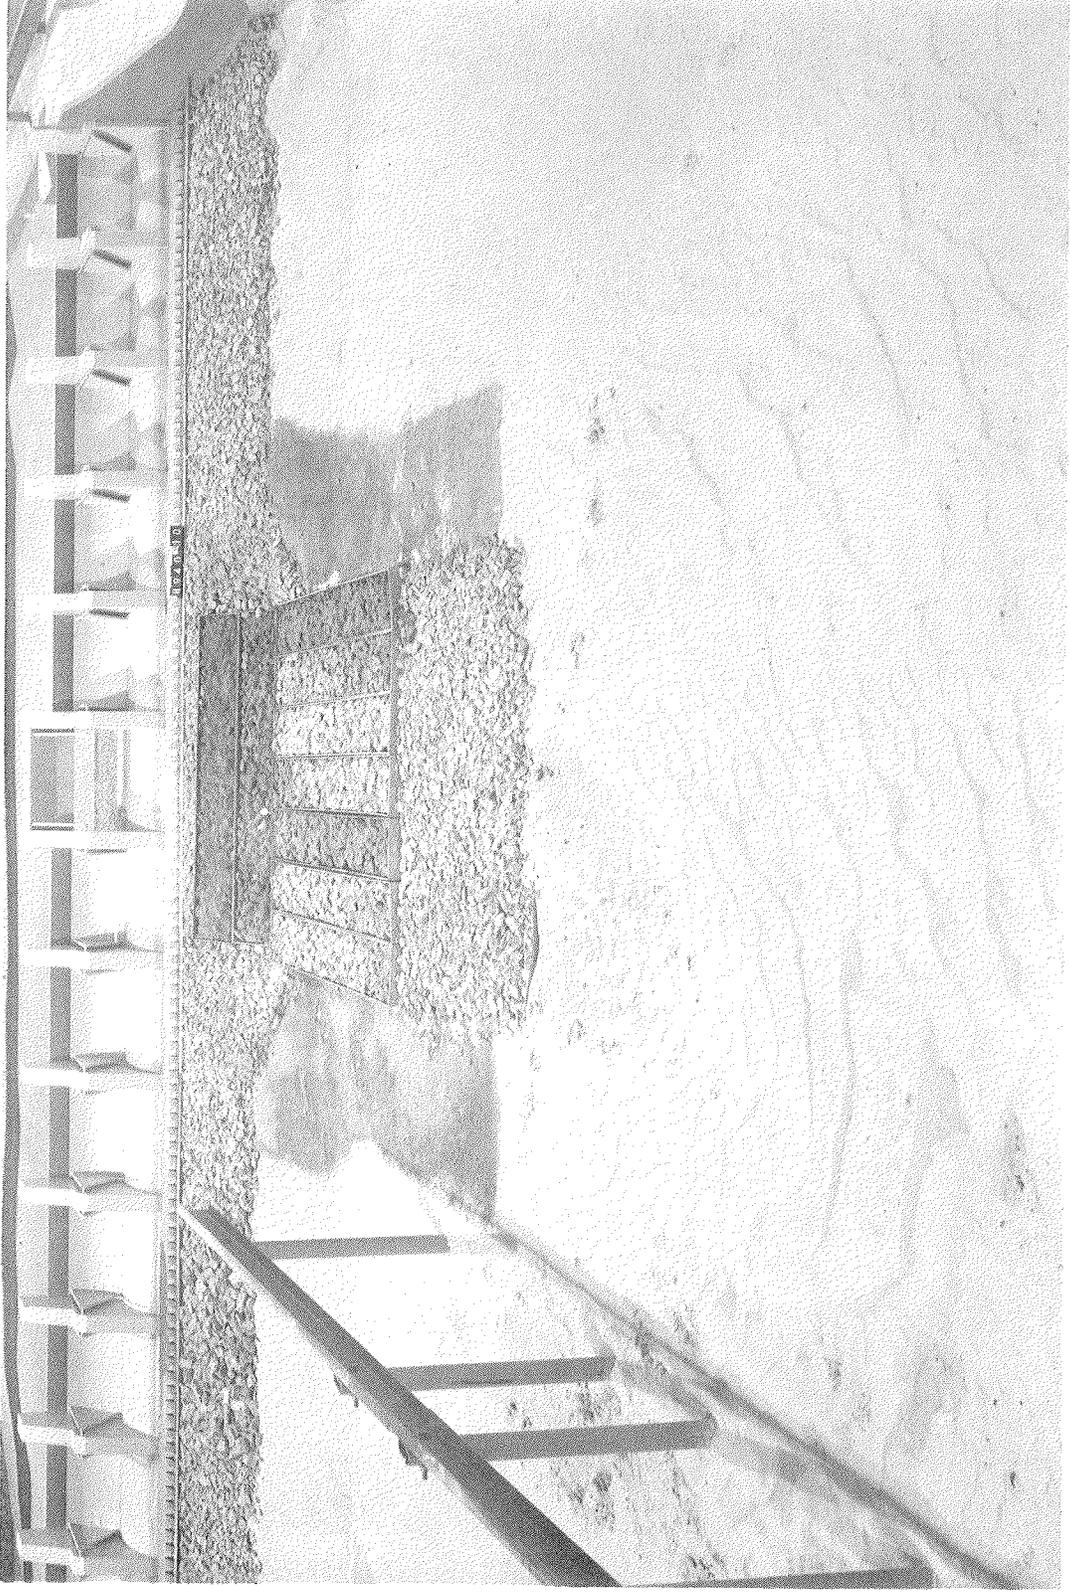
Photo 6. Type 3 scour protection design

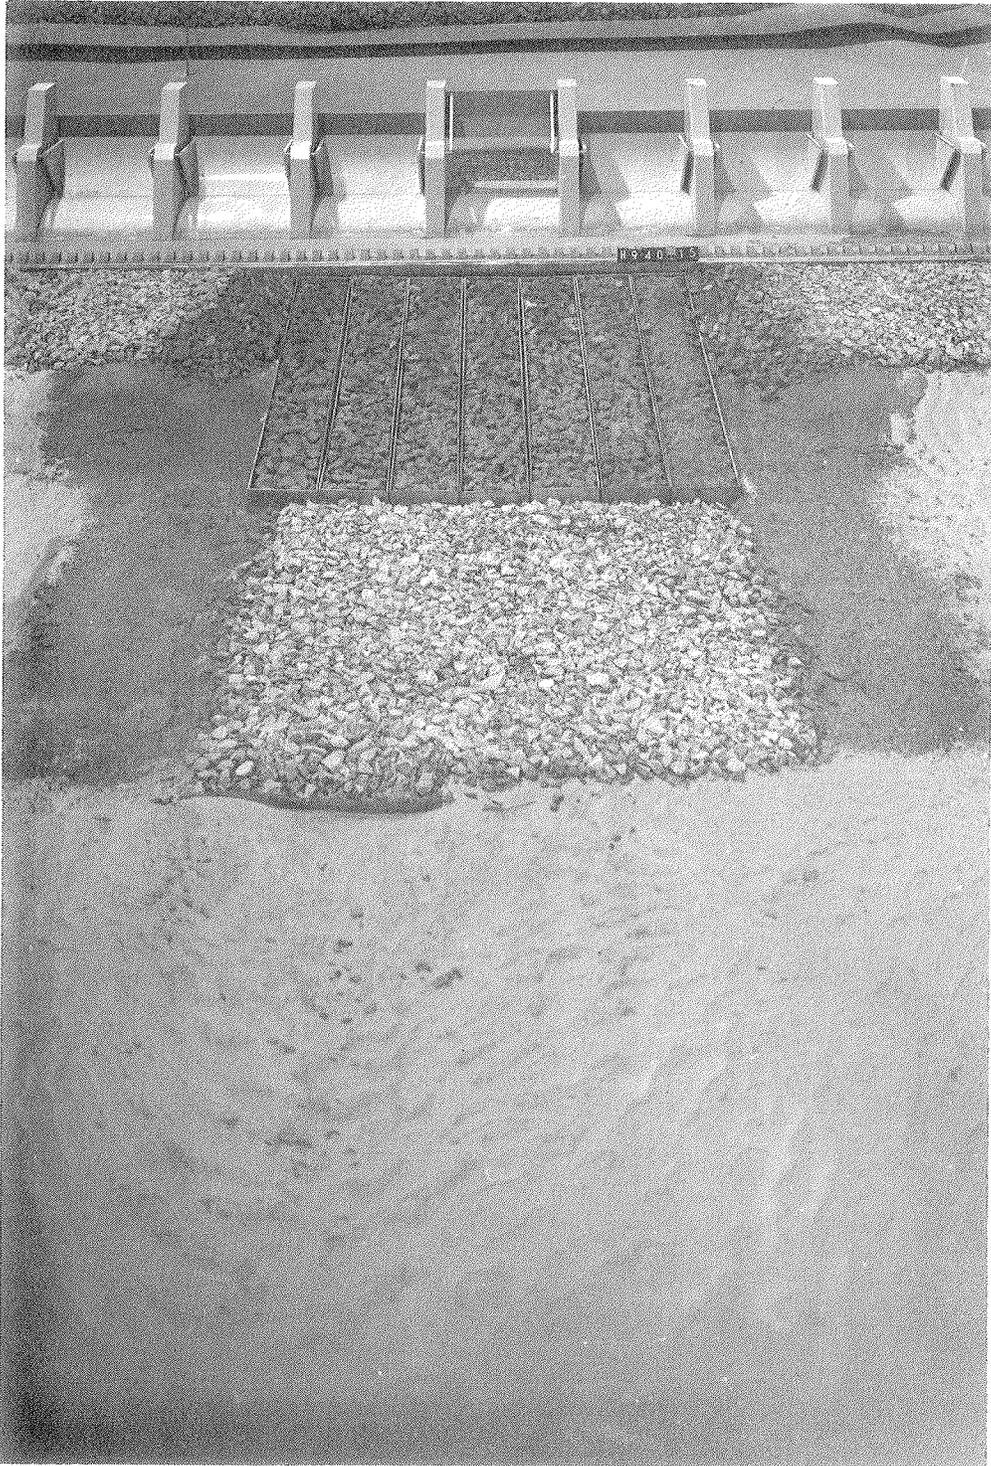
Photo 7. Type 4 scour protection design

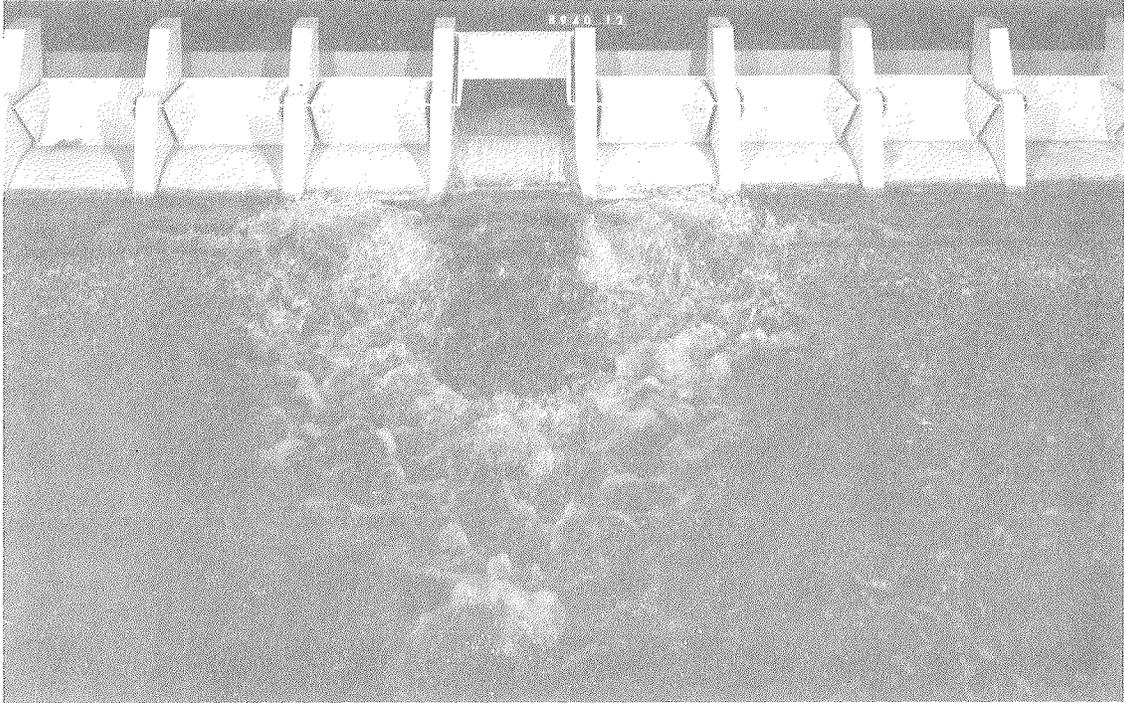
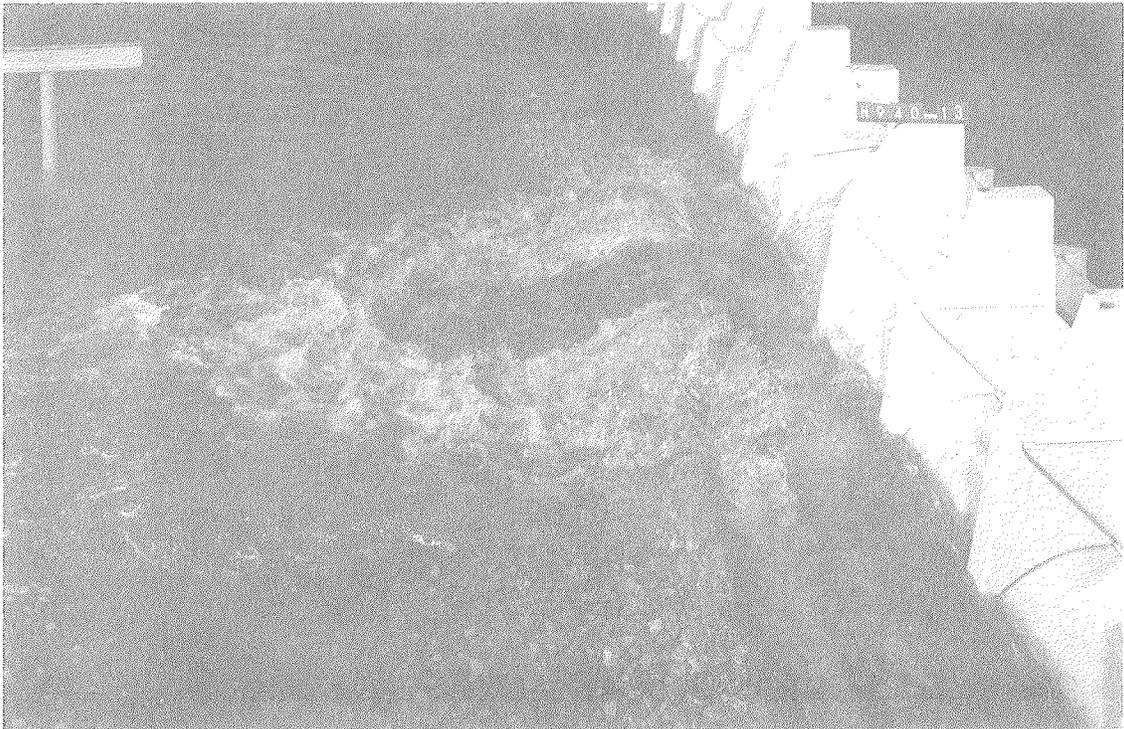
Photo 8. Flow conditions with type 4 scour protection design, normal upper pool, gate 6 fully open, tailwater el 118

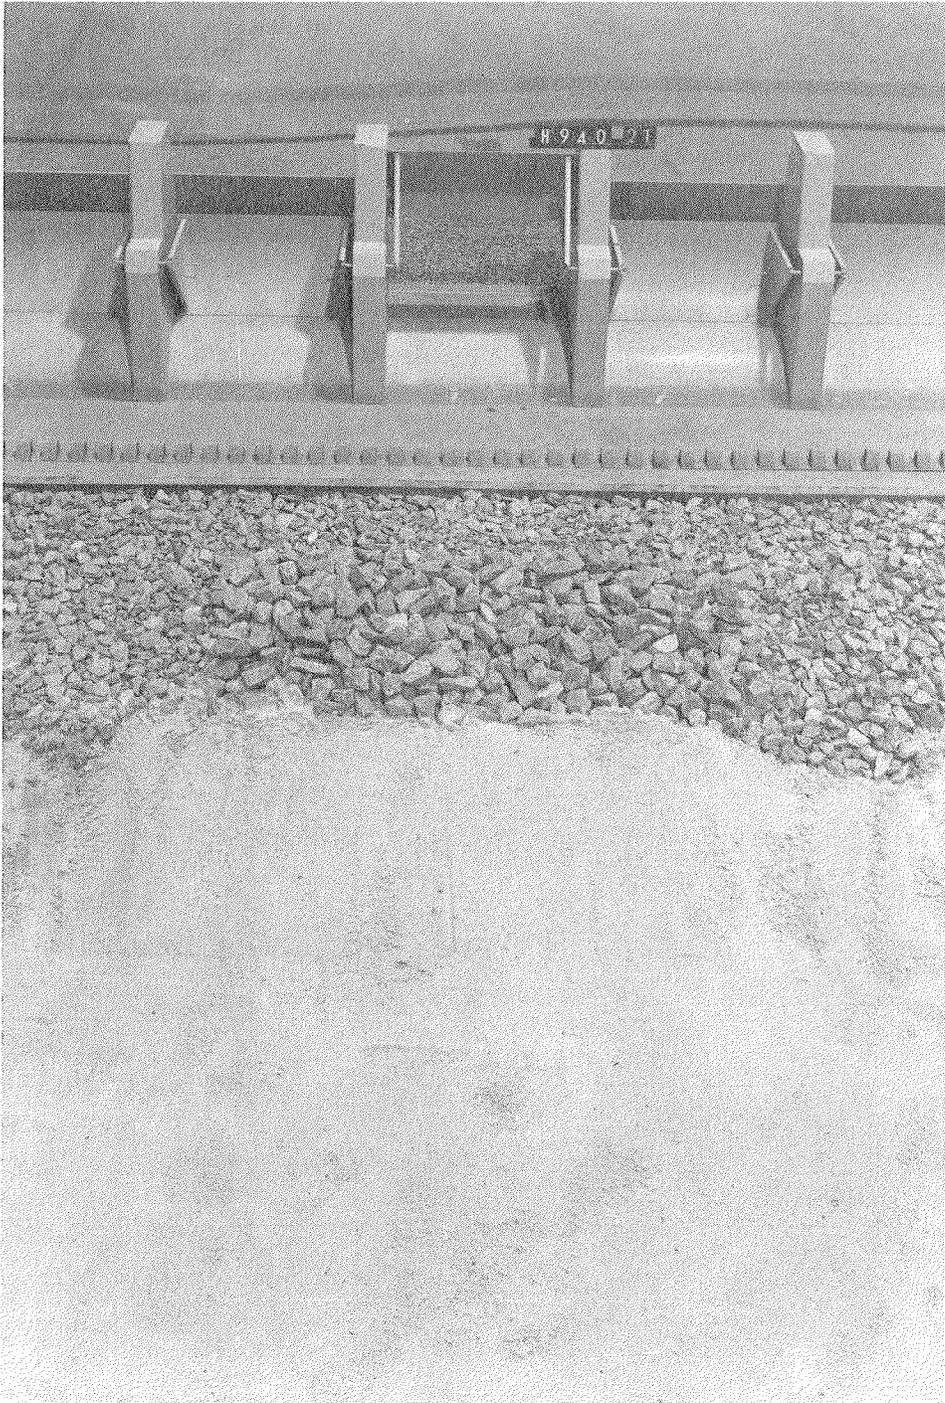
Photo 9. Type 5 scour protection design

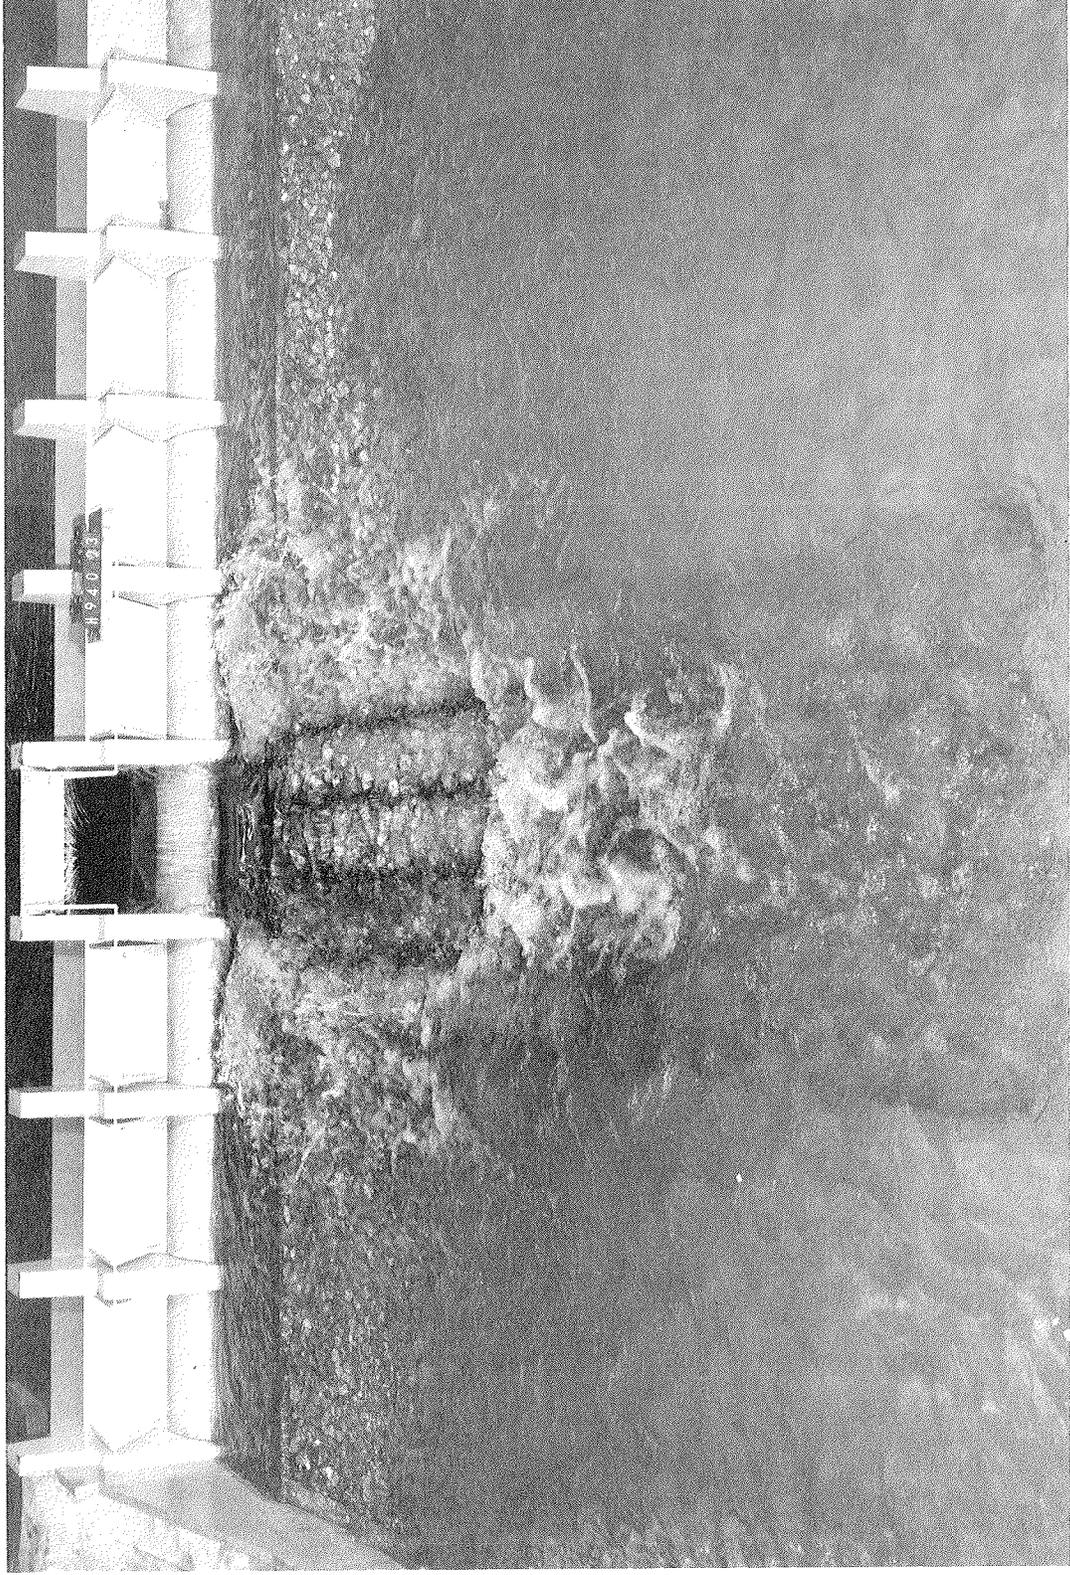
Photo 11. Flow conditions with the type 7 scour protection design, normal upper pool, one gate fully open, tailwater el 112.9

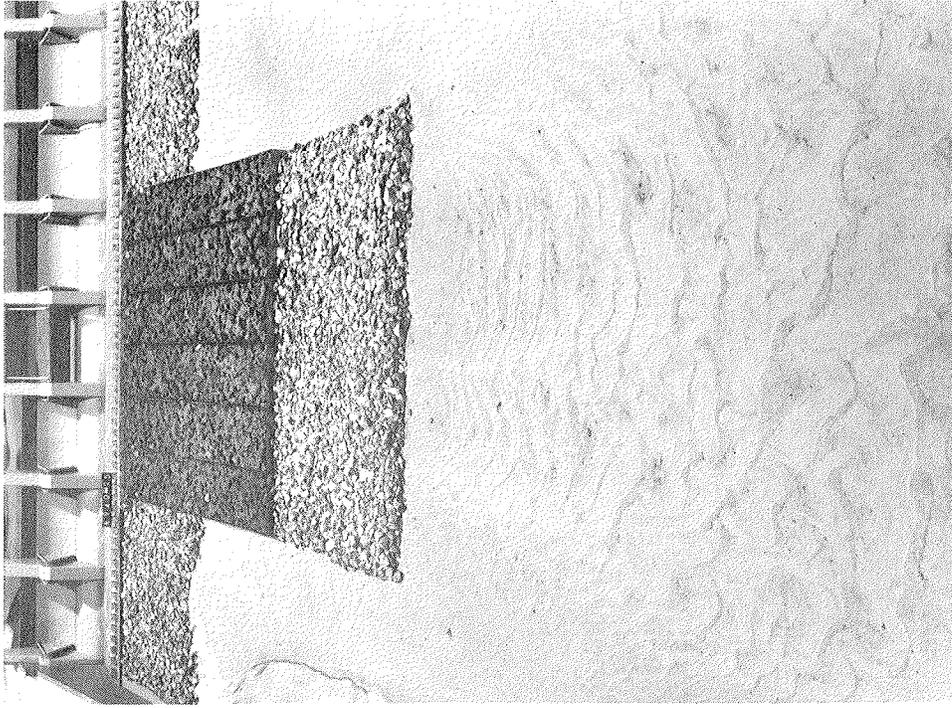
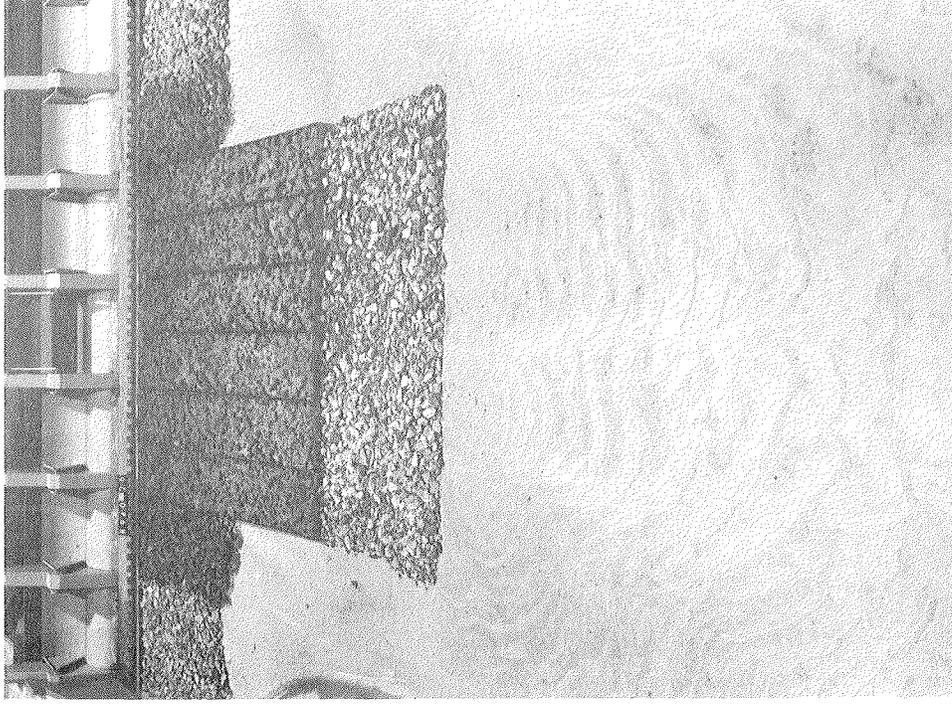
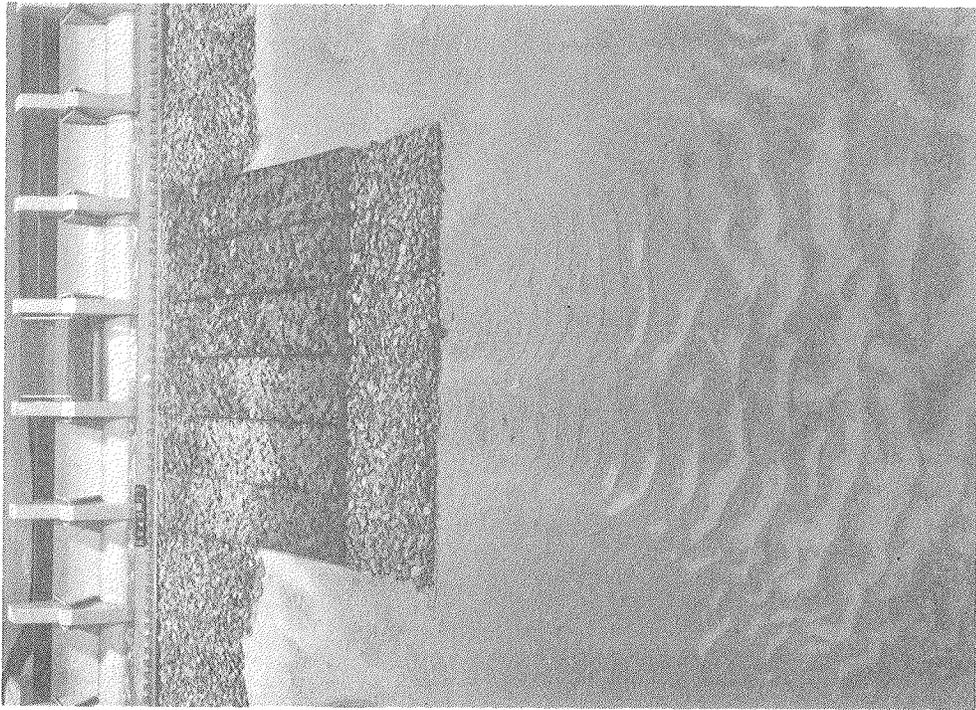
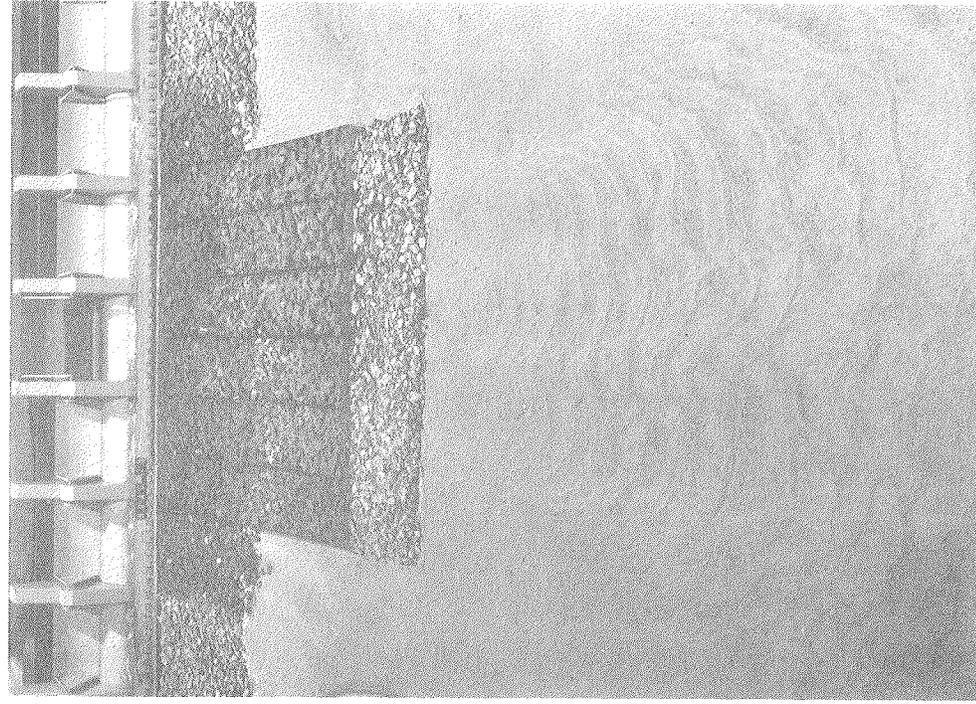
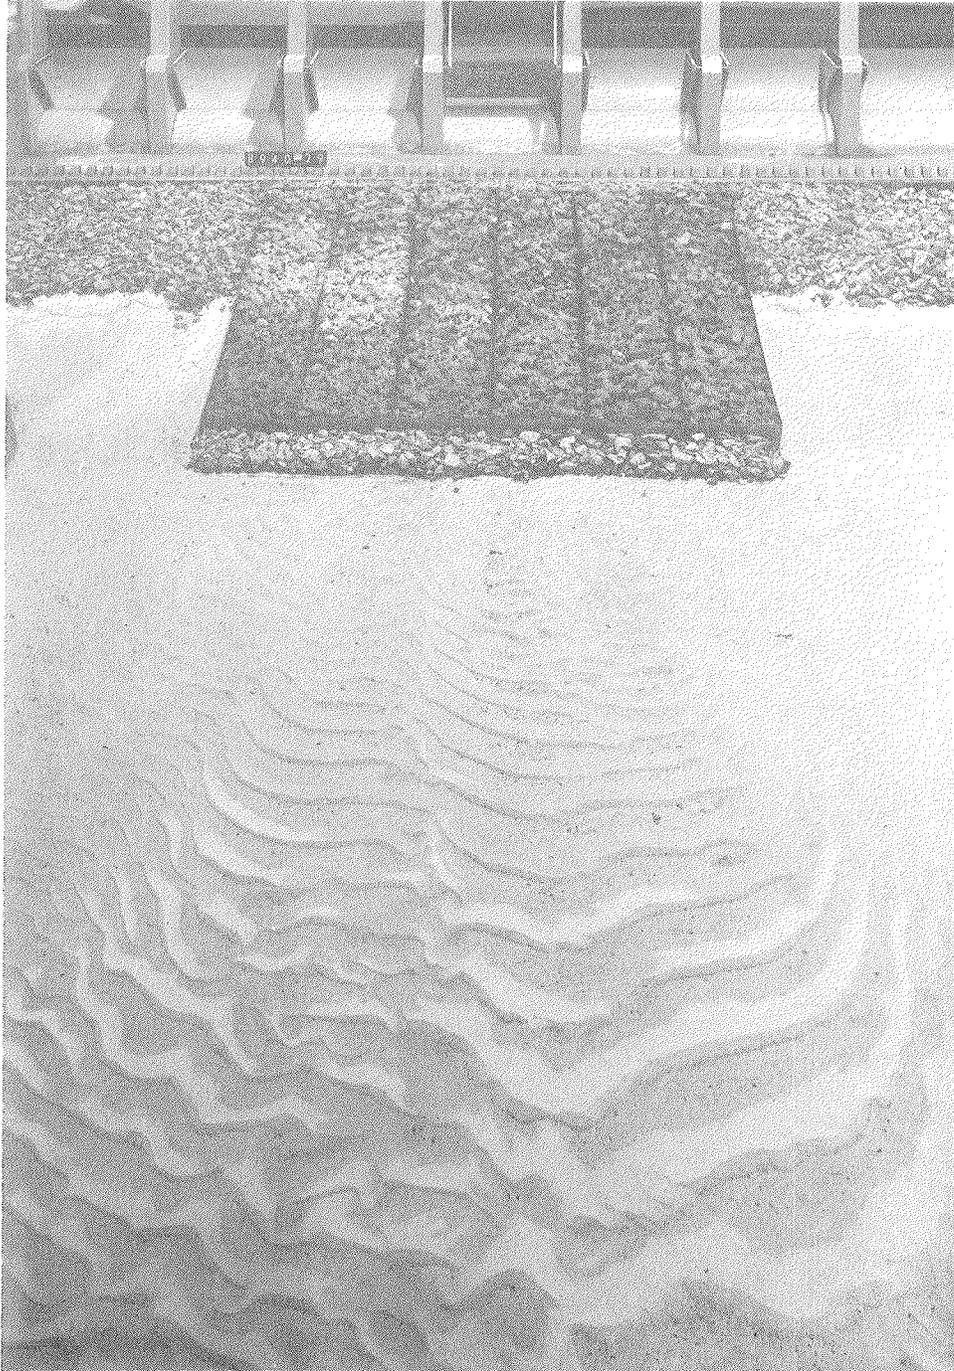
a. Blanket length 130 ft

b. Blanket length 100 ft

Photo 12. Scour in exit channel after operations with normal upper pool, one gate fully open, and tailwater 113, for various lengths of Riprap No. 7 placed downstream of barges (Sheet 1 of 3)

c. Blanket length 70 ft

d. Blanket length 50 ft

e. Blanket length 25 ft

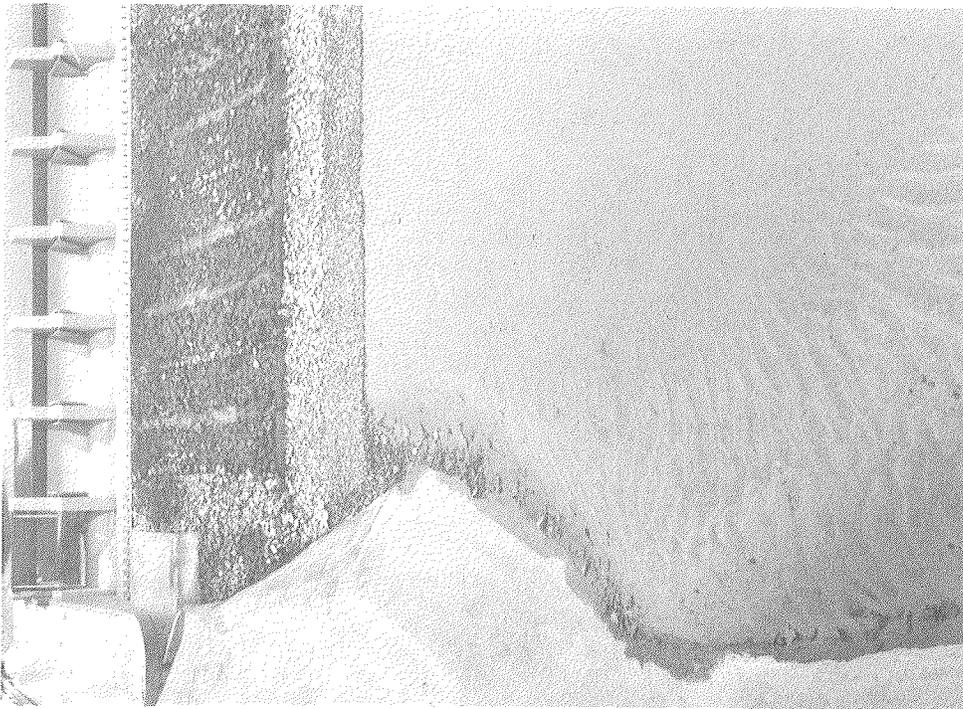
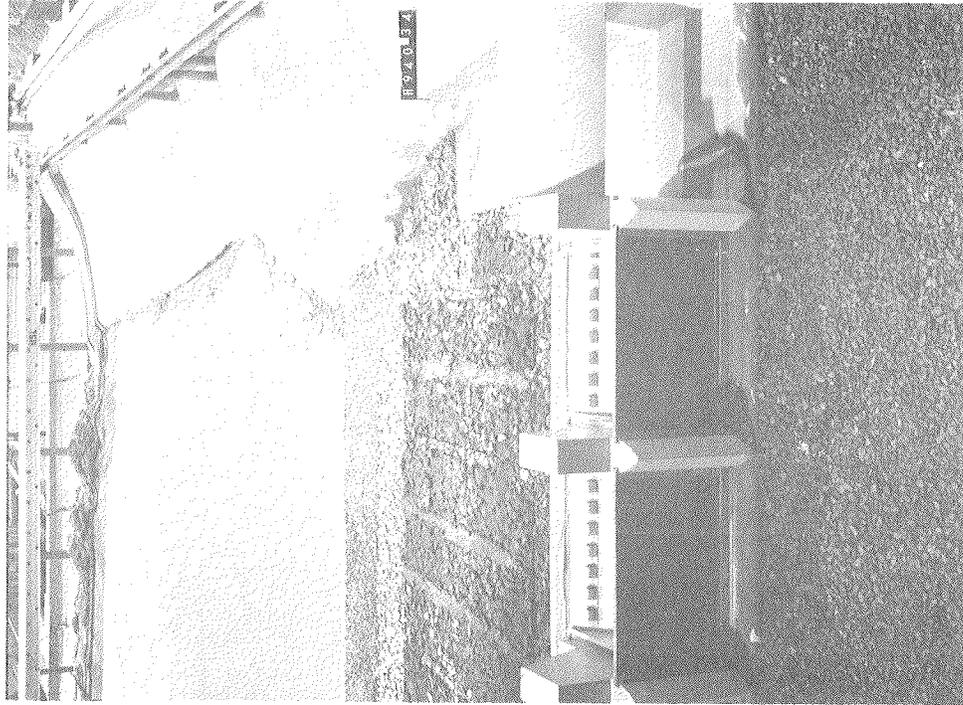
Photo 14. Type 9 scour protection design after 8 hr (prototype) of operation with gate 16 opened fully to the normal pool and tailwater
el 113

The type 9 scour protection design shown in Plate 9 provided adequate protection for single gate operations with minimum tailwater. The design consisted of a 15-ft length of riprap to be placed at the same elevation as the existing end sill and then grouted to form a large mass. Following the grouted riprap were barges 190 ft long by 35 ft wide by 12 ft deep placed on a 1V on 6H downward slope. The barges were filled with riprap and also grouted to form a large and solid mass. The large mass of revetment was necessary to withstand the forces caused by the hydraulic jump. A 50-ft length of Riprap No. 7 offset 4.5 ft below the top of the downstream end of the barge was placed downstream from the barge, followed by a 50-ft length of Riprap No. 8. This smaller size riprap helped to reduce the severity of the localized disturbances at the end of the blanket of Riprap No. 7 and transition the flow to the natural river bottom.

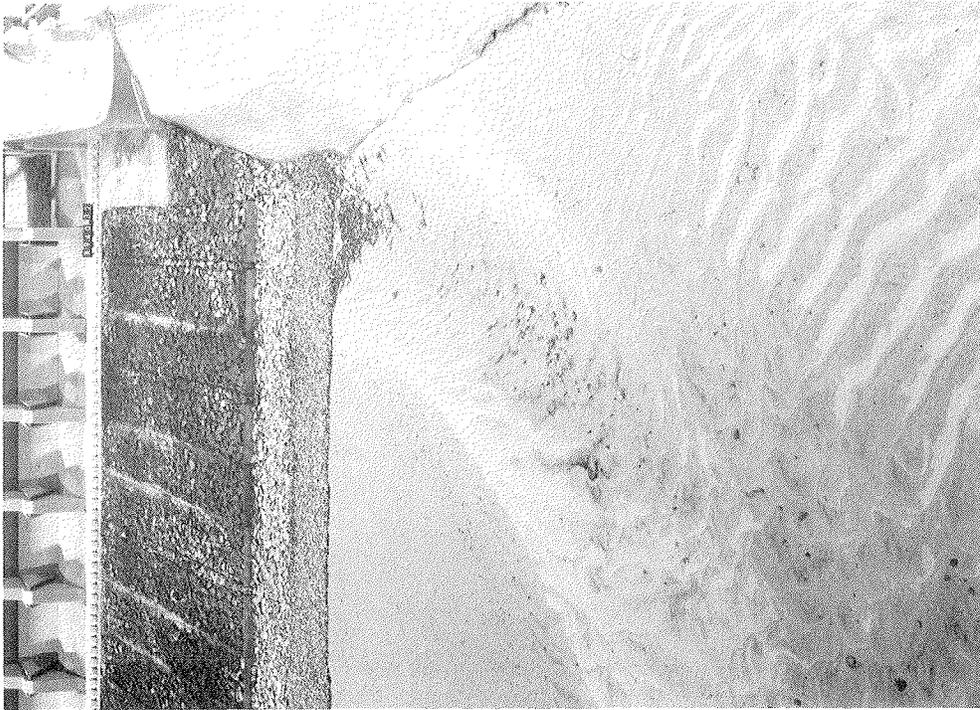
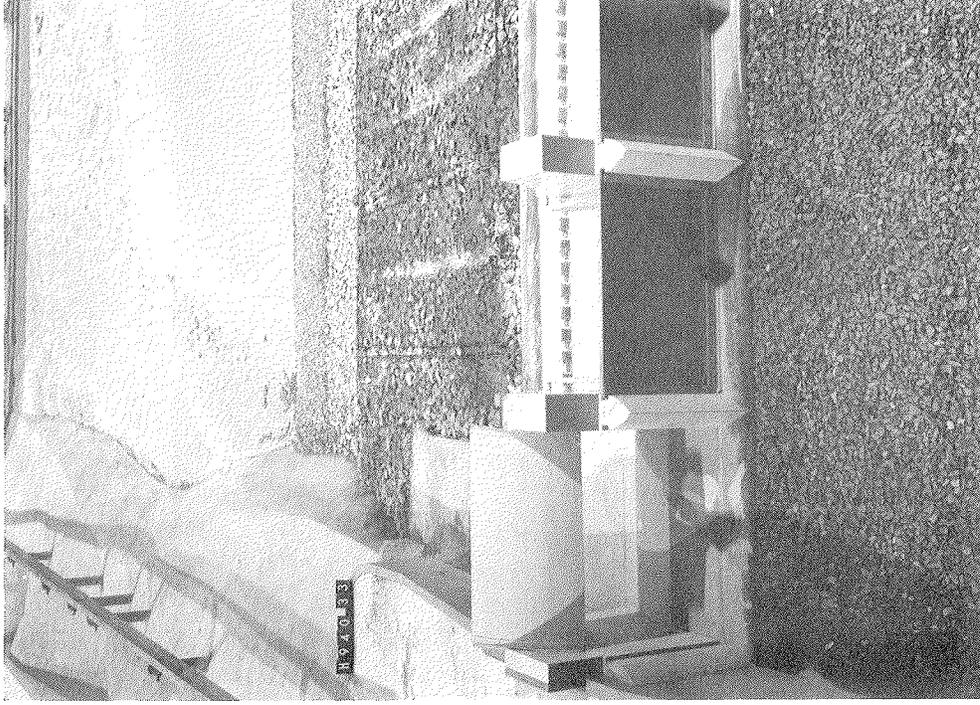
Photo 15. Type 9 scour protection design after 4 hr (prototype) of operation with gate 1 opened fully to the normal upper pool and tailwater el 113

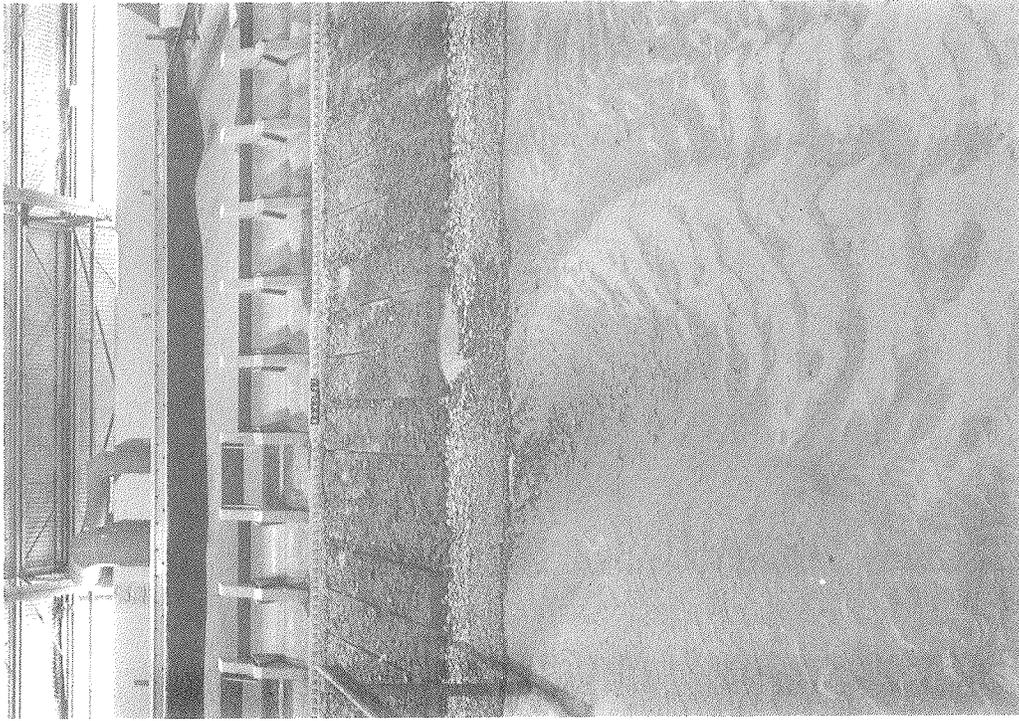
Photo 20. Results from operations with gate 7 opened fully to the normal pool and tailwater el 135. Note stability of Riprap No. 8

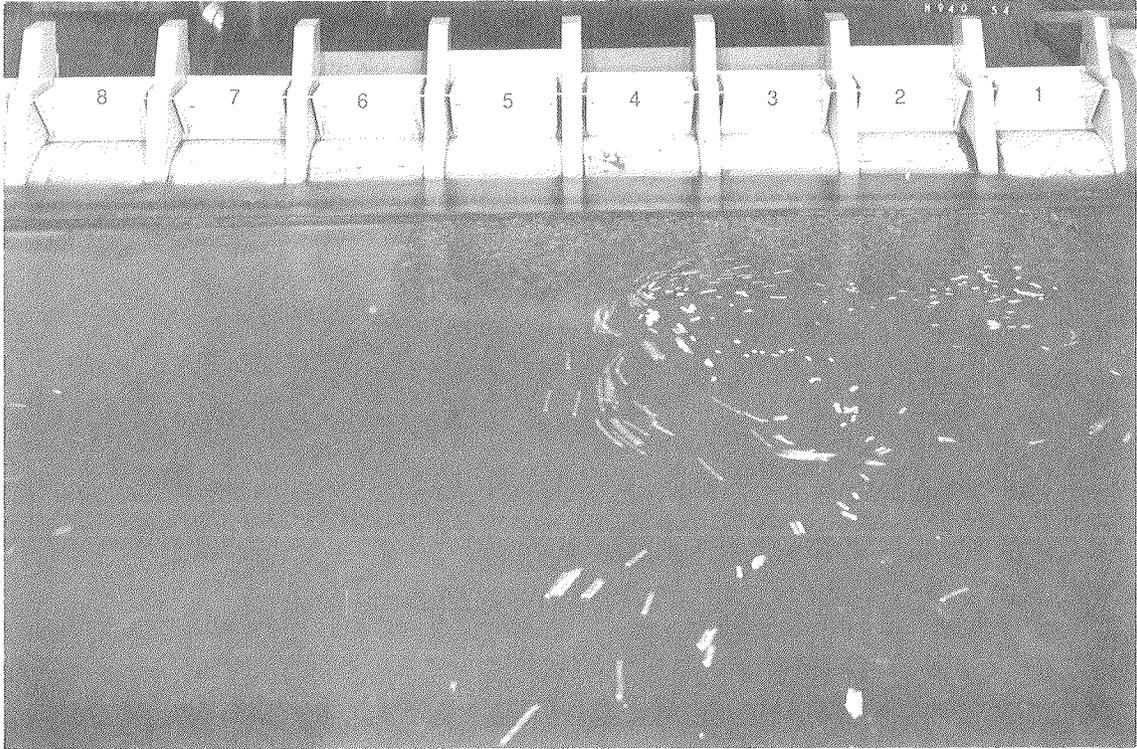
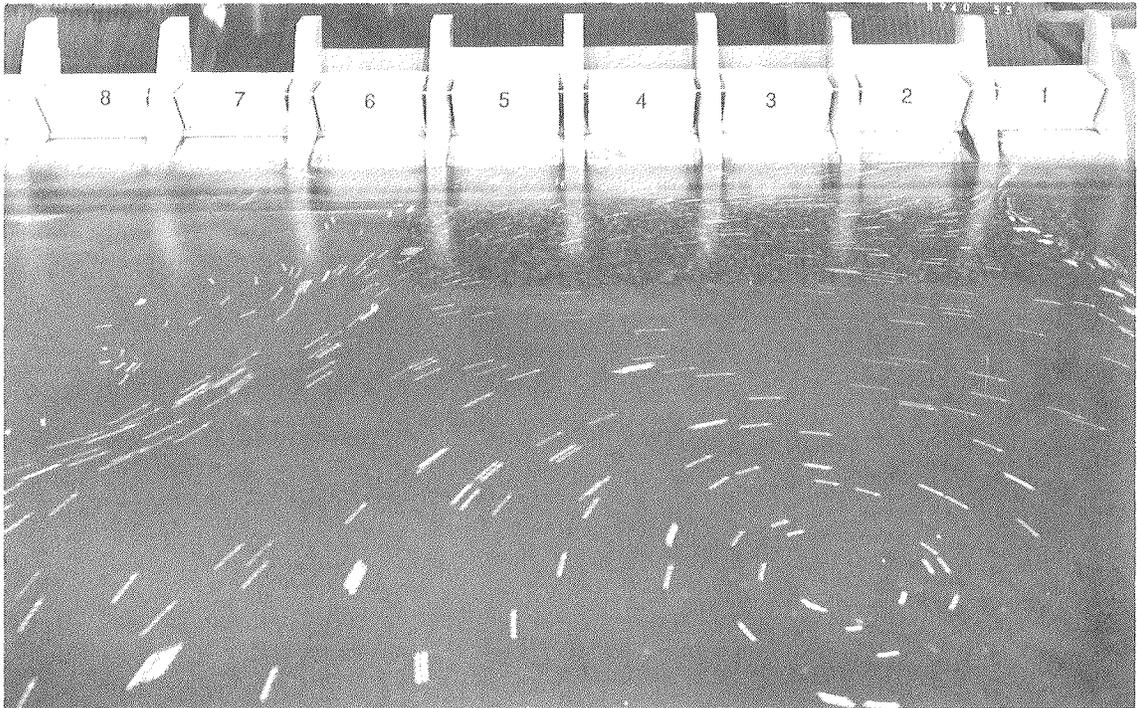
Photo 23 shows flow conditions with gates 1-4 closed for a discharge of 50,000 cfs and pool el 162. These conditions would exist when barges are being placed in the vicinity of gate 2. No adverse flow conditions were observed, flow circulation was minimal, and velocities were less than 3.5 fps. Photos 24 and 25 show flow conditions for a discharge of 15,000 cfs with gates 2-6 and 1-4 closed, respectively. A larger flow circulation pattern was observed with the higher tailwater, but no harmful conditions were observed.

Photo 24. Flow conditions with gates 2-6 closed, a discharge of 15,000 cfs, and pool el 162

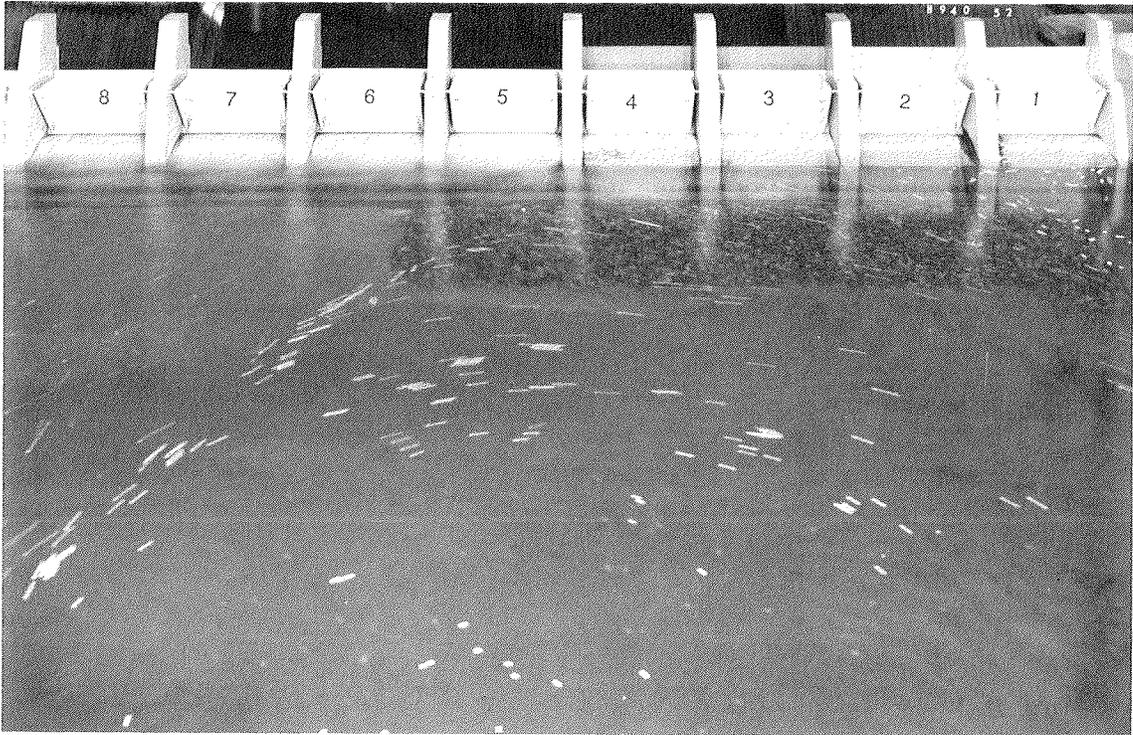
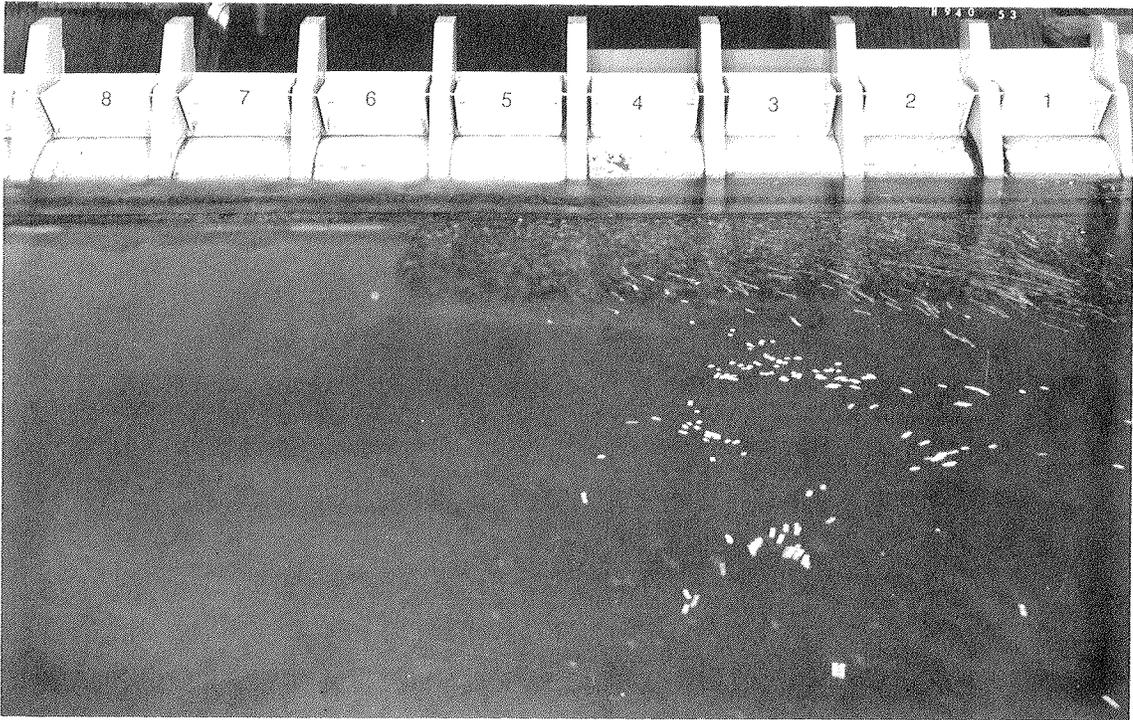
Photo 25. Flow conditions with gates 1-4 closed, discharge of 15,000 cfs, and pool el 162

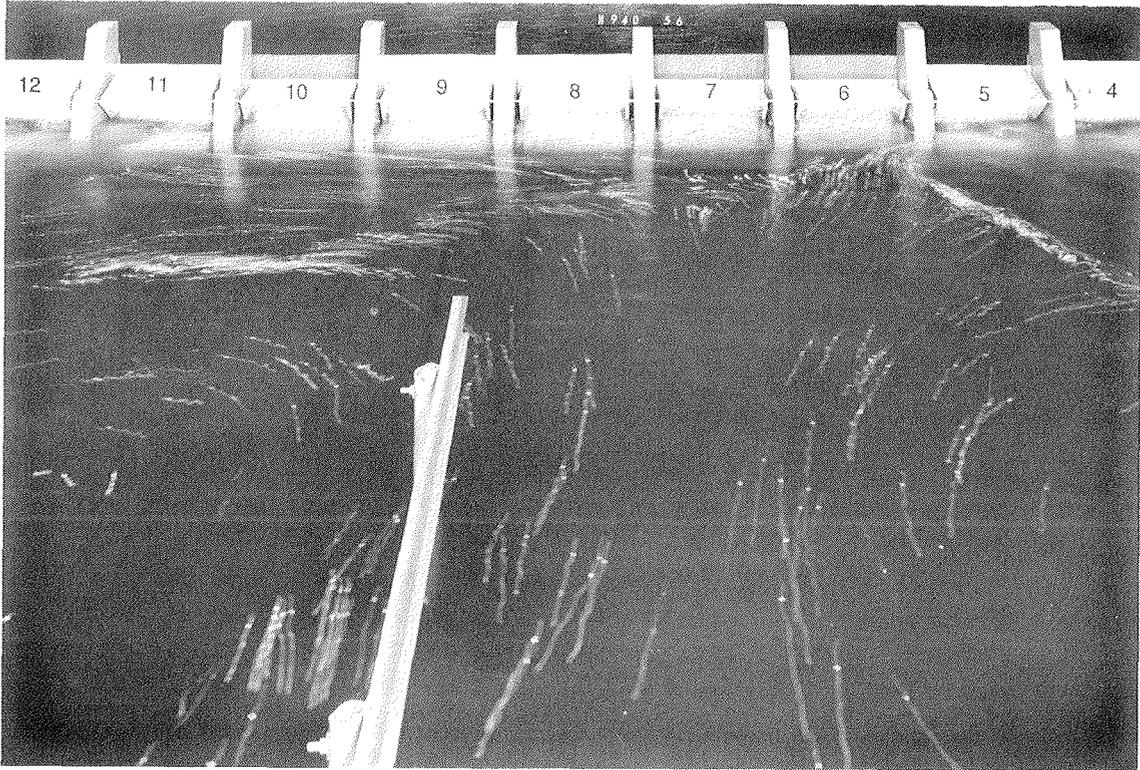
Photo 26. Flow conditions with gates 6-10 closed, discharge of 112,600 cfs, pool el 164, and tailwater el 150

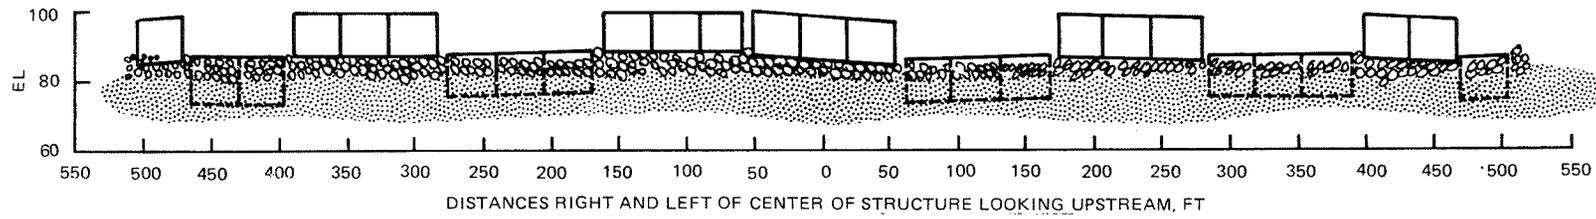
BARGE PLACEMENT IN TYPE 9 SCOUR PROTECTION PLAN

SECTION B-B
