Technical Report HL-93-7
August 1993

Scour Protection for Dam No. 2, Arkansas River, Arkansas

Hydraulic Model Investigation

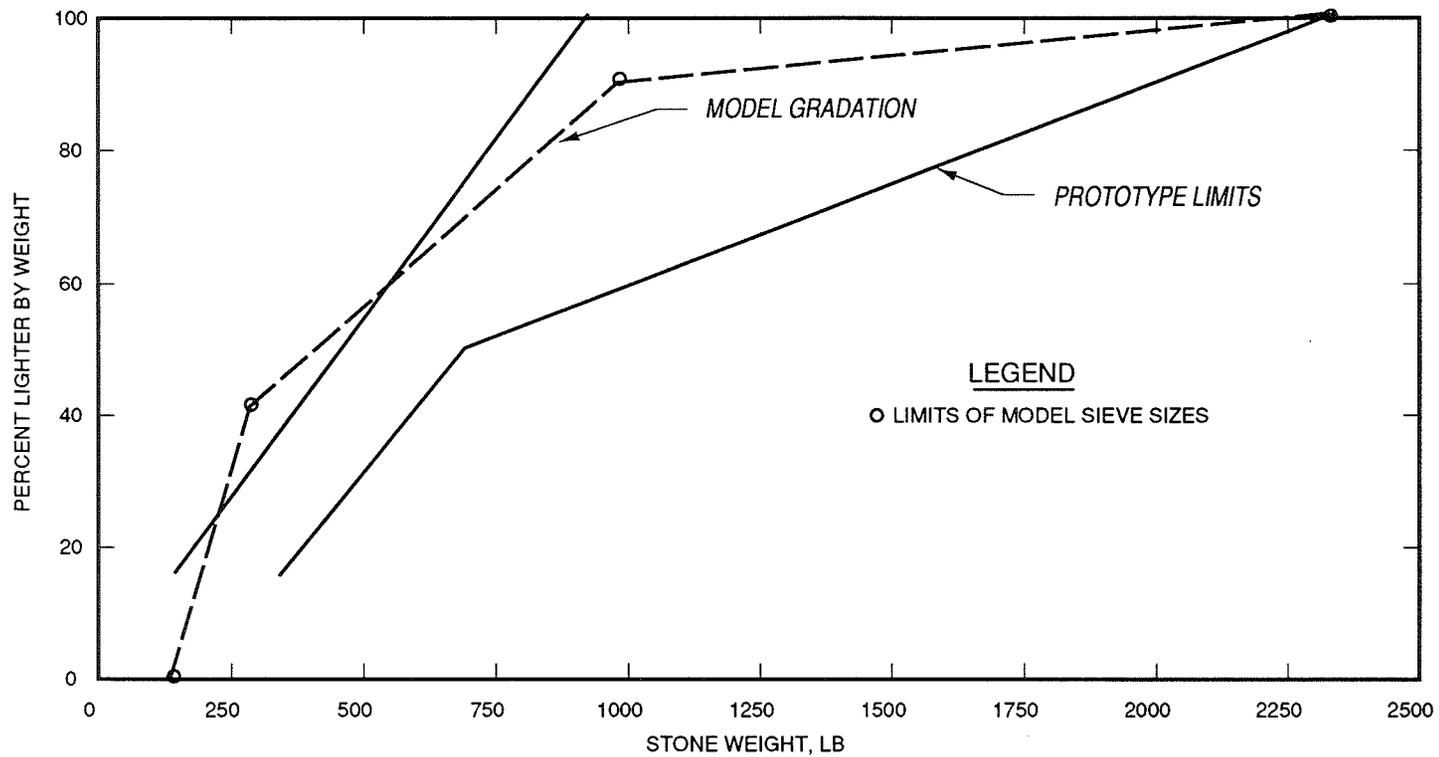
STAGGERED PLACEMENT OF BARGES WITH
TYPE 9 SCOUR PROTECTION DESIGN

NOTE: VIEW IS LOOKING UPSTREAM AT DOWNSTREAM END OF BARGE

RIPRAP NO.9 GRADATION
BLANKET THICKNESS=54IN.

$D_{50(MAX)} = 24$ IN.
