*General Investigation Research and Development Program*

## **Flood-Fighting Structures Demonstration and Evaluation Program: Laboratory and Field Testing in Vicksburg, Mississippi**

July 2007

Final report

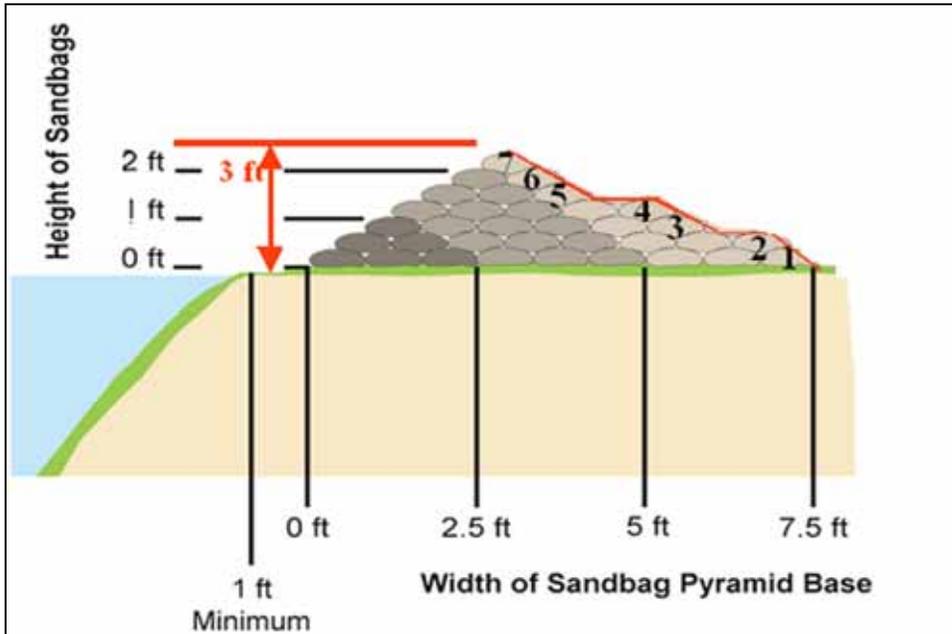
Figure 2-18. 2002 levee, as-built

The 2002 sandbag levee was built without any instruction or supervision from a person with field experience. The as-built structure is shown in Figure 2-18.

The sandbags were placed too high upon the preceding sandbags and did not lie flat on the concrete floor like those in Figure 2-17. This made each layer higher than it was supposed to be.

The structure did not appear as the Seattle District's design because of the stacking problem, and it also had a void between each connecting bag. The resulting voids caused the pretest sandbag levee to seep excessively (7 gal/ft of levee at a water elevation of 95 percent times the height of the structure). A safety analysis of the as-built structure was performed with the following results. For the sandbag levee with water at 3-ft elevation on the poolside, the factor of safety against sliding was calculated to be 1.75 (friction factor of 0.45), and the factor of safety against overturning was calculated to be 2.49.

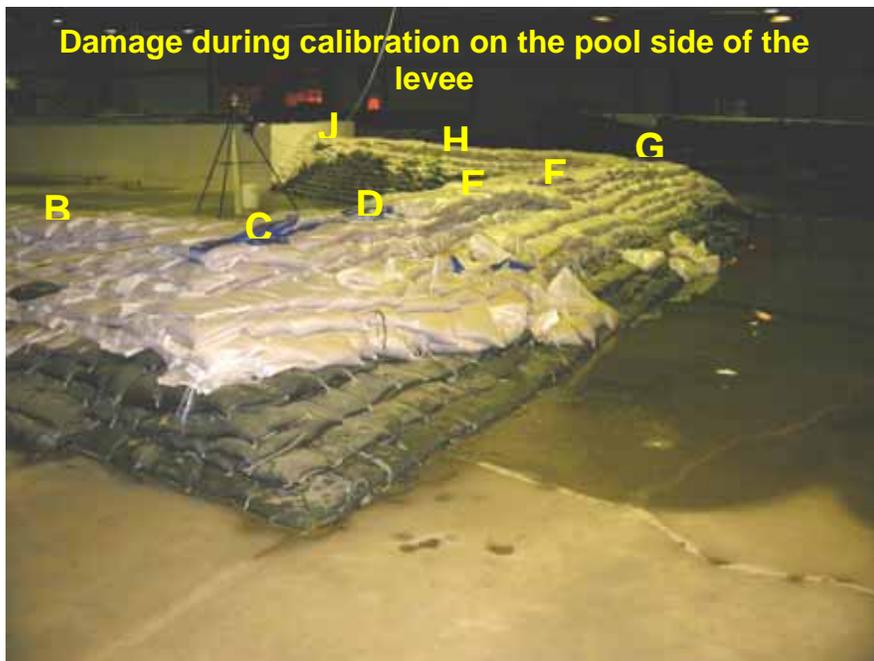
Figure 2-27. Damage done during calibration of wave machine

coloring the water red from the fines leaching out of the sand. During the calibration of the 7-in. waves, more discoloration of the water was noticed. Sandbags were washed away from the side and the top of the center of the structure. Figure 2-27 shows that sandbags moved between point c and point g. The structure was rebuilt and the top of the levee was leveled. Because this happened in calibration of the wave machine prior to the actual testing, it is called a rebuild. This calibration was for all products to follow and was not part of normal testing. Total rebuild time was 11 hr with four people or 44 man-hours. The levee after the rebuild is shown in Figure 2-28.

Figures 2-27 and 2-28 and accompanying text show and explain the failure that required rebuild. A four-man crew took 11 hr (total 44 man-hours) to repair the damage. The rebuild was required from calibration needed to establish the limiting wave forces for all future tests. For this reason, the rebuild is not considered part of the test repairs.

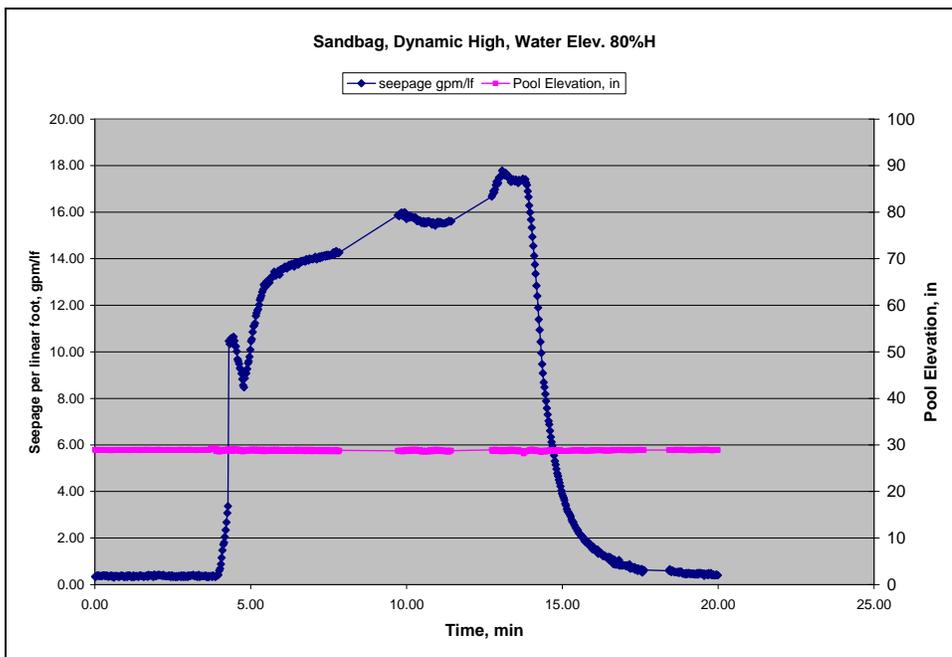
Figure 2-34. Seepage with dynamic testing at 80 percent levee height and 10- to 13-in. waves

**10- to 13-in. wave test, reservoir level at 80 percent levee height.** The water level in the reservoir on the pool side of the sandbag levee was held at a height 28.8 in., and wave heights were generated in packets of 10 to 13 in. for a period of 10 min.

Flow rate significantly increased from 0.37 to 17.52 gpm/ft due to overtopping of each wave front. No displacement was observed. Figure 2-34 shows extensive damage

occurred during this test requiring Repair 2. Repair 2 is discussed in the maintenance section of this chapter.

Repair 2 was needed after testing with the pool at 80 percent of levee height and 10- to 13-in. waves. A four-man crew took 30 min (total time 2 man-hours) to remove damaged sandbags and repair the barrier.

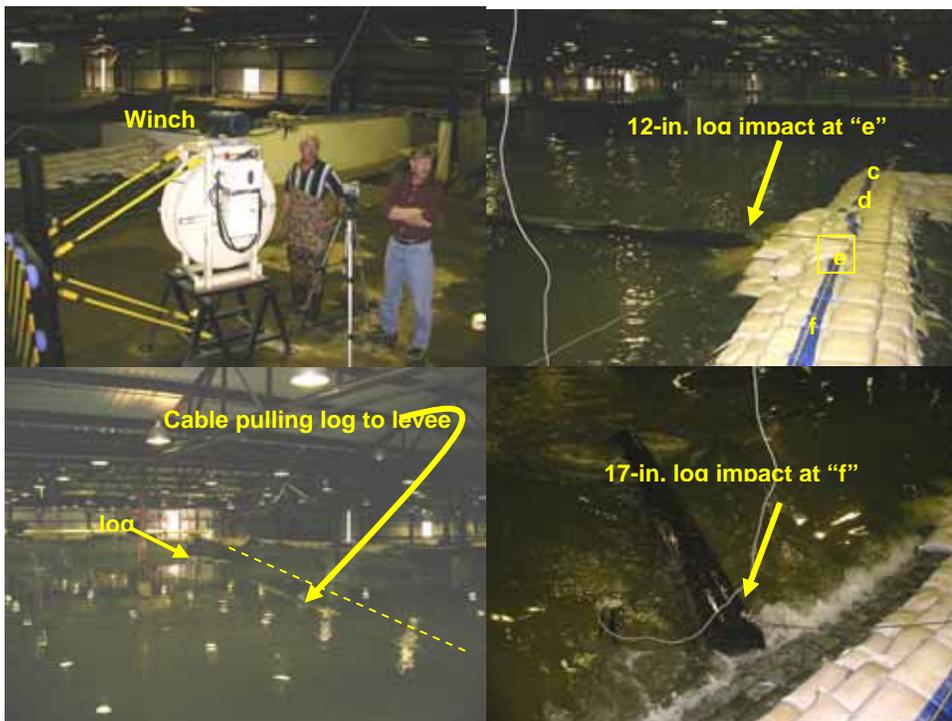
Figure 2-35. 12- and 16-in. logs at point of impact

The locations of impact are shown in Figure 2-35. The impact occurred at "e" for the 12-in. log and at "f" for the 16-in. log. No damage occurred from either log test, although the larger log left a small indentation on the barrier's front face. No permanent lateral displacement was observed during either test, and no vertical deformation was noted.

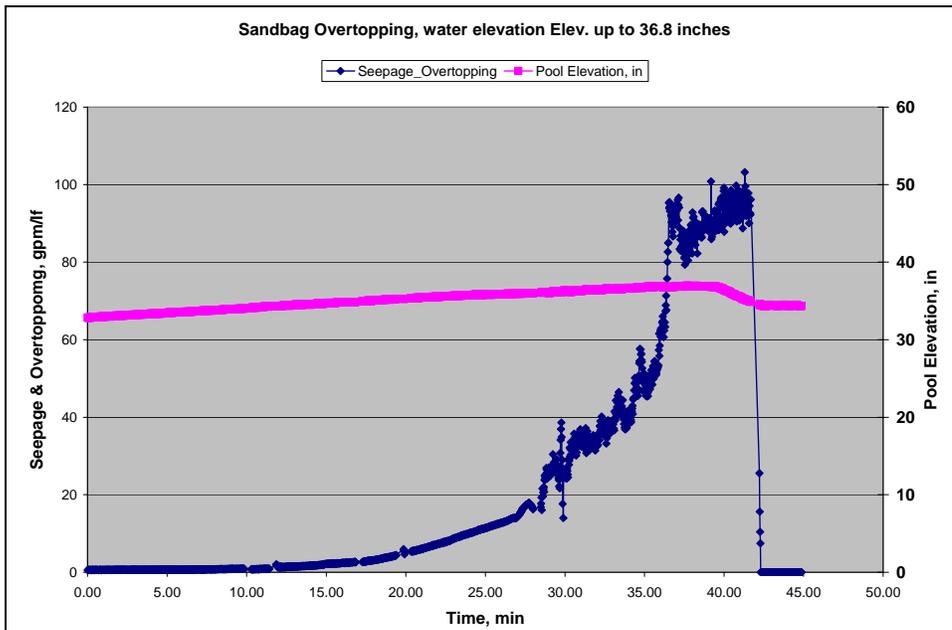
Figure 2-36. Seepage and overtopping

However, the pool overtopped the levee at an elevation of 37 in. (approximately 1 in. above the crest), and continued for a period of 5.7 min. Progressive levee failure occurred as the total flow rate increased from 30.3 to 96.0 gpm/ft. A total flow rate of 2450 to 7,760 gpm is shown in Figure 2-36. Failure and results of failure are shown in Figures 2-37 through 2-40.

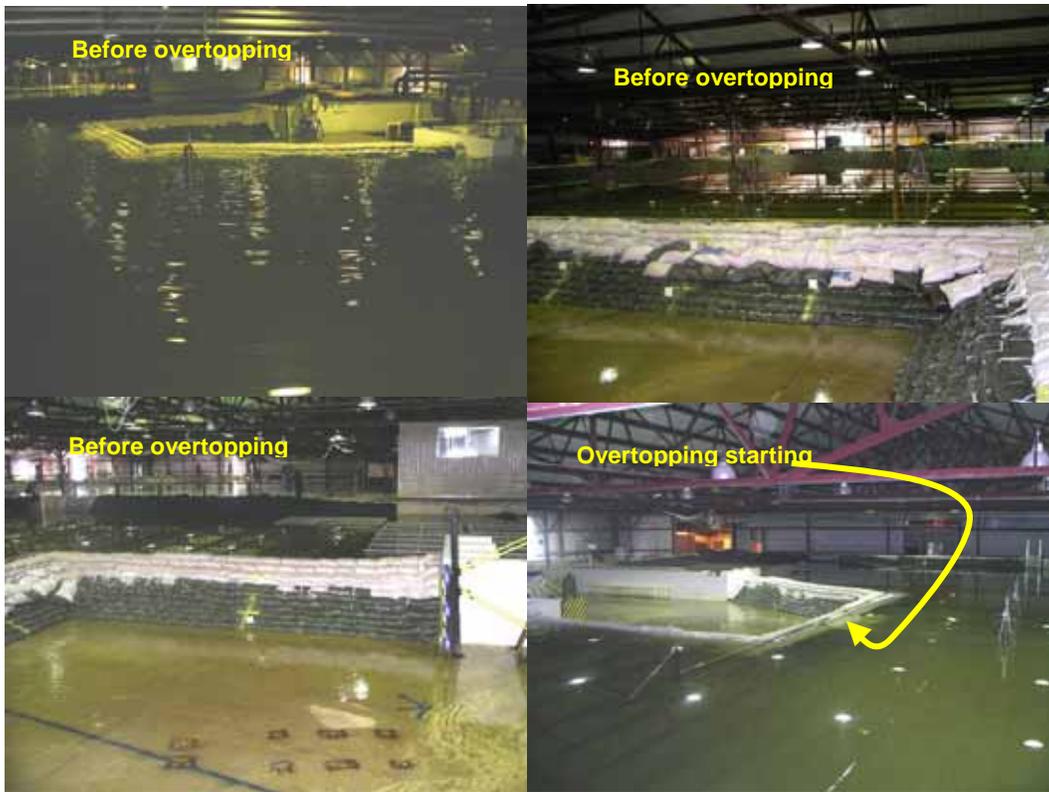
Figure 2-37. Sandbag levee prior to overtopping

The levee failed during overtopping before the pool elevation reached 37.5 in. The pumping rate continually increased until failure occurred. Thus, the structure failed before the test criterion was reached. Figure 2-37 shows the structure prior to testing. Figure 2-38 shows the progressive failure during overtopping. Figure 2-39 shows the sandbag levee after failure. The autopsy of Figure 2-40 shows that the bags became filled with water by the wave action and emptied as the sand flowed out like water (liquefaction). The wave action caused the untied bags to empty. Once the sandbags became light enough, the waves washed the bags from the levee causing failure. Some of the bags found on the landside were completely empty.

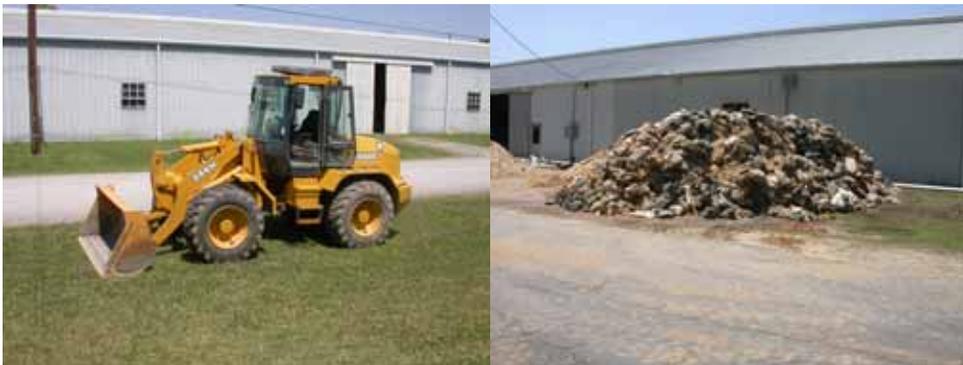
Figure 2-43. Heavy equipment used to disassemble sandbags and waste sandbags

The sandbags were broken and torn during removal and were not fit to be used again. The sandbags were piled into one large stack, similar to that seen in real-world flood fights. The equipment and sandbag pile can be seen in Figure 2-43.

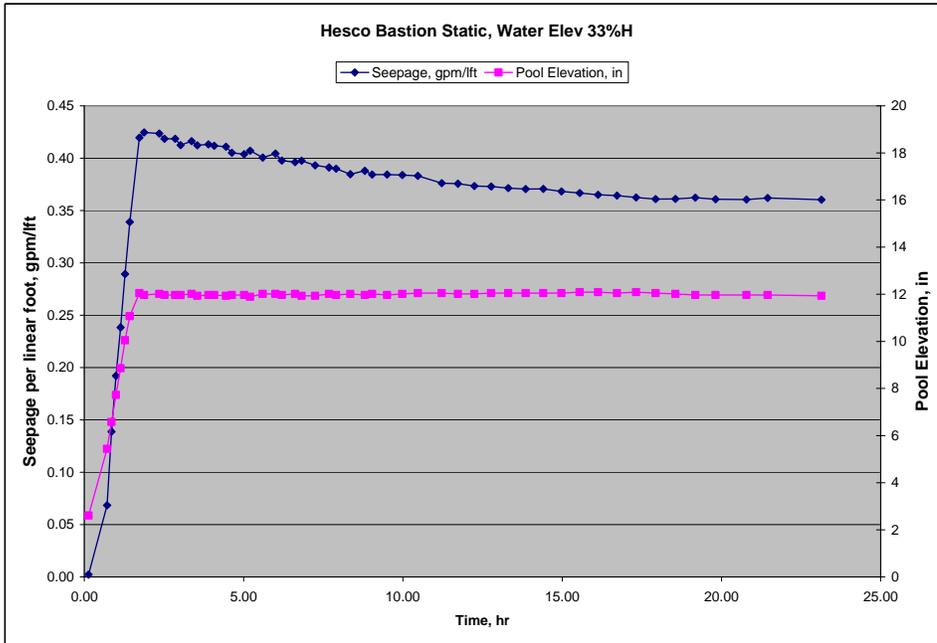
**Hydrostatic head test, 1-ft reservoir (33 percent height).** The water level in the reservoir on the pool side of the levee was raised to a height of 1 ft (33 percent of the levee height). Seepage flow rate ranged from 0.36 to 0.42 gpm/ft (Figure 2-62), and no displacement was observed. Most of the flow rate was observed coming from the wall corners, and the vertical joint between unit ends.

Figure 2-62. Seepage-flow rate per linear foot at 1-ft pool elevation (33% H)

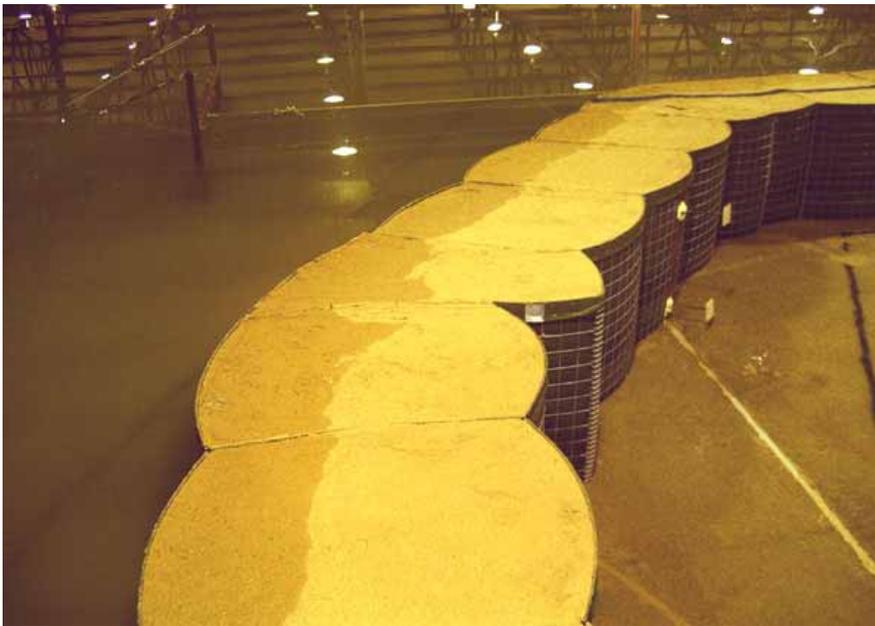
Figure 2-63 shows the wetting front observed on top of the structure as the water saturated the dry sand. Figure 2-64 is a close-up of seepage occurring at a vertical joint between units.

Figure 2-63. View of left wall water saturation

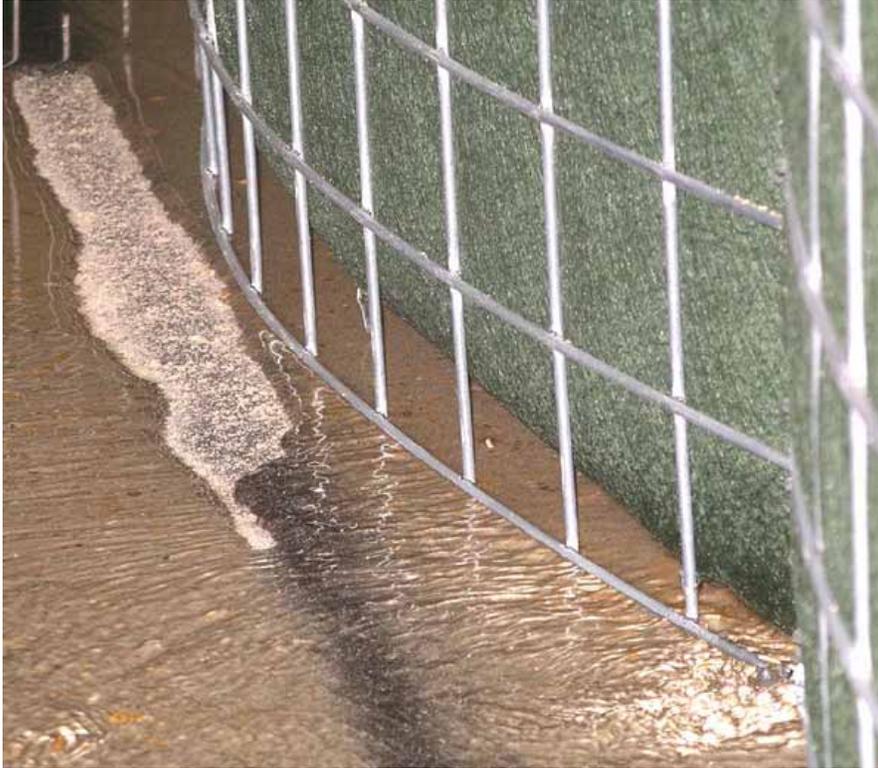
Figure 2-64. Close-up of seepage through vertical joint between units

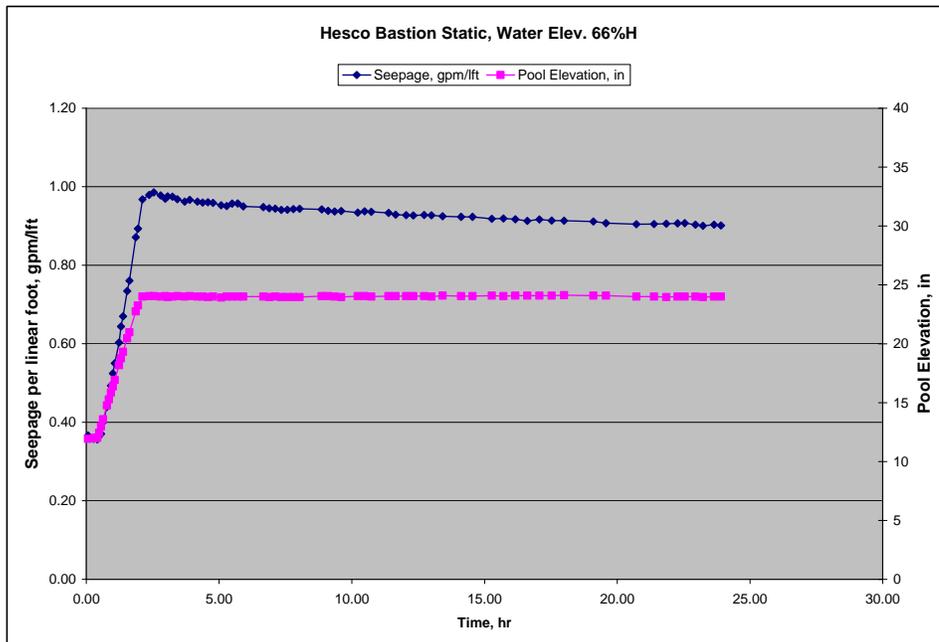
**Hydrostatic head test, 2-ft reservoir (66 percent height).** The water level in the reservoir on the pool side of the levee was raised to a height of 2 ft (66 percent of levee height). Seepage flow rate ranged from 0.90 to 0.97 gpm/ft (Figure 2-65), and no displacement was observed. Most of the flow was observed coming from the wall corners and the vertical joint between unit ends. Figure 2-66 shows the structure from the front.

Figure 2-65. Seepage flow rate per linear foot at 2-ft pool elevation (66% H)

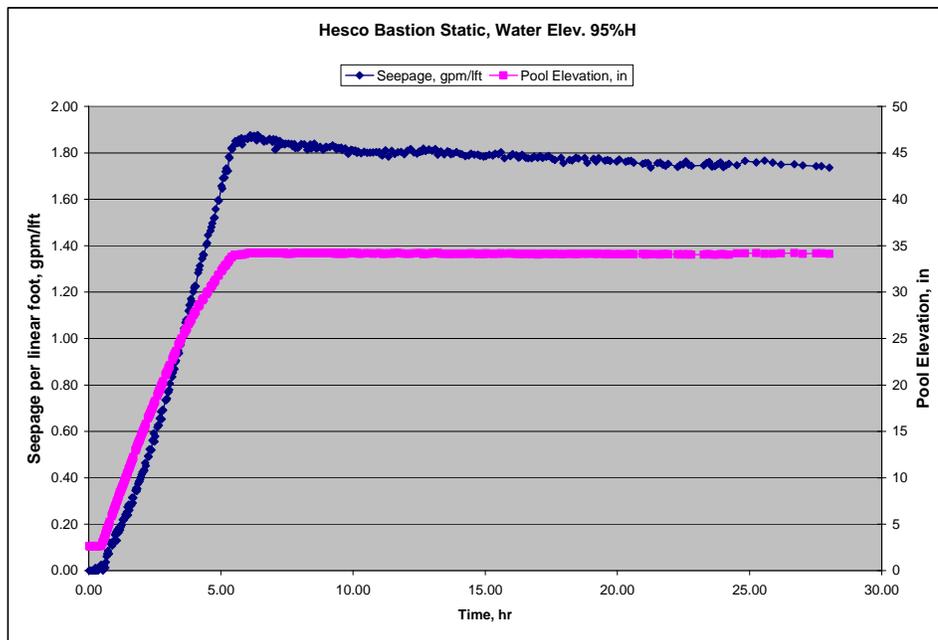
**Hydrostatic head test, 3-ft reservoir (95 percent height).** The water level in the reservoir on the pool side of the levee was raised to an approximate height of 34 in. (95 percent of levee height). Seepage flow rate ranged from 1.76 to 1.86 gpm/ft (Figure 2-67). Lateral displacement ranged from 3 to 9 mm. Vertical deformation was observed to range from 0.24 to 2.28 in., and was assumed to be a result of units “barreling” as the sand became completely saturated. Most of the flow was observed coming from the wall corners and the vertical joint between unit ends.

Figure 2-67. Seepage flow rate per linear foot at 95 percent pool elevation

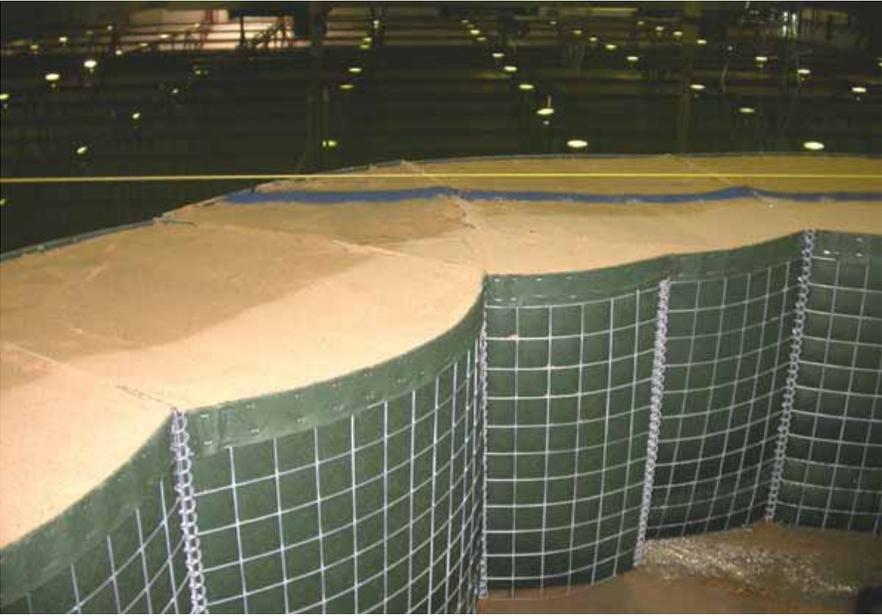
**3-in. wave test, reservoir level at 66 percent levee height.** The water level in the reservoir of the levee was lowered from the 95 percent level to a height of 24 in. within an interval of about 2 hr. The wave generator was activated and the waves began to impact the levee. Flow rate was observed to range from 0.81 to 0.83 gpm/ft (Figure 2-68), with no displacement. No wave overtopping was observed. Figure 2-69 is a view of the left wall and center wall intersection showing seepage at the wall base.

Figure 2-69. Left wall and center wall intersection

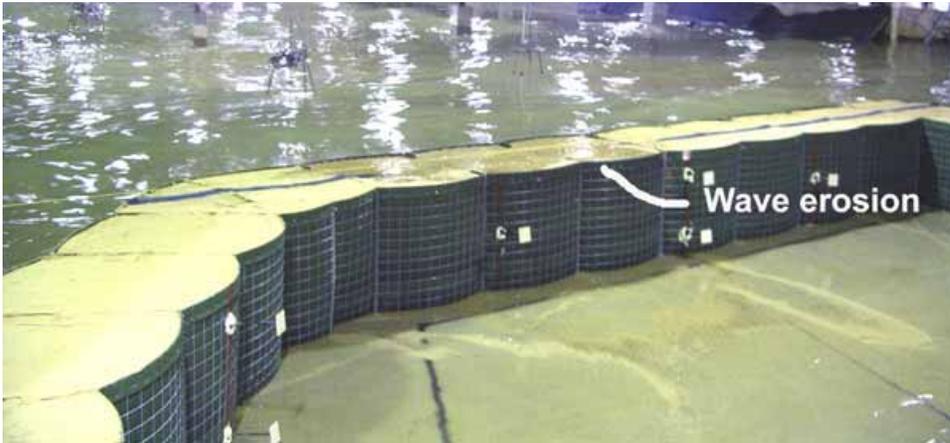
**10- to 13-in. wave test, reservoir level at 66 percent levee height.** The water level in the reservoir on the pool side of the levee was held at a height of 24 in., the wave generator was activated, and the waves began to impact the levee. Flow rate was observed to range from 0.78 to 0.98 gpm/ft (Figure 2-71), with no displacement. Minor sporadic wave overtopping was observed, primarily along the center wall (Figure 2-72).

Figure 2-72. Center wall wave-induced erosion

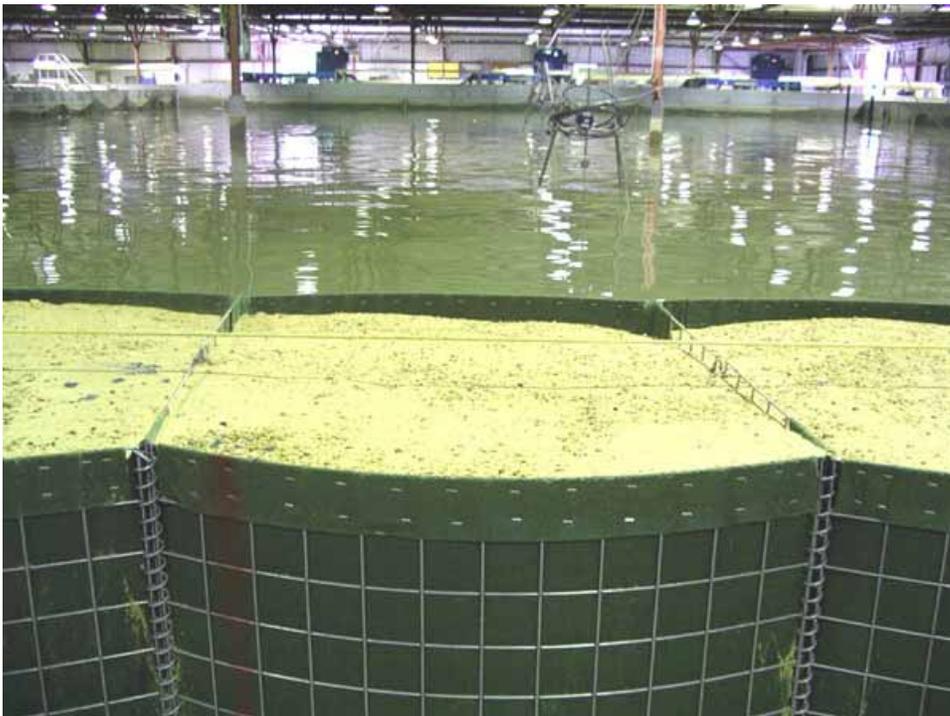
At the conclusion of the test, sand had eroded and settled from the top of the center wall (Figure 2-73), and a solution was devised to prevent further erosion during subsequent testing. As shown in Figures 2-74 and 2-75, a tarp covering was placed on the wall top and secured with cable ties.

Figure 2-73. Sand eroded from top of center wall

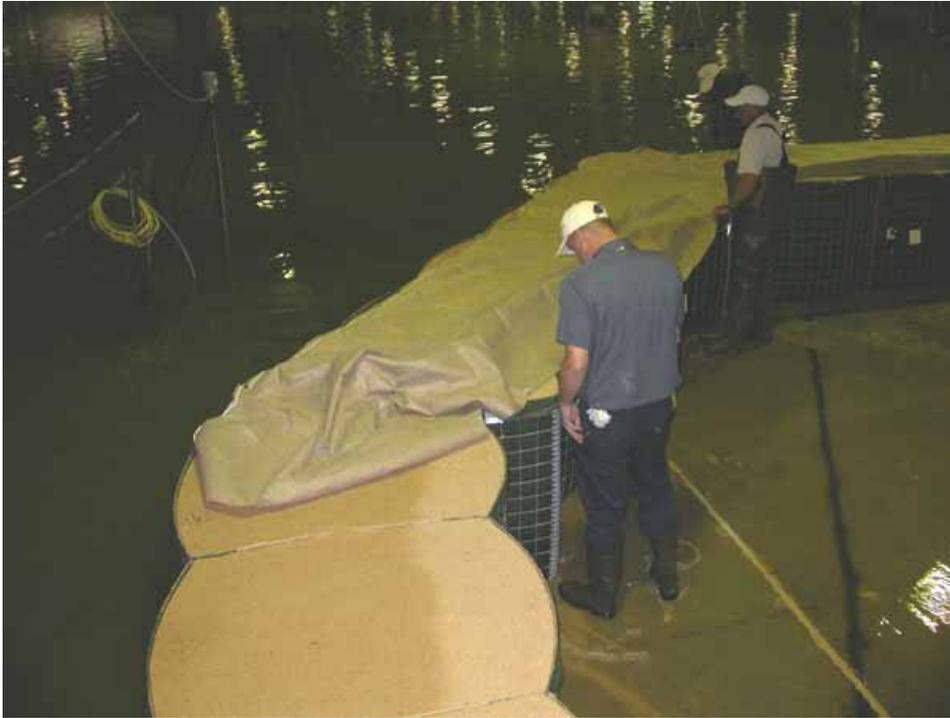
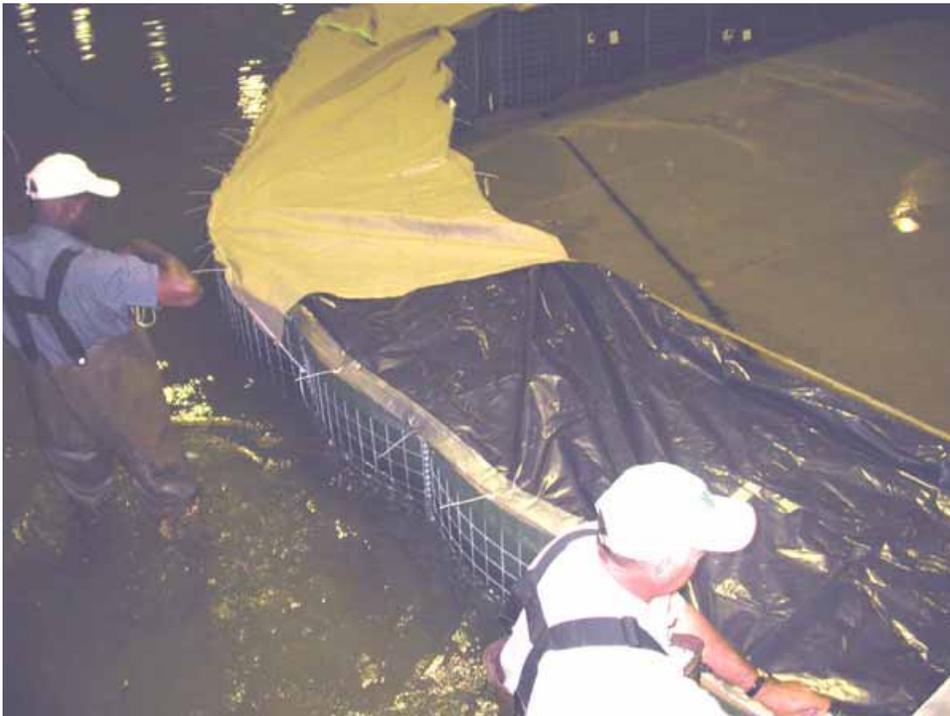
Figure 2-74. Covering top of wall with tarp to prevent further erosion

Figure 2-75. Securing with cable ties

Repair 1 was performed prior to the 80 percent small (2- to 3-in.) wave test. It consisted of adding a top membrane fabric over the units, and adding cable ties and wire ties. A four-man crew took 24 min (1.6 man-hours) to do this work. Figure 2-87 shows this work (see also Figures 2-74 and 2-75).

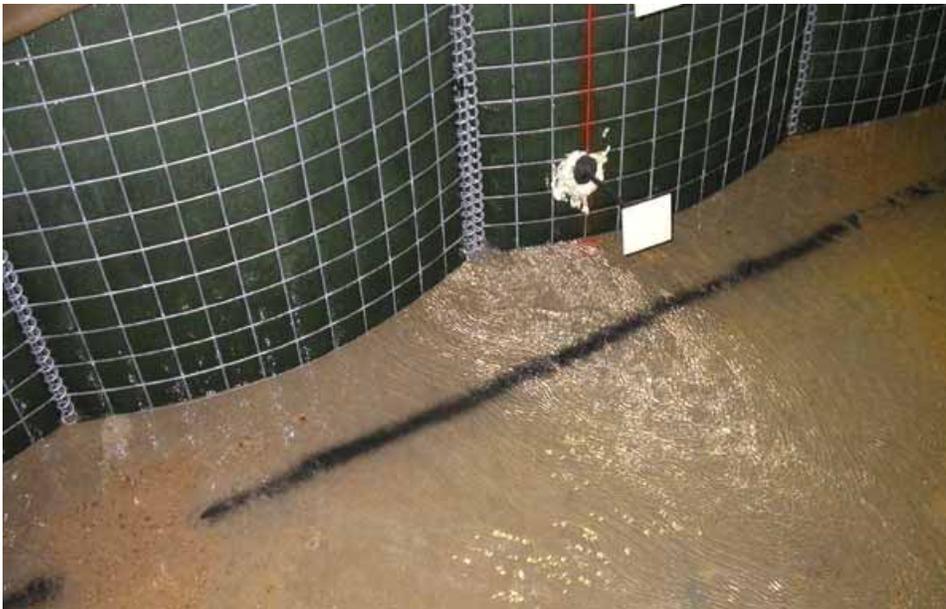
was activated, and the waves began to impact the levee. Flow rate was observed to range from 1.03 to 1.04 gpm/lft (Figure 2-76), with no displacement. No wave overtopping was observed. Figure 2-77 shows seepage under the center wall base.

Figure 2-77. Seepage at vertical joint and wall base

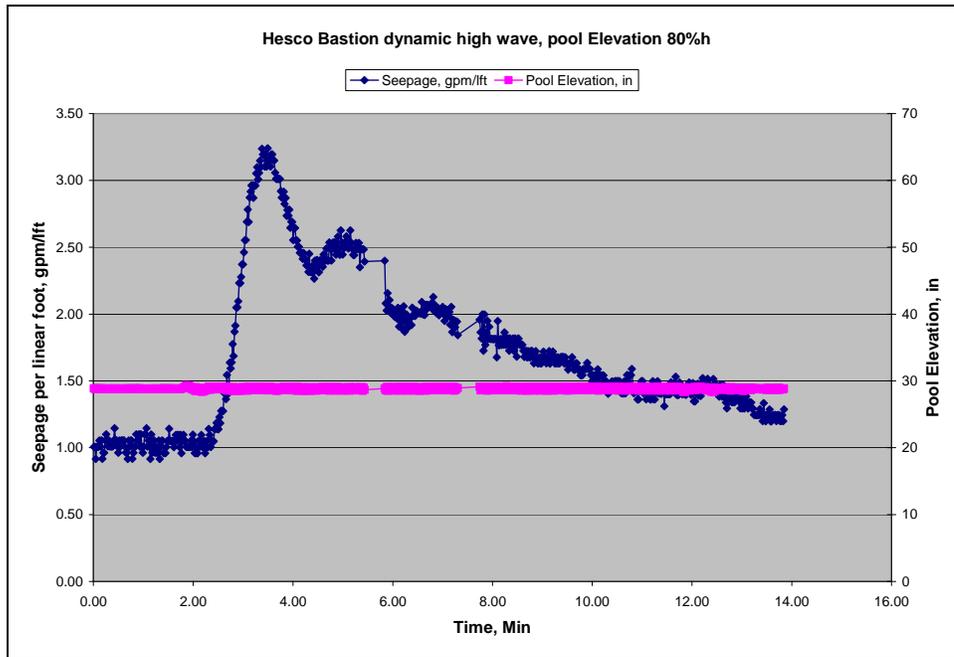
**10- to 13-in. wave test, reservoir level at 80 percent levee height.** The water level in the reservoir on the pool side of the levee was held at a height of 29 in., the wave generator was activated, and the waves began to impact the levee. Flow rate was observed to range from 1.05 to 3.14 gpm/ft (Figure 2-80), with no displacement. Wave overtopping was observed at each wave front, which contributed to the significant flow rate increase. Figure 2-81 shows wave overtopping.

Figure 2-80. Seepage flow rate per linear foot, high wave at 80 percent pool elevation

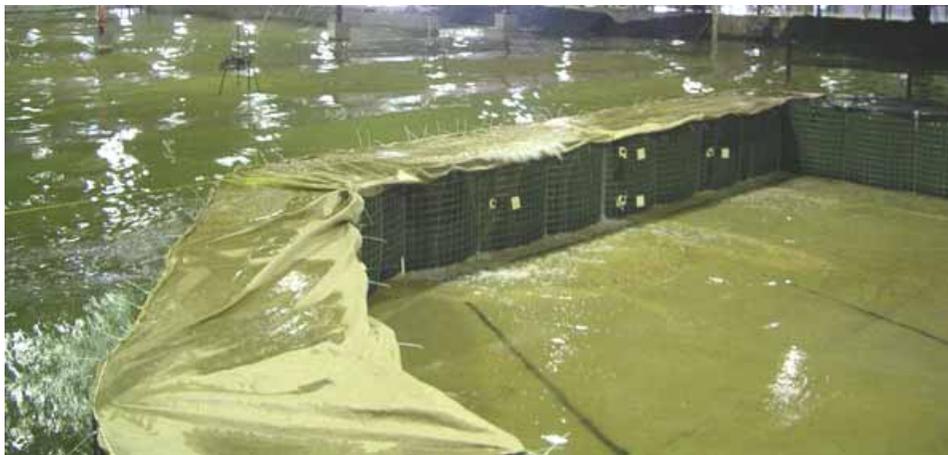
Figure 2-81. Wave overtopping along center wall

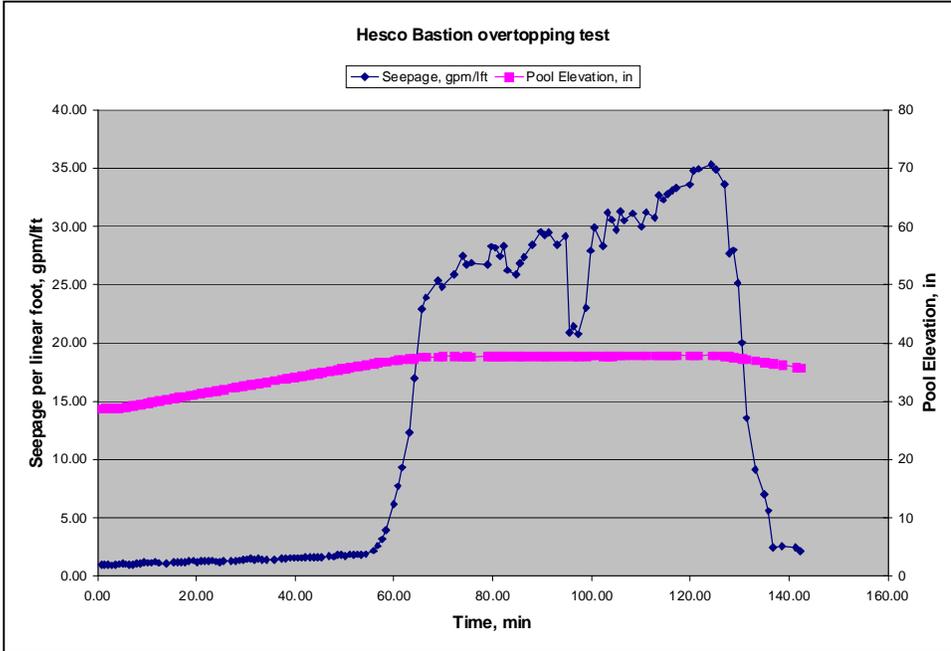
withstood overtopping without failure. Overtopping water combined with seepage water to increase the measured flow rate within a range of 25.2 to 35.0 gpm/ft (1,800 to 2,500 gpm) in the span of 1 hr as shown in Figure 2-82. The overflow was uniform due to the uniform levee height. Figures 2-83 and 2-84, show the overtopped levee.

Figure 2-82. Seepage flow rate per linear foot during overtopping

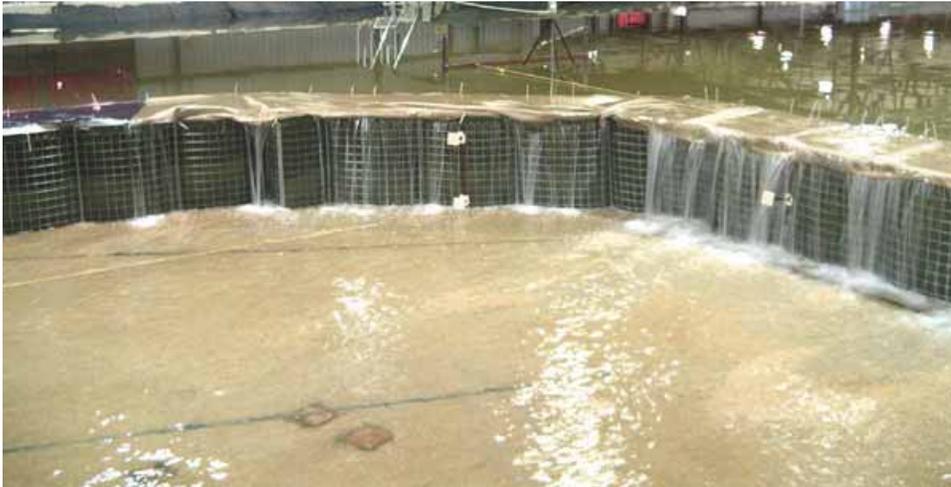
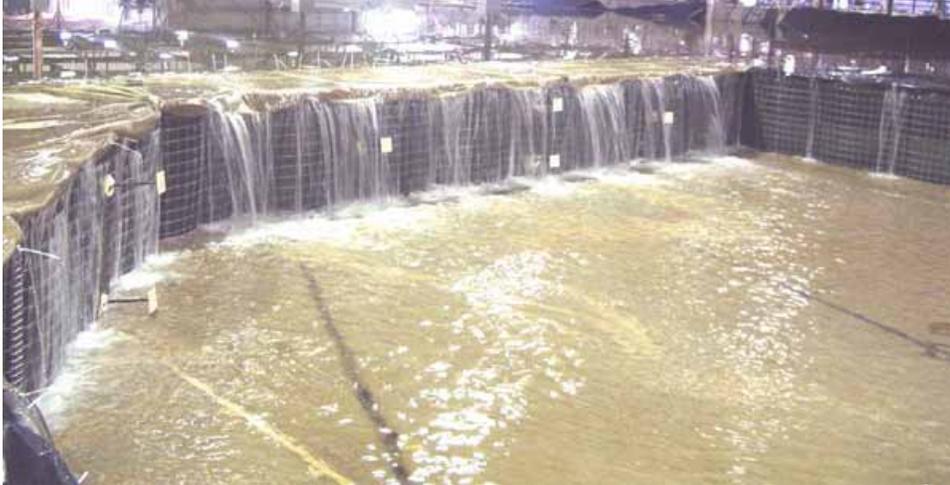
Figure 2-83. Overtopped levee structure, view from right wall

Figure 2-84. Overtopped levee structure, view from left wall

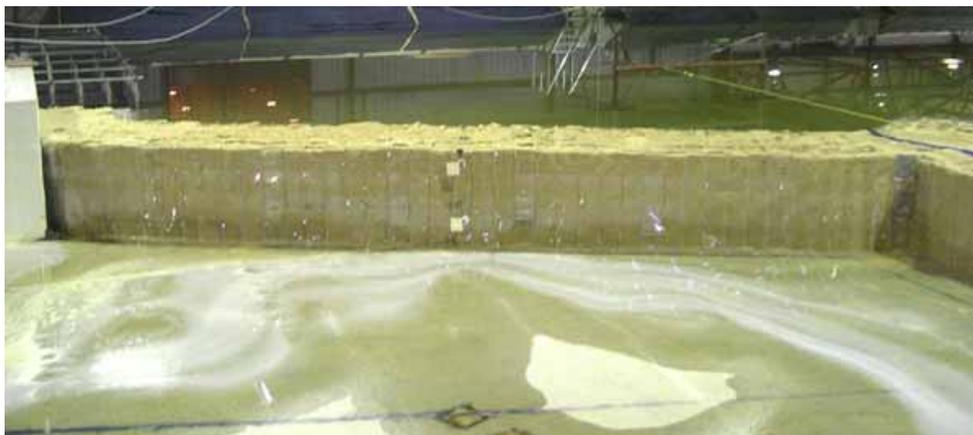
**Hydrostatic head test, 2-ft reservoir (66 percent height).** The water level in the reservoir on the pool side of the levee was raised to a height of 2 ft (66 percent of levee height). Seepage flow rate was measured in the range from 0.063 to 0.089 gpm/lft (Figure 2-129), and no horizontal displacement was observed. However, vertical settlement or subsidence can be seen in Figures 2-130 through 2-132. A white liquid can be seen in the seepage through the levee as shown in Figure 2-130.

Figure 2-130. View of seepage under left wall

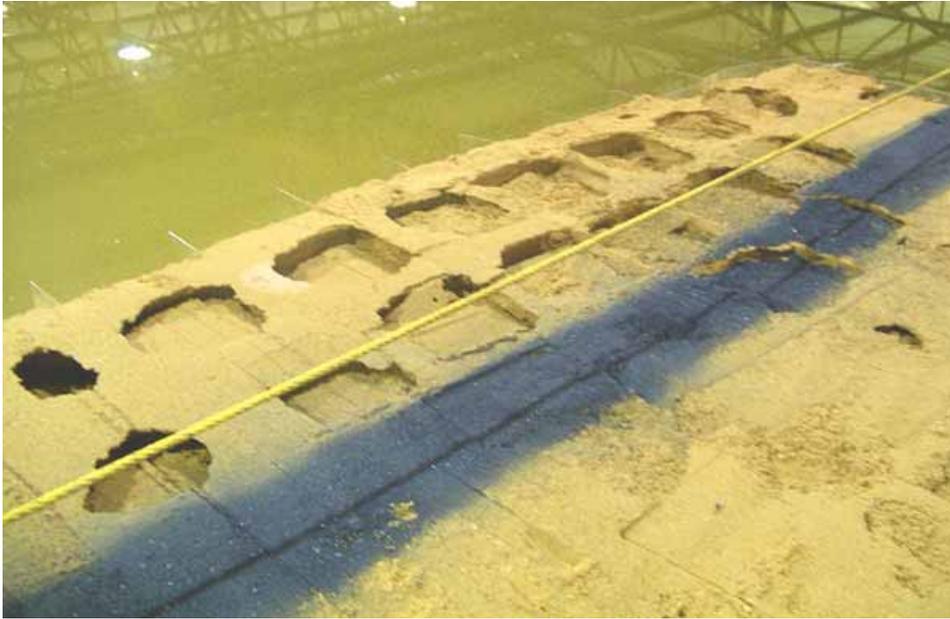
Figure 2-131. Sand subsidence in outer grid cells along center wall

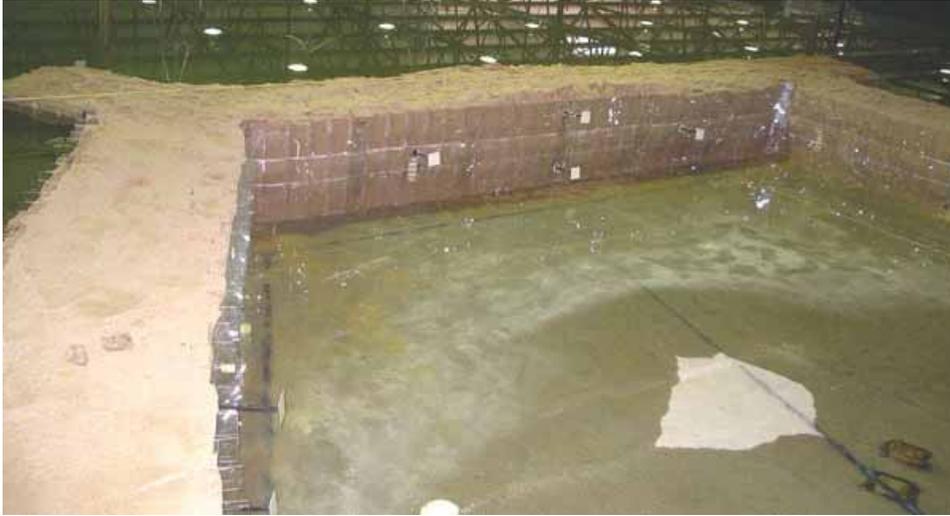
Figure 2-135. View of seepage under structure

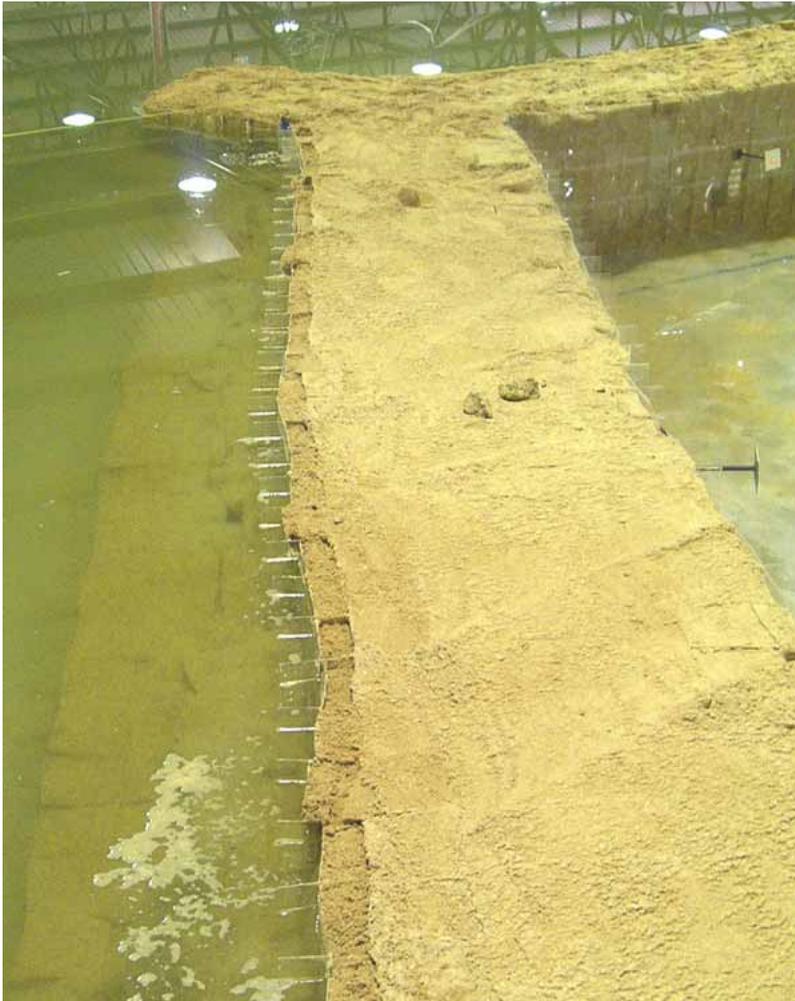
**Hydrostatic head test, 3-ft reservoir (95 percent height).** The water level in the reservoir on the pool side of the levee was raised to a height of 34 in. (95 percent of levee height) as shown in Figure 2-133. Seepage flow rate was measured in the range from 0.084 to 0.108 gpm/ft (Figure 2-134), and no displacement was observed. Figure 2-135 shows that most of the leakage was observed coming from the wall corners. Figure 2-136 shows settlement along the right outside edge.

Figure 2-136. View looking down left wall

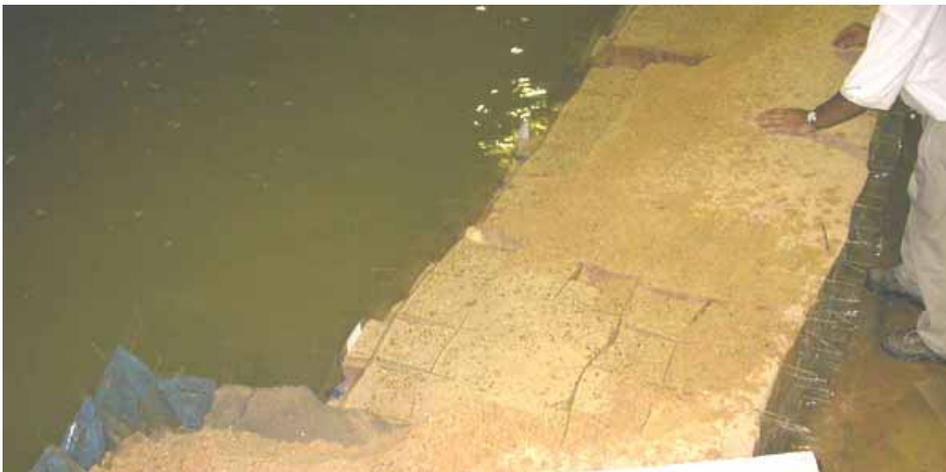
displacement was observed. Overtopping did occur sporadically, which contributed to the flow rate increase. Figure 2-143 shows aftermath of wave action against the left wall near the concrete wall abutment. Minor surface erosion was evident.

Figure 2-143. Surface erosion from wave action

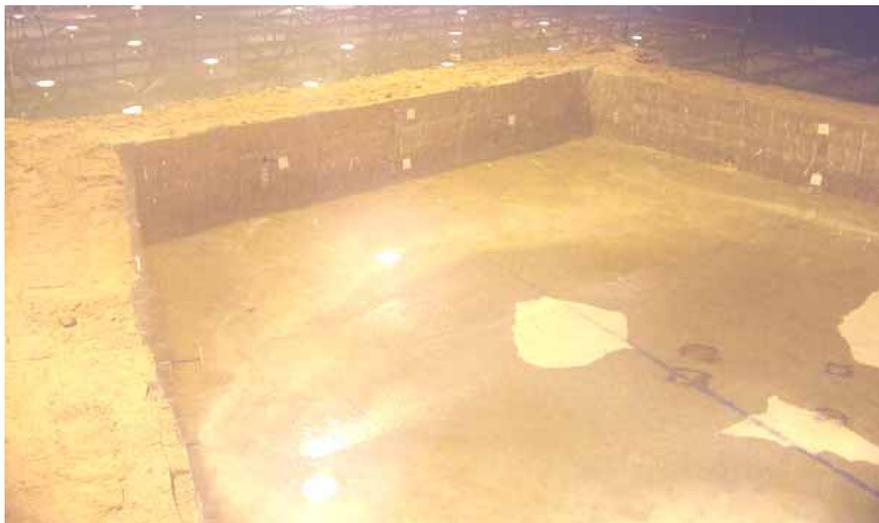
**3-in. wave test, reservoir level at 80 percent levee height.** The water level in the reservoir on the pool side of the levee was raised to a height of approximately 29 in., the wave generator was activated, and the waves began to impact the levee. Seepage flow rate was measured in the range from 0.039 to 0.046 gpm/ft (Figure 2-144), and no displacement was observed. No overtopping was observed, but some surface sand settling was observed (Figure 2-145).

Figure 2-145. View immediately after test showing some sand settling on left wall surface

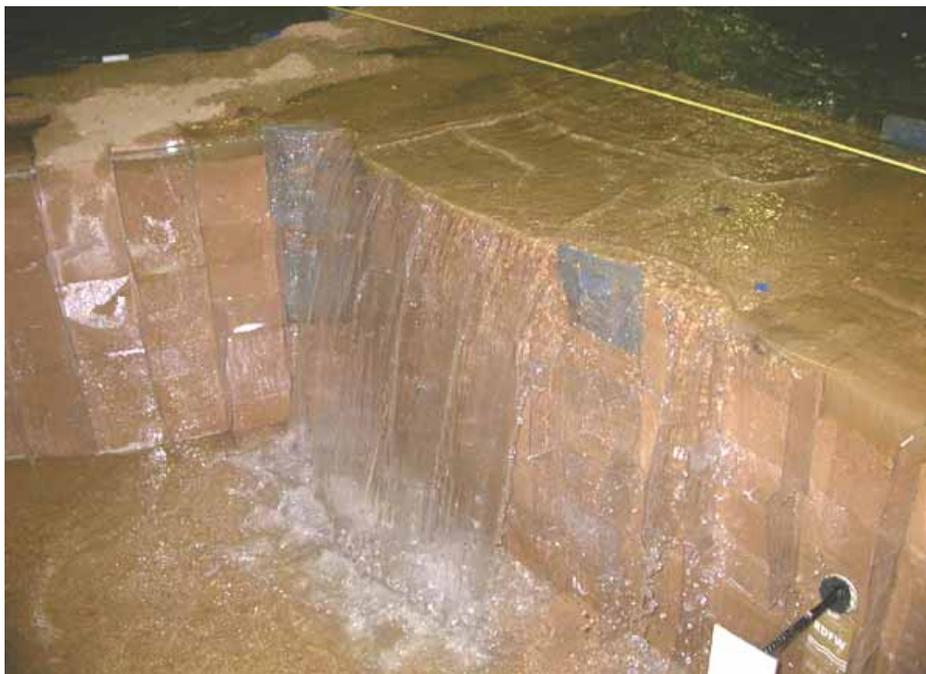
**7- to 9-in. wave test, reservoir level at 80 percent levee height.** The water level in the reservoir on the pool side of the levee was held at a height of 29 in., the wave generator was activated, and the waves began to impact the levee. Seepage flow rate was measured in the range from 0.048 to 4.48 gpm/ft (Figure 2-146), and no displacement was observed. Overtopping did occur sporadically, which contributed to the flow rate increase (Figures 2-147 and 2-148).

Figure 2-147. Sporadic wave overtopping at intersection of left and center walls

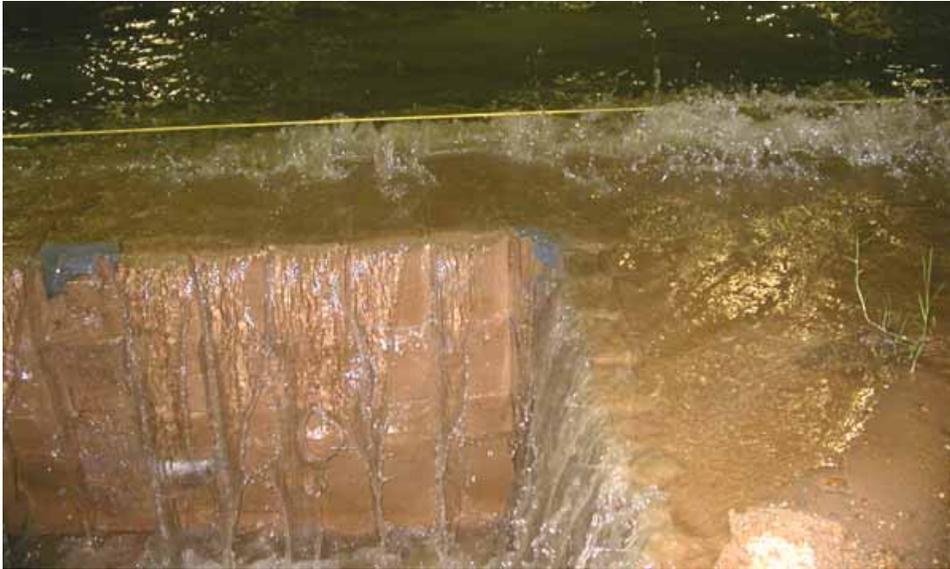
Figure 2-148. Sporadic wave overtopping at intersection of right and center walls

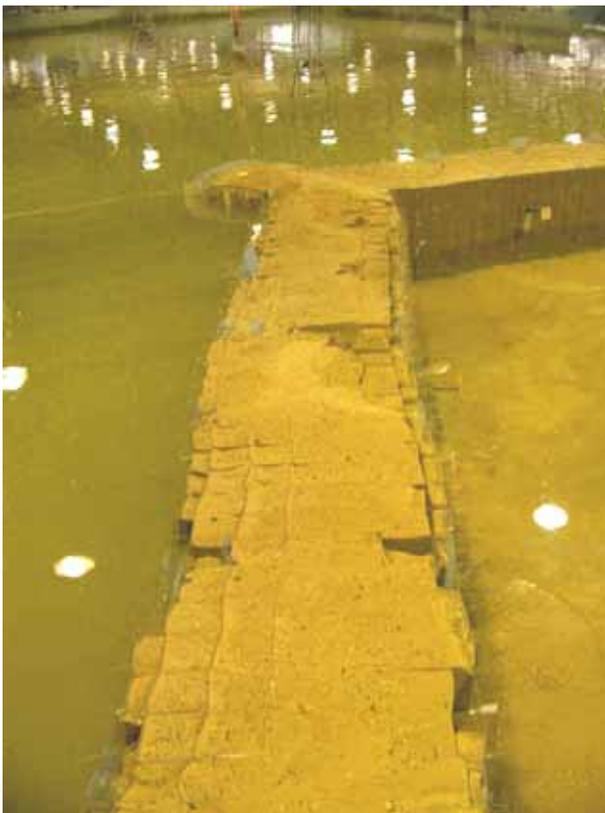
At the conclusion of the test, the condition of the levee structure was observed. As seen in Figures 2-149 and 2-150, minor surface erosion resulted from the sporadic wave overtopping action.

Figure 2-149. Surface erosion on left wall at conclusion of test

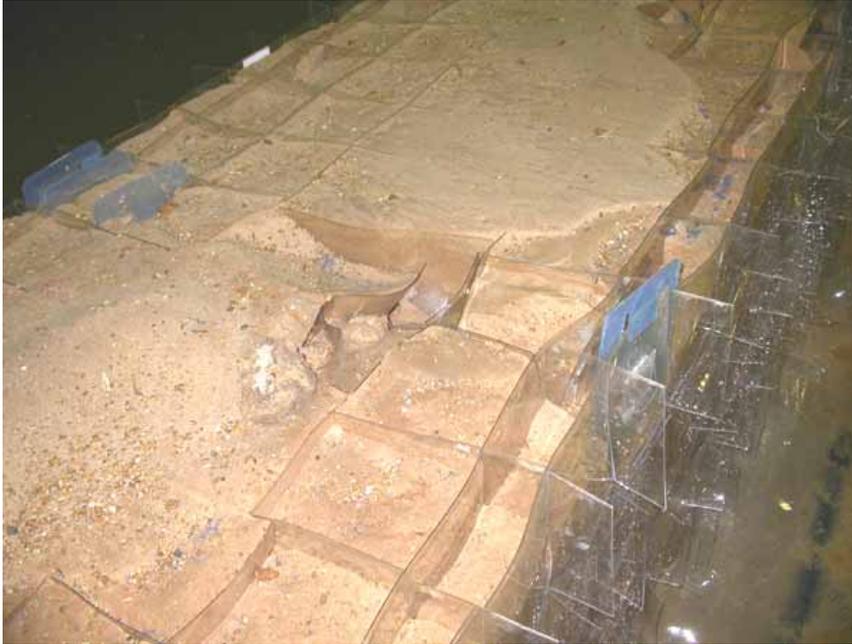
Figure 2-150. Close-up of surface erosion on left wall
