*General Investigation Research and Development Program*

## **Flood-Fighting Structures Demonstration and Evaluation Program: Laboratory and Field Testing in Vicksburg, Mississippi**

July 2007

Final report

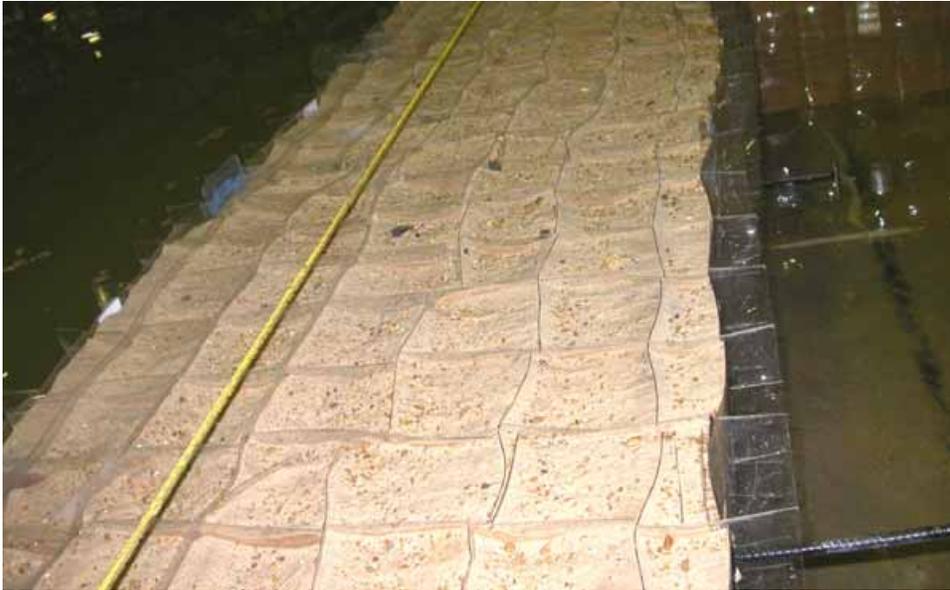
Figures 2-154 and 2-155 are close-ups of the surface erosion observed at the test conclusion.

Figure 2-154. Close-up of center wall after test was concluded

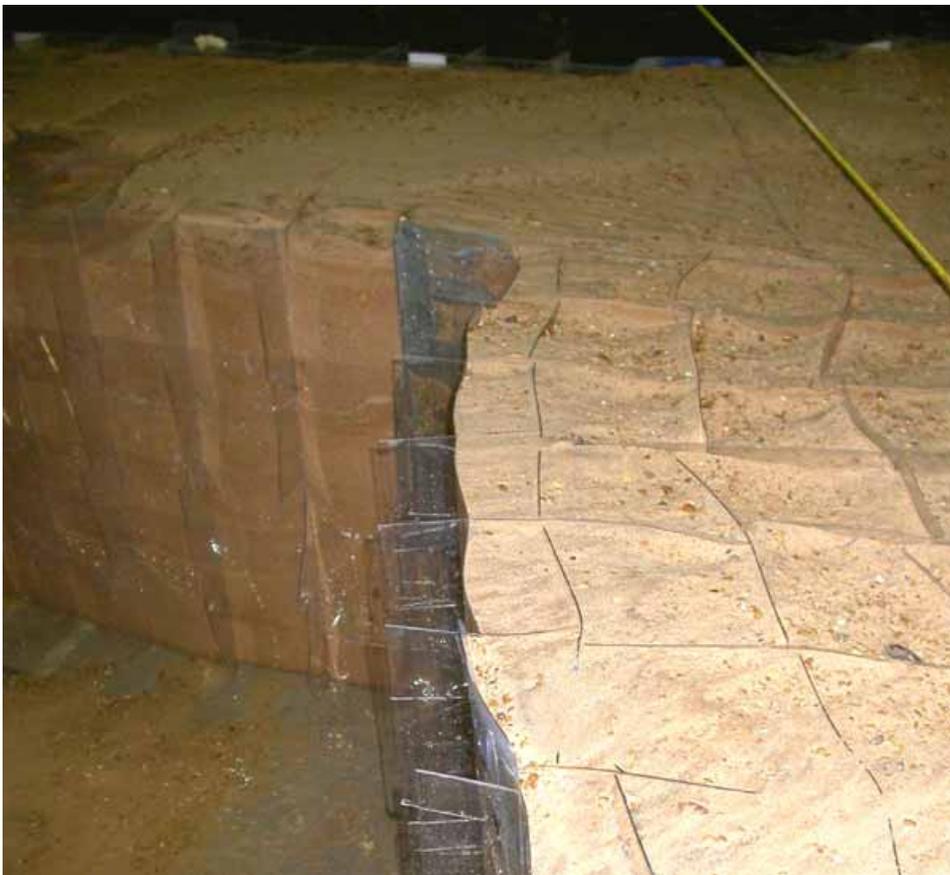
Figure 2-155. Close-up at intersection of left and center walls

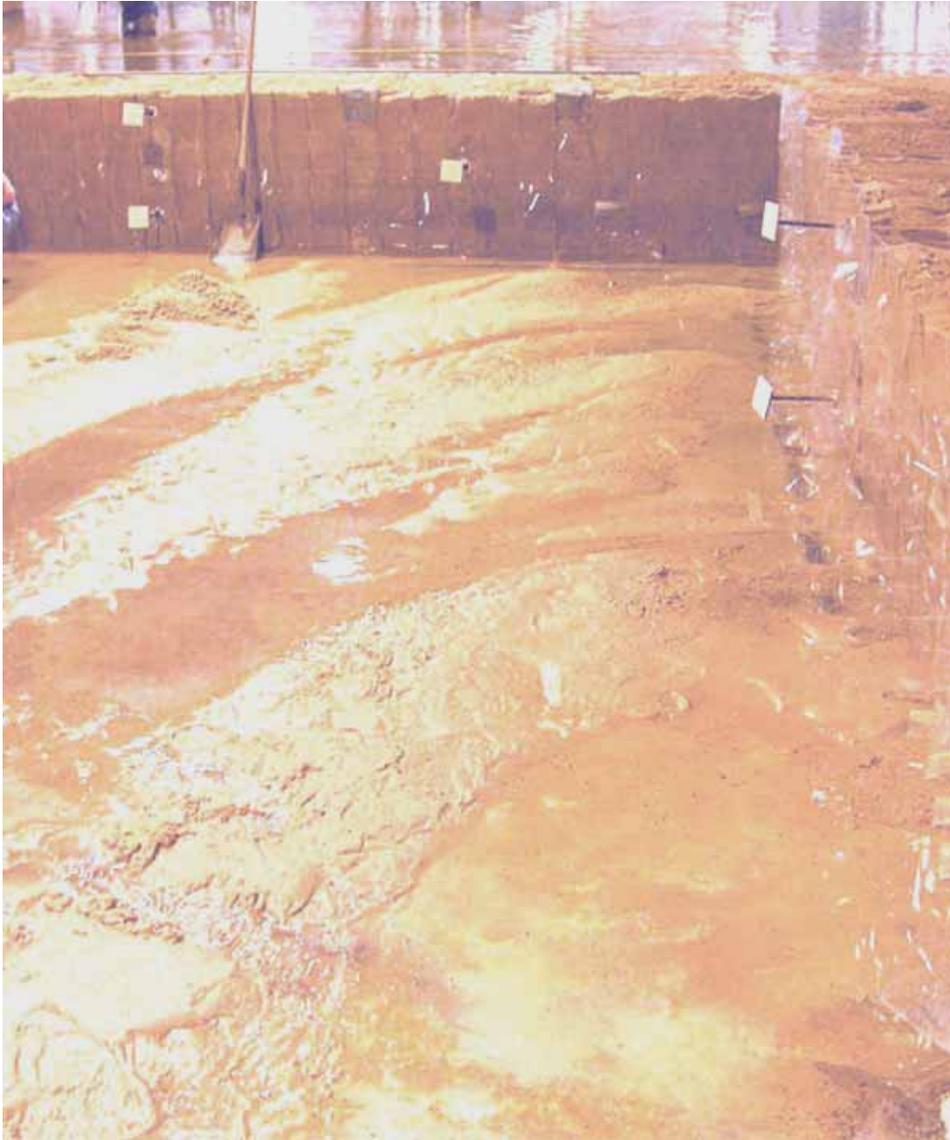
Figure 2-157 shows an overall view of the overtopped levee. Figure 2-158 shows a close-up of the left wall with the overtopping test in progress, and Figure 2-159 shows the eroded sand on the concrete floor after the test was concluded.

Figure 2-159. Eroded sand deposited on floor (view toward center and right walls)

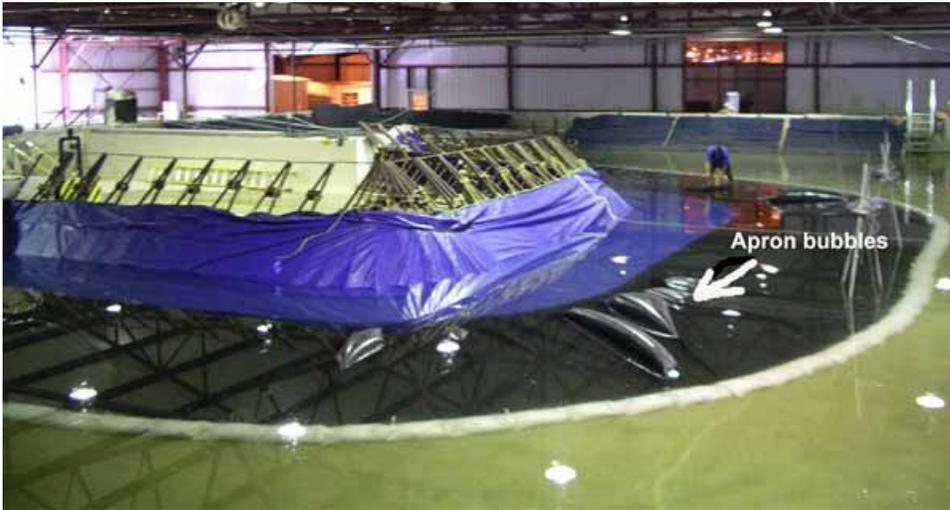
Figure 2-215. Air bubbles beneath apron

**Hydrostatic head test, 1-ft reservoir (33 percent height).** The water level in the reservoir on the pool side of the levee was raised to a height of 1 ft (33 percent of levee height). As the initial pool elevation began to rise, some air pockets under the apron were observed. The supervisor walked out and placed a few sandbags on these air pockets to flatten them out (Figure 2-215). The barrier had very little water seepage, ranging from

Repair 1 occurred after the 33 percent hydrostatic test. The remainder of air pockets beneath the apron were flattened out by walking down and/or placing a sandbag on the air pocket. One supervisor took 30 min for this repair (0.5 man-hours).

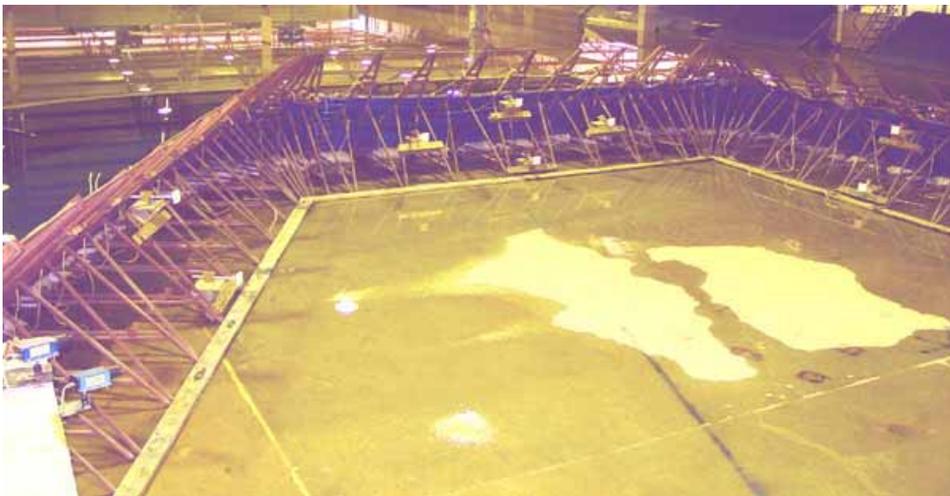
Figure 2-216. Under-apron seepage at 1-ft hydrostatic test

0.08 to 0.11 gpm/lft (Figures 2-216 and 2-217). Zero displacement was observed. Prior to the next test, Repair 1 was performed (discussed in the following paragraphs).

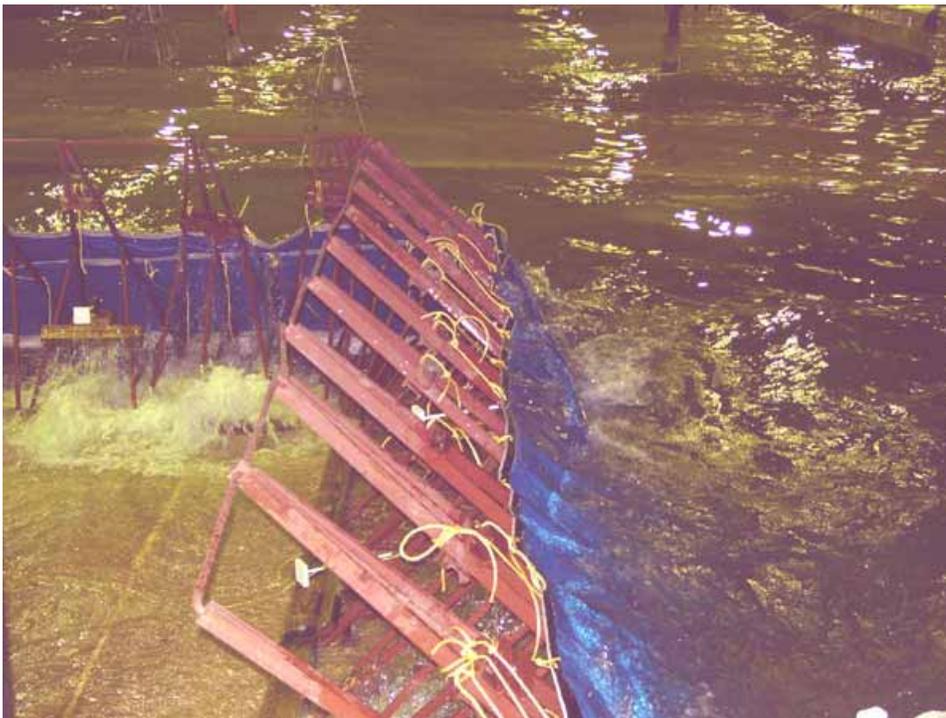
Figure 2-232. 7- to 9-in. wave test showing wave overtopping

The 7- to 9-in. test were conducted within a few minutes after the wave basin was stilled from the aborted test. Wave run-up and overtopping contributed to raising the seepage pit flow rate from the rate of 0.175 to 10.72 gpm/ft (Figure 2-231). No displacement was noted. Figure 2-232 shows typical wave overtopping.

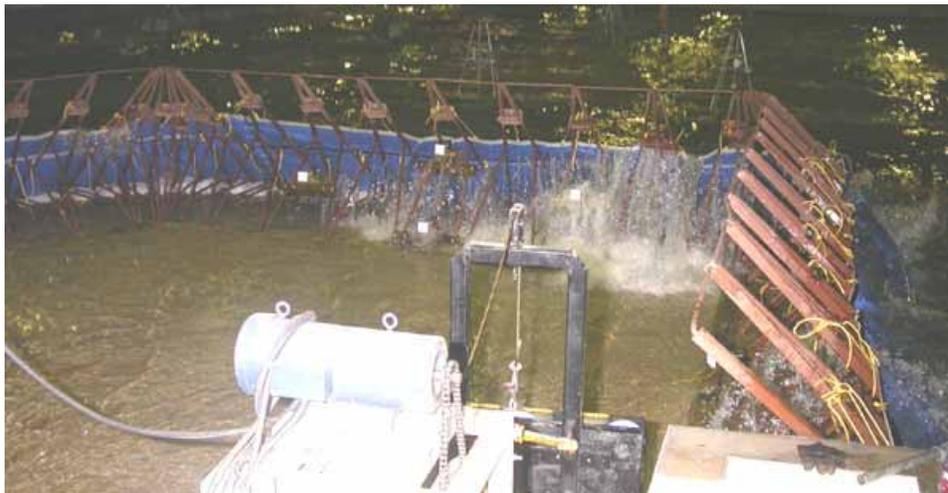
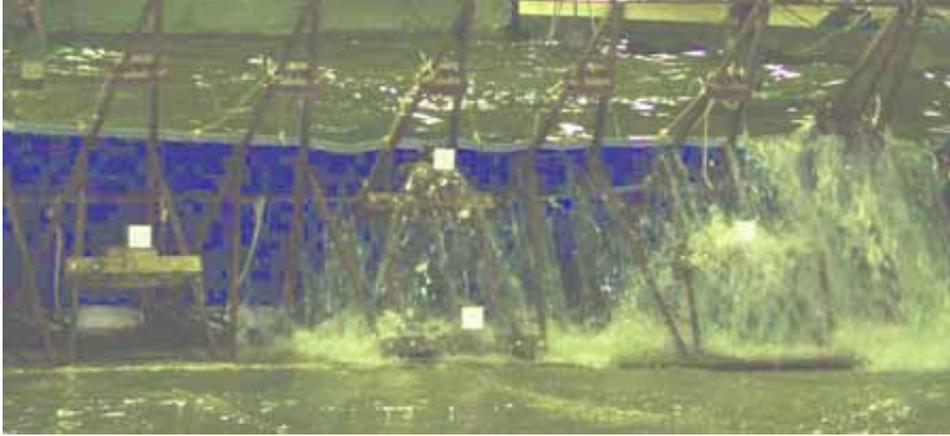
**10- to 13-in. wave test, reservoir level at 80 percent levee height.** The water level in the reservoir on the pool side of the levee was held at a height of 29 in., the wave generator was activated, and the waves began to impact the levee. Flow rate increased from 0.175 to 20.43 gpm/ft (Figure 2-233) due to wave overtopping. Figures 2-234 and 2-235 show the test in progress. No displacement was observed.

Figure 2-234. 10- to 13-in. wave test showing wave overtopping along center wall (partial view of impact test apparatus)

Figure 2-235. 10- to 13-in. wave test showing wave overtopping along center wall

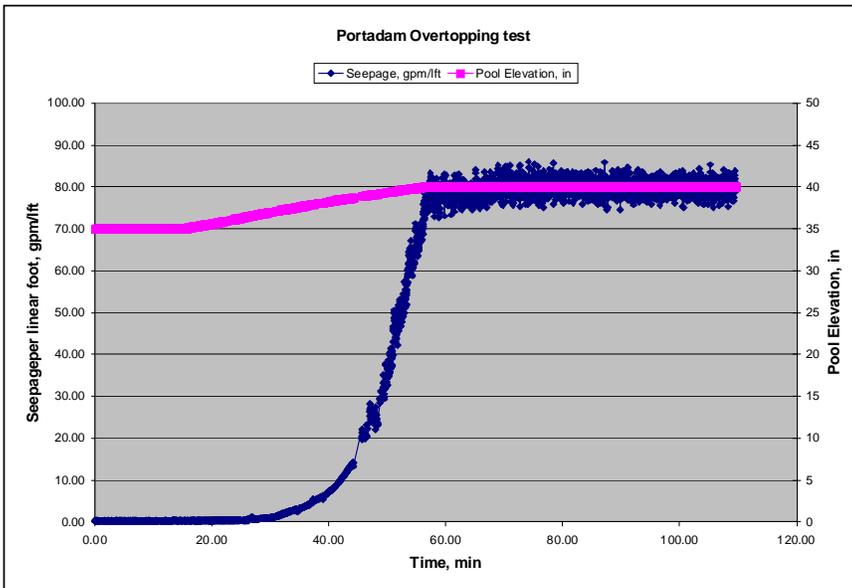
Figure 2-236. Seepage flow rate per linear foot during overtopping

The water level was slowly raised to 40 in. (approximately 1 in. higher than the highest edge of the tarp) and held for 1 hr while overtopping occurred. Total flow rate due to overtopping ranged from 78.8 to 80.3 gpm/ft (5,400 to 5,500 gpm/ft) as shown in Figure 2-236. The large flow can be contributed to the sagging membrane between frames, which makes low points all along the levee. There was no barrier failures were observed during the test. No displacement was noted. Figures 2-237 and 2-238 show overtopping.

Repair 2 occurred prior to overtopping. A three-man crew took 30 min (1.5 man-hours) to install additional tarp ties at the abutment walls, and a plugging compound (a 1-gal can of UGL Drylock Fast Plug®) was placed along each abutment wall at the tarp edge.

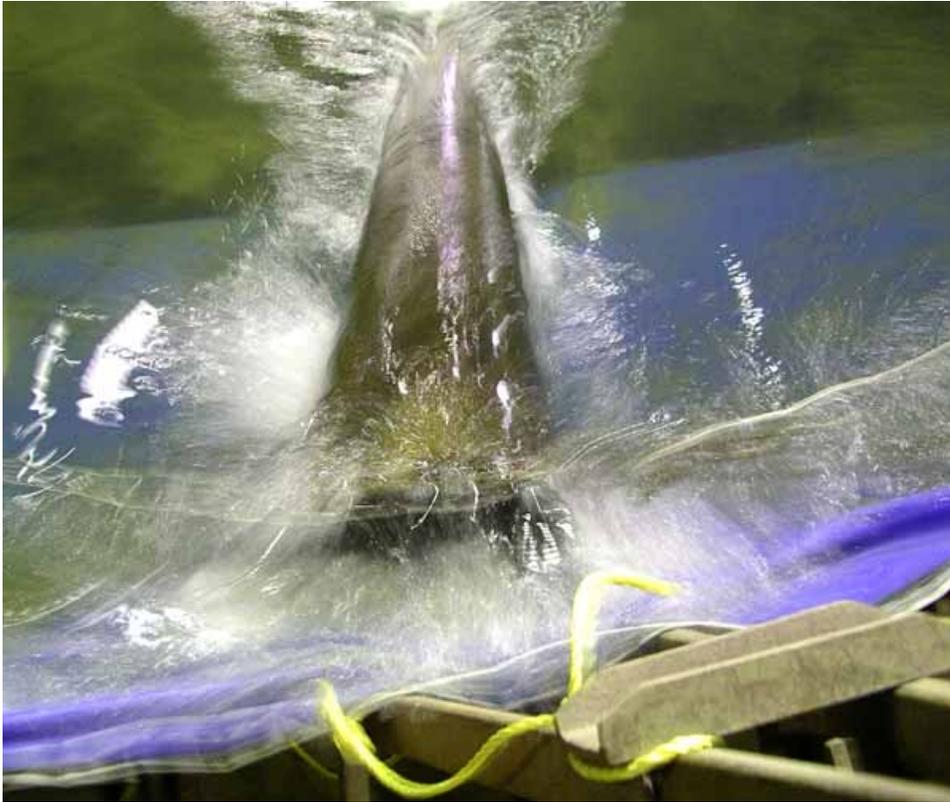
Figure 2-239. Log impact

The water level was slowly dropped to the 66 percent height (2 ft) while preparations were made for the log impact test. The small-diameter log (12-in.) struck the tarp (Figure 2-239) and created a one-eighth-in. diam hole (Figure 2-240), resulting in insignificant additional leakage until the larger log impacted the structure as described in the following paragraphs.

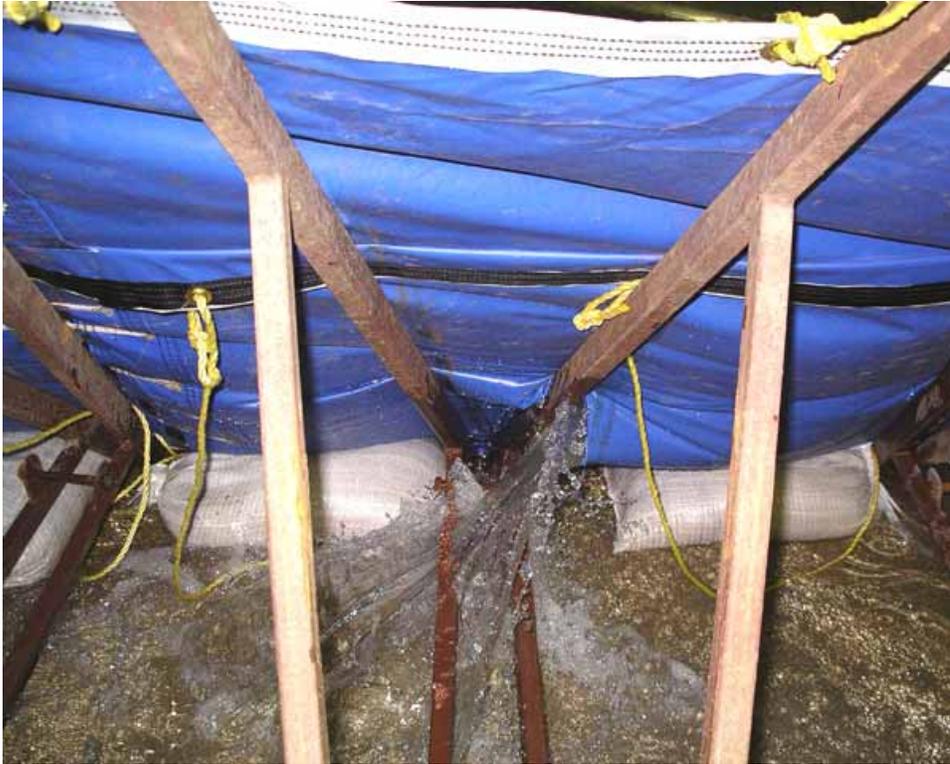
Figure 2-241. Water inflow after large log impact

The larger diameter log (16-in.) struck the tarp about 3 ft to the left of the trajectory path, and created an 8-in.-long vertical slit (gash) in the tarp at the waterline (Figure 2-241) at a steel frame member. The gash increased the flow rate, but no structural failure or displacements due to impact were observed. Due to the ripstop ability of the vinyl tarp, the slit size did not increase (Figure 2-242), and the inflow seepage remained constant at around 3.5 gpm/lft (Figure 2-243). The seepage due to the tear remained constant until the pool elevation was lowered at the test conclusion, also shown in Figure 2-243.

Repair of the impact damage was not pursued or performed, so Repair 3 was not needed. The Portadam® representative was not onsite during the log impact test, the damage appeared to have no probability of contributing to progressive failure or increased leakage, and a field repair would have served no useful purpose since the testing program had concluded.

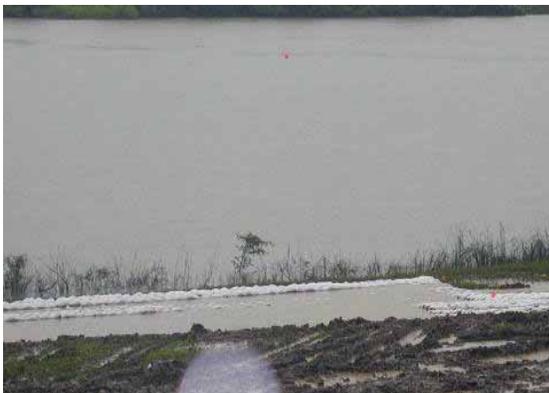
Ponding of rainwater on the inside of the structure delayed the beginning of construction on day 2 (Figure 3-38). The water was removed by pumping into the river (Figure 3-39). Once most of the water was removed, the area was bulldozed to make the site workable (Figure 3-40). The construction crew ranged from 14 to 23 laborers from both the District volunteers and the Mat Sinking Unit, and one equipment operator. Equipment used in constructing the 3-ft-high structure included a flatbed truck, trailer, and bulldozer. The construction crew took 27.5 hr (419.8 man-hours) to construct the 3-ft-high structure.

Figure 3-38. Rain water collected inside structure

Figure 3-39. Water being pumped from structure

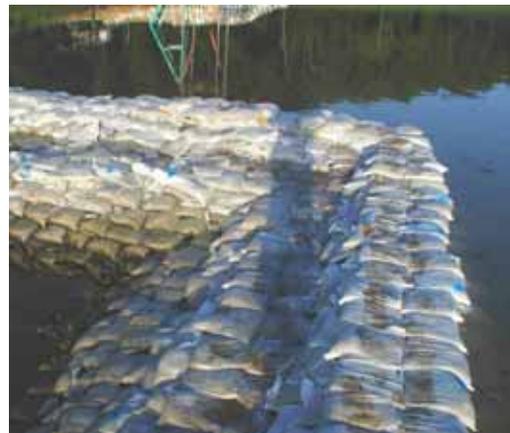
The sandbag structure was constructed in May 2004 during a time when the river level was falling. However, by early June, the river had begun to rise and by the morning of 4 June, approximately 1 ft of water was standing against the structure. Figures 3-45 through 3-50 are a series of daily photos of the sandbag structure during the field testing. As the river continued to rise, the sandbag structure was exposed to higher water levels. The daily water levels against the structure are noted in each figure caption. These water levels were based on 8 a.m. readings for the Mississippi River at the Vicksburg gage. The testing of the sandbag structure ended when the structure overtopped on 7 June 2004.

Figure 3-48. 7 June 2004, structure overtopping

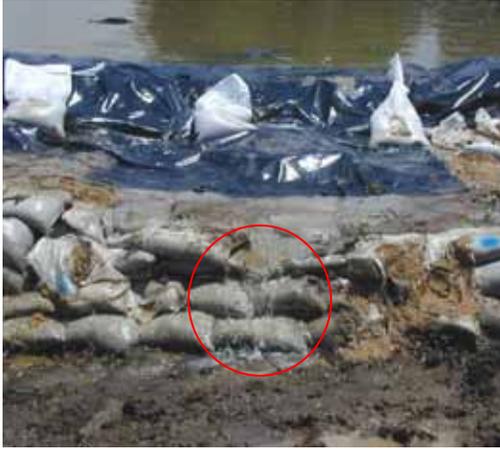
Figure 3-49. 7 June 2004, seepage through structure

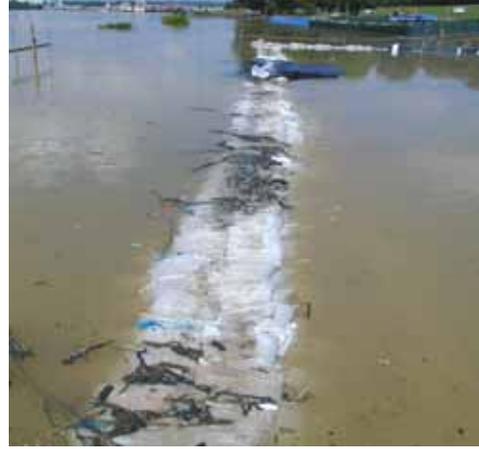
Figure 3-50. 7 June 2004, overtopped structure

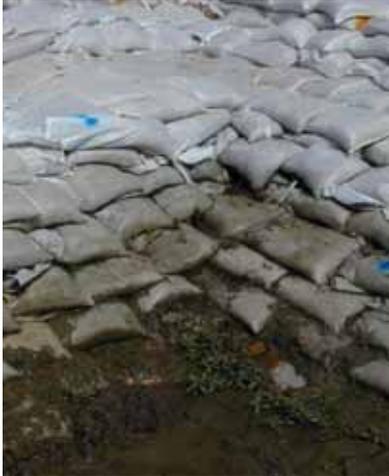
During the field test, seepage was collected in a buried concrete tank (Figure 3-51a, b). Seepage rates were determined by computing the change in volume in the tank over a specific time. As the water level against the structure rose, the seepage rates increased. The first photo was taken on 5 June 2004 while the seepage rate was low. The second photo was taken on 6 June 2004 when the seepage rate had increased. Figure 3-52 is a photo of the seepage observed through the overlapping sandbags. Figure 3-53 shows the seepage water on the protected side of the structure. To compare seepage rates for all four structures, the wetted area for each structure for given water surface elevations was computed (Figure 3-54). The seepage rate for the sandbag structure exceeded 4,500 gal/hr when the structure had almost 700 sq ft of wetted area. The rate of seepage increased markedly when the wetted area reached 500 sq ft. As the seepage rate increased, an attempt was made to reduce the seepage by draping the east tieback with plastic sheeting and weighting the sheeting with sandbags (Figure 3-55a, b). The draping of the sheeting did not decrease the flow of water through the structure. The plastic sheeting was also draped over a low section of the riverward face to protect against concentrated flow (Figure 3-56). These were the only modifications made to the sandbag structure.

Figure 3-52. Seepage through structure

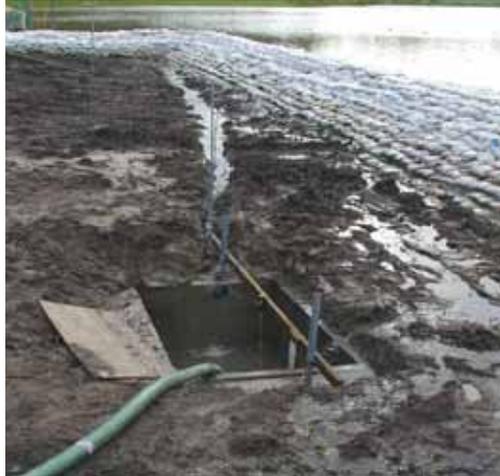
Figure 3-53. Seepage on protected side structure

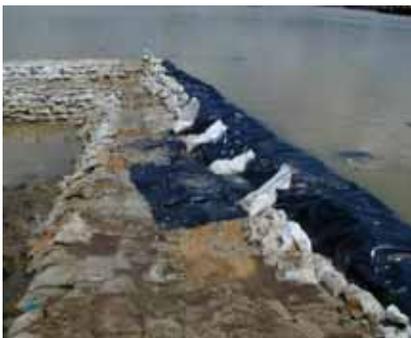
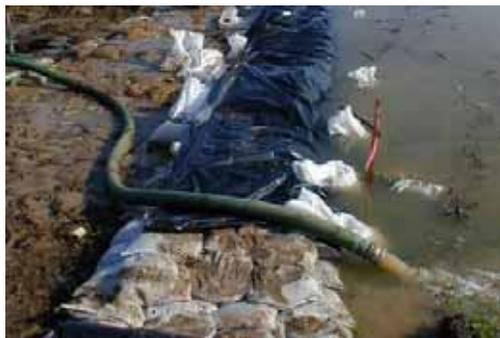
Figure 3-55. Attached plastic sheeting to east tieback of sandbag structure

a. Prior to overtopping

| <b>Table 3-1<br/>Sandbag Structure Field Testing Summary</b> | |
|--|---|
| Repairs | All Minor – Structural Integrity Not Threatened<br>Added Plastic Sheeting Immediately Prior to Overtopping to Reduce Seepage |

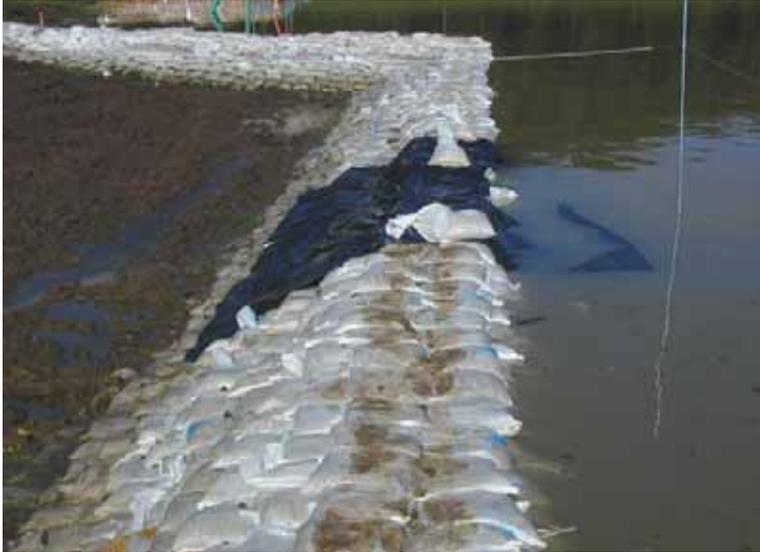
Figure 3-56. Plastic sheeting over riverward face

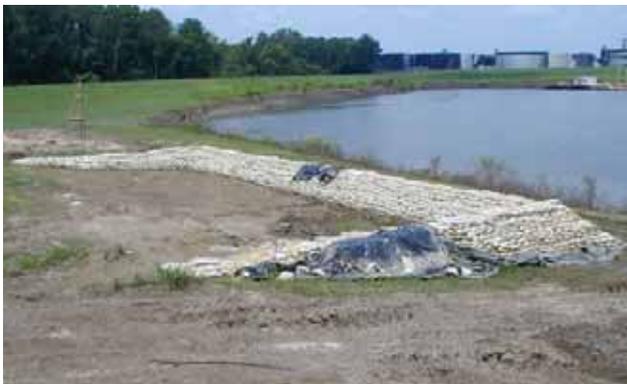
Before removal of the sandbags began, photographs were taken to document the effects of the water on the structure after being submerged for over 30 days (Figures 3-57 through 3-60). The structure was subjected to hot, wet weather for 2 months. During this time, deterioration of the sandbags was noticeable. On the morning of 19 July, removal of the sandbag structure was initiated. The weather was hot and humid with a heat index near 105 deg F. The removal process required two equipment operators, front-end loader, and a bulldozer. The removal began with the bags on the east tieback being pushed into a pile by the bulldozer. The front-end loader then scooped up the bags and carried them to the disposal area. This was repeated until the entire structure was completely removed (Figures 3-61 through 3-66). Removal of the sandbag structure took a total of 2.6 hr (3.5 man-hours). Unlike the other three product structures, the sandbag structure was not removed to be reused. Therefore, a direct comparison of removal times for the other three product structures to the removal time for the sandbag structure cannot be made.

Figure 3-57. Structure after being submerged

| <b>Table 3-1<br/>Sandbag Structure Field Testing Summary</b> | |
|--|---|
| Durability | The sandbag structure stayed in the field for 2 months and was subjected to hot, wet weather. The bags deteriorated badly. The Vicksburg District EM Office determined that sandbags did not meet specs (not adequate weave count). |

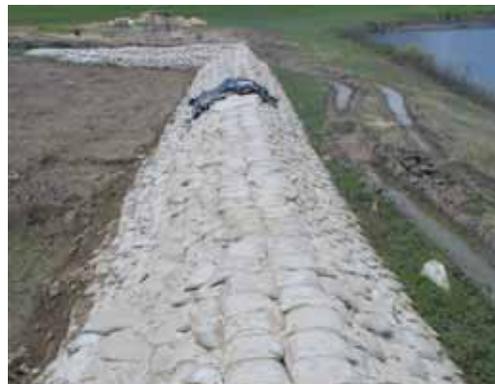
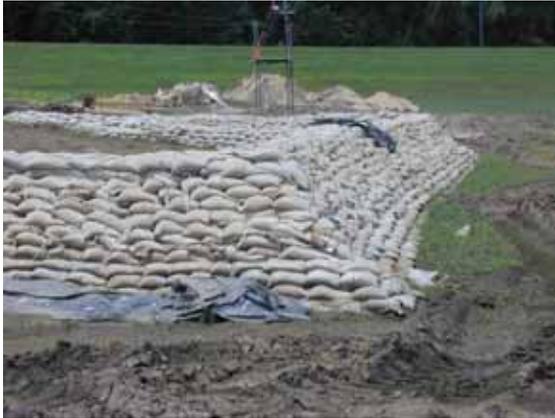
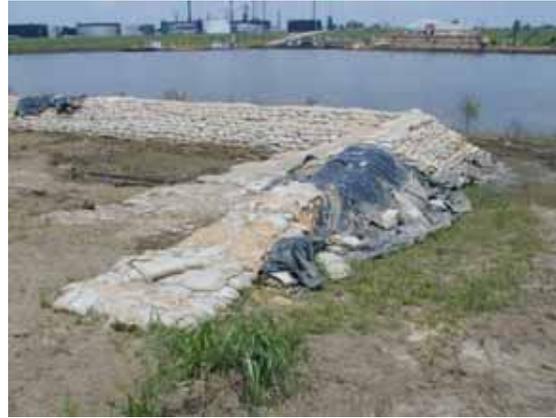
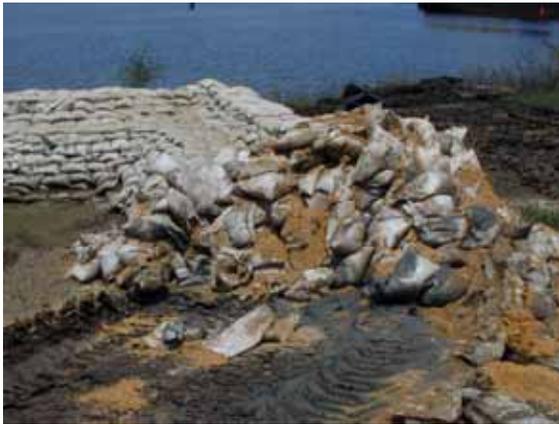
Figure 3-58. Riverward face

Figure 3-59. East side of structure

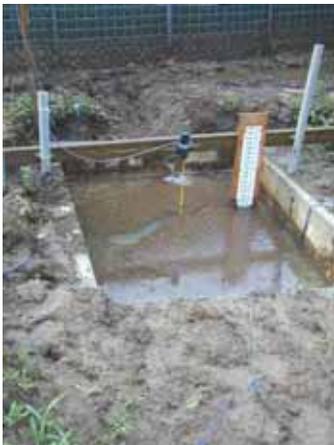
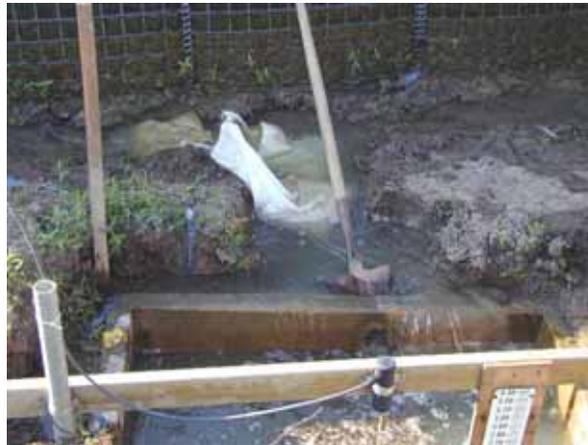
Figure 3-88. Hesco Bastion seepage collection tank

During the field test, seepage was collected in a buried concrete tank located on the protected side of the structure. Seepage rates were determined by computing the change in volume in the tank over a specific time. As the water level rose against the structure, seepage rates increased. Figure 3-88 shows two photographs of the Hesco Bastion structure seepage tank. The first photograph was taken on 6 June 2004 while the seepage rate was low. The second photograph was taken on 10 June 2004 when the seepage rate had increased noticeably. Figure 3-89 is a photograph of the seepage observed through the joint between adjacent units. Figure 3-90 shows the seepage water on the protected side of the structure. To determine seepage rates, the wetted area for each structure for a given water surface elevation was computed. Table 3-3 provides the seepage rates for the Hesco structure. The seepage rates for the Hesco Bastion structure were high. The seepage rates were high enough that the Hesco Bastion representative attempted repairs to try to reduce through seepage.

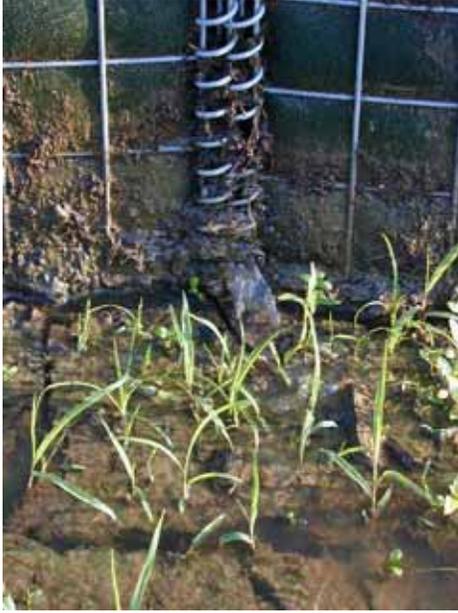
Figure 3-89. Seepage through joints

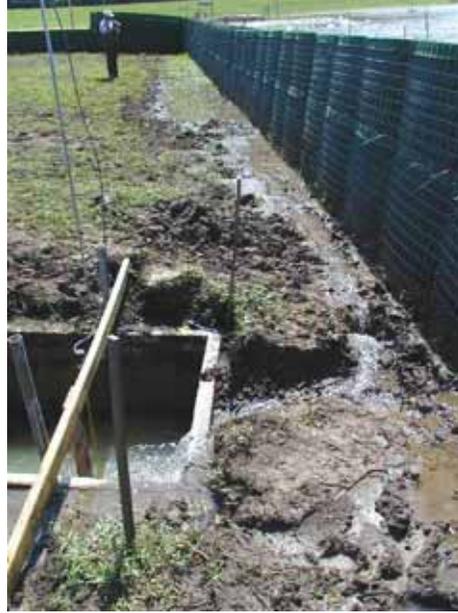
Figure 3-90. Seepage on protected side

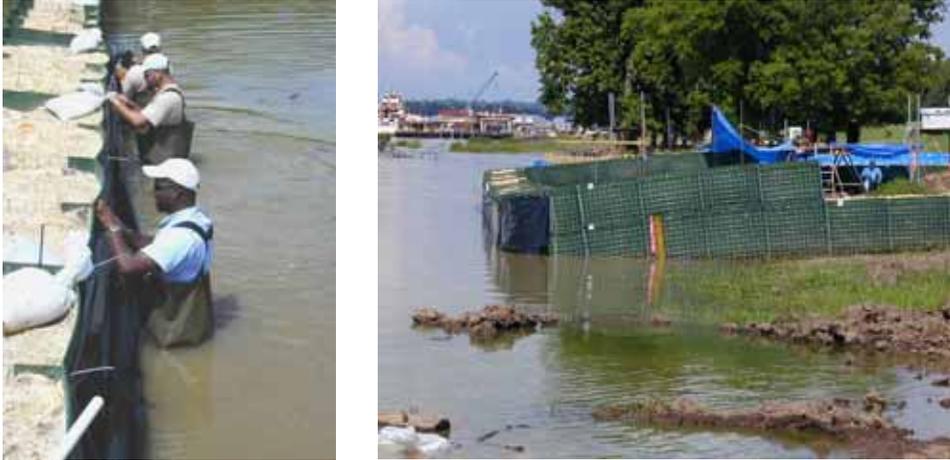
Figure 3-91. Attaching plastic sheeting to riverward face of Hesco Bastion structure

The first repair was made on 8 June and included the addition of plastic sheeting to the riverward face of the structure (Figure 3-91). This repair was made with 2.5 to 3.0 ft of water against the structure. The plastic sheeting was rolled out and attached to the top of the top layer units with zip-ties. The sheeting was weighted and held against the bottom of the base row units with sandbags. At the time that the repair was made, the seepage rate was approximately 4,000 gal/hr. The repair temporarily reduced seepage, with the rate falling to approximately 3,000 gal/hr. The repair was made on the afternoon of 8 June. By the morning of 9 June, the seepage rate had risen to approximately 4,300 gal/hr with only a few tenths of a foot rise in the river level.

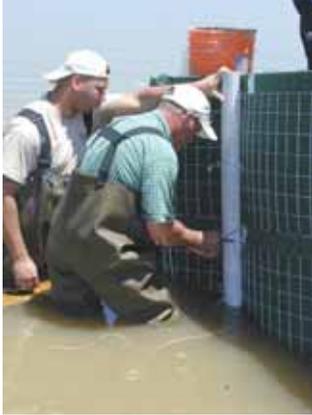
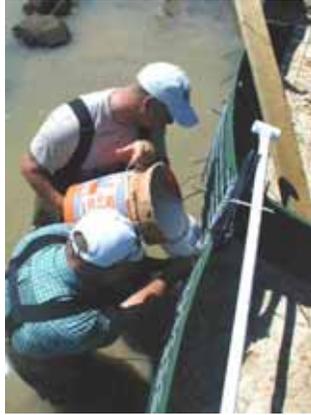
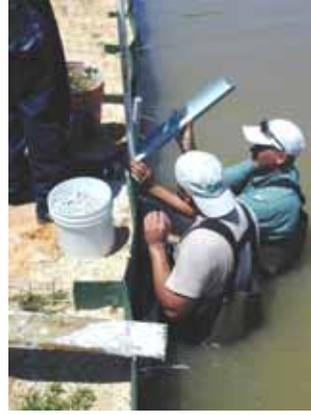
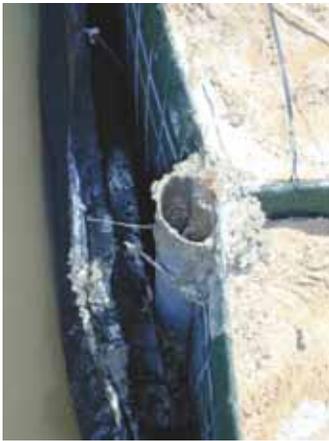
Figure 3-92. Attempt to reduce seepage using bentonite

The second repair was made on 9 June. This repair consisted of attaching half sections of 4-in. PVC sewer pipe across the unit joints with zip ties. Bentonite slurry, dry powder, and pellets along with sand was poured into the top of the pipes and packed down (Figure 3-92). Hesco representatives expected the bentonite in the pipes to swell and seal the joints. This repair was made with just over 3 ft of water against the structure. After the pipes were installed, the seepage rate continued to increase. Once the river levels dropped after the testing was completed, the Hesco Bastion structure was visually inspected. Apparently, an excess of bentonite was packed into the pipes. As the bentonite swelled, the pipes were pushed away from the joints thus providing no sealing of the joints.

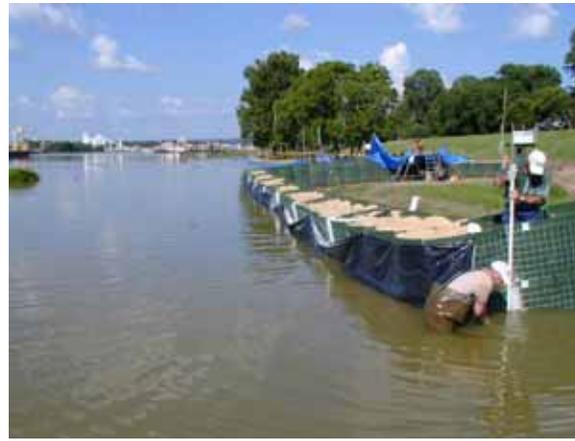
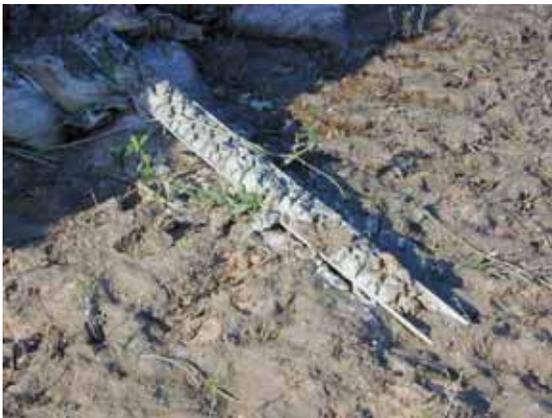
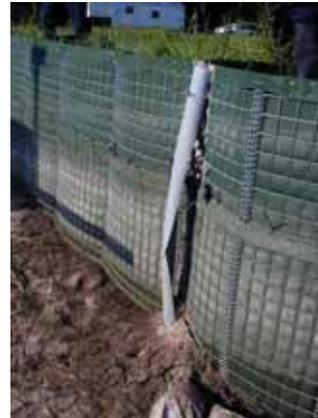
d. Pipe with bentonite

e. Packing bentonite into pipes

f. Bentonite-filled pipes after water receded

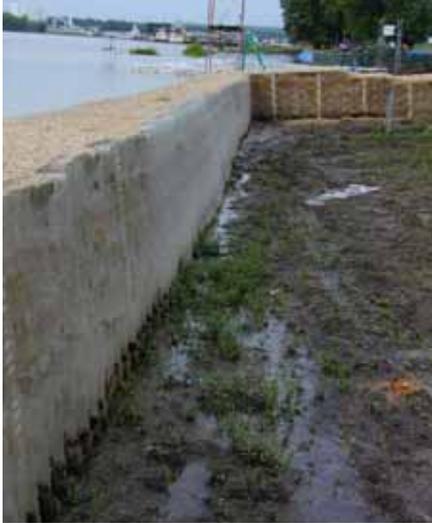
The structure was continuously monitored for structural damage, material loss, and structure failure or fatigue. The seepage rate was calculated a minimum of four times per day. Measurable seepage began 6 June 2004. Figures 3-120 and 3-121 show the seepage water flowing within the structure and collecting in the sump tank.

Figure 3-120. Seepage behind RDFW structure

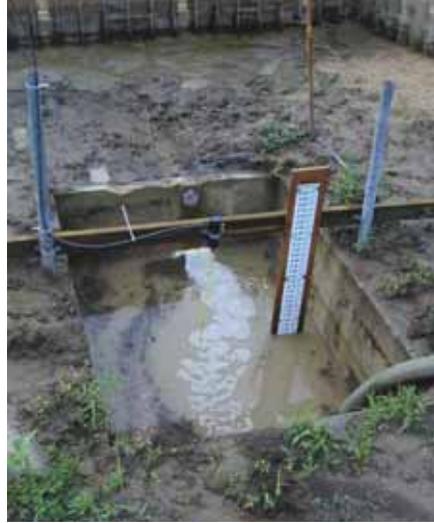
Figure 3-121. Seepage collection in sump tank

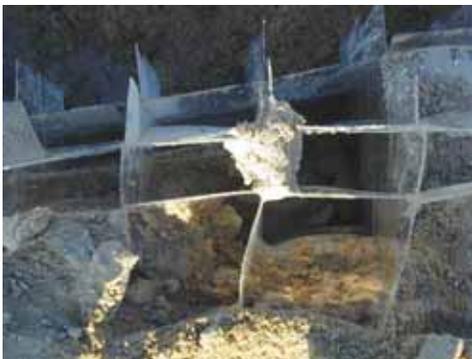
During testing, no major repairs were required to the RDFW structure. One minor repair performed by the RDFW representative was to refill units where the sand was washed out where the units had not been properly placed during construction (Figures 3-122 and 3-123). This repair was accomplished by adding sand to the washed-out compartments of the units (Figures 3-124 and 3-125). The repairs were completed by one RDFW representative, four government laborers, and one government equipment operator using shovels and a backhoe. Also during testing, a small sand boil (or pin boil) developed in the northeast corner of the structure near the sump tank. The boil was contained by placing a RDFW half unit over the boil (Figures 3-126 and 3-127).

Figure 3-122. Fill material washed out of units (view down from top)

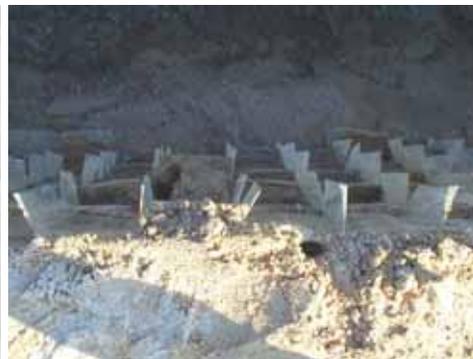
Figure 3-123. Shifting of units (view down front edge from top)

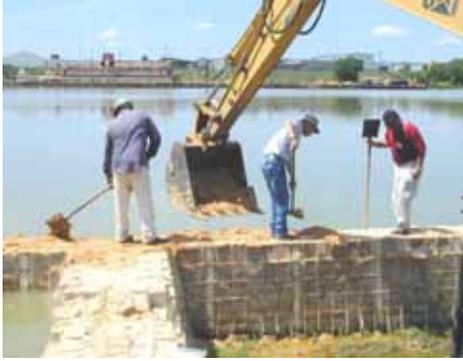
Figure 3-124. Replacing sand washed out or lost from shifted units

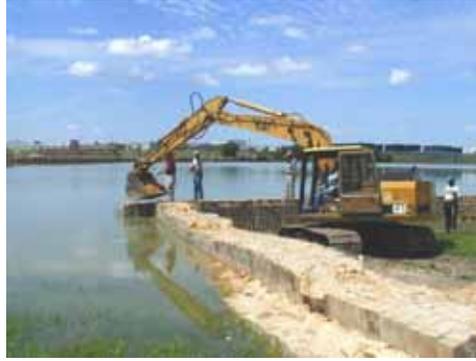
Figure 3-125. Trackhoe replacing sand field

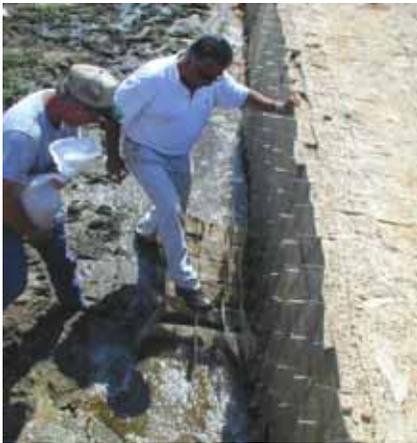
Figure 3-126. Using RDFW unit to contain sand boil

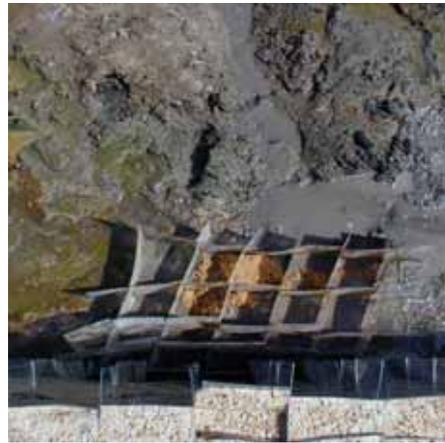
Figure 3-127. Contained sand boil

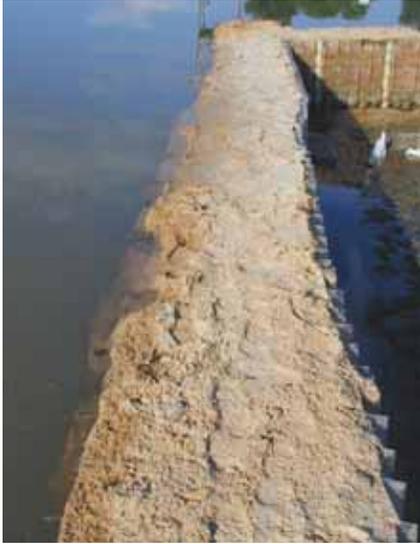
Testing ended when the structure was overtopped by water flowing freely over the structure. Overtopping occurred on 11 June 2004 with the water level on the structure at 4.2 ft. Figures 3-128 and 3-129 show the RDFW structure just before and during overtopping on 11 June 2004, 6 days after the beginning of the testing process. Final overtopping is shown in Figure 3-130.

Figure 3-128. RDFW structure before overtopping

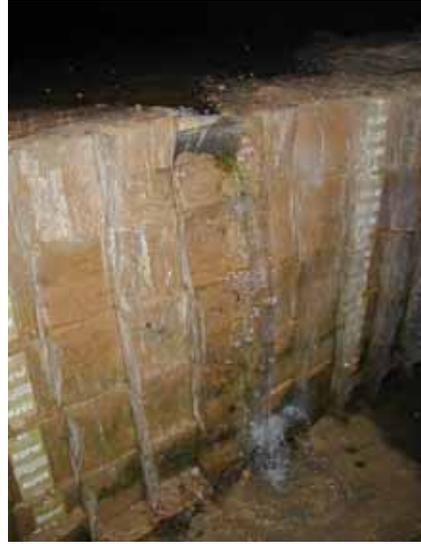
Figure 3-129. Overtopping of RDFW structure

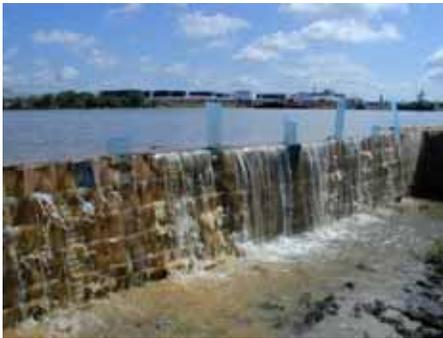
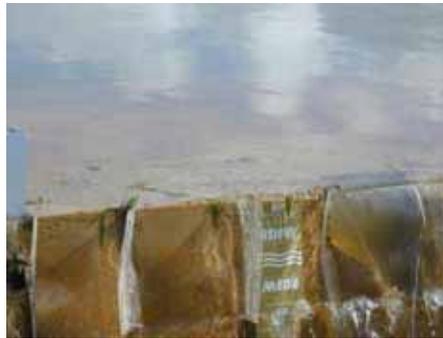
Figure 3-130. Final overtopping of RDFW structure

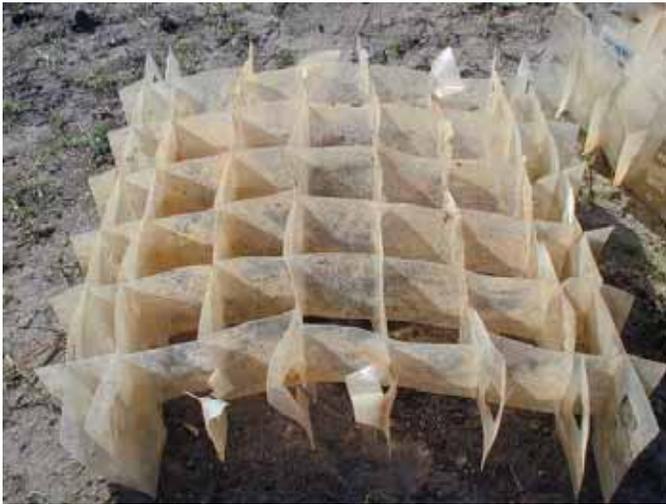
Once removed, the RDFW units were inspected for damage. Some damage to the units was identified (Figure 3-144). The most damage was to the top row, bottom row, and the end units. Some individual panels of these units could be saved with the damaged pieces being replaced. Once the damaged pieces are replaced, the unit is reusable. Each RDFW unit consists of 14 pieces. Geocell Systems conducts a replacement procedure that they term “cannibalize” the units. This procedure includes the removal and replacement of damaged pieces within a unit with undamaged pieces to make the unit reusable. While minor damage was sustained during testing from the units shifting against the weight of the water, most of the damage to the RDFW units occurred during removal. Damage to the bottom units was attributed to the use of heavy machinery. By approximate field estimates, approximately 90 percent of the units were reusable.

Figure 3-144. Damaged RDFW unit

The units can be cleaned by washing the sand, mud, and debris off with a garden hose. However, they were not cleaned during this project. The used units that were not damaged or could be repaired (cannibalized) were folded flat and returned to the wooden crates. The units damaged beyond repair were disposed of.

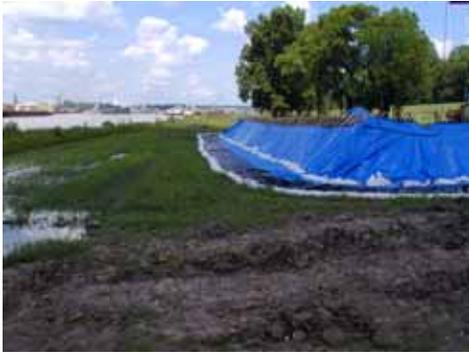
The Portadam structure was constructed during May 2004 during a time when the river was receding. The river began to rise in early June, and by the morning of 5 June approximately 0.3 ft of water was standing against the Portadam structure. Figures 3-158 through 3-165 are a series of daily photos of the Portadam structure during the field testing. As the river continued to rise, the structure was subjected to greater static loadings. Daily water levels against the structures are given in figure captions. These water levels were determined from the 8 a.m. readings for the Mississippi River at the Vicksburg gage. Testing of the Portadam structure ended early on the morning of 11 June when the structure overtopped and flow over the structure exceeded the pump capacity on the protected side.

Figure 3-158. 4 June 2004, no water against structure

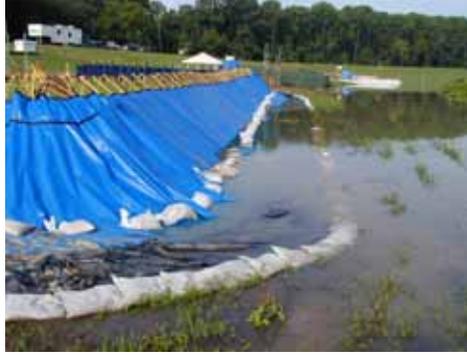
Figure 3-159. 5 June 2004, 0.3 ft of water against structure

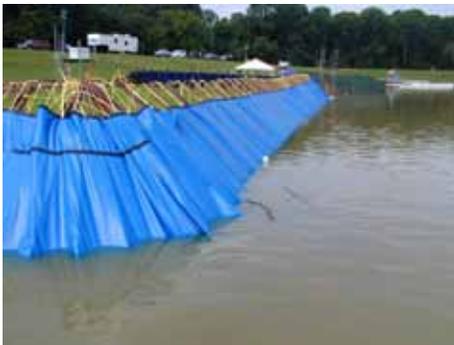
Figure 3-160. 6 June 2004, 1.3 ft of water against structure

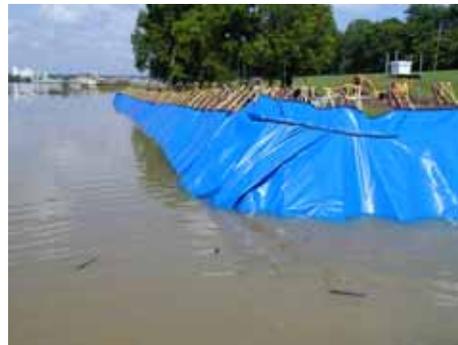
Figure 3-161. 7 June 2004, 2.1 ft of water against structure

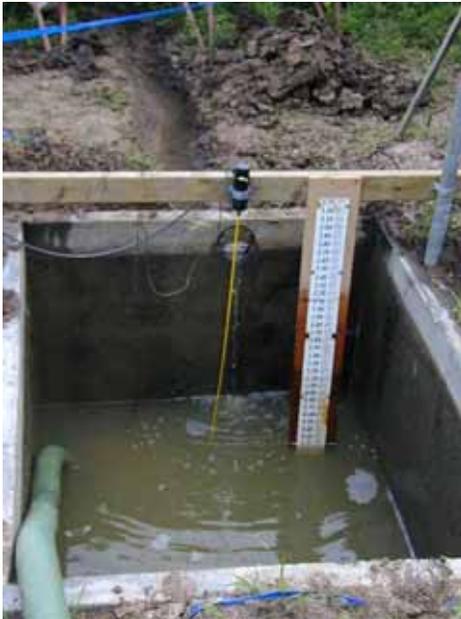
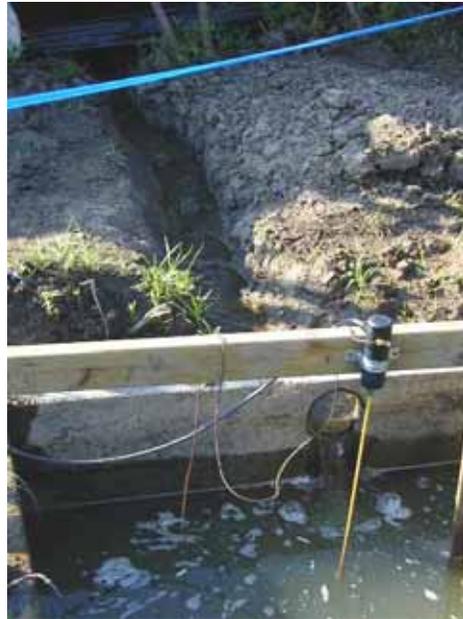
During the field test, seepage was collected in a buried concrete tank. Seepage rates were determined by computing the change in volume in the tank over a specific time. Seepage began as soon as the river rose high enough to put water against the structure. As the water levels continued to rise, the structure experienced only limited increases in seepage. Figure 3-166 shows the Portadam structure seepage tank. The first photo was taken on 6 June 2004 with less than 1.5 ft of water against the structure. The second photo was taken on 10 June 2004 with over 3.5 ft of water against the structure. These photographs indicate that the seepage was not significantly greater on 10 June than it was on 6 June. Table 3-10 shows the seepage rate for the Portadam structure, which only gradually increased as the water levels against the structure increased. At the time that the Portadam structure overtopped, its seepage rate was the lowest of the four structures.

Figure 3-166. Portadam seepage collection tank

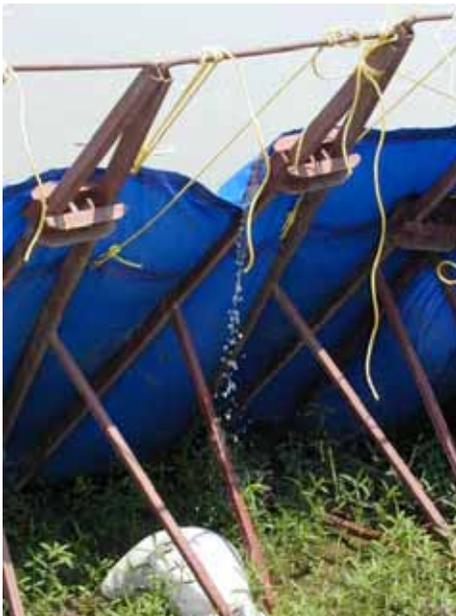
During testing, no major repairs were required to the Portadam structure. However, two minor repairs and one standard preparation for overtopping were made. The minor repairs consisted of removing slack in the top of the liner membrane where the membrane was sagging. At these two locations, water began to flow over the top of the liner membrane on 10 June 2004 (Figure 3-167). The first repair included folding the top of the liner over on top of itself and holding it in place with a pair of vice grip pliers (Figure 3-168). The second repair included clamping off in the northeast 90-degree turn a section of liner with two pieces of a wooden survey stake and two c clamps (Figure 3-169). These repairs allowed for a more uniform overtopping of the structure. At the request of the Portadam representative, government laborers made the typical overtopping preparation, which consisted of placing plastic sheeting on the ground along the overtopping impact zone. This sheeting reduces the potential for erosion around the supporting frame. Figure 3-170 is a photograph of the installed plastic sheeting.

Figure 3-167. Sagging liner
