*General Investigation Research and Development Program*

## **Flood-Fighting Structures Demonstration and Evaluation Program: Laboratory and Field Testing in Vicksburg, Mississippi**

July 2007

Final report

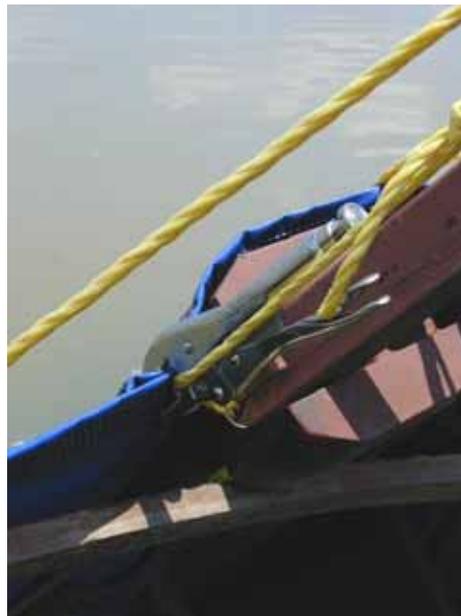
Figure 3-168. Sagging liner repair (repair 1)

During testing, no major repairs were required to the Portadam structure. However, two minor repairs and one standard preparation for overtopping were made. The minor repairs consisted of removing slack in the top of the liner membrane where the membrane was sagging. At these two locations, water began to flow over the top of the liner membrane on 10 June 2004 (Figure 3-167). The first repair included folding the top of the liner over on top of itself and holding it in place with a pair of vice grip pliers (Figure 3-168). The second repair included clamping off in the northeast 90-degree turn a section of liner with two pieces of a wooden survey stake and two c clamps (Figure 3-169). These repairs allowed for a more uniform overtopping of the structure. At the request of the Portadam representative, government laborers made the typical overtopping preparation, which consisted of placing plastic sheeting on the ground along the overtopping impact zone. This sheeting reduces the potential for erosion around the supporting frame. Figure 3-170 is a photograph of the installed plastic sheeting.

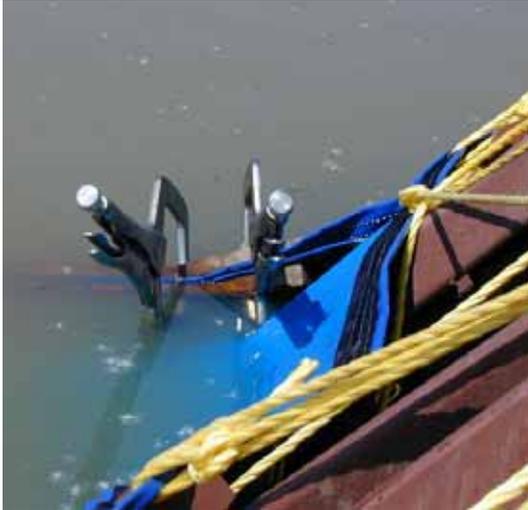
Figure 3-169. Sagging liner repair (repair 2)

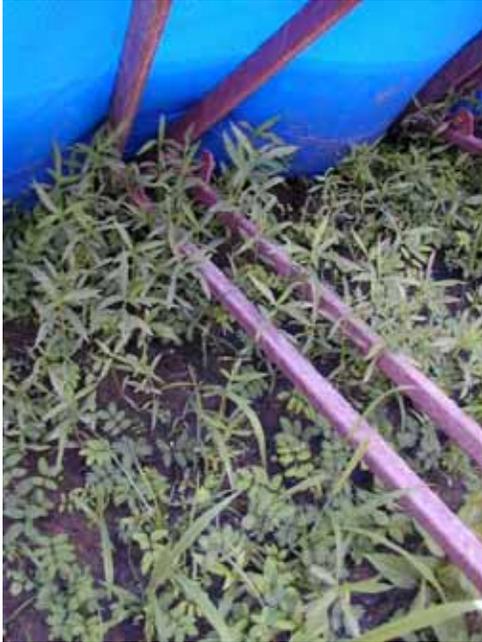
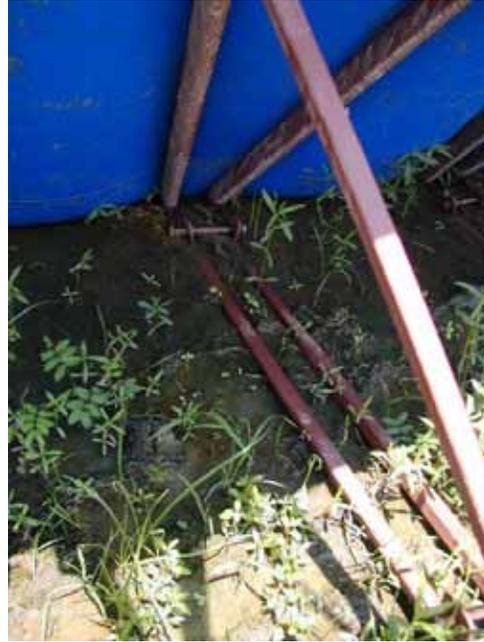
As the river rose, the ground around the riverward face of the supporting frame became saturated. The weight of the water on the structure pushed the supporting frame into the saturated soil approximately 4 in. (Figure 3-171). The sinking of the supporting frame increased structural stability by reducing the potential of sliding but also reduced the height of the structure. Reducing the structure height resulted in a decreased level of protection. The weight of the water also applied a significant load on the liner, especially around the corners where excess liner is located and at the connection between the two sections of liner. Though stressed, no damage to the liner was observed. Figure 3-172 shows the excess liner sagging between the supporting frame members. Figure 3-173 shows the stress on the liner seam.

a. Unsunk frame along east tieback

b. Sunk frame along riverward face

Figure 3-171. Reduced protection due to sinking of supporting frame

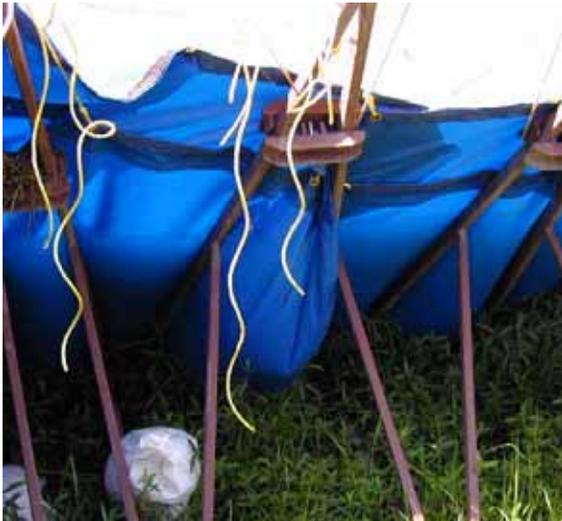
Figure 3-172. Sagging of liner between supporting frame members

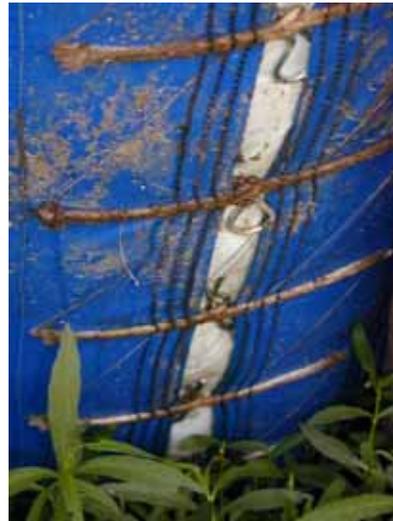
Figure 3-173. Stressed liner seam

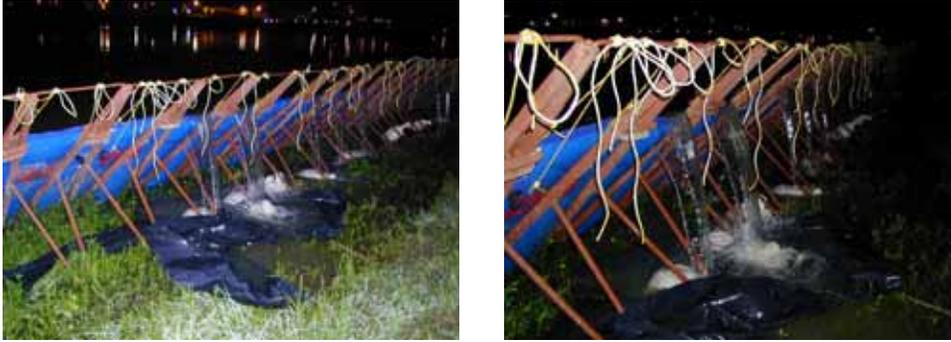
Early in the morning hours of 11 June 2004, the Portadam structure overtopped. By 5 a.m., the structure was overtopped at nine separate locations along the riverward face (Figure 3-174). Shortly thereafter, the pump capacity on the protected side of the structure was exceeded. At that point, the pump was removed and testing ended (Figure 3-175). Figure 3-176 is a photograph of the Portadam structure after the field testing had ended and the protected side had filled with water.

Figure 3-174. Overtopping of Portadam structure
