TECHNICAL REPORT HL-90-19

A STUDY OF VEGETATION ON REVETMENTS SACRAMENTO RIVER BANK PROTECTION PROJECT

PHASE 1

LITERATURE REVIEW AND PILOT STUDY

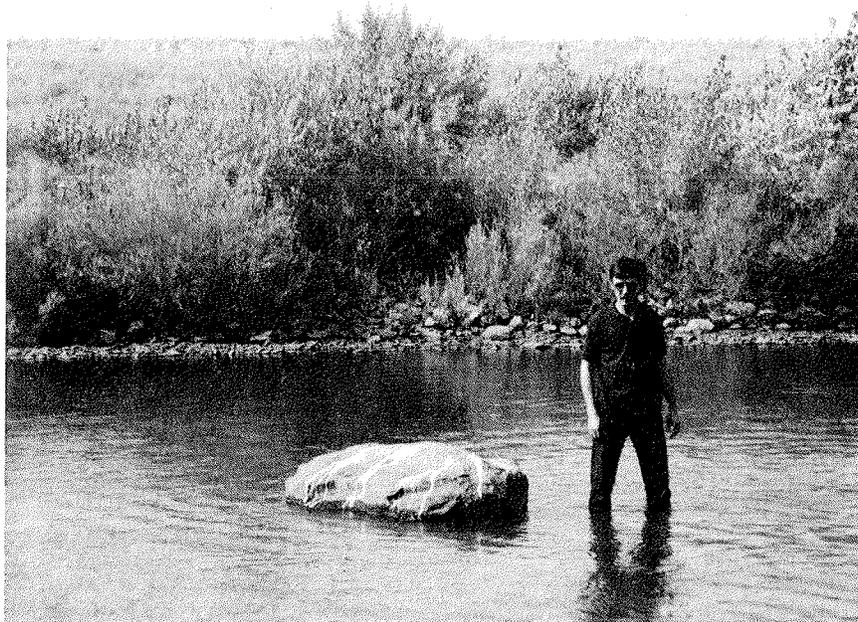
Figure 6. Volunteer vegetation in riprap revetment, South Platte River below Chatfield Reservoir, near Denver, CO, September 1989

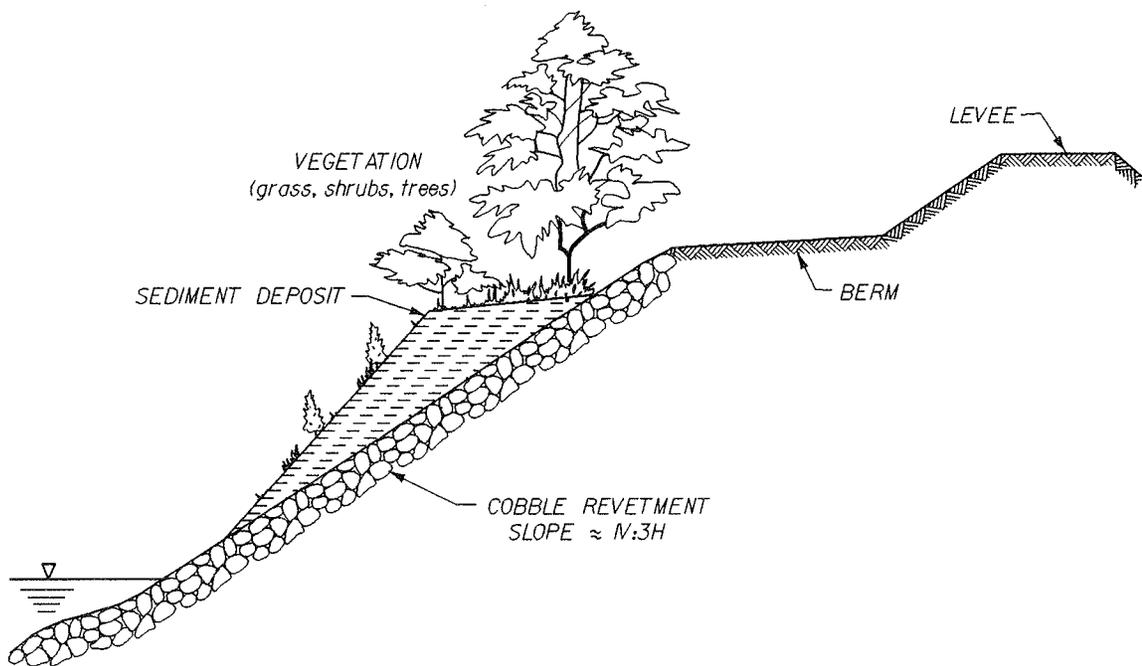
Figure 15. Cross section through a typical vegetated sediment deposit on a cobble revetment

Most of the cobble revetments were covered with wedge-shaped sediment deposits as shown in Figure 15. The faces of the wedges extended from near

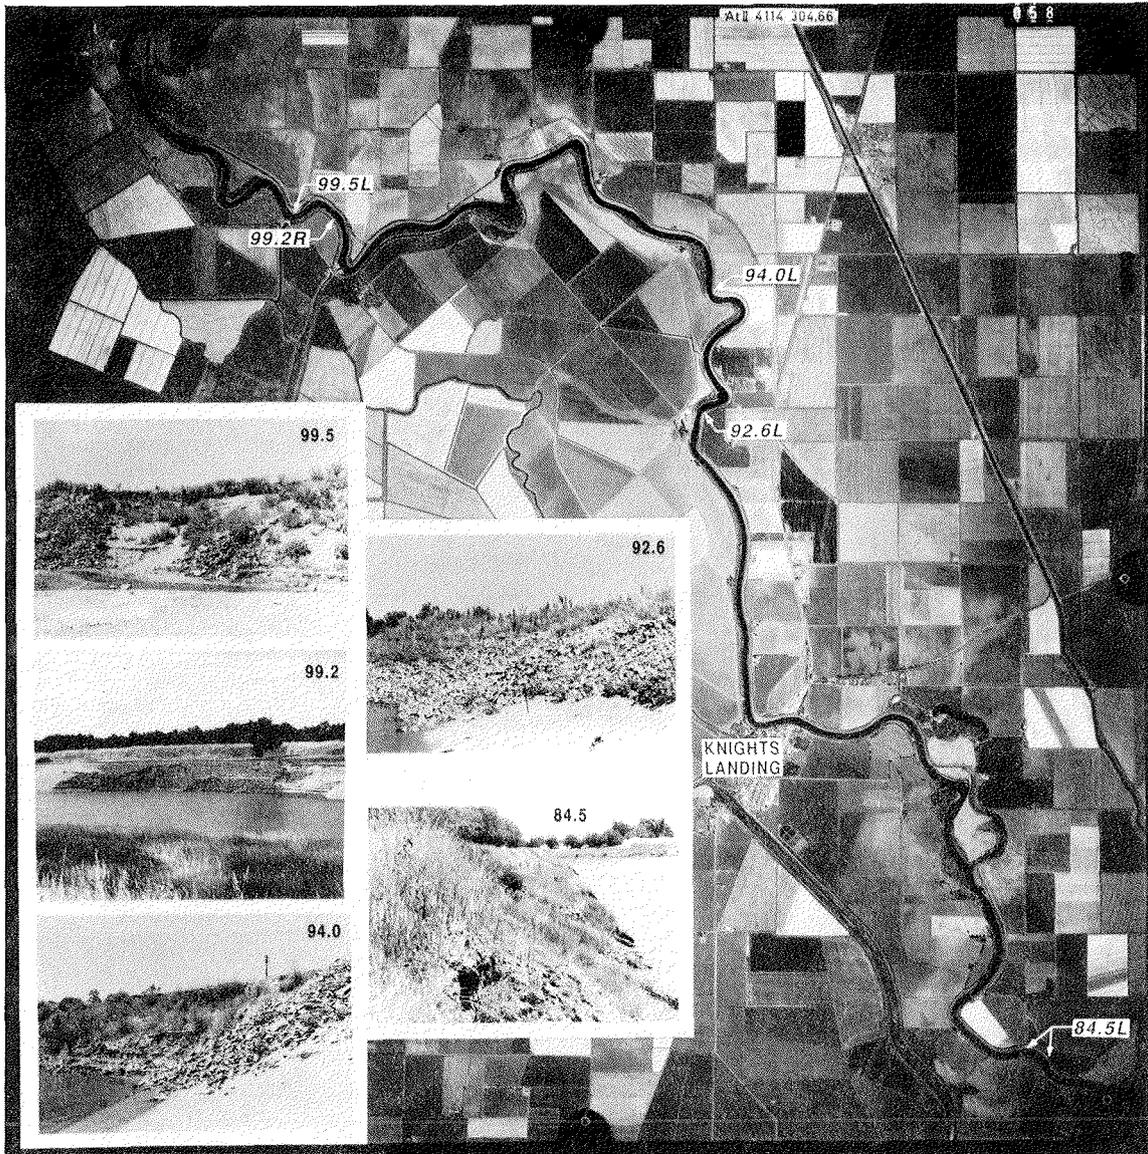
The five PL-99 1986 flood damage sites in the pilot study reach were inspected. The relative locations of these sites are shown in Figure 19. Photographs of each site from 1986 are shown as Figures 20a-e. Construction data and information from the PL-99 files are given in Tables 4 and 6. Of the five sites in the pilot study reach, only 94.0L was repaired after the 1986 flood. None of the sites supported large vegetation.

Figure 19. Location of 1986 flood PL-99 damage sites, pilot study reach, Sacramento River

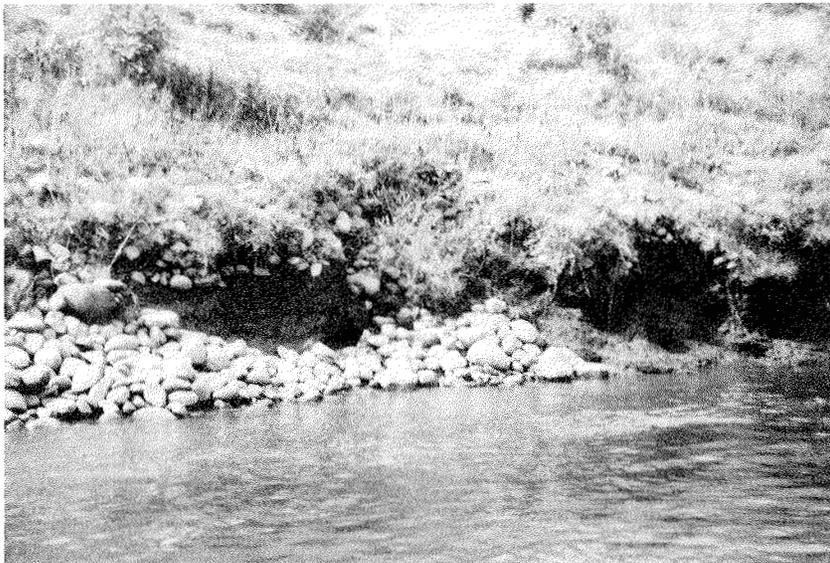
b. RM 101.3R

Nearly all of the cobble revetment damage appeared to be related to toe failure. These sites were characterized by an unprotected vertical channel bank surface that rose from the water, as shown in Figure 21a. The toe material at these locations was cohesive. Cobble was generally present at the top of the vertical surface, as shown in Figure 20b, and was generally found on the channel bottom adjacent to the vertical surface. (This was verified by probing with a boathook.) No upper bank problems were present at most of the sites. Usually the sediment berm above these failures was either undisturbed or had a failure plane at the location of the vertical clay face. The length and height of the damaged areas varied widely, but they were generally less than 50 ft long and 4 ft high. Other toe failures occurred as underlying bank material was removed and rock was launched along irregular failure surfaces.

Figure 21. Typical cobble revetment damage observed in pilot study reach

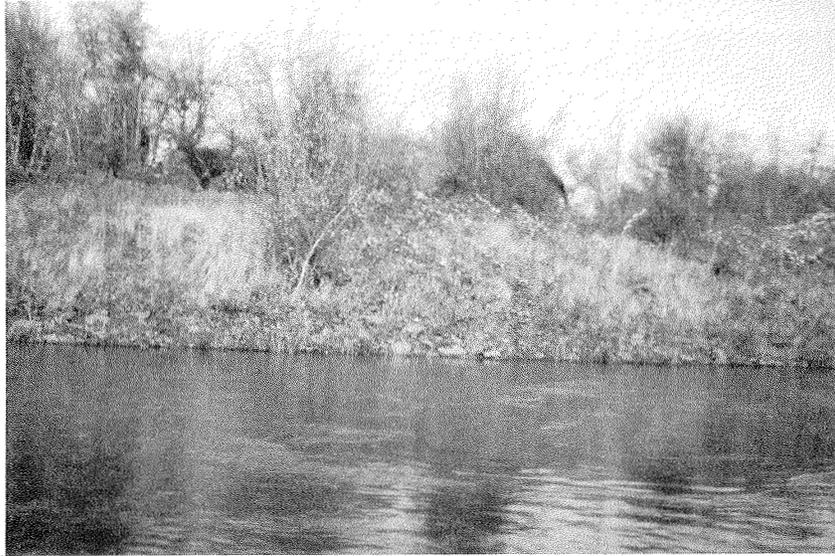
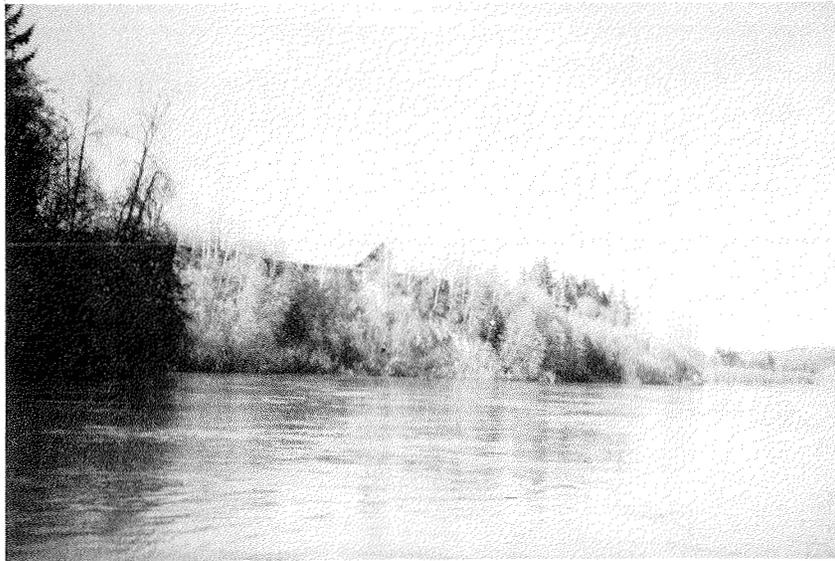
Figure 31. Vegetation observed on Willamette River revetments, November 1981

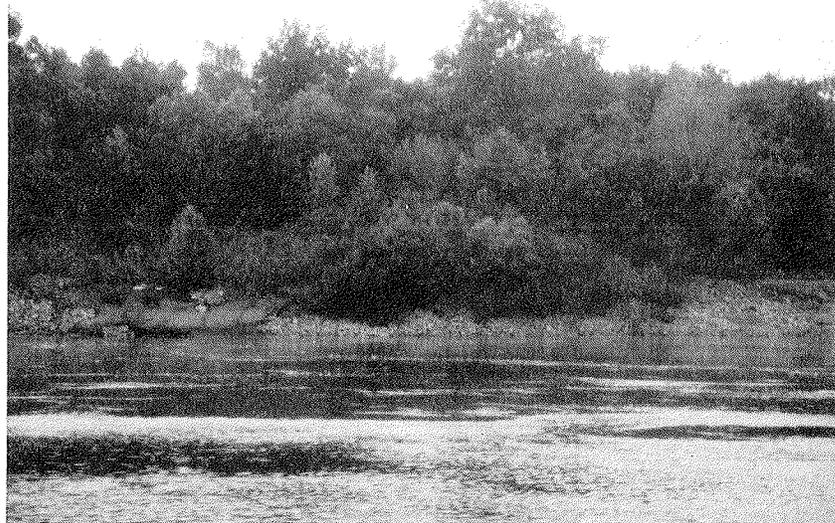
Figure 35. Catfish Point Revetment, Mississippi River, RM 574, October 1989

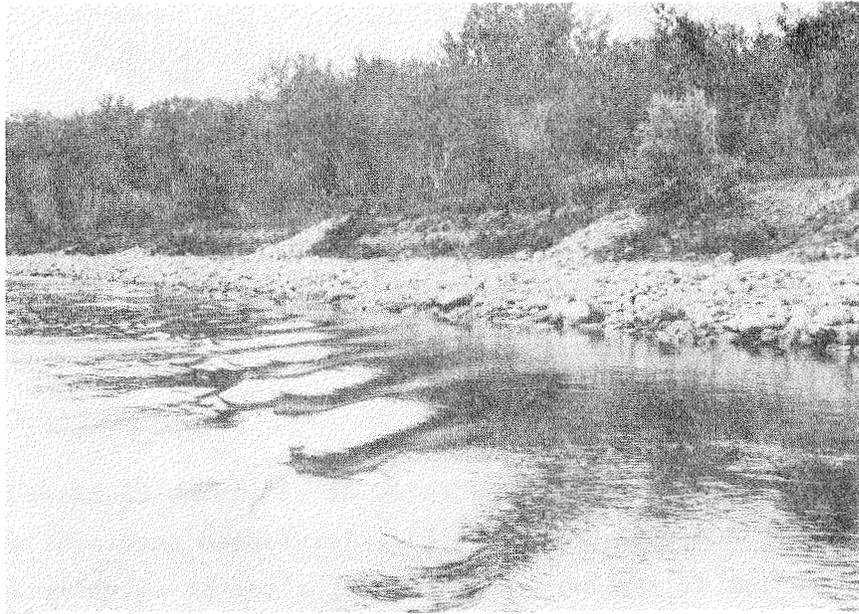
a. Reinforced revetment construction showing tiebacks

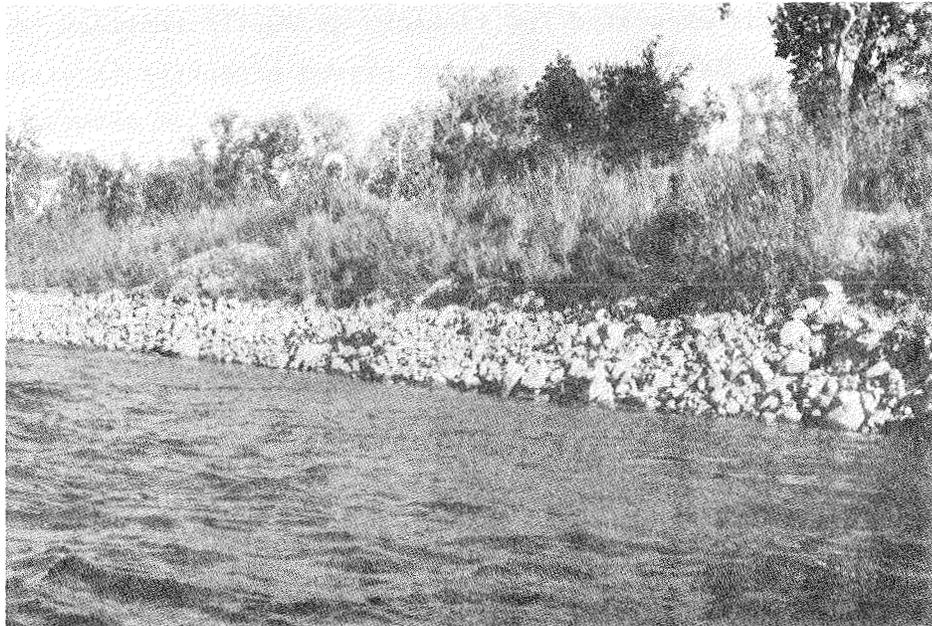
b. Vegetation established between tiebacks
