Technical Report HL-95-13
March 1996

Redeye Crossing Reach, Lower Mississippi River

Report 2 Navigation Conditions

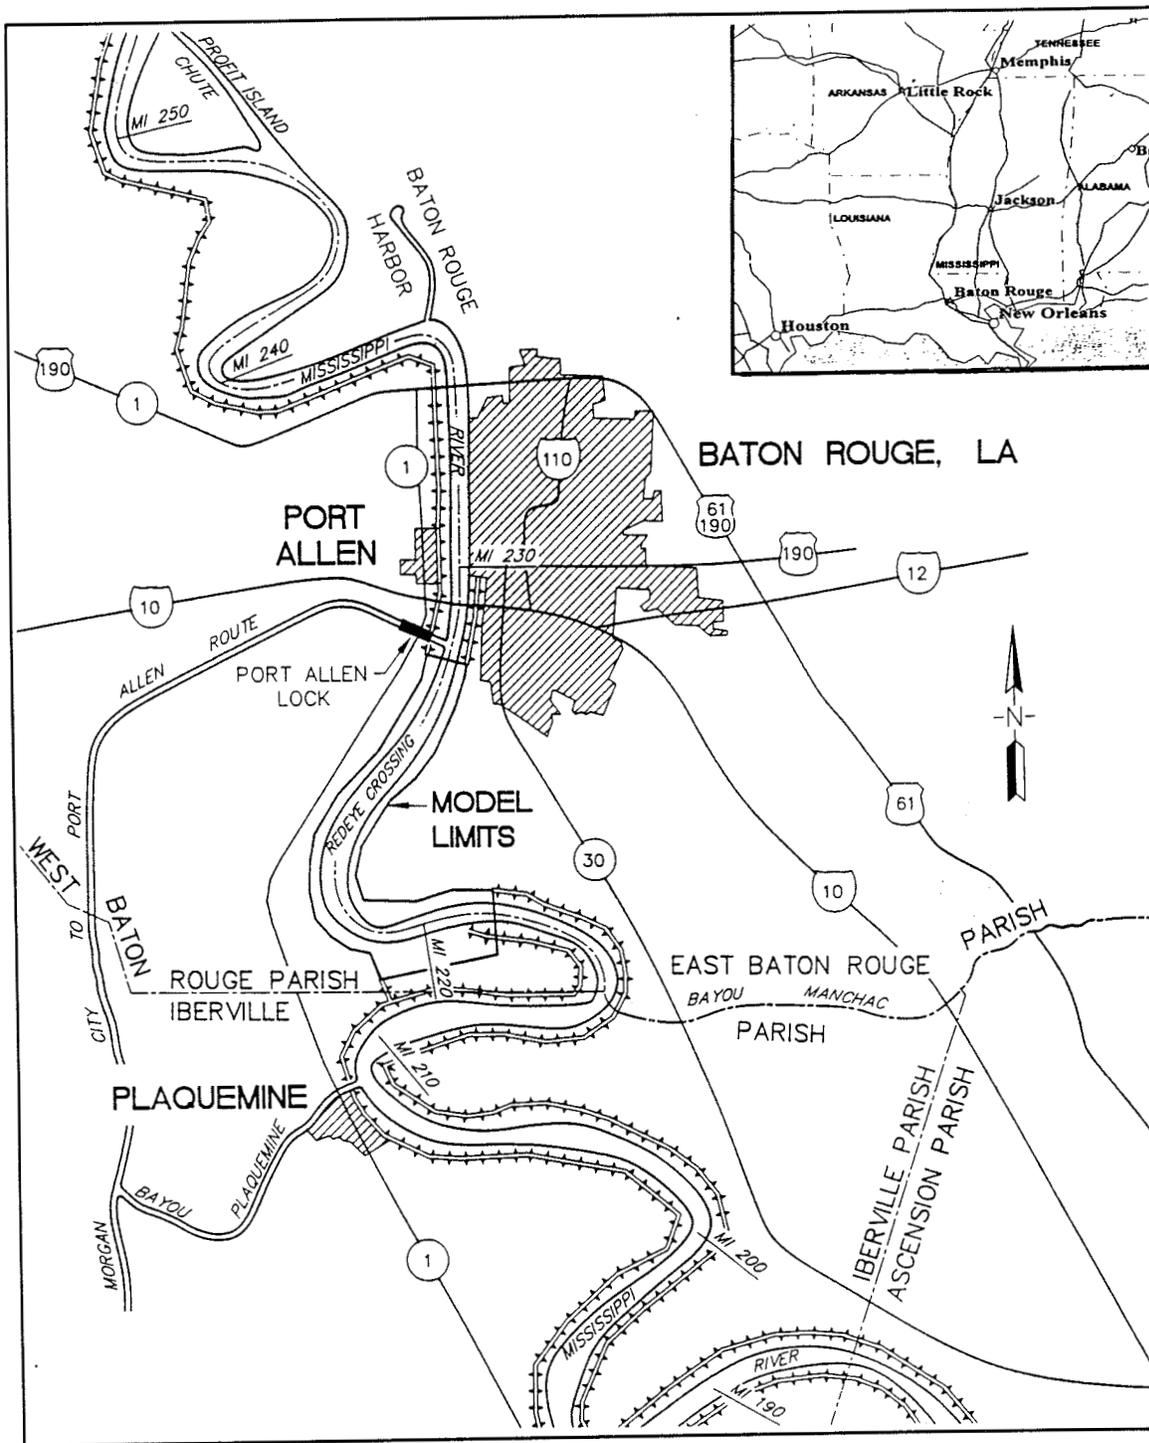
Figure 1. Vicinity map

Redeye Crossing is located on the lower Mississippi River between River Miles 223 and 225 Above Head of Passes (AHP) about 3 miles¹ downstream of the I-10 Highway bridge at Baton Rouge, LA (Figure 1). Traffic on this section of river consists of tows from 1 to 49 barges powered by towboats from 800 to over 10,000 hp. Oceangoing vessels with drafts up to 40 ft use the deepwater channel. The present channel requires approximately 3 million cubic yards of dredging annually to maintain the 40-ft deep-draft navigation channel through the crossing. The proposed 45-ft deep-draft navigation channel would require increased maintenance dredging. Several studies have shown that dredging can be reduced by altering the hydrodynamics of a system through strategically implementing training structures.

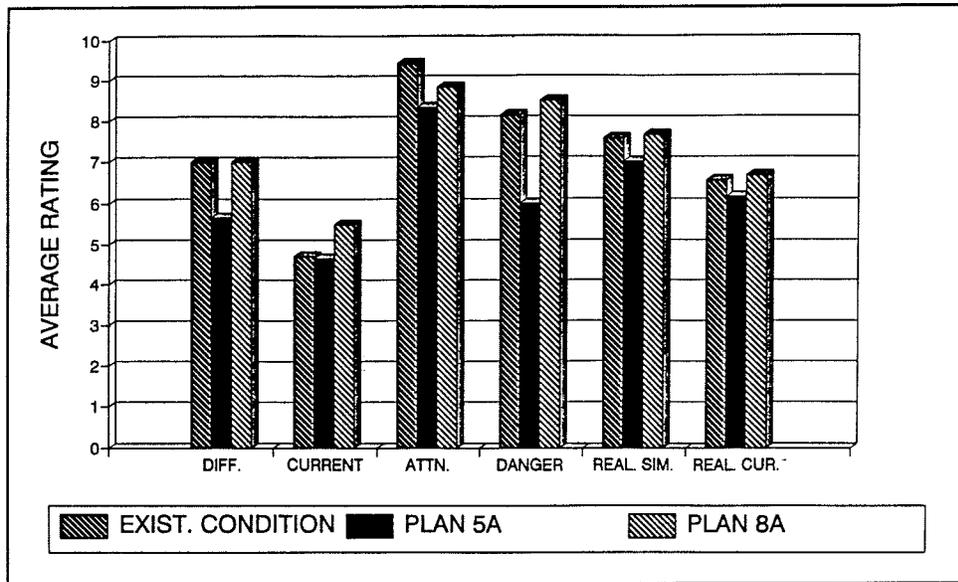
Figure 2. Ship pilot ratings, 228,000-cfs flow, upstream runs

Upstream runs, 228,000-cfs flow. For all questions, the pilots rated Plan 5A about the same as or lower than the existing condition (Figure 2). The largest difference of rating was for danger of grounding or striking an object where the plan condition was actually rated considerably lower than the existing condition. Plan 8A was rated as almost the same or slightly higher for all questions than the existing condition, except for attention required, where it was rated slightly lower than the existing condition.

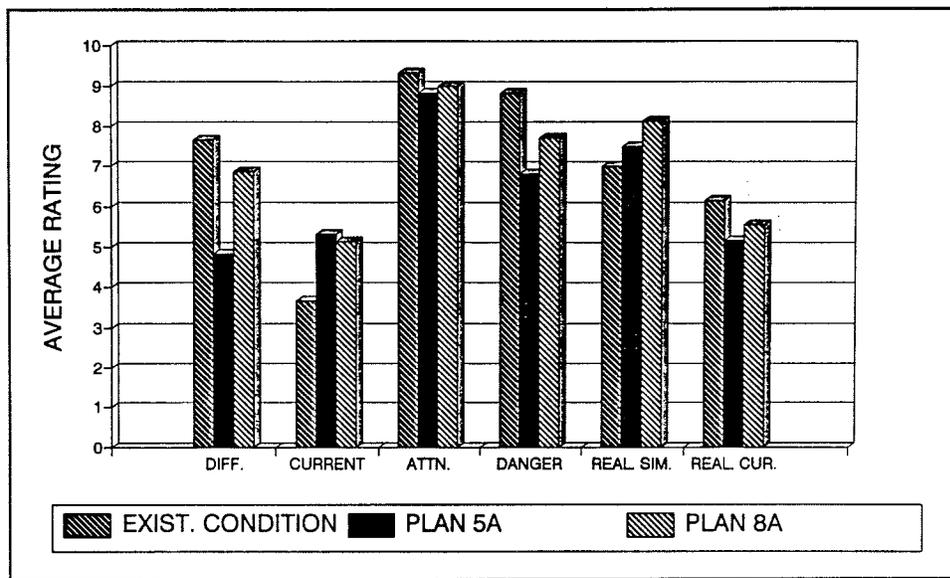
Figure 3. Ship pilot ratings, 228,000-cfs flow, downstream runs

Downstream runs, 228,000-cfs flow. The ratings for this flow condition (Figure 3) show that the pilots rated the two plan channels slightly lower than the existing channels for all but current effect and simulator realism. Difficulty of run, danger of grounding or striking an object, and attention required were rated lower for the plan channels (considerably lower for Plan 5A) than the existing condition, even though the current effect was rated considerably higher for the plan channels than the existing.

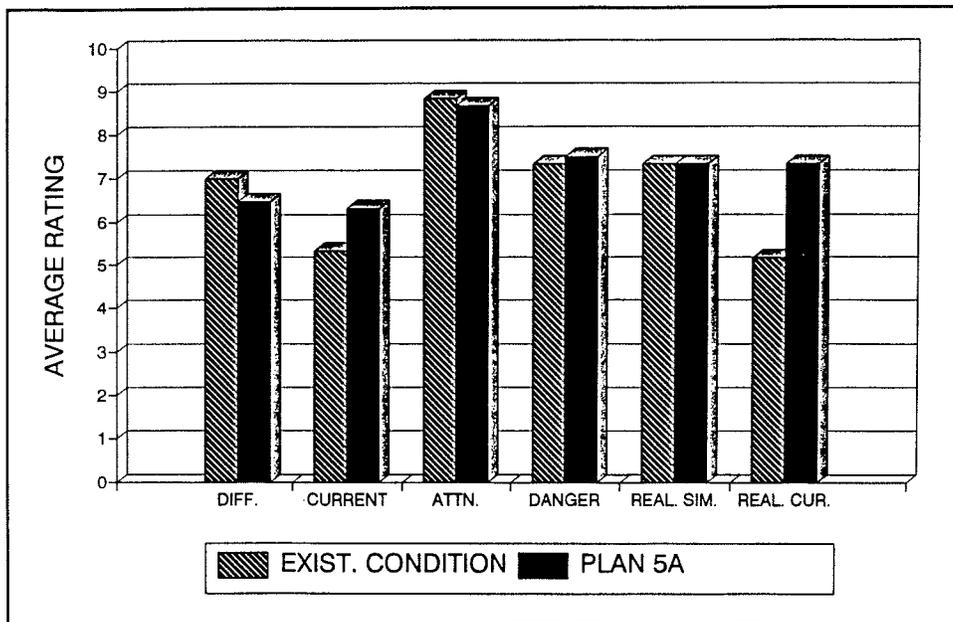
Figure 4. Ship pilot ratings, 450,000-cfs flow, upstream runs

Upstream runs, 450,000-cfs flow. Difficulty of run, attention required, danger of striking an object, and simulator realism were rated almost equally or slightly lower for Plan 5A than the existing condition (Figure 4). Current effects and current realism were rated higher for Plan 5A than the existing condition.

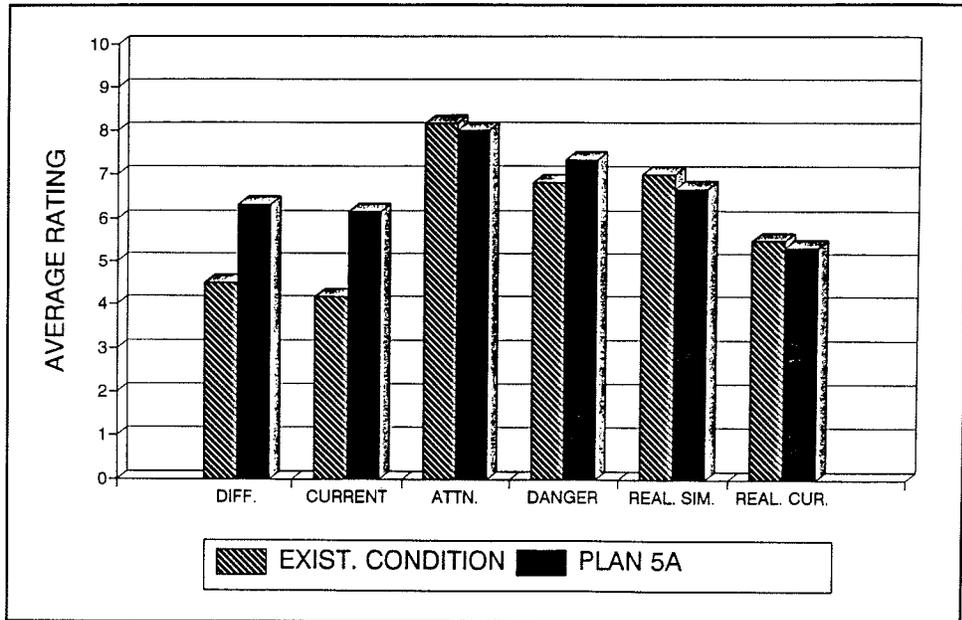
Figure 5. Ship pilot ratings, 450,000-cfs flow, downstream runs

Downstream runs, 450,000-cfs flow. Plan 5A rated nearly the same or higher in all questions than the existing condition (Figure 5). The pilots rated difficulty of run and current effects to be much higher than with the existing condition but rated the danger of striking an object or grounding only slightly higher.

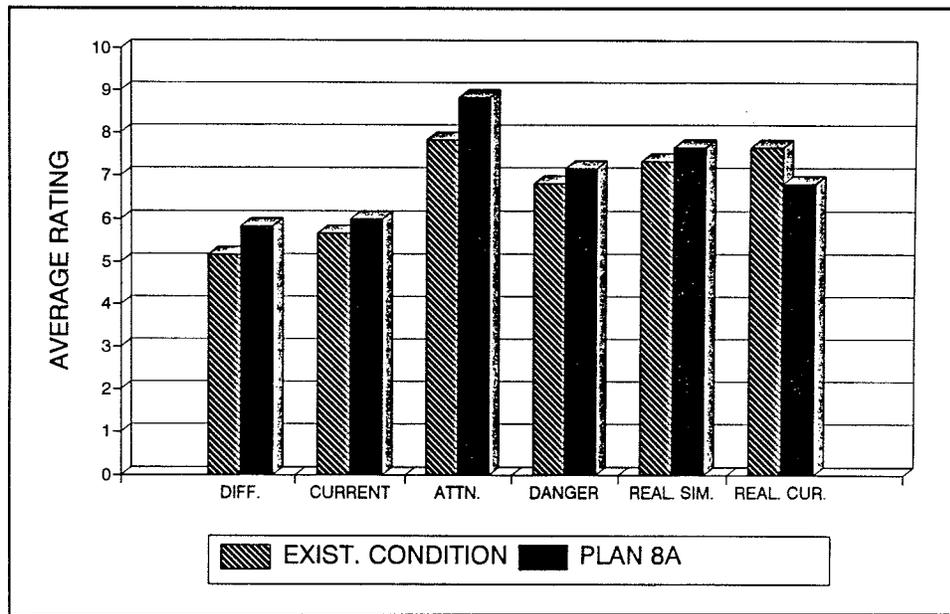
Figure 6. Ship pilot ratings, 530,000-cfs flow, upstream runs

Upstream runs, 530,000-cfs flow. The ratings for all questions, except current realism, are higher for Plan 8A than for the existing condition (Figure 6). The differences in the ratings are small except for attention required, which had a significantly higher rating.

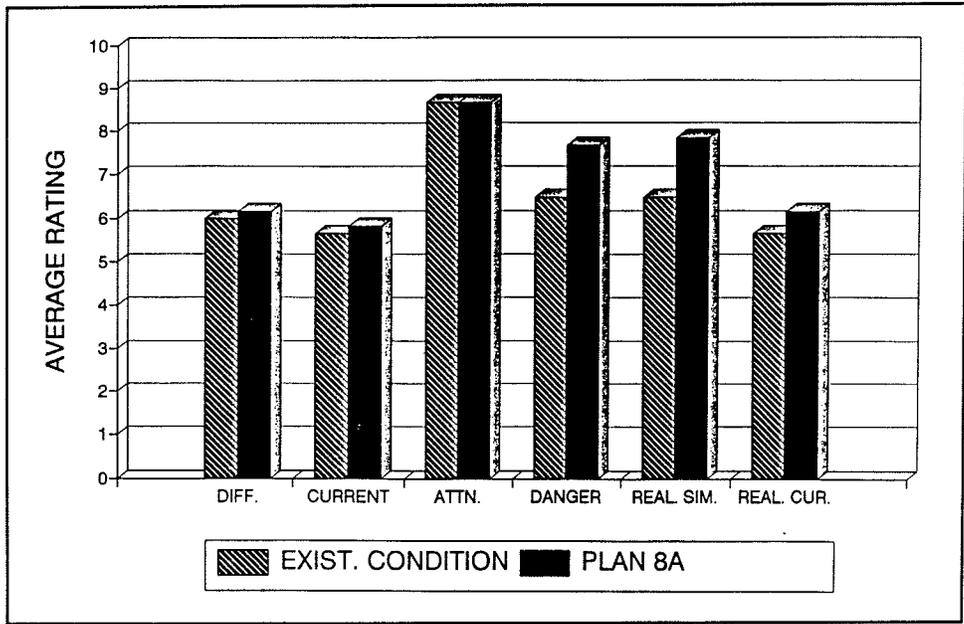
Figure 7. Ship pilot ratings, 530,000-cfs flow, downstream runs

Downstream runs, 530,000-cfs flow. The ratings for Plan 8A are equal to or higher than the existing condition for all questions (Figure 7). The differences in the ratings are small, except for danger of grounding or striking an object, which is significantly higher. Simulator realism is also rated much higher for the plan condition than with the existing condition.

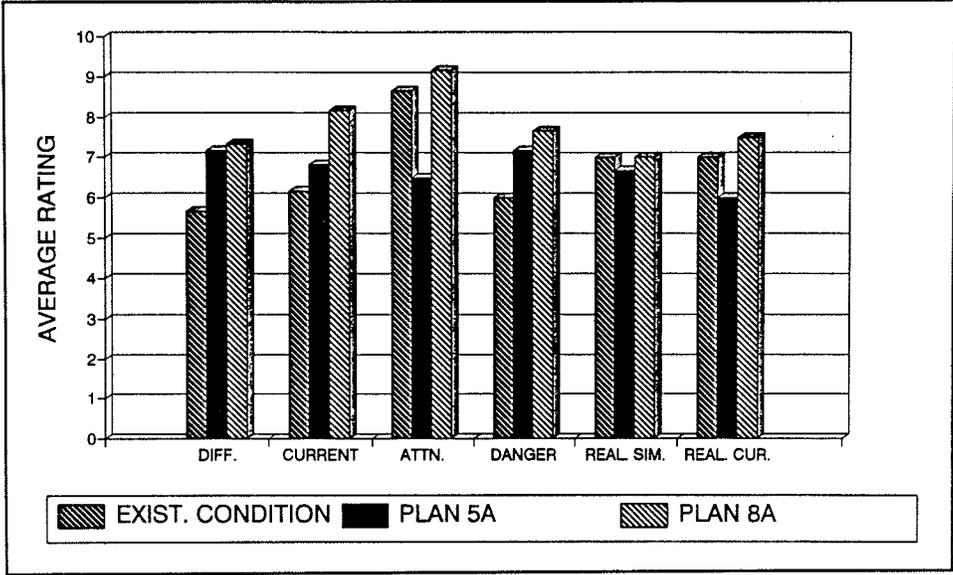
Figure 8. Ship pilot ratings, 1,500,000-cfs flow, upstream runs

Upstream runs, 1,500,000-cfs flow. Plan 8A was rated equal to or greater than both the existing condition and Plan 5A for all questions (Figure 8). Plan 5A was rated higher than the existing condition for difficulty, current effects, and danger of striking an object, but lower for attention required and realism of simulator and currents. The rating for attention required is much lower for Plan 5A than for the existing condition. This is not easily explainable, since the pilots rated difficulty and danger much higher for Plan 5A than for the existing condition.

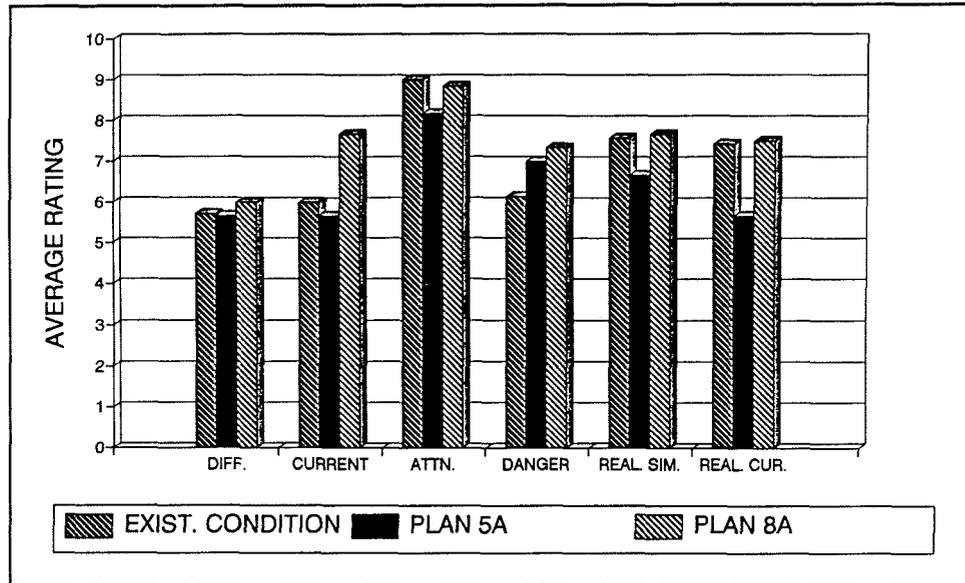
Figure 9. Ship pilot ratings, 1,500,000-cfs flow, downstream runs

Downstream runs, 1,500,000-cfs flow. Plan 5A is rated lower for all questions, except for danger of striking an object, than the existing condition (Figure 9). Plan 8A is rated nearly the same as or higher than the existing condition for all questions except for attention required, where it was rated slightly lower.

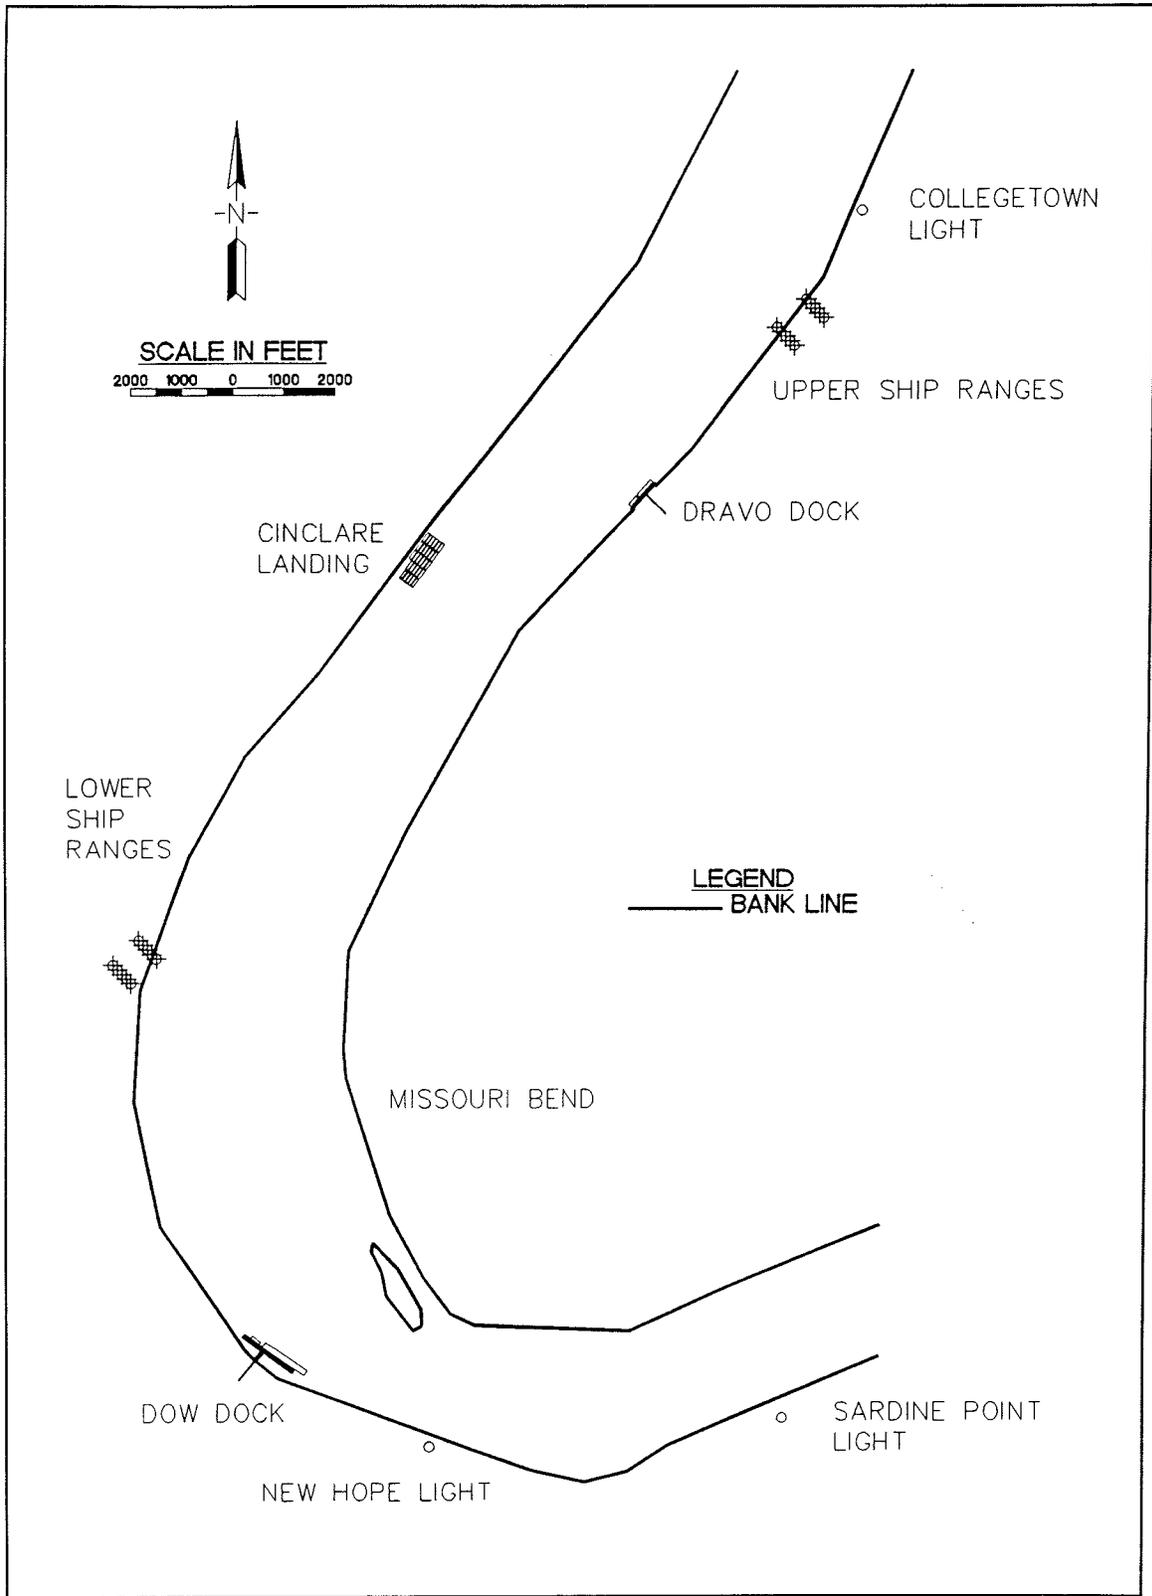
Figure 10. Area map showing landmarks for vessel locations in track plots

A complete set of the composite ship track plots for the channel test conditions is presented in Plates 11-30. The track plots also show the closest point that each pilot came to the ghost tow during his run. The minimum clearance distance between the ship and the tow is provided in Table 1. An area map,

providing the significant local landmarks used to describe the vessel location for the track plots, is provided in Figure 10.

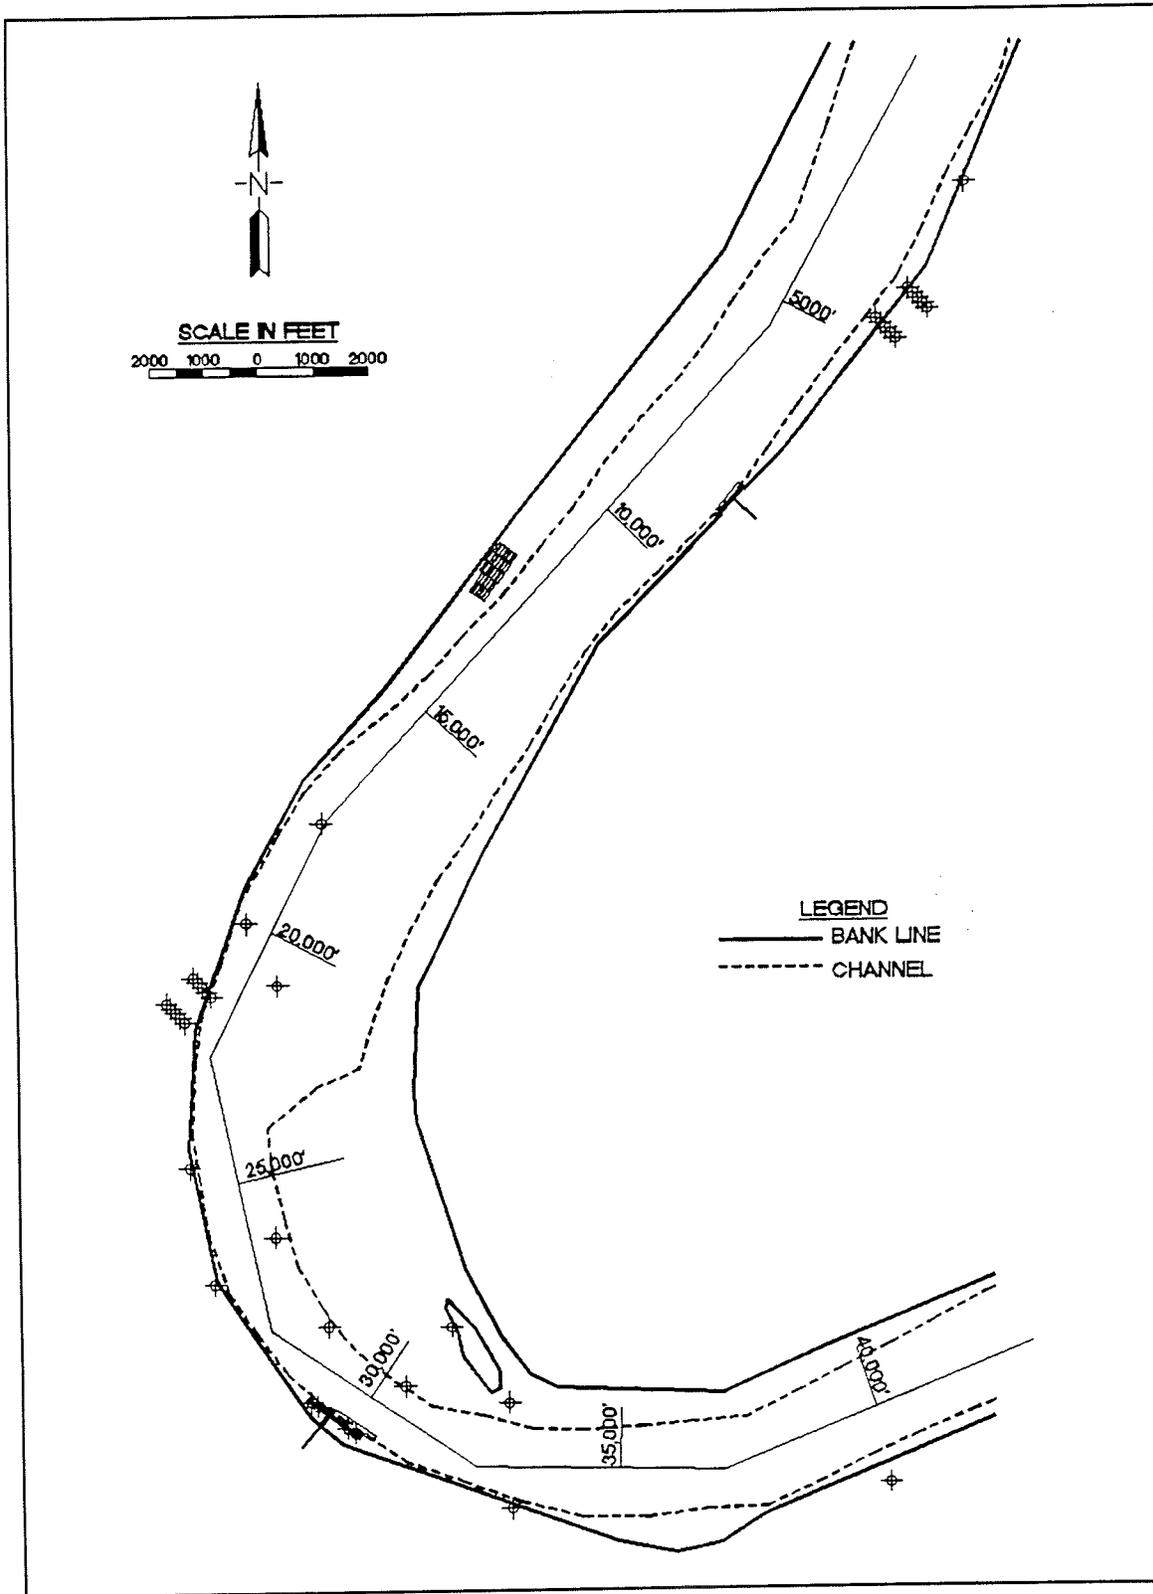
Figure 11. Distance along track

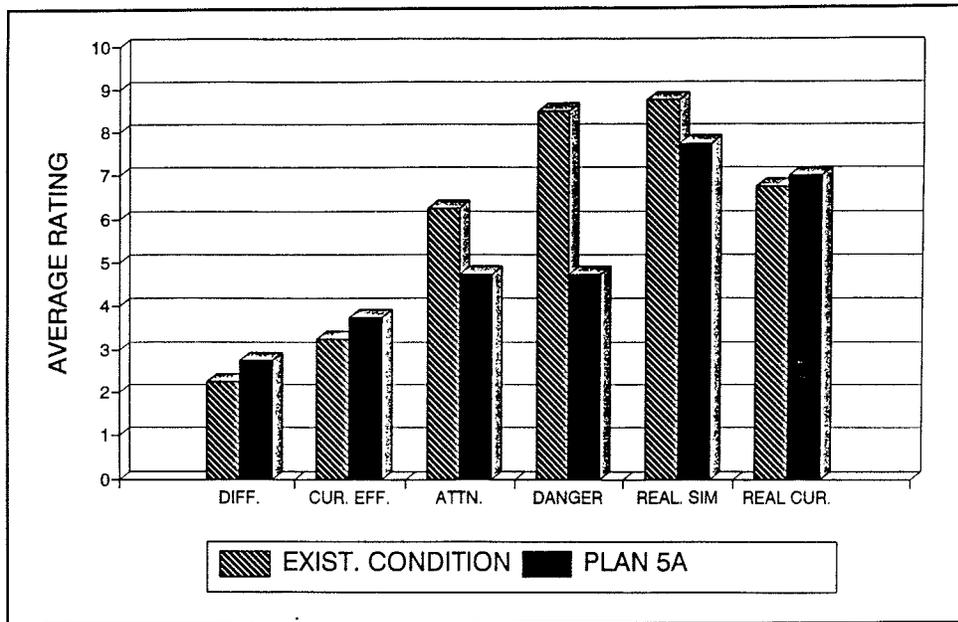
Figure 12. Small-tow pilots' ratings, 228,000-cfs flow, upstream runs

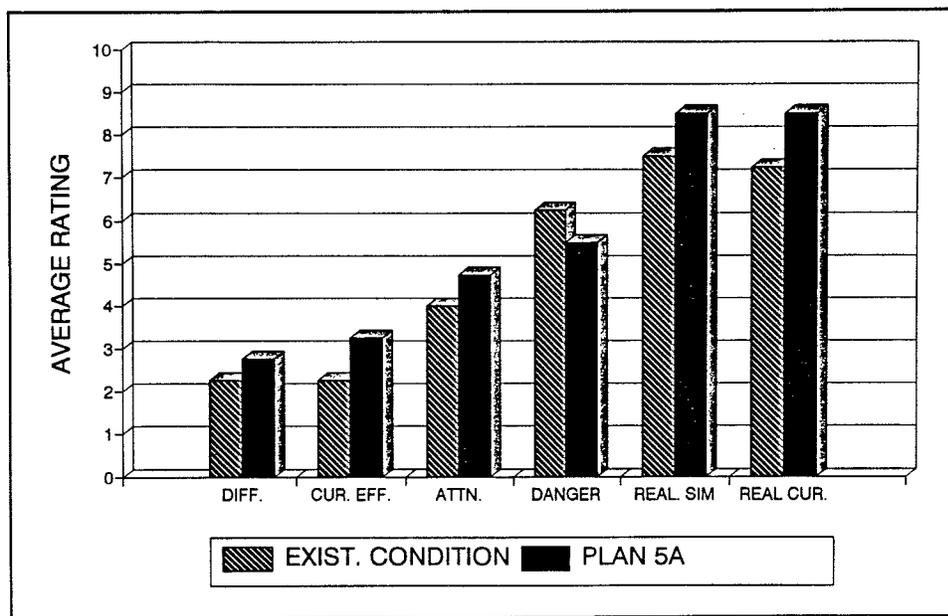
Figure 13. Small-tow pilots' ratings, 228,000-cfs flow, downstream runs

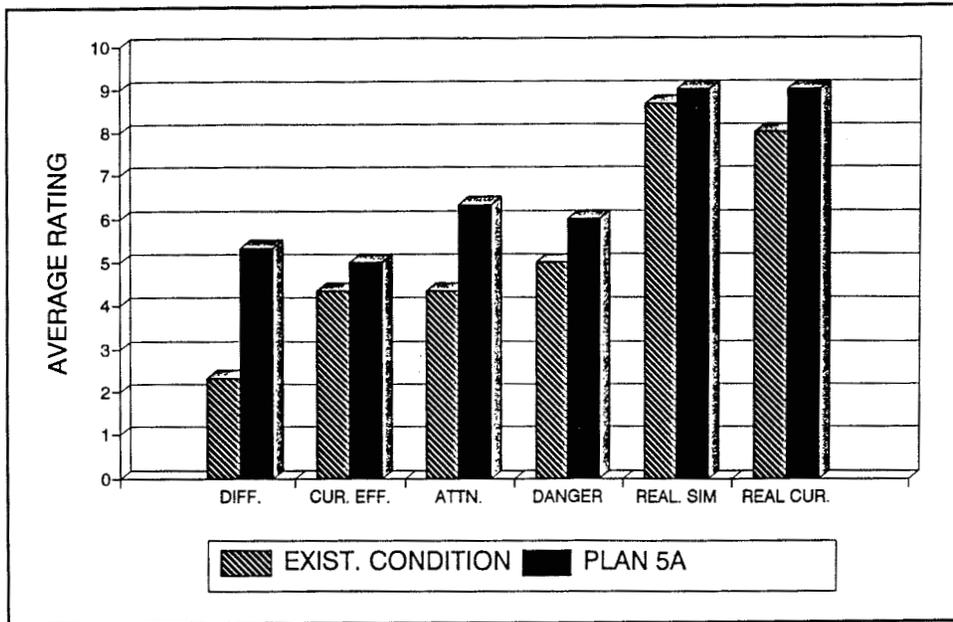
Figure 14. Small-tow pilots' ratings, 450,000-cfs flow, upstream runs

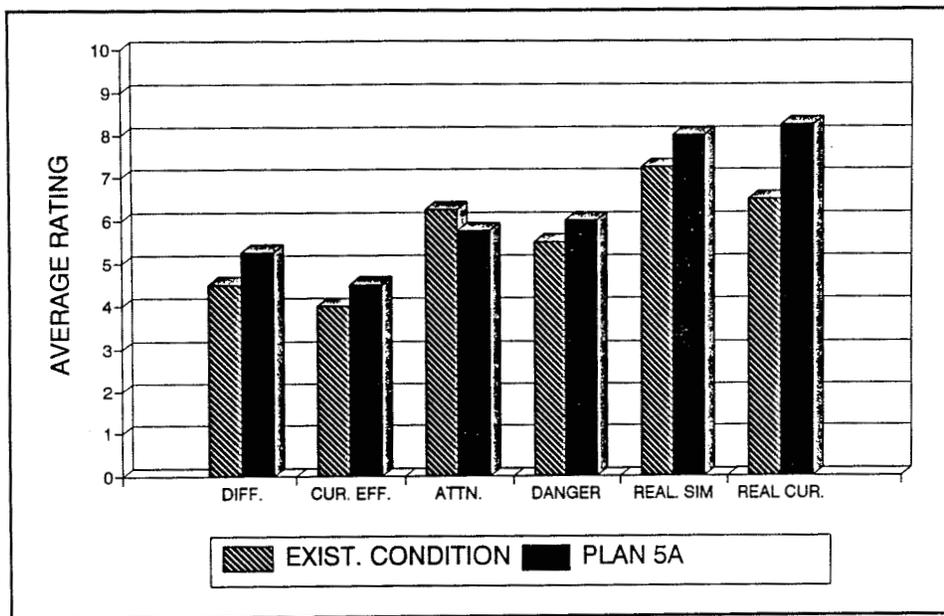
Figure 15. Small-tow pilots' ratings, 450,000-cfs flow, downstream runs

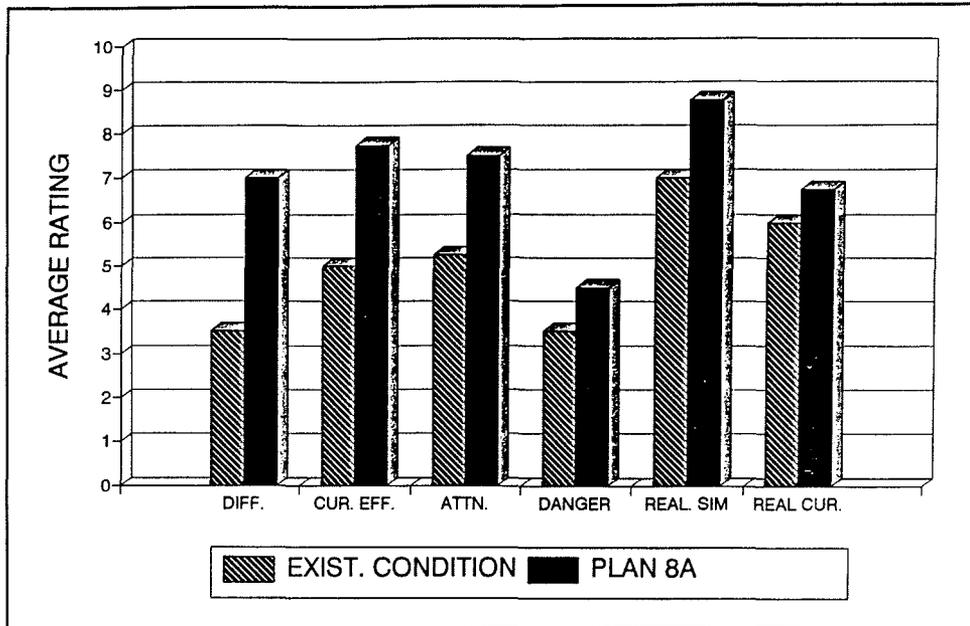
Figure 16. Small-tow pilots' ratings, 670,000-cfs flow, upstream runs

Upstream runs, 670,000-cfs flow. The pilots rated each question much higher for Plan 8A than the existing condition (Figure 16). The large differentials in the ratings indicate that the pilots found Plan 8A with this flow condition to be much more difficult.

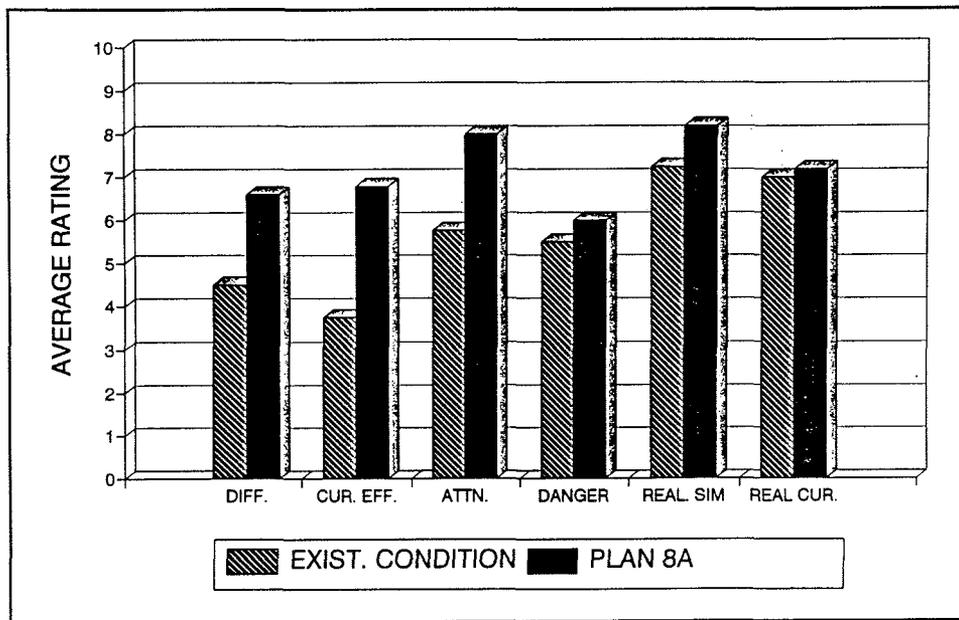
Figure 17. Small-tow pilots' ratings, 670,000-cfs flow, downstream runs

Downstream runs, 670,000-cfs flow. The pilots again rated each question higher for Plan 8A than the existing condition (Figure 17). Although they rated the difficulty of run, current effects, and attention required much higher, they rated the danger of grounding to be slightly higher, indicating that they found the downbound runs to be more difficult than the upbound runs.

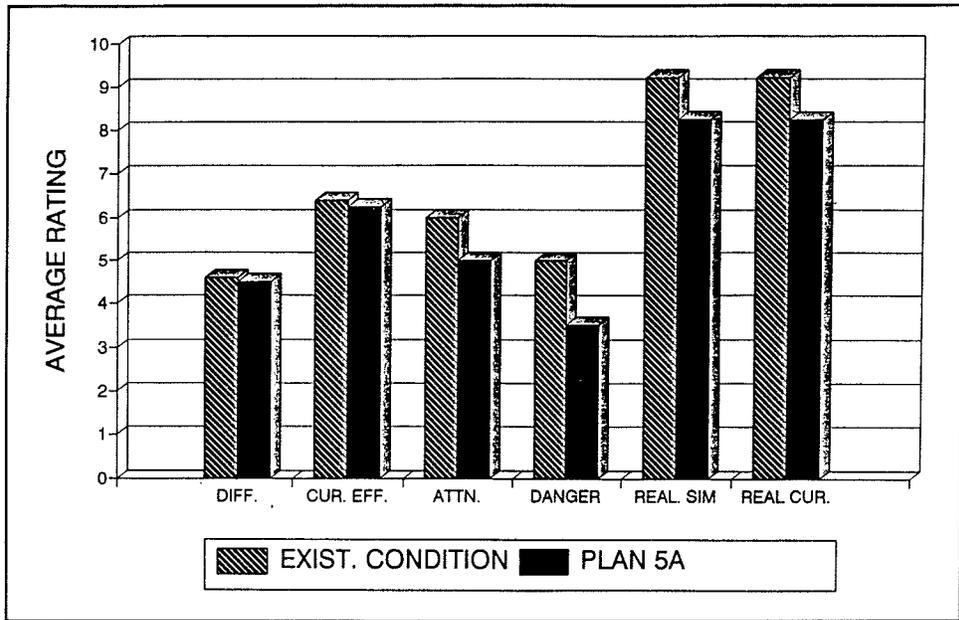
Figure 18. Small-tow pilots' ratings, 1,500,000-cfs flow, upstream runs

Upstream runs, 1,500,000-cfs flow. The pilots rated each question lower for Plan 5A than for the existing condition (Figure 18). The differences in the ratings for difficulty and current effects are negligible, but the ratings for attention required and danger of grounding are considerably lower for Plan 5A, suggesting that the runs with Plan 5A were somewhat easier to make than with the existing condition.

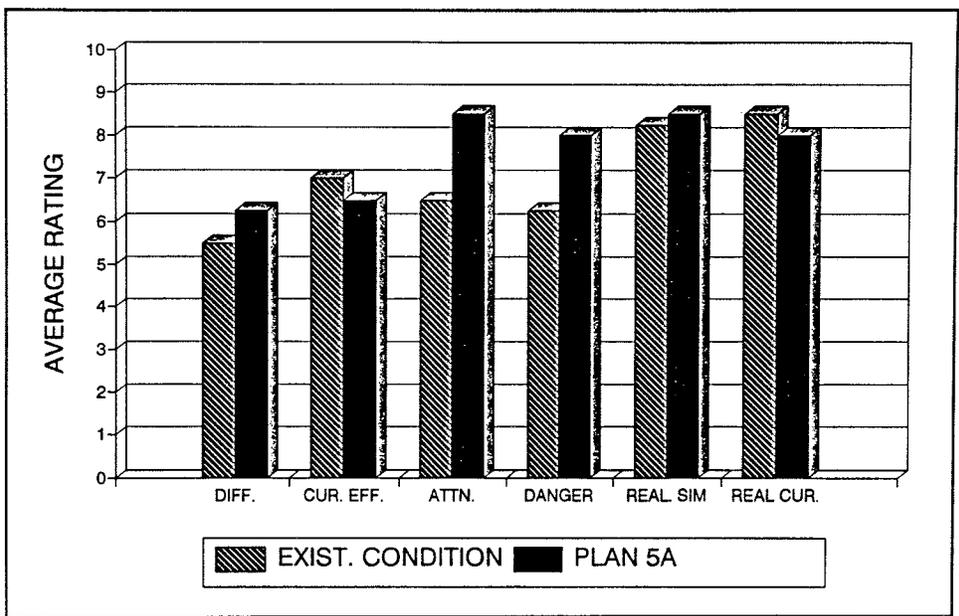
Figure 19. Small-tow pilots' ratings, 1,500,000-cfs flow, downstream runs

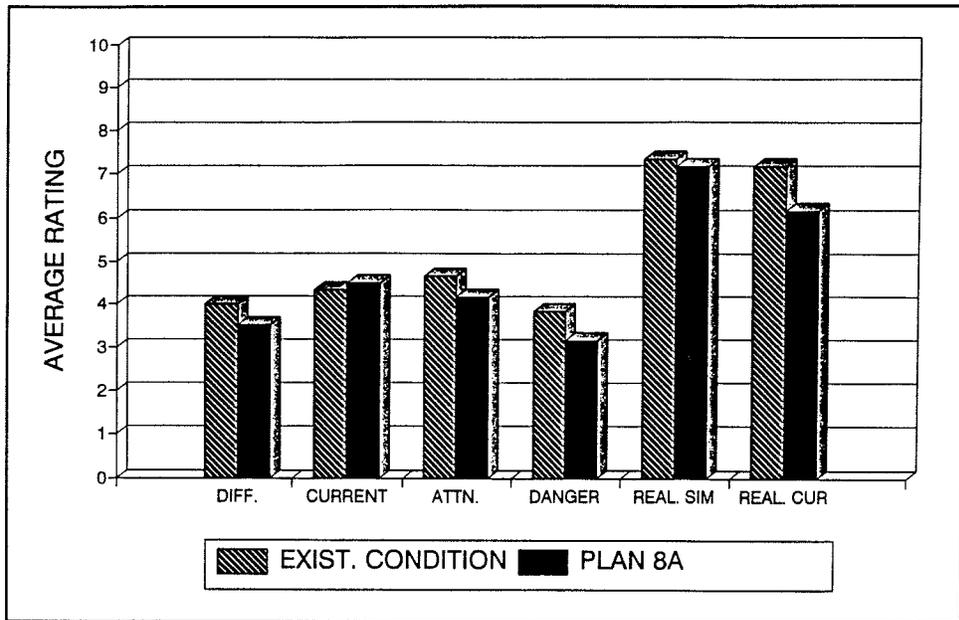
Figure 20. Large-tow pilots' ratings, 228,000-cfs flow, downstream runs

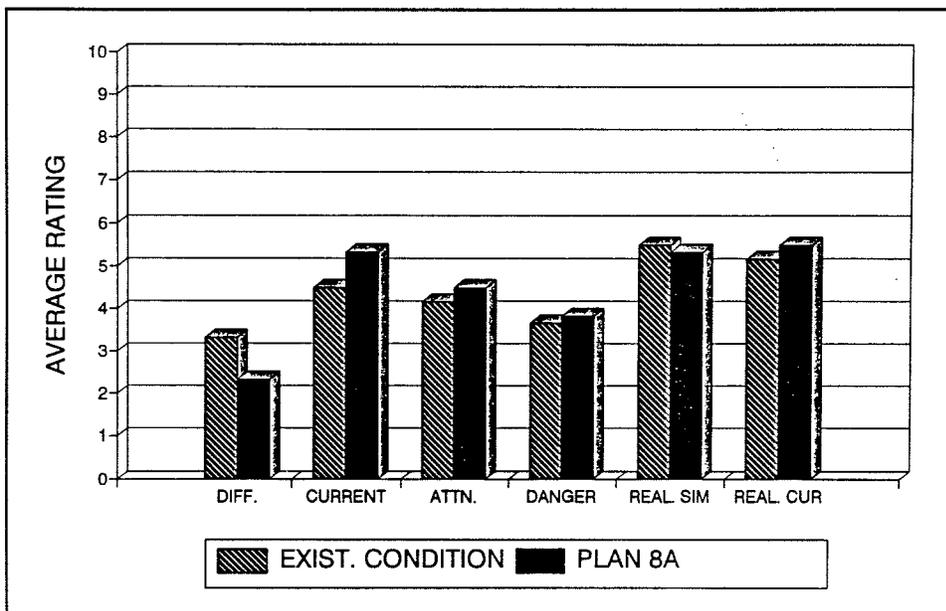
Figure 21. Large-tow pilots' ratings, 228,000-cfs flow, upstream runs

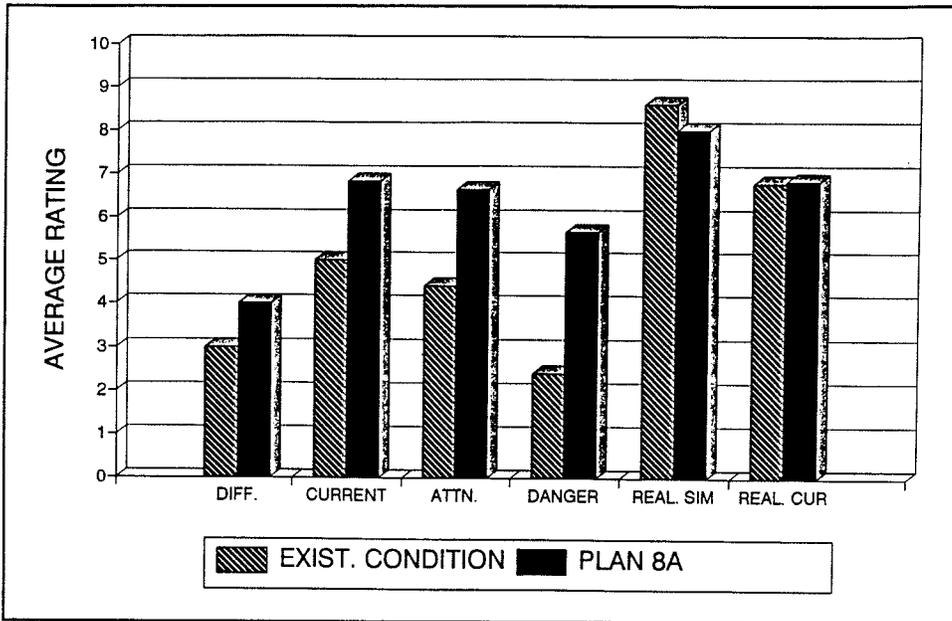
Figure 22. Large-tow pilots' ratings, 670,000-cfs flow, downstream runs

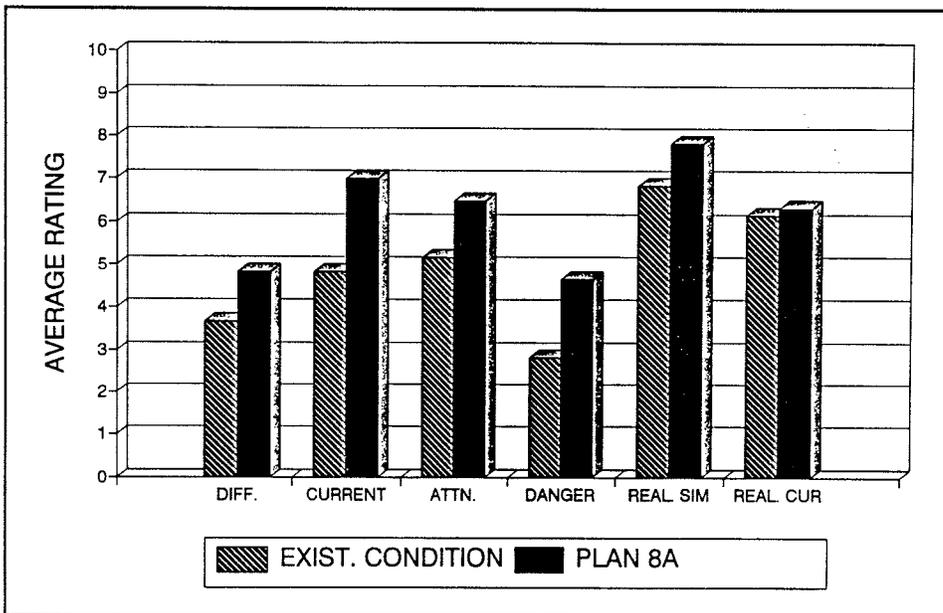
Figure 23. Large-tow pilots' ratings, 670,000-cfs flow, upstream runs

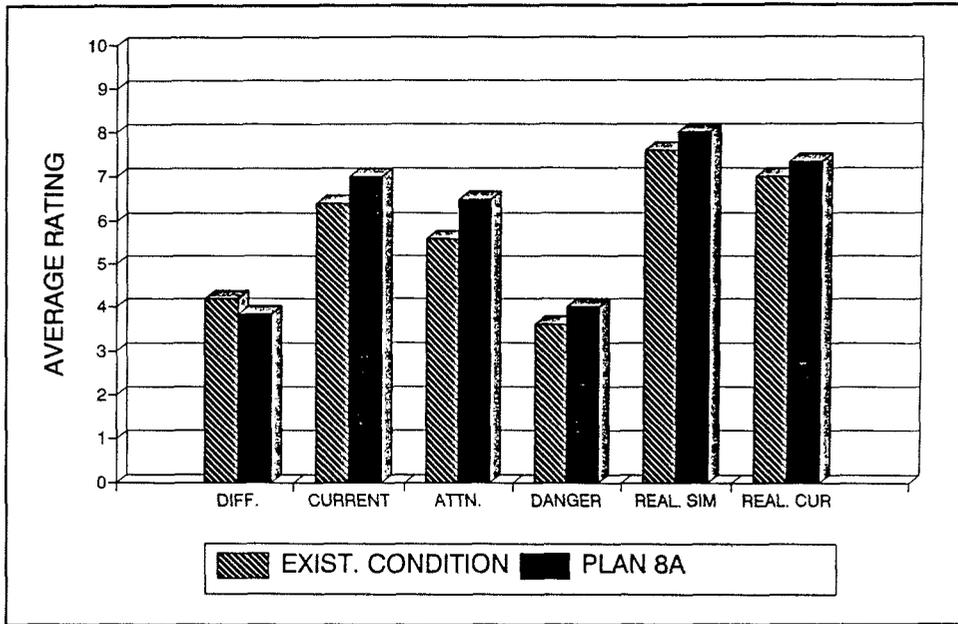
Figure 24. Large-tow pilots' ratings, 1,500,000-cfs flow, downstream runs

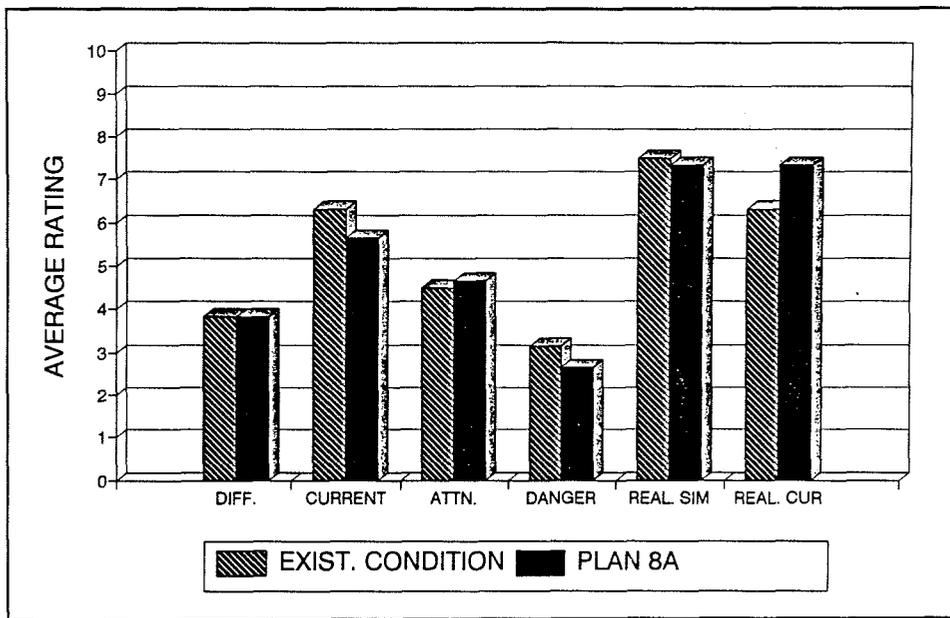
Figure 25. Large-tow pilots' ratings, 1,500,000-cfs flow, upstream runs

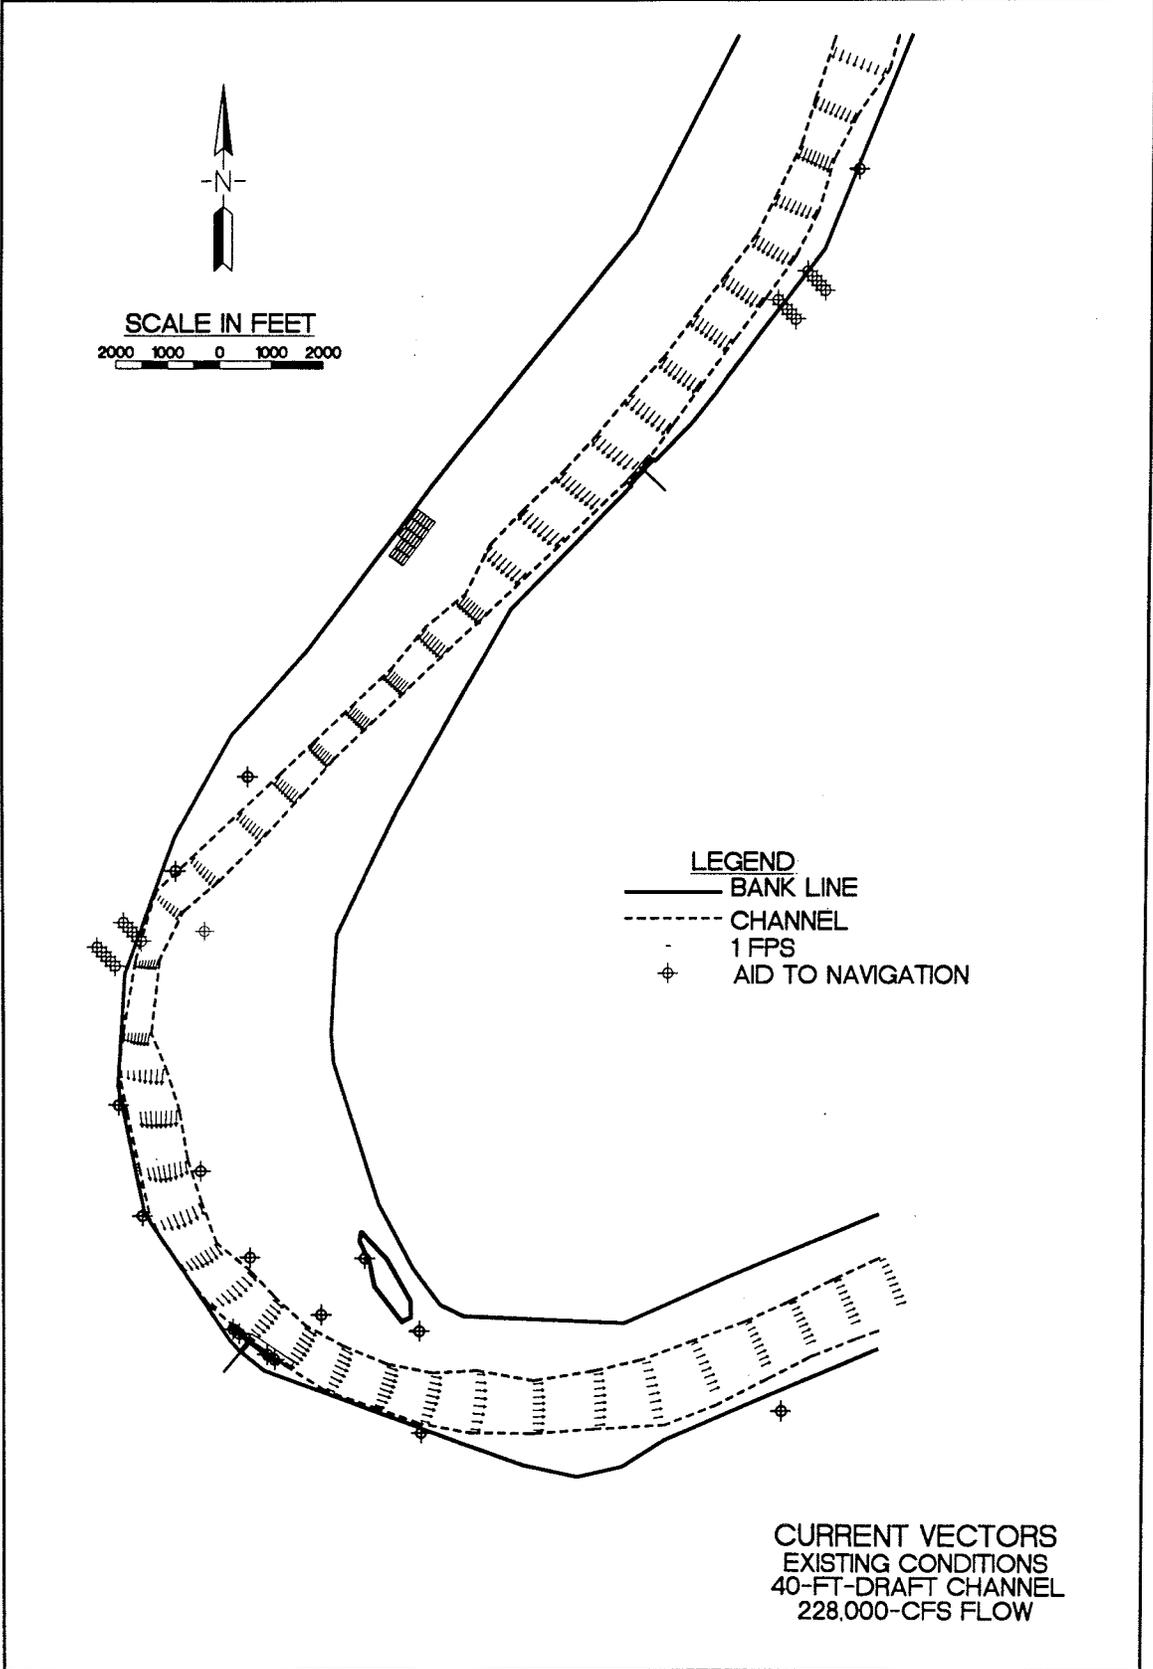
CURRENT VECTORS
EXISTING CONDITIONS
40-FT-DRAFT CHANNEL
228,000-CFS FLOW

dikes was to be allowed was set at 12 ft. For Plan 5A Optimized at the time of the ship tests, the maximum dike elevation was +5 ft; therefore, a 17-ft stage (450,000 cfs) was the minimum before tow traffic might be allowed to pass over the dikes. Likewise, Plan 8A Optimized was tested at a minimum 20-ft stage (530,000 cfs), yielding a slightly higher clearance of 13 ft before tows could pass over the dikes. Current vector plots for the existing condition are presented in Plates 1-4, Plan 5A in Plates 5-7, and Plan 8A in Plates 8-10.
