Technical Report HL-95-13
March 1996

Redeye Crossing Reach, Lower Mississippi River

Report 2 Navigation Conditions

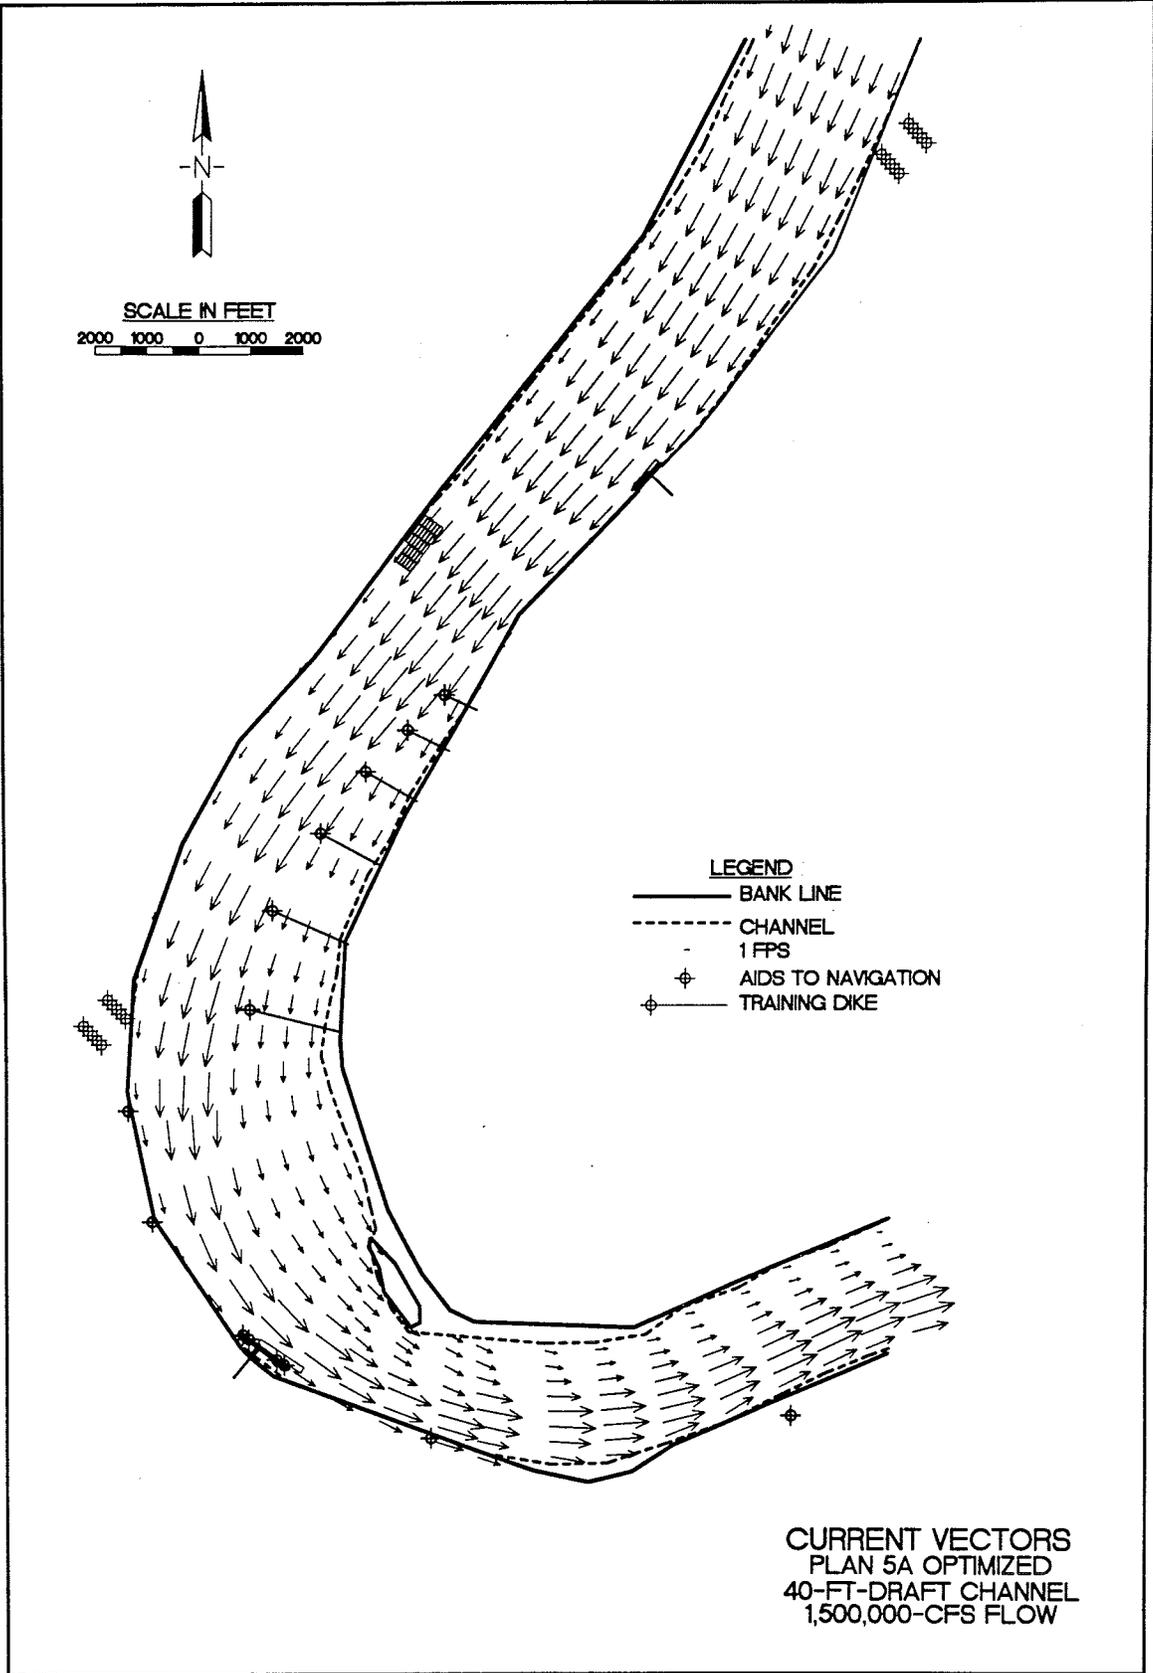
CURRENT VECTORS
 PLAN 5A OPTIMIZED
 40-FT-DRAFT CHANNEL
 1,500,000-CFS FLOW

dikes was to be allowed was set at 12 ft. For Plan 5A Optimized at the time of the ship tests, the maximum dike elevation was +5 ft; therefore, a 17-ft stage (450,000 cfs) was the minimum before tow traffic might be allowed to pass over the dikes. Likewise, Plan 8A Optimized was tested at a minimum 20-ft stage (530,000 cfs), yielding a slightly higher clearance of 13 ft before tows could pass over the dikes. Current vector plots for the existing condition are presented in Plates 1-4, Plan 5A in Plates 5-7, and Plan 8A in Plates 8-10.

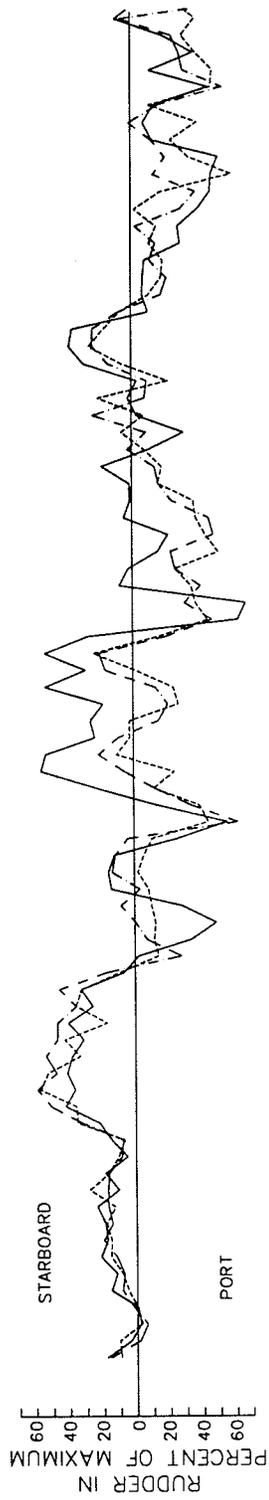
RUDDER ANGLE
840' X 138' X 43' SHIP
228,000 CFS FLOW
DOWNSTREAM RUNS

LEGEND
 BASE CONDITION ———
 PLAN 5A OPTIMIZED - - - -
 PLAN 8A OPTIMIZED - . - .

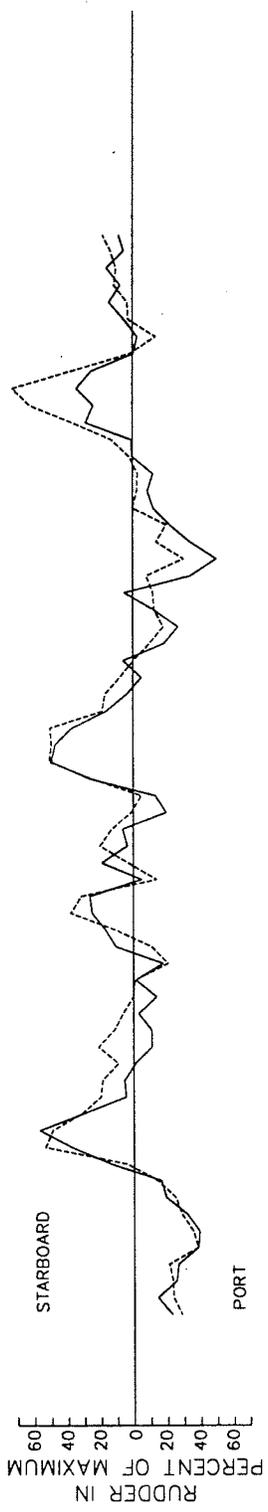
**RUDDER ANGLE
840' X 138' X 43' SHIP
450,000-CFS FLOW
UPSTREAM RUNS**

DISTANCE ALONG TRACK IN FEET

LEGEND
BASE CONDITION ———
PLAN 5A OPTIMIZED - - - - -

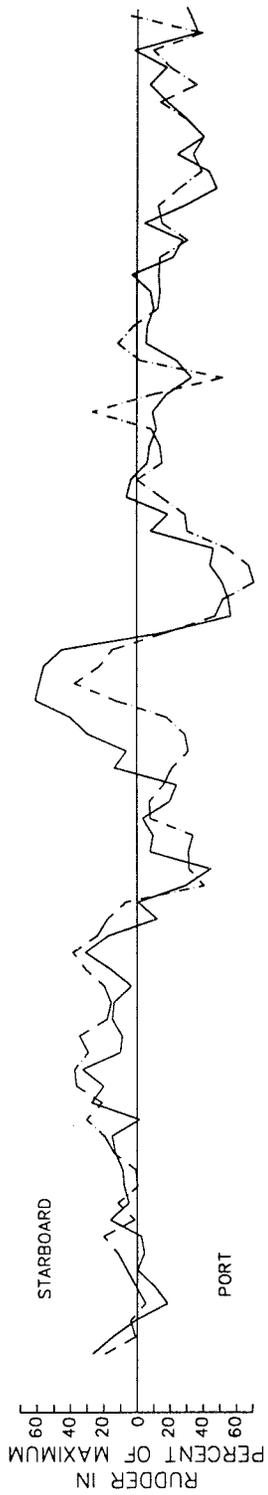
RUDDER ANGLE
840' X 138' X 43' SHIP
530,000 CFS FLOW
DOWNSTREAM RUNS

DISTANCE ALONG TRACK IN FEET

LEGEND
 BASE CONDITION ———
 PLAN 8A OPTIMIZED - - - -

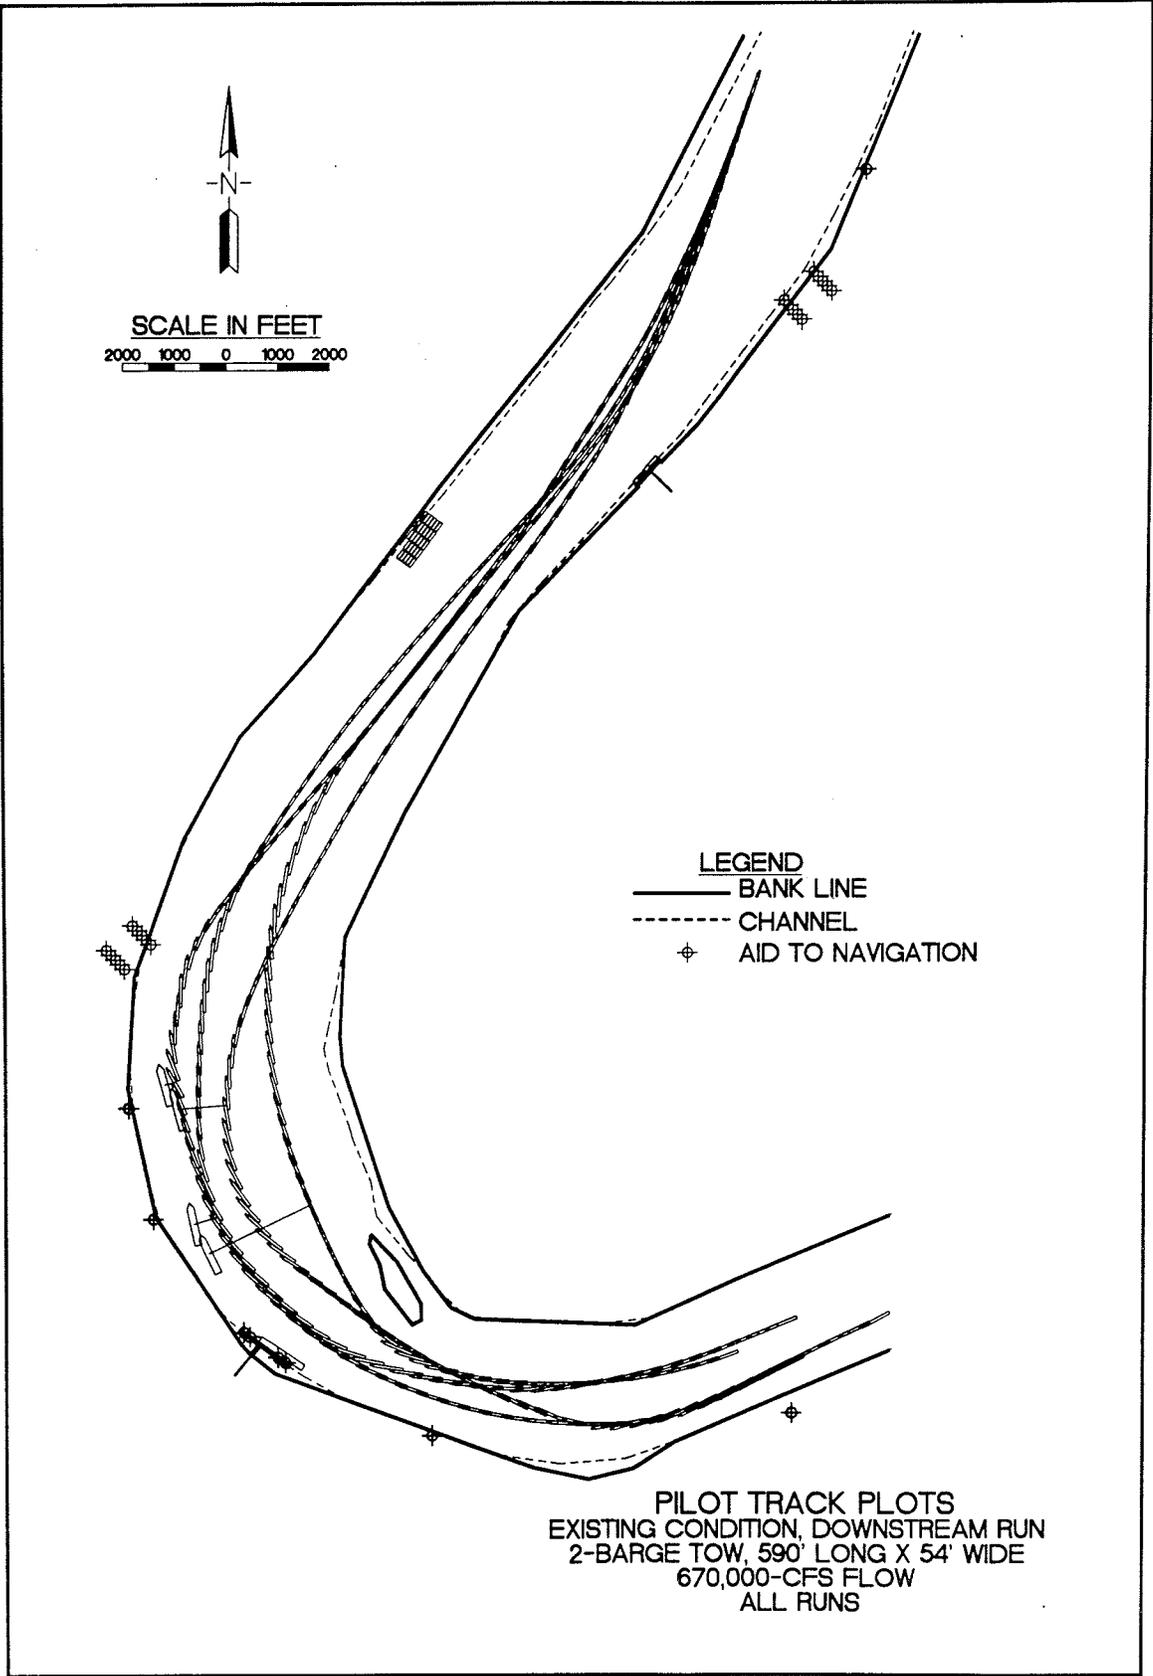
PILOT TRACK PLOTS
 EXISTING CONDITION, DOWNSTREAM RUN
 2-BARGE TOW, 590' LONG X 54' WIDE
 670,000-CFS FLOW
 ALL RUNS

Upstream runs, 670,000-cfs flow. For the existing condition (Plate 63), all the pilots ran approximately the same track till they passed the foot of the island (sometimes referred to as towhead or Towhead Island). Three of the pilots turned along the island and stayed near the left descending bank through Missouri Bend. The fourth pilot stayed well out in the channel till he got up to the lower ship ranges, then he crossed toward the left bank. This pilot's run was terminated early, due to a simulator malfunction. Of the three pilots who came through the bend along the left bank, two stayed along the left bank up to near Cinclare Landing, then one of them crossed to the right bank, then they both continued upstream. The third pilot crossed from left to right within Redeye Crossing and continued upstream along the right bank. For Plan 8A (Plate 64), the pilots again used basically the same track till they reached the foot of the island. Two of the pilots stayed along the left bank and continued up past the ends of the dikes. One pilot crossed to the right bank at the island and remained along the right bank for the remainder of his run. The last pilot started toward the right bank, then changed his mind or possibly ran into difficulties with power in the higher currents, and moved back toward the left bank. He remained along the left side till he passed the last dike downstream. At that point, he worked his way immediately toward the right bank and completed his run along the right bank. The two pilots who remained along the left bank through the dikes worked their way toward the right bank as they reached the upstream end of Redeye Crossing, and they completed their runs along the right bank. The pilots appeared to have somewhat more difficulty staying out of the strong currents, especially with the dikes in place. All meeting and passing of the traffic vessel was performed without incident with both the existing condition and Plan 8A runs.

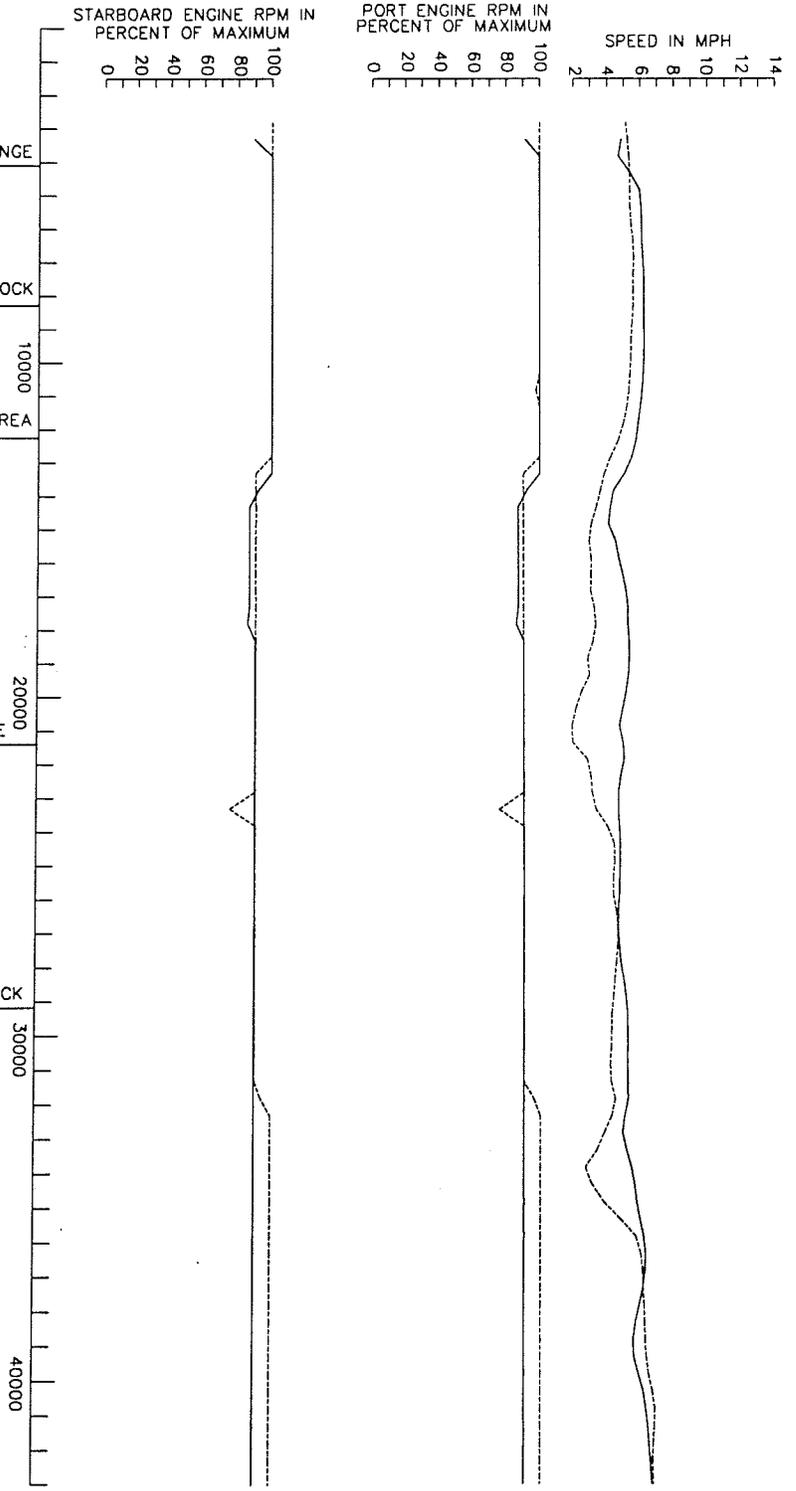
ENGINE RPM AND SPEED

2-BARGE TOW
670,000-CFS FLOW
UPSTREAM RUNS

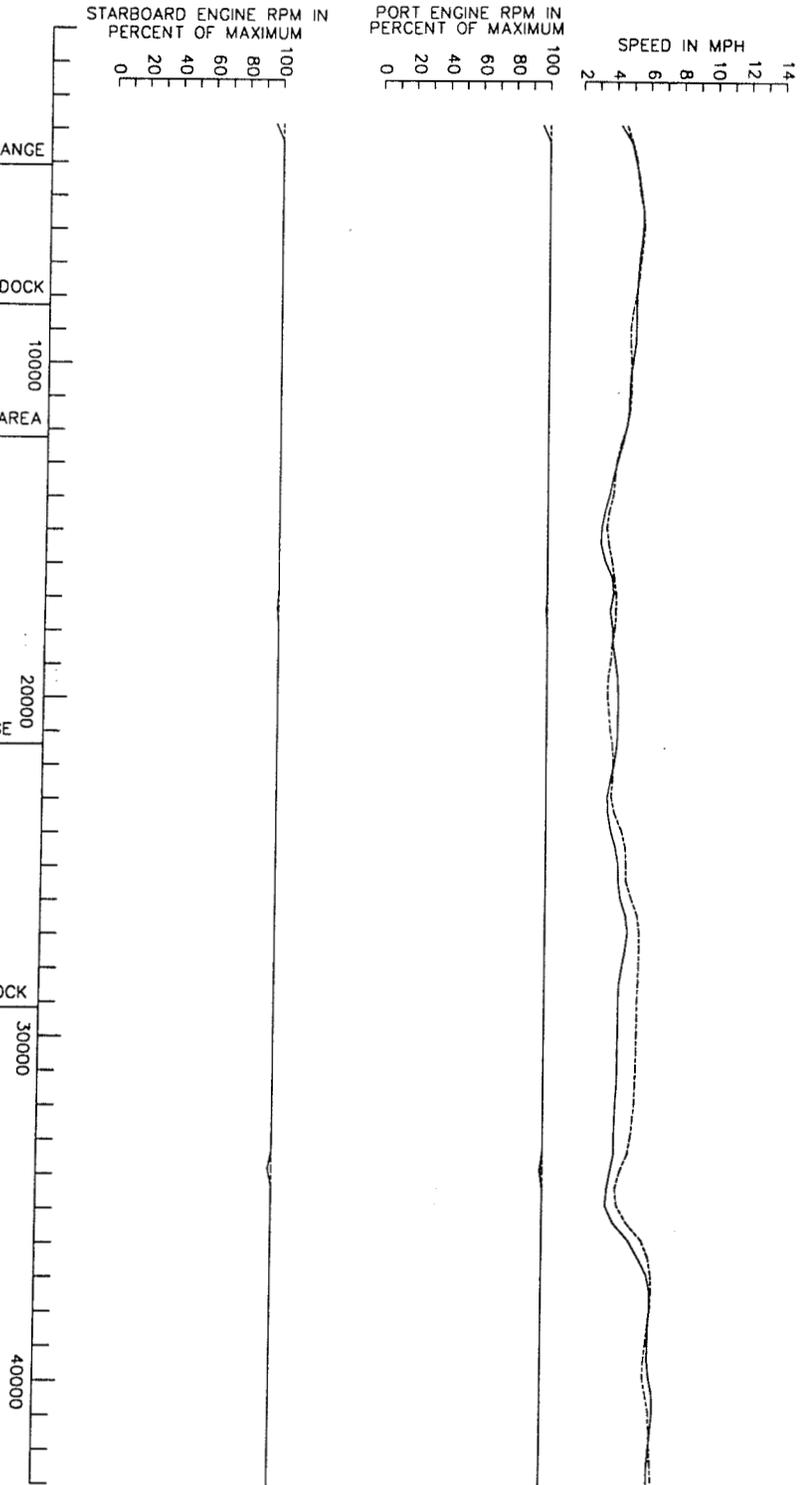
ENGINE RPM AND SPEED
2-BARGE TOW
1,500,000-CFS FLOW
UPSTREAM RUNS

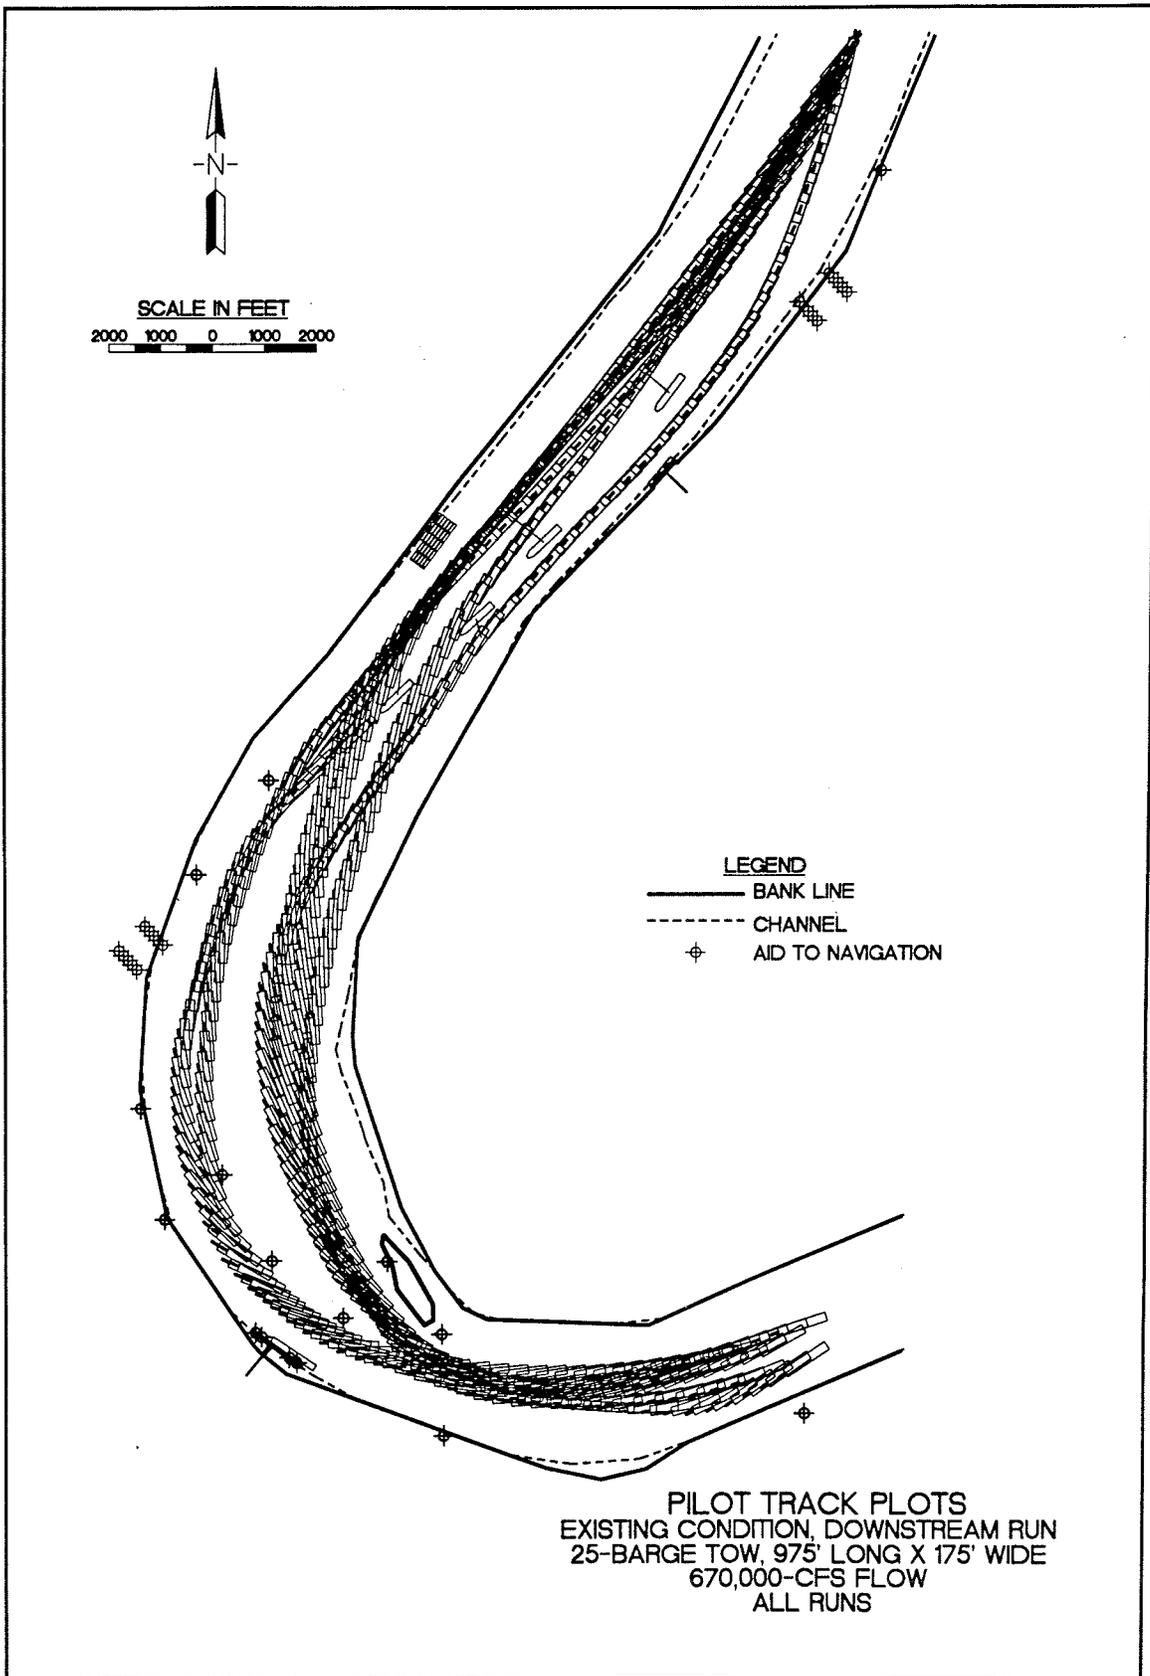
PILOT TRACK PLOTS
 EXISTING CONDITION, DOWNSTREAM RUN
 25-BARGE TOW, 975' LONG X 175' WIDE
 670,000-CFS FLOW
 ALL RUNS

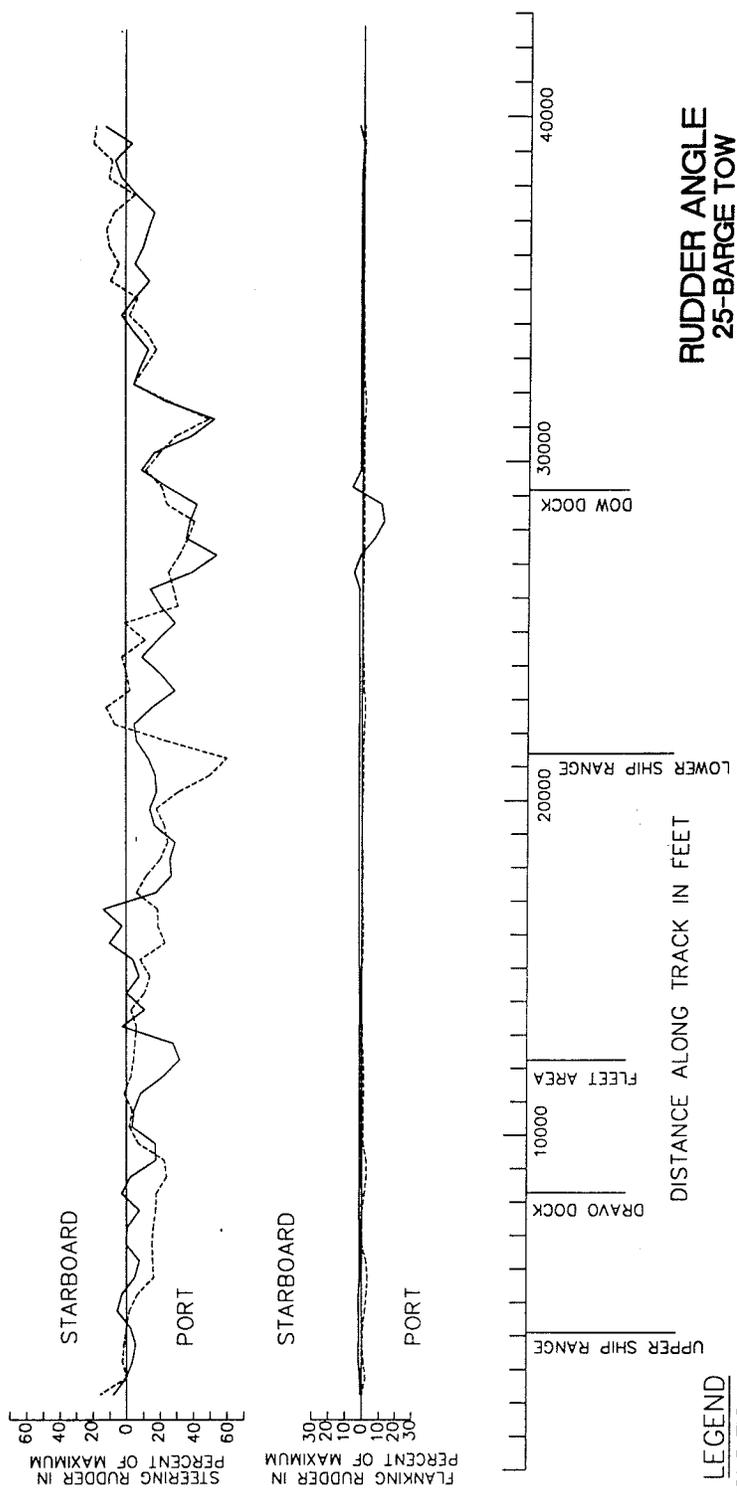
RUDDER ANGLE
25-BARGE TOW
670,000-CFS FLOW
DOWNSTREAM RUNS

LEGEND
 BASE CONDITION
 PLAN 8A OPTIMIZED
