Seabrook, New Hampshire

National Shoreline Erosion Control and
Demonstration Program
Section 227

Kevin Knuuti, P.E. (ERDC)
John Winkelman (New England District)

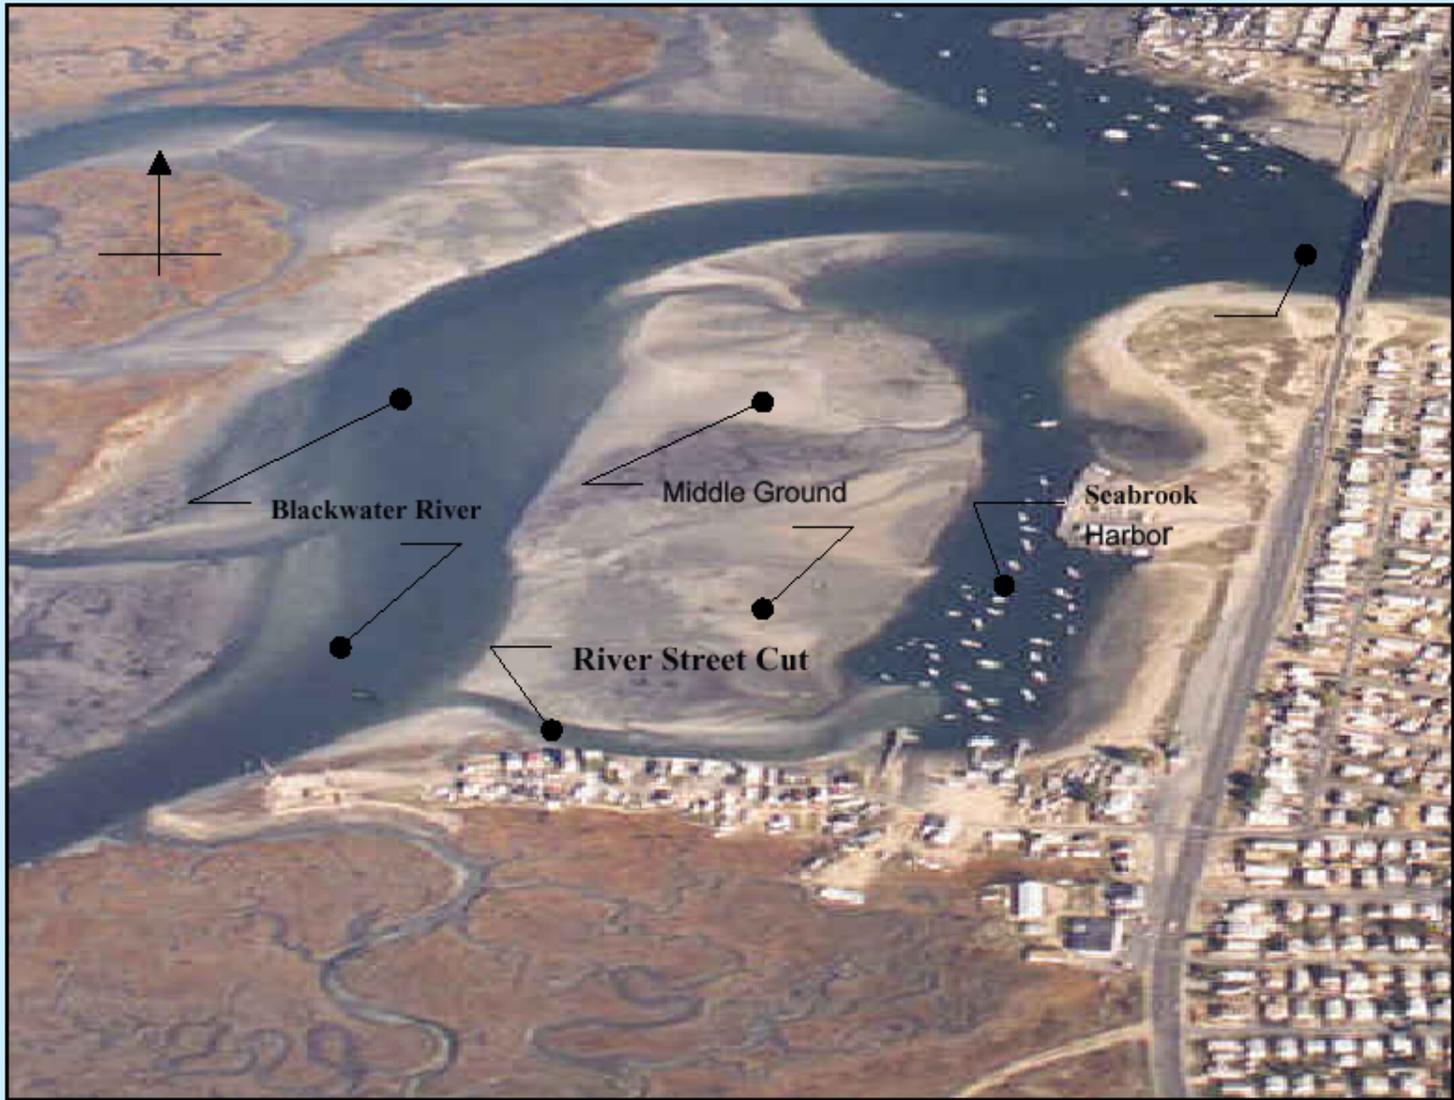
Extent of erosion in the Blackwater River Cut

This erosion began in 1993

This photo was taken in 1998

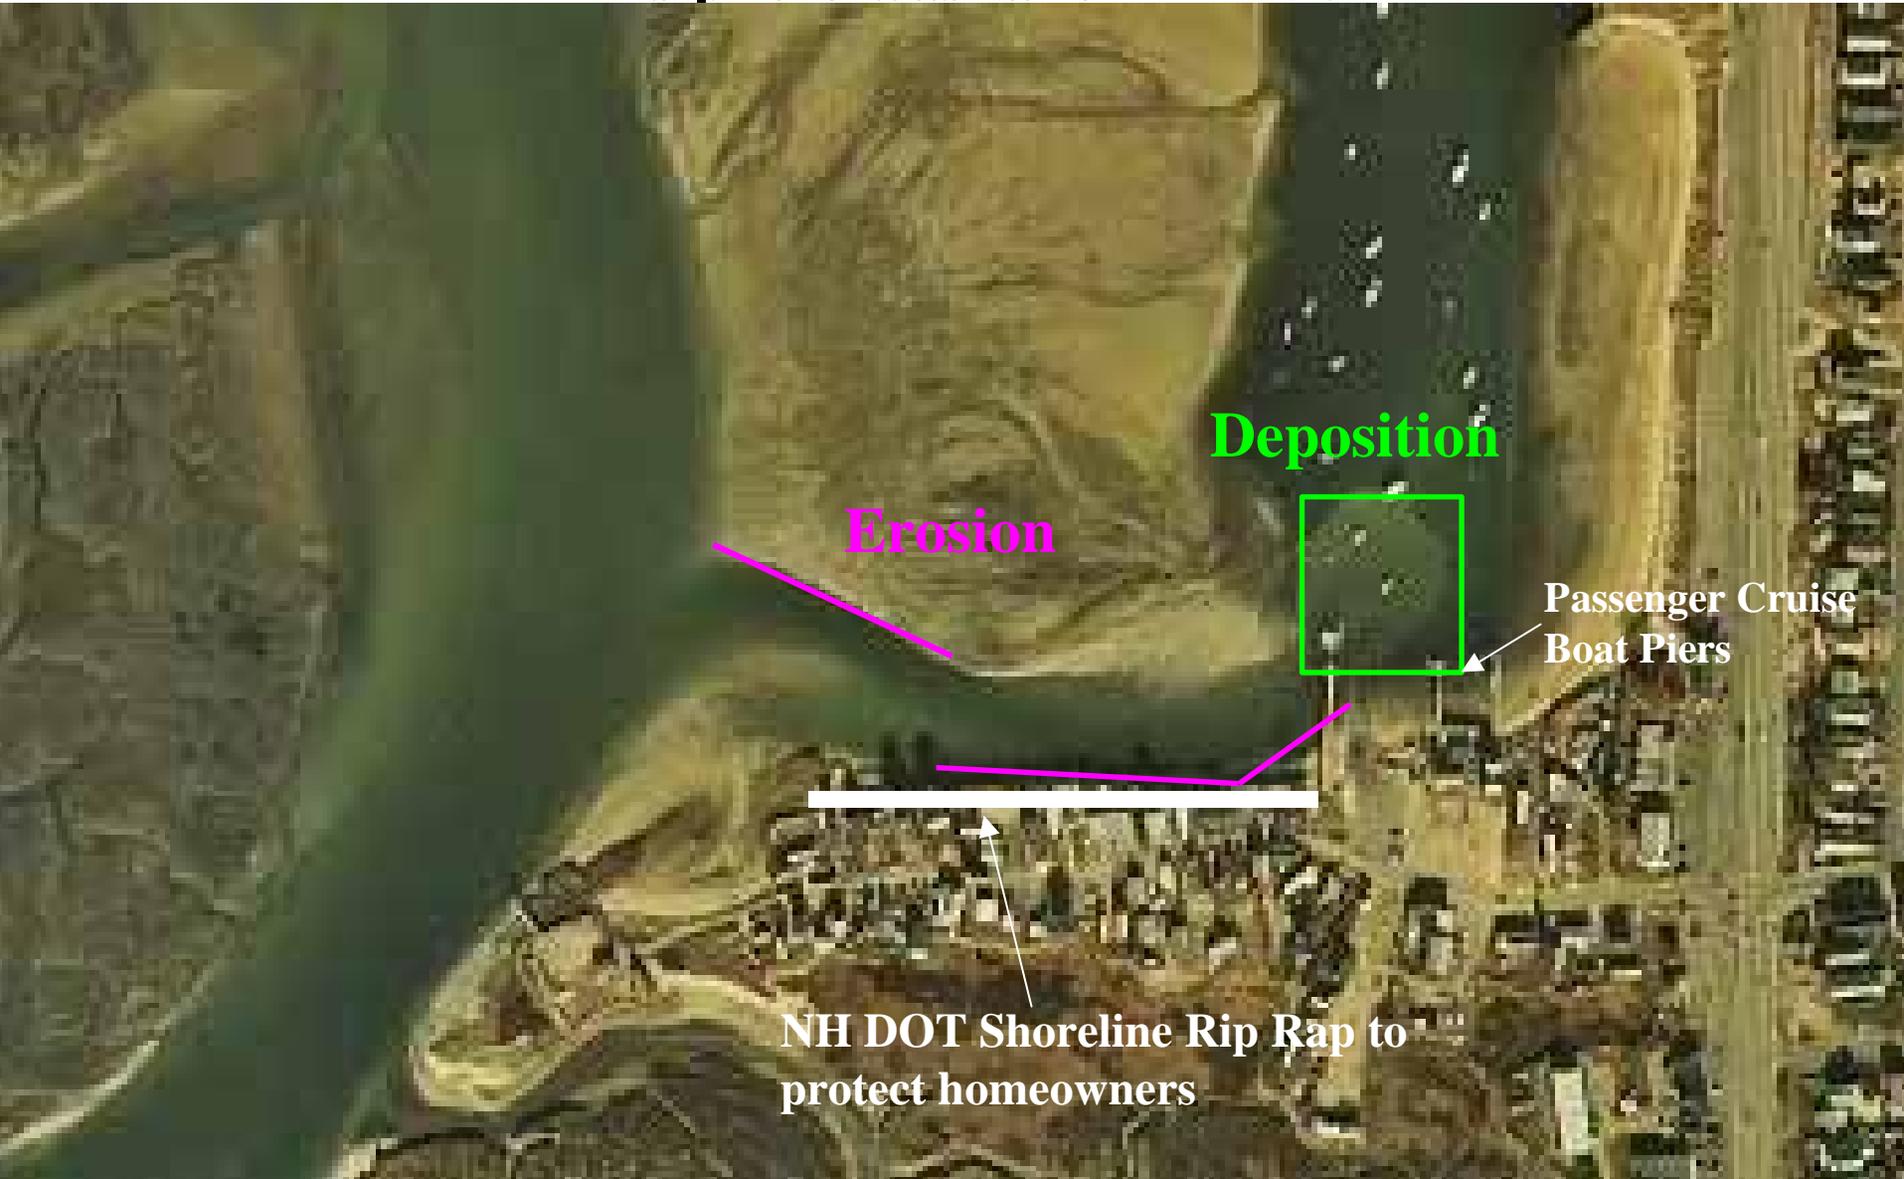
Erosion

Deposition

Passenger Cruise Boat Piers

NH DOT Shoreline Rip Rap to protect homeowners

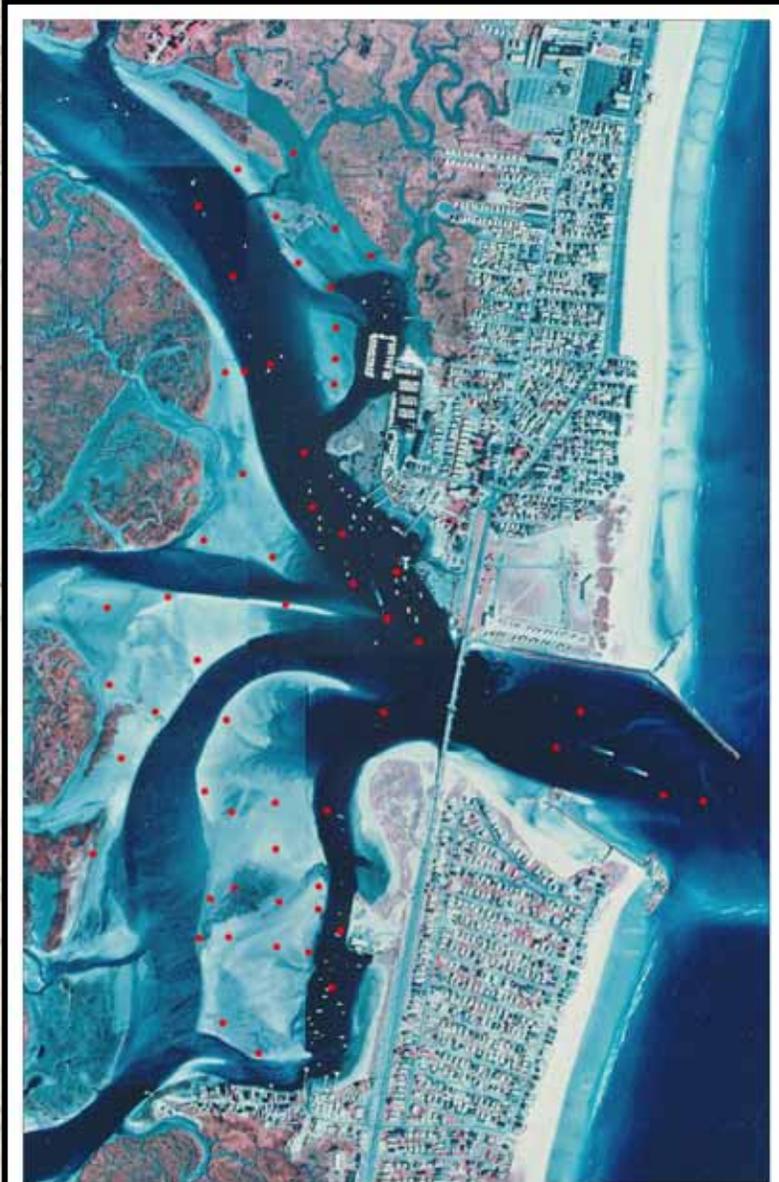
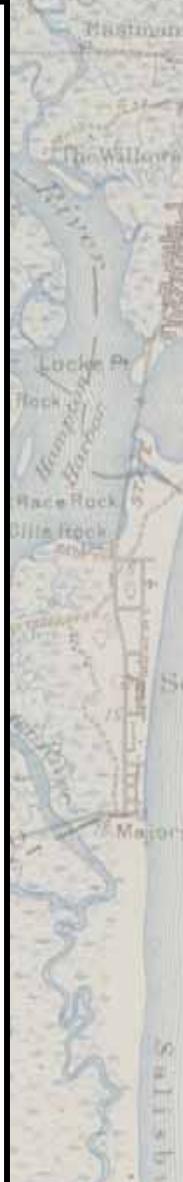
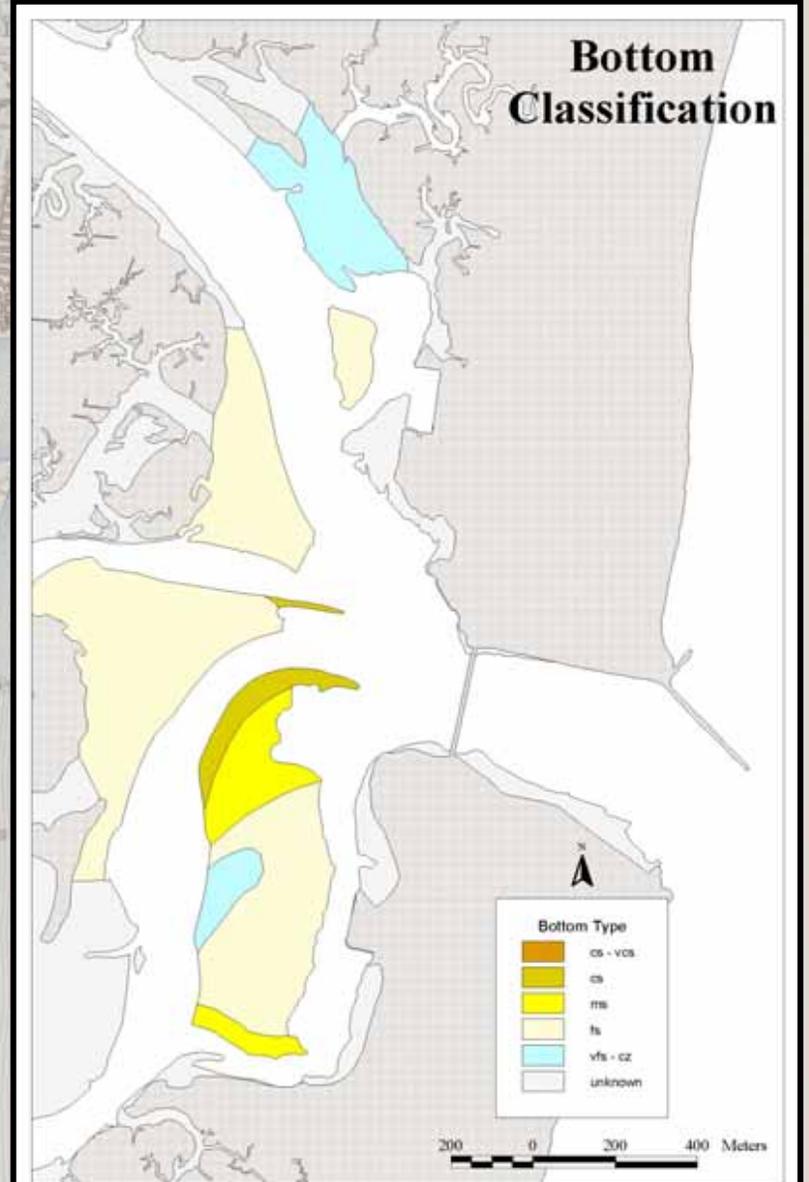
Bottom Sediment

- **System is Dominated by Sand**
- **Inlet is Coarse-grained**
 - Composed of Gravelly Sands
- **Tidal Channels are Dominated by**
 - Hampton River – Medium to Coarse Sand
 - Middle Ground Channel – Fine Sand
 - Blackwater River - ?
- **Flood Tidal Delta is Dominated by**
 - Fine Sand; Medium Sand by Channels
- **Middle Ground Shoal is Dominated by**
 - Fine to Medium Sand; Coarse Sand by Channel;
Very Fine Sand in Bivalve Areas

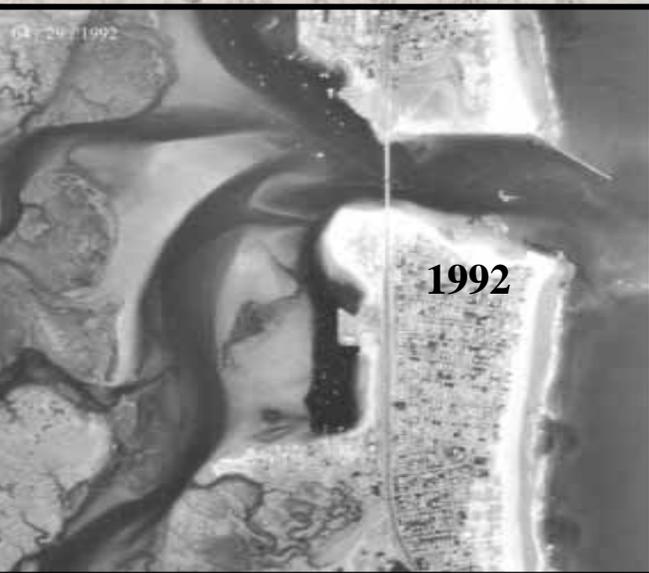
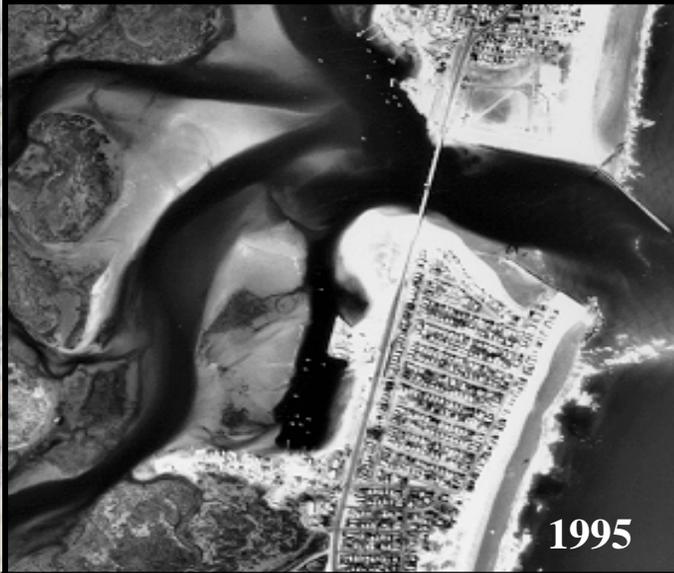
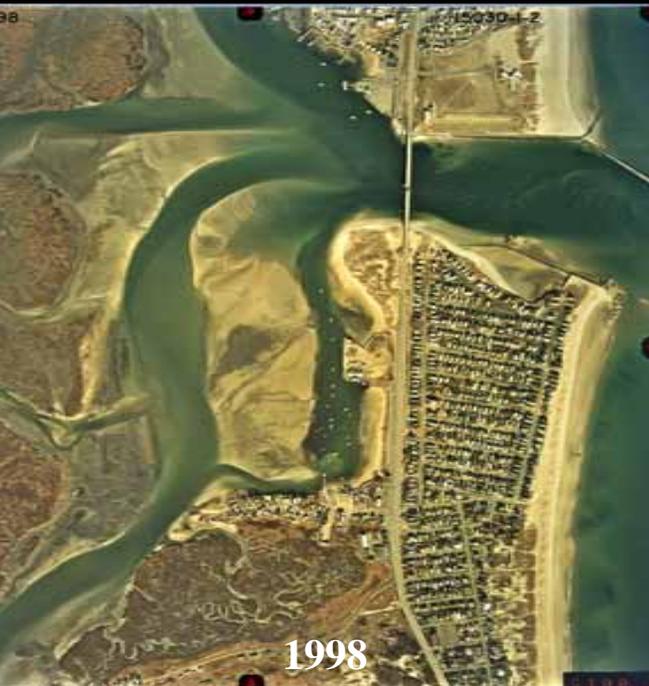
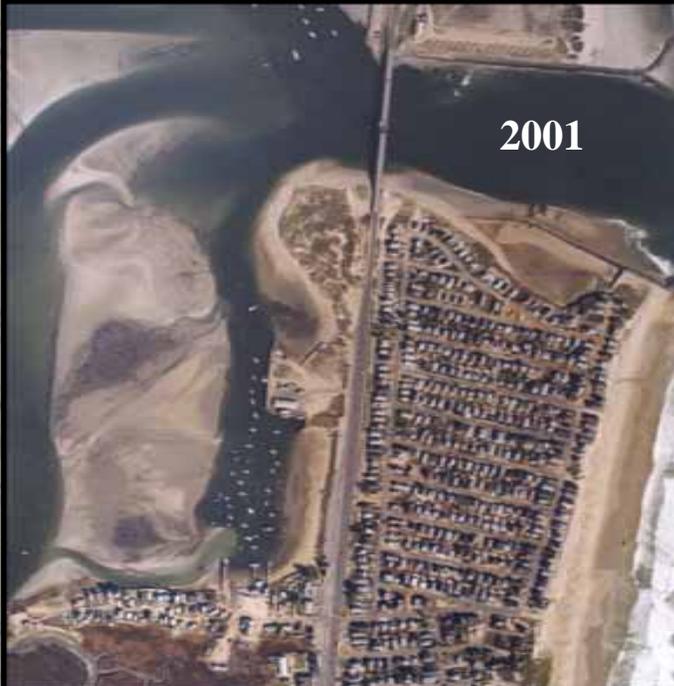
- **Blackwater River and middle ground migrated north**
- **River Street Breach developed**
- **Middle ground separated from the main land**

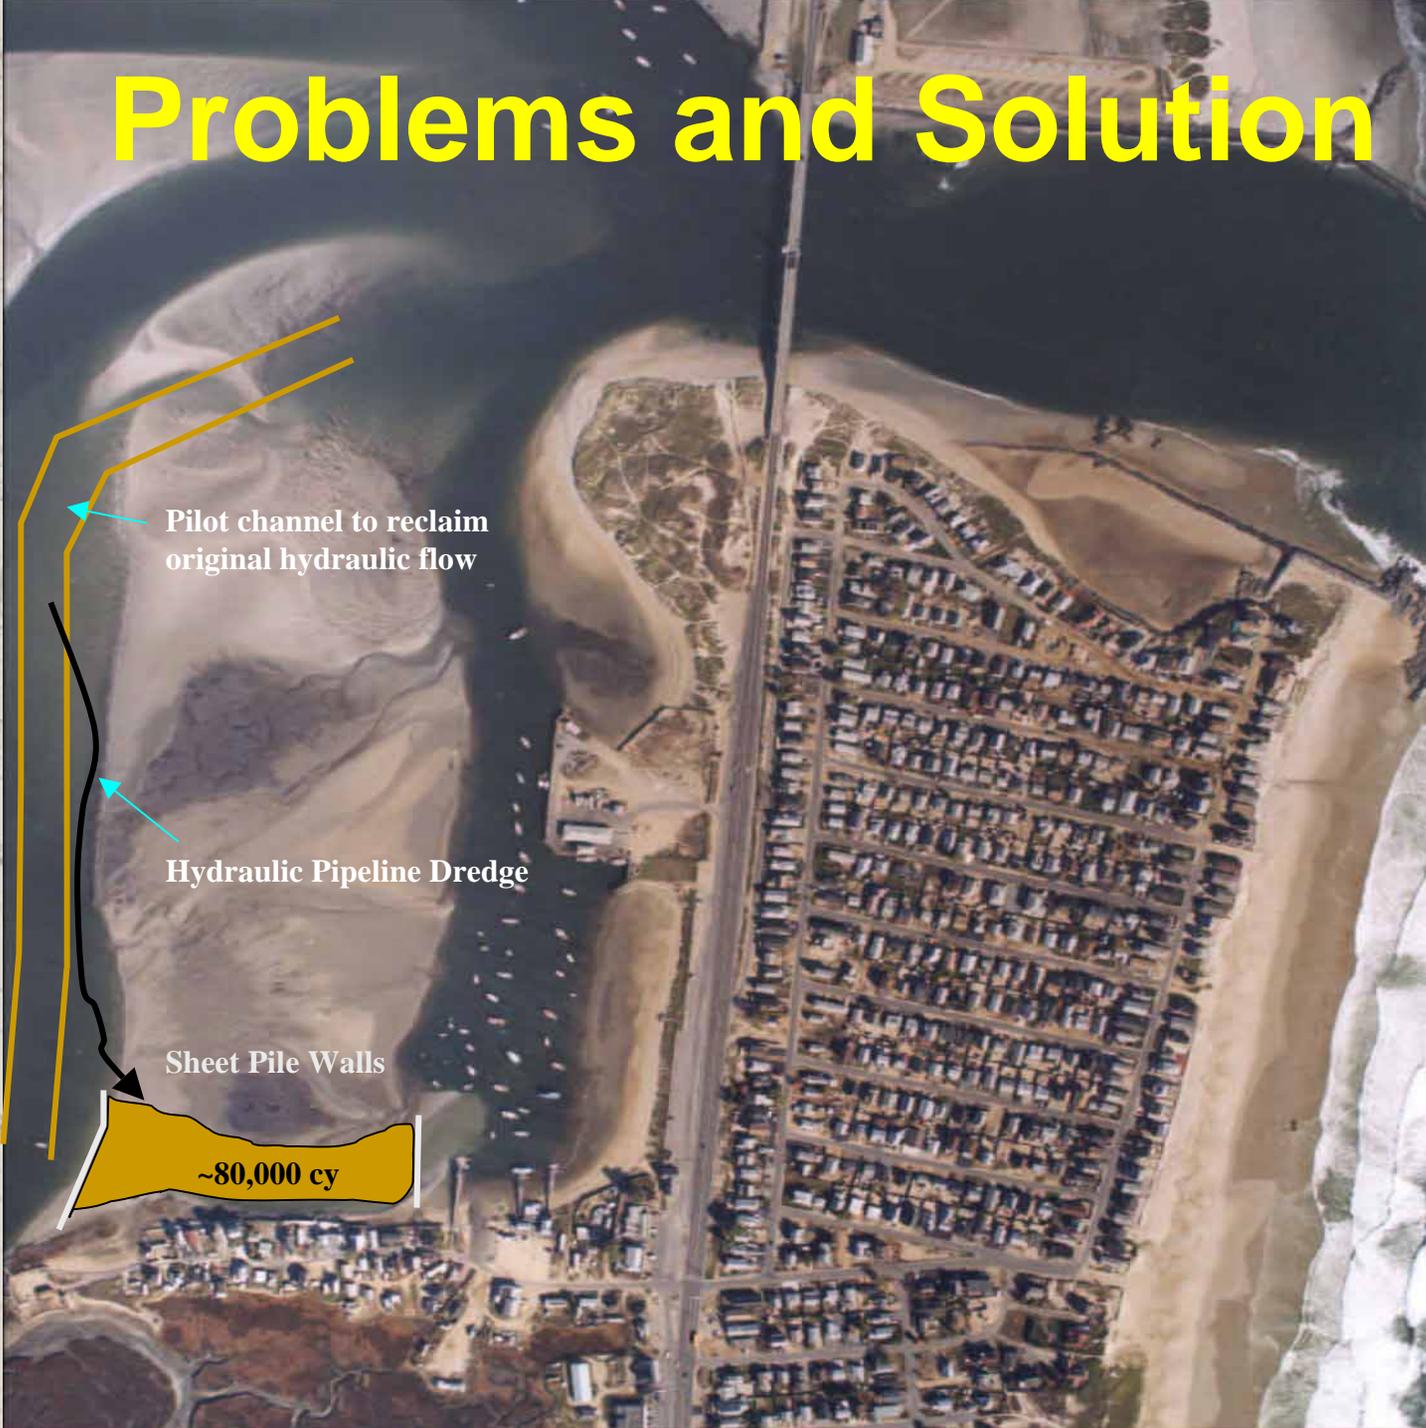
Pilot channel to reclaim original hydraulic flow

Hydraulic Pipeline Dredge

Sheet Pile Walls

~80,000 cy

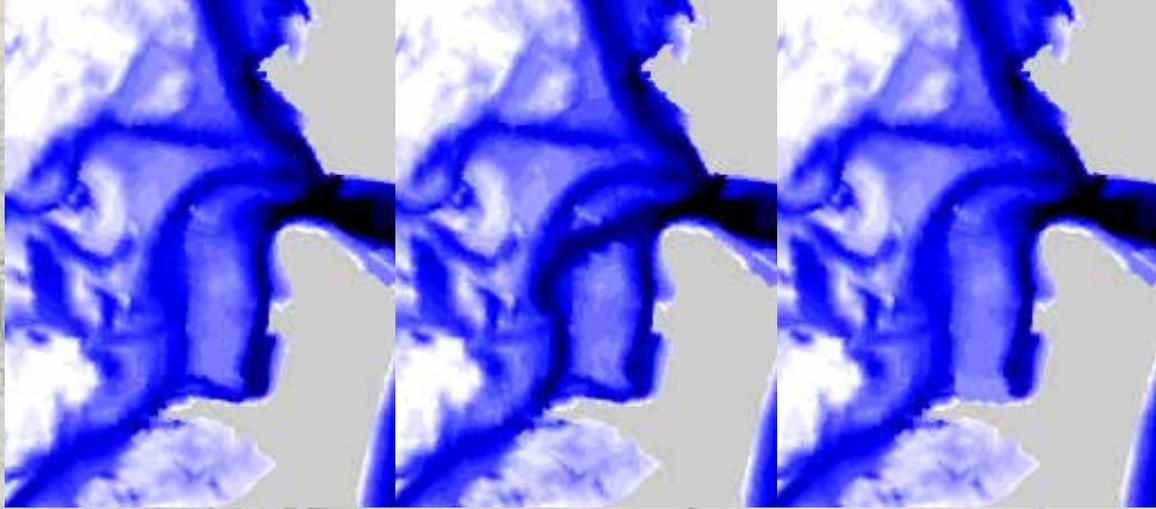
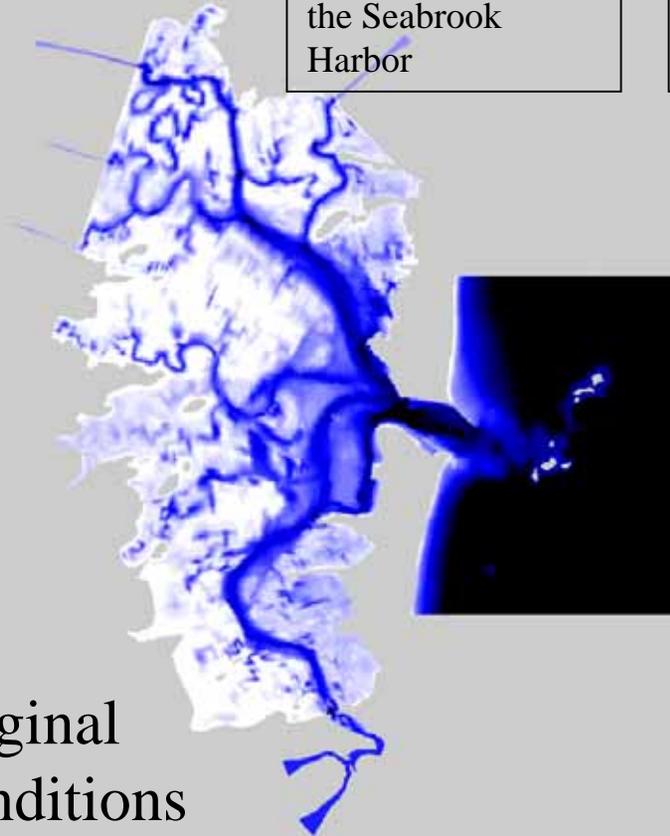
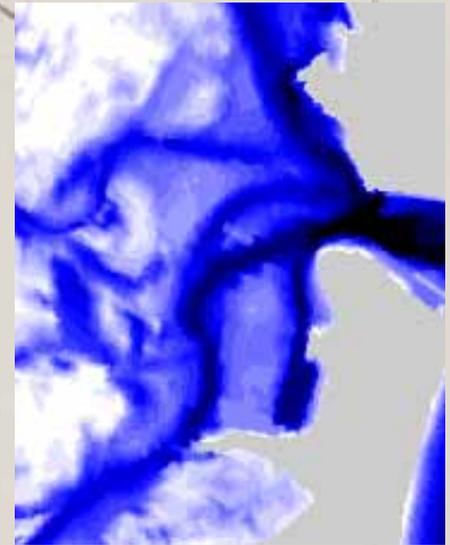
Case 1: Dredging the Seabrook Harbor

Case 2: Dredging the Blackwater River

Case 3: Filling up the *River Street Breach*.

Original Conditions

Case 4: Combination of Case 1, 2 and 3

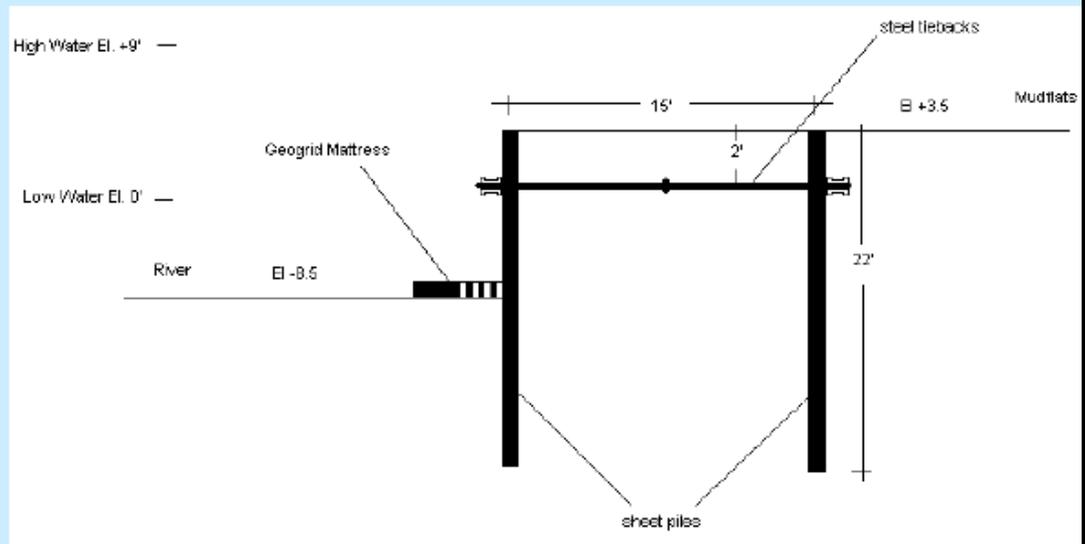
- **Synthetic sheeting:**
Corrosion, Cost
- **Galvanized steel tiebacks and wale:**
Reliability
- **Double Rows of sheets:**
No cantilever
- **Single Wale: No diving**
(winter)
- **Scour protection:**
Protect toe
- **Drainage: Reduce loads**

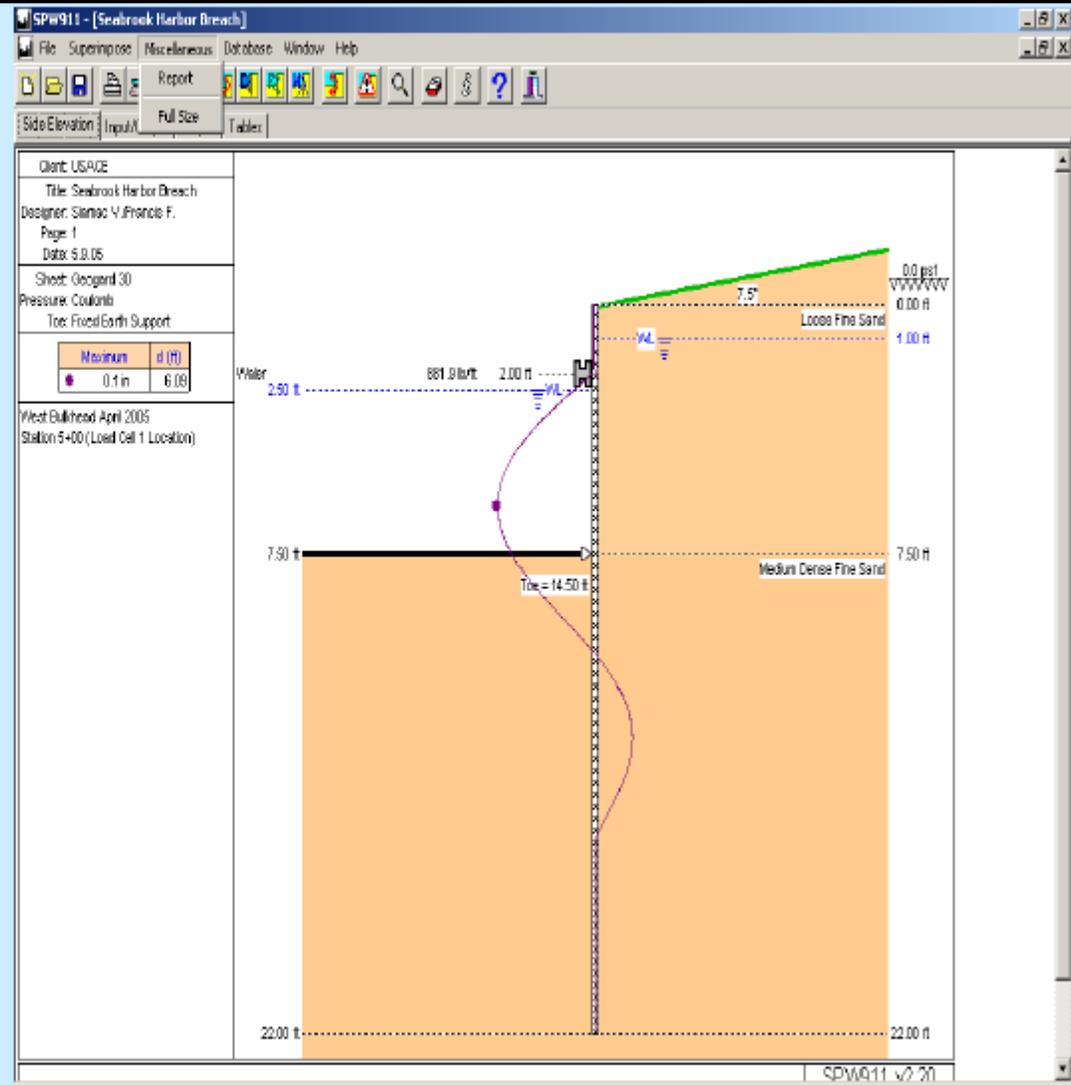
Design Parameters

- 50-year low tide
- 50% drainage in fill
- 12' depth to mudline
- 2 tons horizontal Load per linear foot
- Tiebacks 6' spacing
- 200 psf surcharge

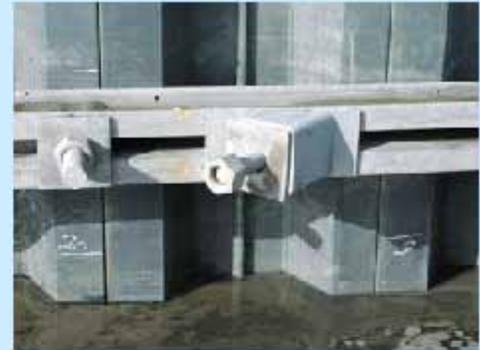
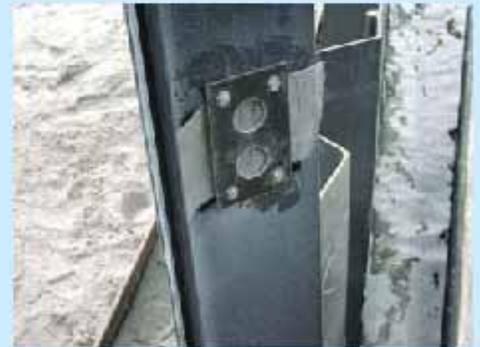
Other Components

- **Wale: 2X 10” galvanized steel Channels on the outside**
- **Tiebacks: 18’ long, 2.25” galvanized steel tiebacks with turnbuckle, Oversized to allow for corrosion**
- **Drains: 2 x 2” dia holes with wire mesh/geotextile backing, located under water to prevent freezing**
