Navigation Infrastructure Management

Portland District Perspective

Portland District Coastal Navigation Projects

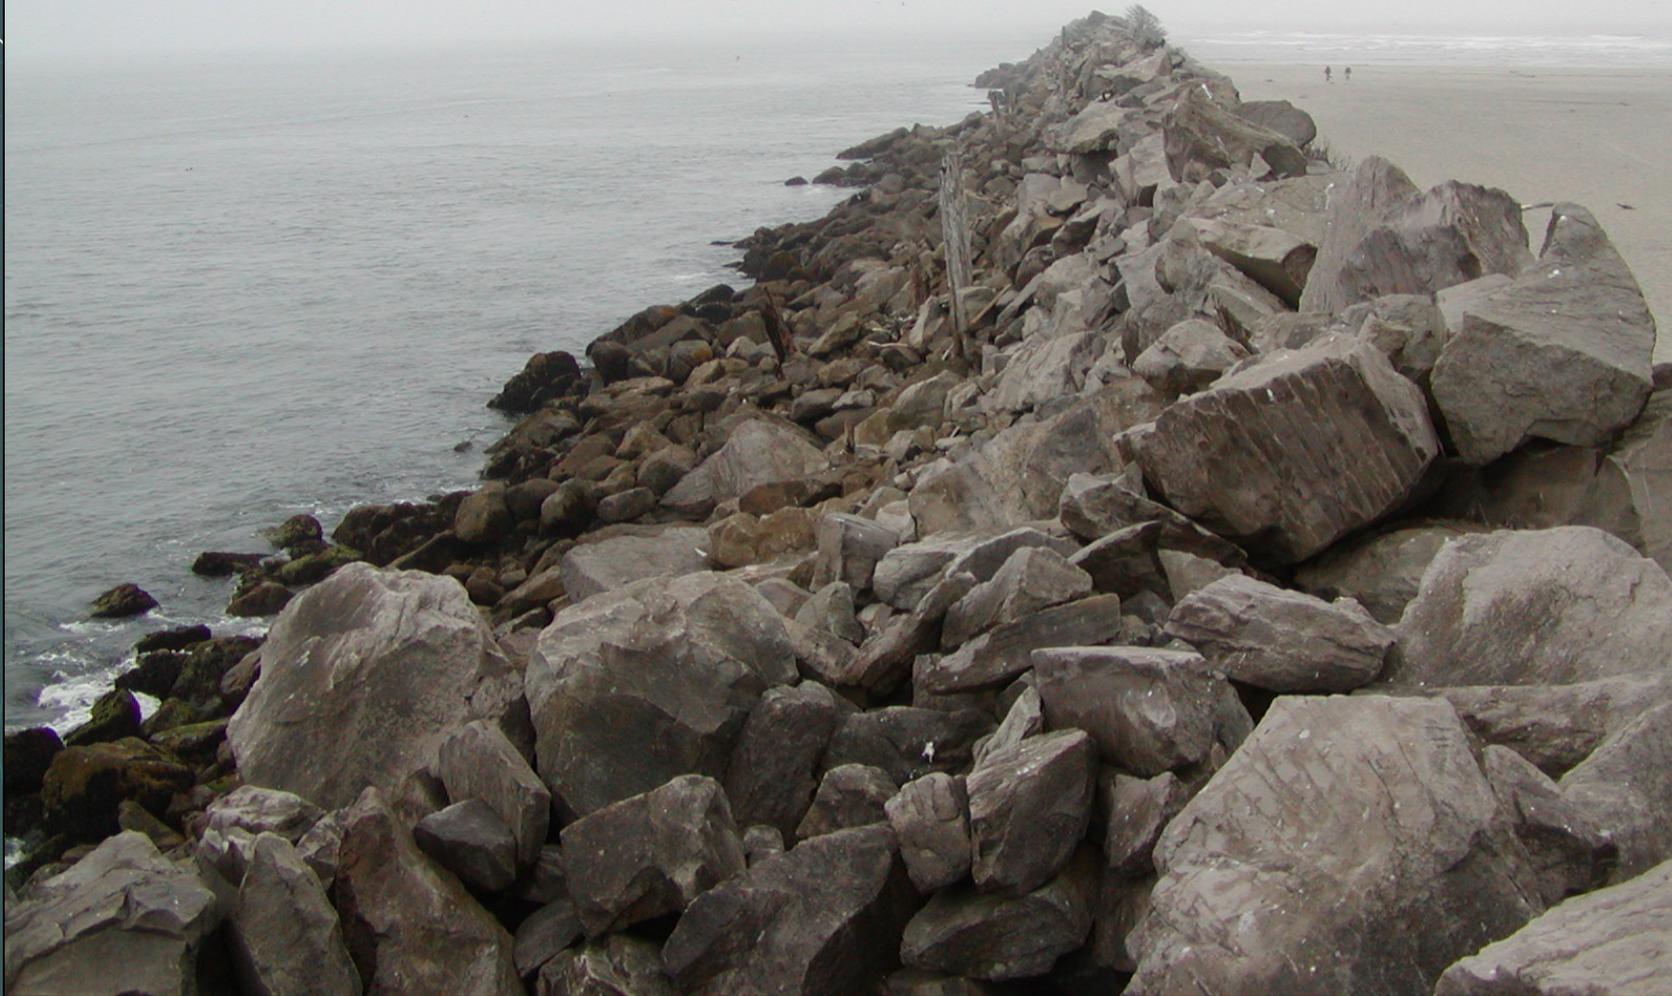
- Field Inspections of Projects (GPS – Damage Zones)
- Aerial, Oblique, and Satellite Photographs
- Regular Communication with Ports and Coast Guard

Ground inspections note new and progressive damage as well as changes in project performance or stability.

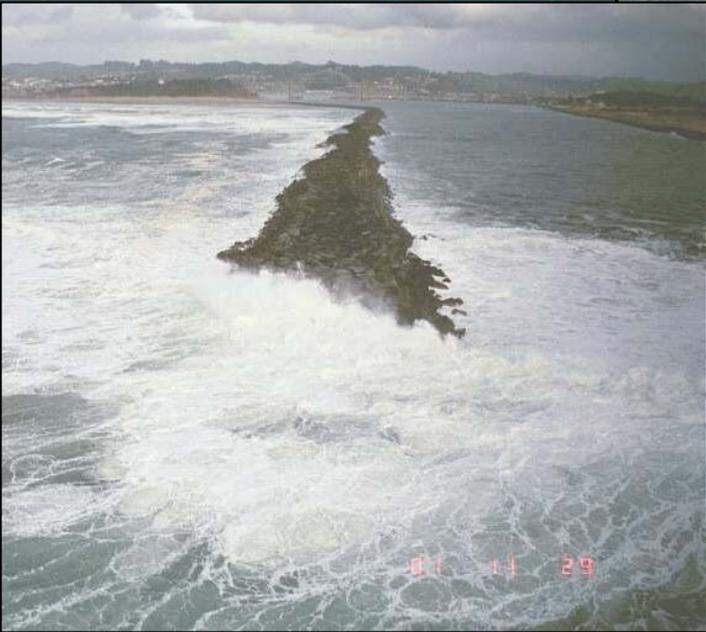
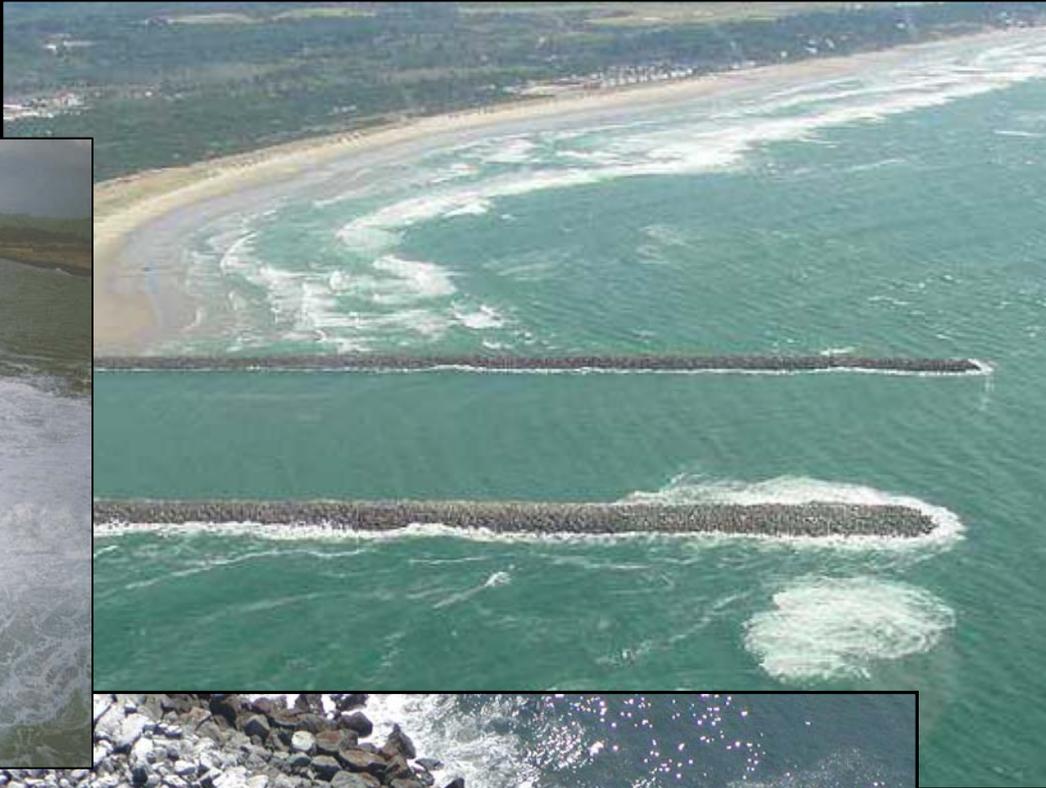
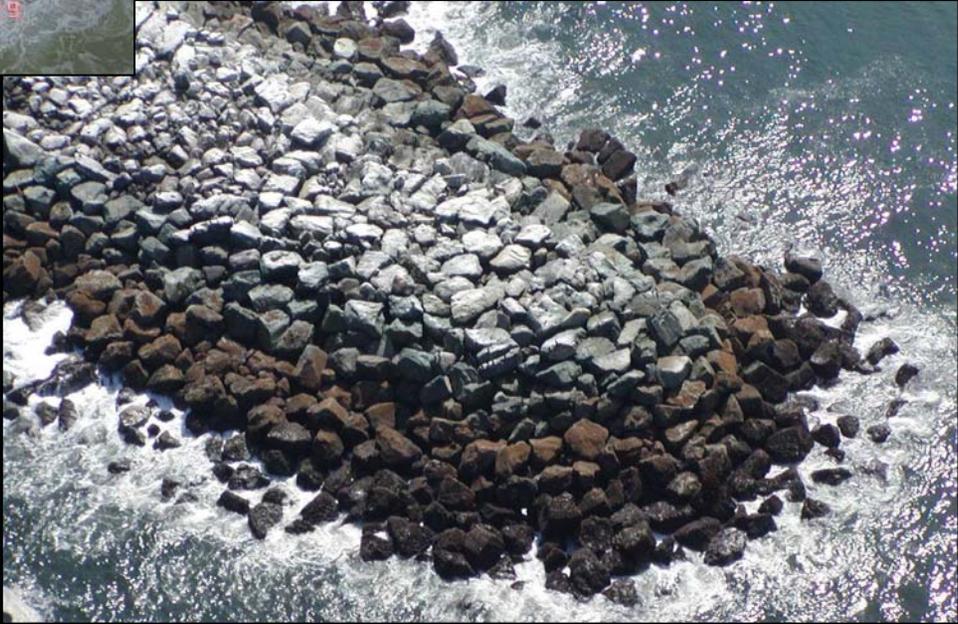
Oblique photos can show damage or damage effects more clearly.

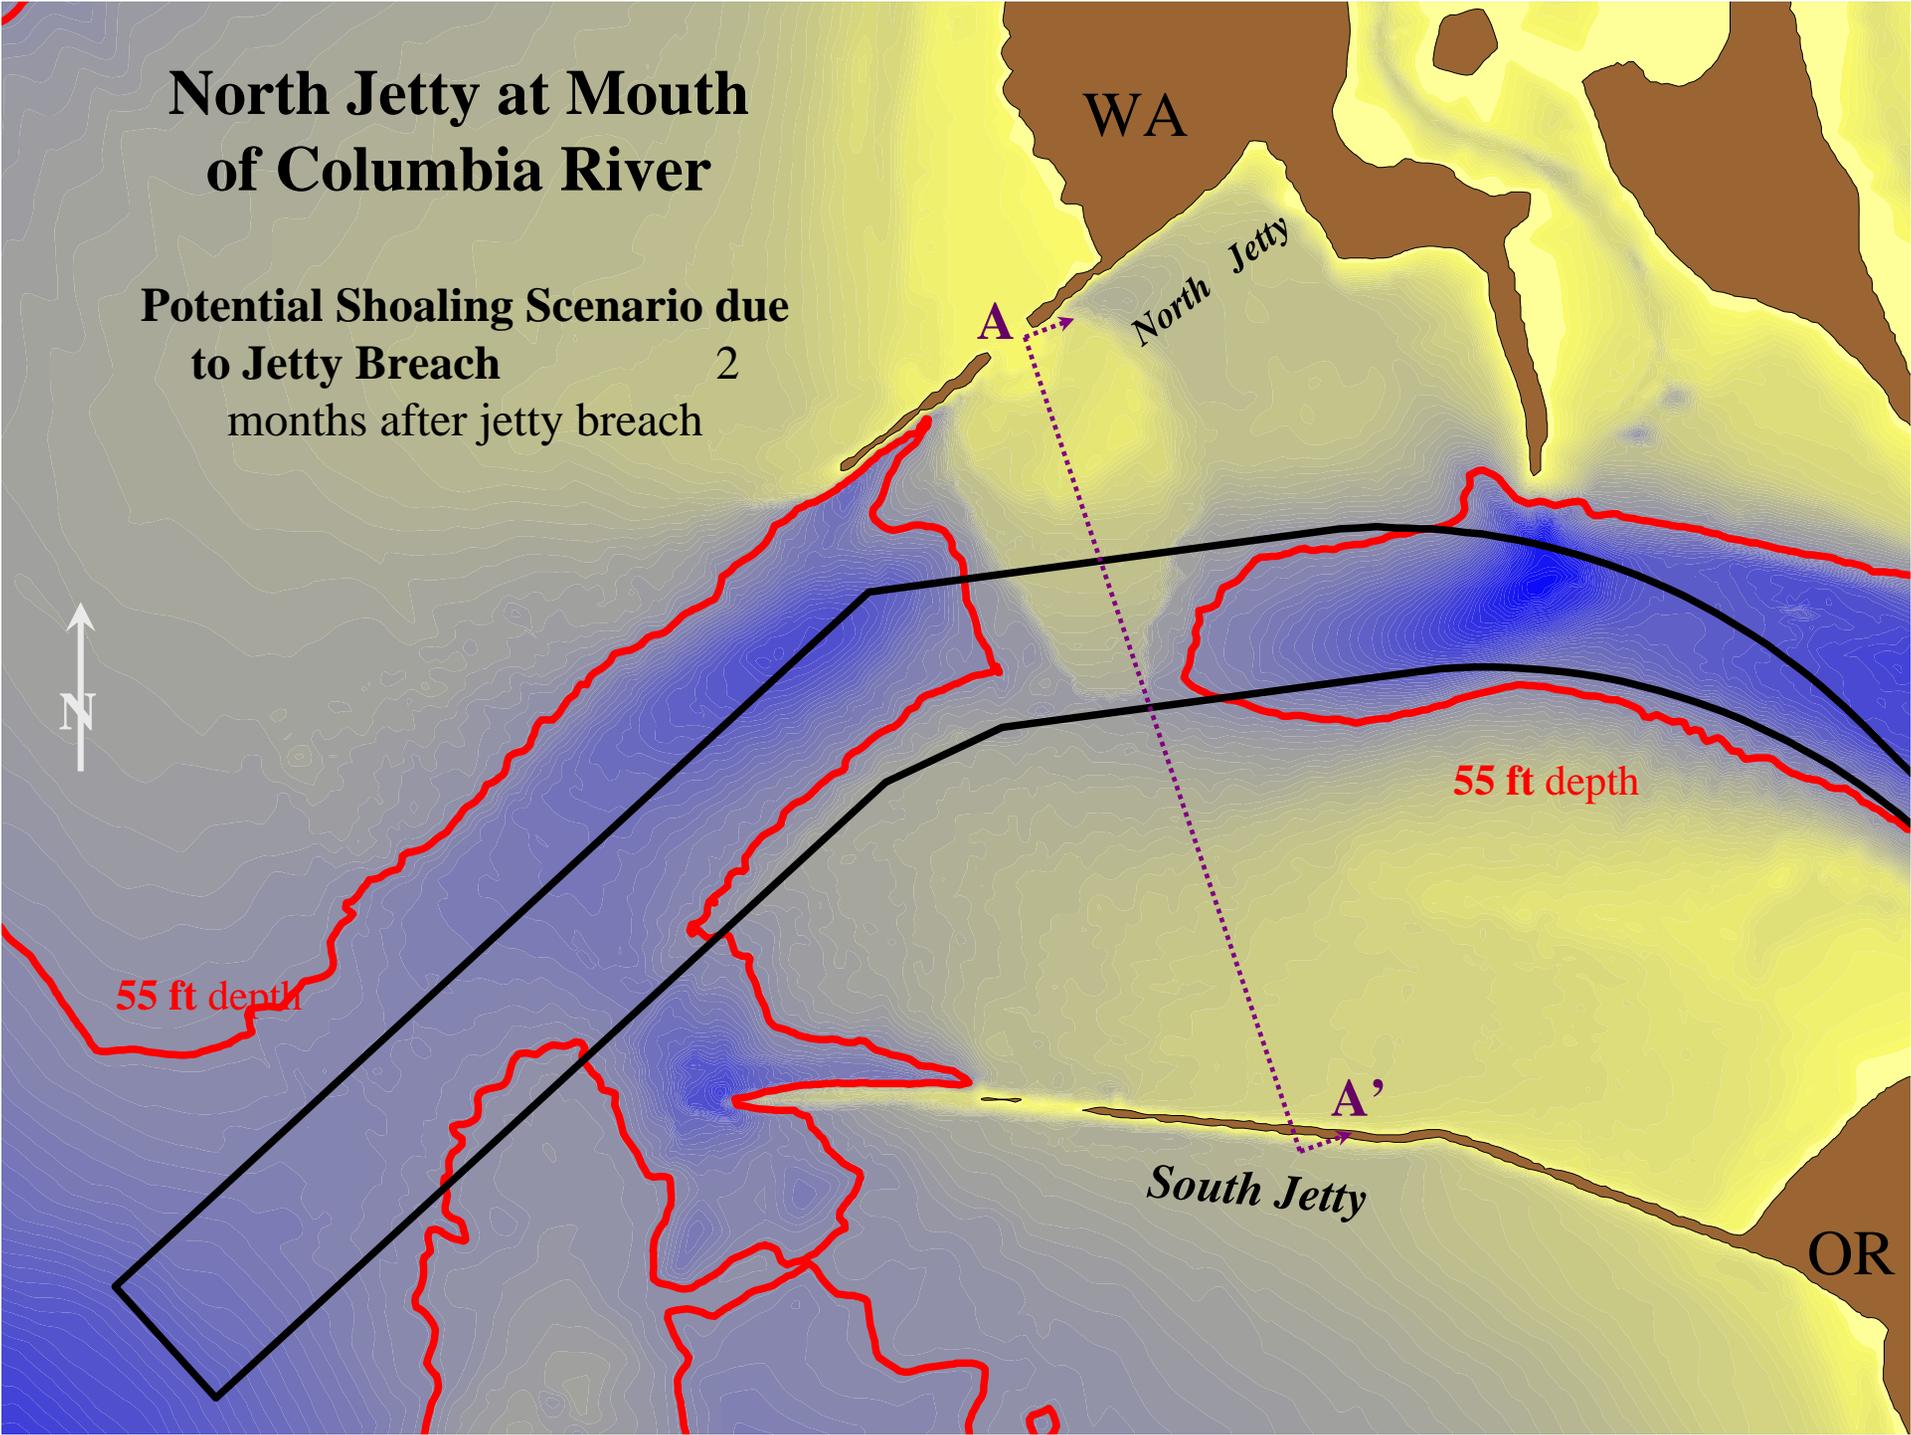
North Jetty at Mouth of Columbia River

Potential Shoaling Scenario due to Jetty Breach
2 months after jetty breach

Excessive Erosion of Shoals Can Lead to Loss of Jetty Foundation = Loss of Jetty
