Fact Sheet

US Army Corps of Engineers
U.S. Army Engineer Research and Development Center

Monitoring Study of Aguadilla Harbor, Puerto Rico

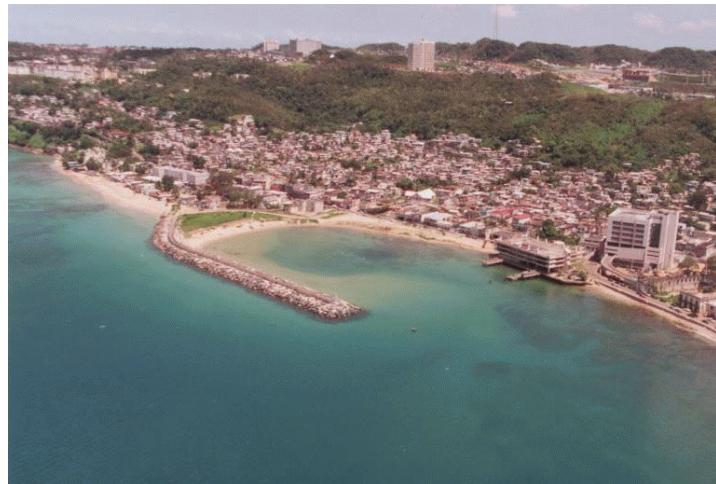
Background: Since its construction in 1995, the Aguadilla small boat harbor, located on the northwest coast of Puerto Rico, has suffered from shoaling by littoral sediment moving through the more porous sections of the breakwater and around the southern tip of the structure. In essence the harbor is trapping sediment during storm events. The City of Aguadilla does not have the resources necessary to keep the harbor free of sediment through regular dredging. In 2001 the Coastal and Hydraulics Laboratory began a four-year monitoring program to assess the performance and functionality of the harbor and breakwater project relative to its design goals.
