# **Noyo Harbor, California, Breakwater Stability and Transmission Tests**

Technical Report CERC-95-17  
October 1995

U.S. Army Corps of Engineers  
Waterways Experiment Station  
3909 Halls Ferry Road  
Vicksburg, MS 39180-6199

Prepared for U.S. Army Engineer District, San Francisco  
211 Main Street, San Francisco, CA 94105-1905

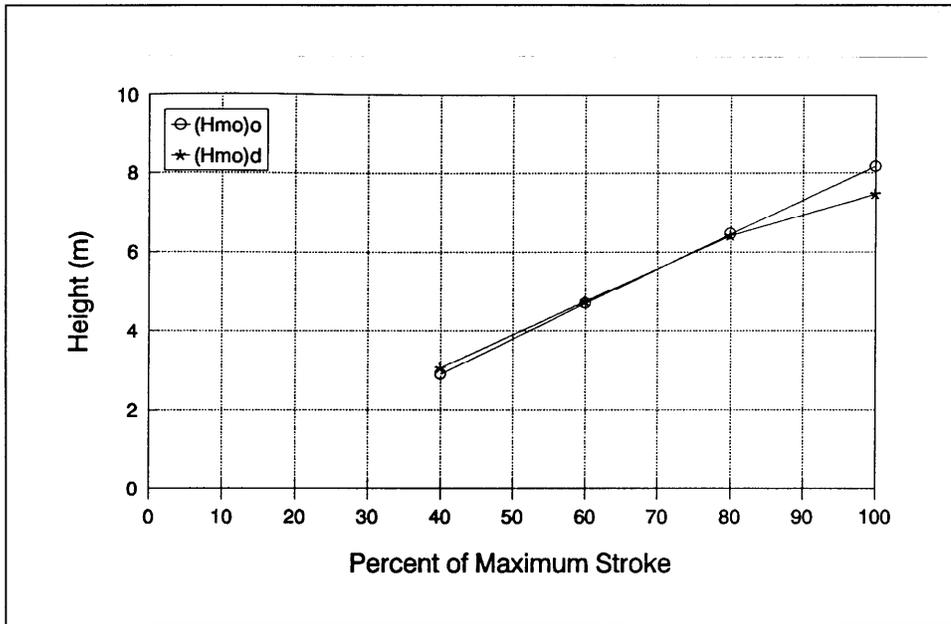
Figure 10. Wave height versus generator stroke, 20-sec regular waves

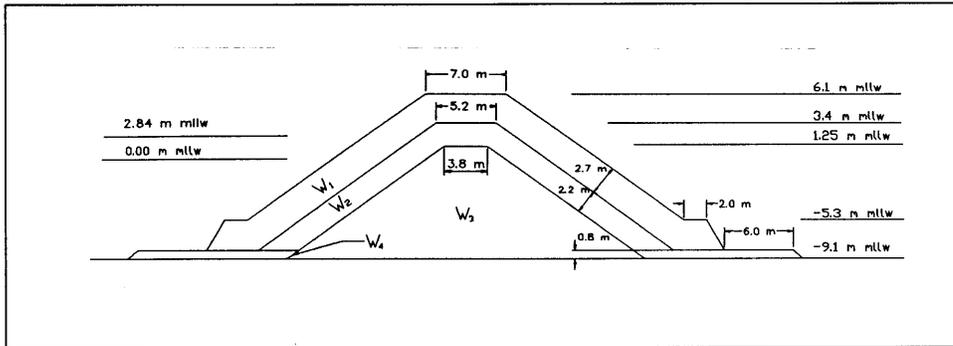
Plan 1 (Figure 11, Photos B1 through B3), proposed by SPN and Sogreah, consisted of one layer of 9-m<sup>3</sup> Accropode armor units placed on a 3V:4H slope. The underlayer consisted of stone ranging from 1,500 to 3,000 kg, core material ranged from 1 to 5,000 kg, and the toe berm was constructed of 50- to 500-kg stone.

Figure 11. Plan 1, two-dimensional stability tests

The structure was stable for original and repeat tests for the design wave conditions at +2.13 m mllw. Plan 1 suffered no damage for the test conditions with no units displaced or rocking (Photos B4 through B6). A stability coefficient of 19.0 was calculated for Plan 1, using Equation 2 with the maximum  $H_{mo}$  of 8.2 m. The structure did not reach a damaged condition and based on observations of the tests, a higher  $K_d$  would have been attained if waves were not limited by depth. Although the armor layer was not damaged, the toe berm material fronting the cross section was displaced.

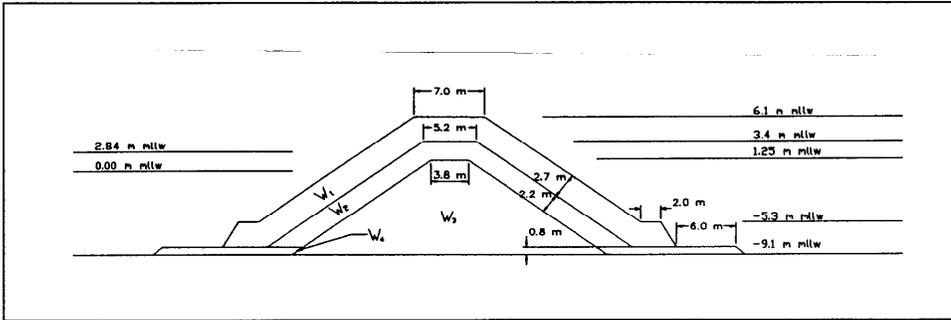
Results from Plan 1 showed the 9-m<sup>3</sup> Accropode units were stable and a less conservative (lighter) armor unit would also be stable. Although the 9-m<sup>3</sup> unit was recommended by Sogreah as the appropriate armor size for the design wave conditions, a lighter Accropode was placed on the structure for testing. Plan 2 consisted of the same geometry and underlayer, core, and toe berm material sizes used in Plan 1, but 7.6-m<sup>3</sup> Accropodes were used as armor layer (Figure 12, Photos B7 through B9).

Figure 12. Plan 2, two-dimensional stability tests

The structure was tested for the design wave conditions at +2.13-m mllw and repeated once. Plan 2 was not damaged for the test conditions with no displaced armor units (Photos B10 through B12); however, four units were observed to rock in place during original and repeat tests. The stability coefficient calculated for Plan 2 was 23.1. The toe berm size was identical to the size used in Plan 1 and was also damaged.

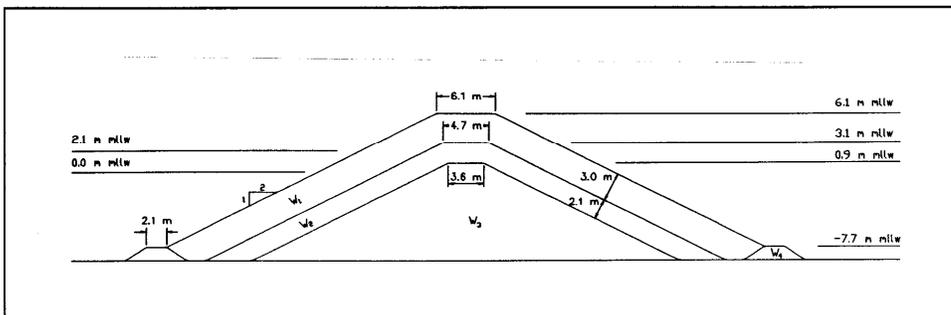
Figure 13. Plan 3, two-dimensional stability tests

through B15, was designed using the method recommended by the *Shore Protection Manual* (1984), and consisted of 453.6- to 1,814.4-kg underlayer stone and 1.4- to 45.4-kg core stone. The toe berm stone was constructed of 907.2-kg stone.

After the structure was subjected to the conditions in Table 3, 1.6 percent of the units were displaced on the sea side (Photos B16 and B17). The structure did not reach a damaged condition and a  $K_d$  of 29.8 was calculated. However, eight units were observed to rock in place during original tests and ten units rocked in place during repeat tests. This movement of units indicates that units would break on the prototype structure, which could result in failure of the structure. Quantitative and qualitative results indicated that Plan 3 was moderately stable for the design wave conditions conducted at +2.13 m mllw. No stone was displaced from the toe berm.

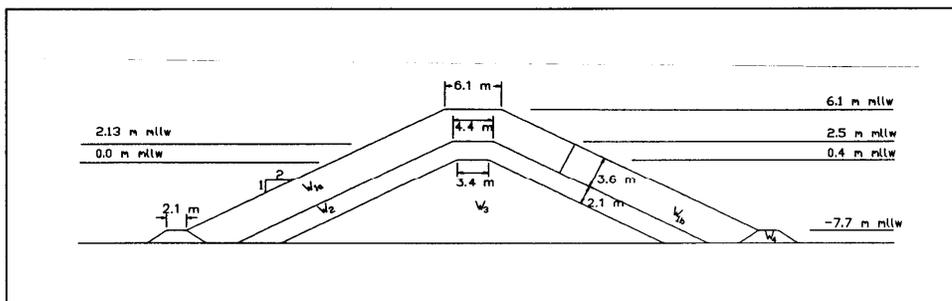
Figure 14. Plan 4, two-dimensional stability tests

Plan 4 was not damaged by the design wave conditions conducted at +2.13 m mllw (Photos B18 through B20), and a  $K_d$  of 14.4 was calculated for the sea-side cross section. Slight rocking of units was observed for wave heights equal to and greater than 6.4 m. Observations during tests indicated that higher waves would not damage the structure and that Plan 4 appeared to be a conservative design. The toe berm was stable with no stone displaced.

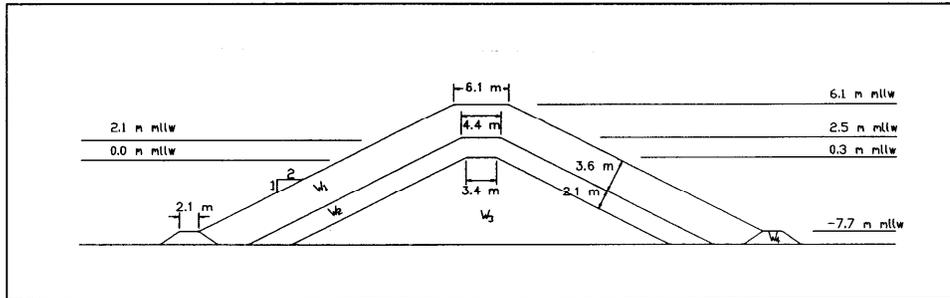
Results from Plans 3 and 4 indicated the optimal dolos size for stability was heavier than  $3.8 \text{ m}^3$  and lighter than  $7.9 \text{ m}^3$ . Plan 5 (Figure 15, Photos B21 through B23) consisted of  $5.9\text{-m}^3$  dolos on the armor layer. The underlayer, core, and toe berm stone sizes remained the same as Plan 4.

Figure 15. Plan 5, two-dimensional stability tests

No units were displaced from the  $5.9\text{-m}^3$  cross section and a  $K_d$  of 19.5 was calculated, but five units were observed to rock in place during wave action. Plan 5 was stable and less units were observed to rock in place than with Plan 3. However, the increase in stability between the  $3.8\text{-m}^3$  and  $5.9\text{-m}^3$  dolos was not significant. The 907.2-kg toe berm was stable.

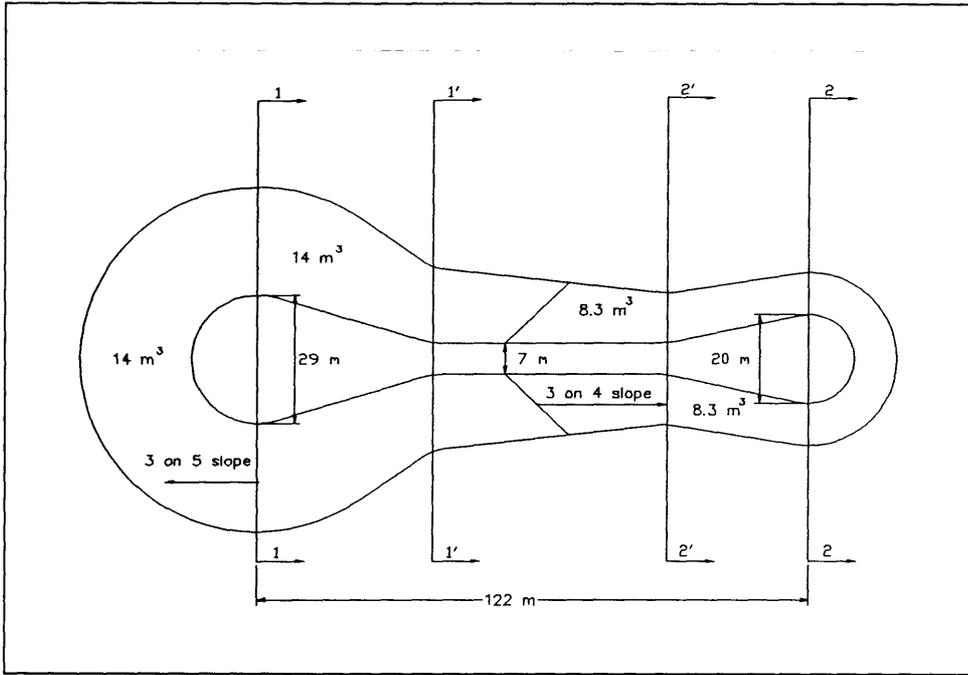
Figure 17. Original Noyo breakwater plan

Plan 1, the proposed plan, consisted of 14-m<sup>3</sup> Accropodes on the north roundhead and 8.3-m<sup>3</sup> units on the south roundhead (Figure 17) and was exposed to Storm I conditions. The armor layer became loose and Accropodes were displaced at the toe during tests with 20-s, 6.4-m waves. This period and height were repeated to determine if further damage would occur and if the limiting wave condition had been reached. Damage did not increase when the condition was repeated, but the plan failed after the structure was subjected to the higher waves in the test series. Armor units were observed to slip on the structure slope, which indicated the mechanism of failure to be an unstable toe (Photos C1 through C4).

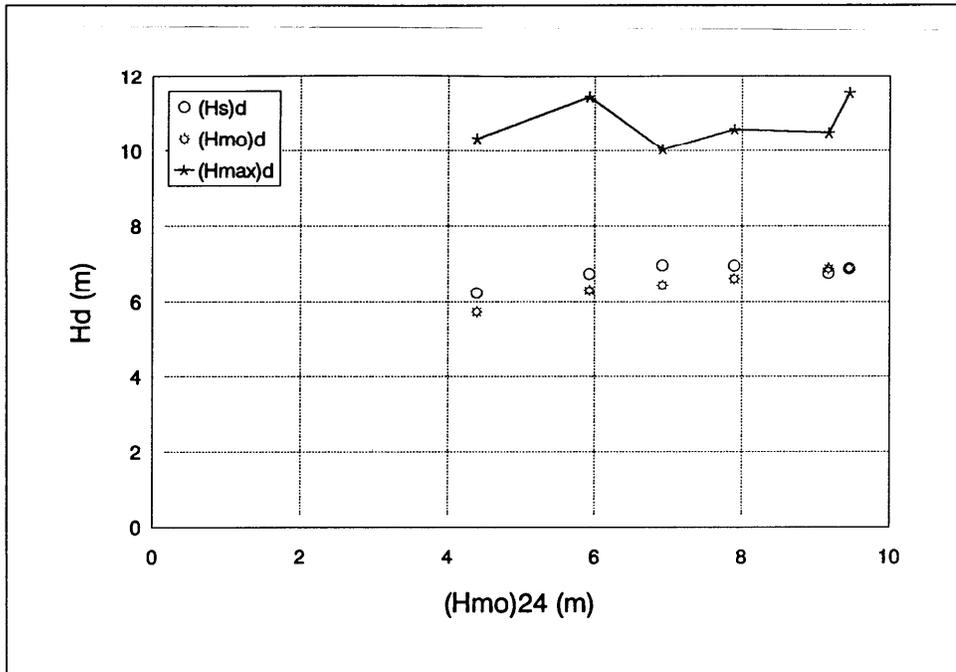
Figure 23. Wave height at north roundhead, 13-sec waves

Design wave heights at the proposed structure were selected from Figures 23 through 25, which show results of three-dimensional calibration of the facility for peak periods of 13, 17, and 20 sec, respectively. Offshore wave height at the wave generator depth of 24 m  $(H_{mo})_{24}$  is plotted versus  $(H_{max})_d$ ,  $(H_s)_d$ , and  $(H_{mo})_d$  at the north roundhead, where  $(H_{max})_d$  = maximum wave height at north roundhead, three-dimensional tests,  $(H_s)_d$  = significant wave height at north roundhead, three-dimensional tests, and  $(H_{mo})_d$  = zero-moment wave height at north roundhead, three-dimensional tests. A depth-limited breaking condition was reached at the structure location for non-breaking conditions at the generator for all periods. Storm I design conditions for stability tests are shown in Table 7. The total duration of Storm I was approximately 30 hr prototype. Some breakwater plans were subjected to additional waves without rebuilding the structure. Storm IA conditions consisted of the ten Storm I waves beginning with the  $T_p = 13$  sec,  $(H_{mo})_d = 5.8$  m condition and continuing to  $T_p = 20$  sec and  $(H_{mo})_d = 8.1$  m in Table 7. Storm IB consisted of three Storm I waves which began with  $T_p = 17$  sec,  $(H_{mo})_d = 7.2$  m and concluded with  $T_p = 20$  sec,  $(H_{mo})_d = 8.1$  m.

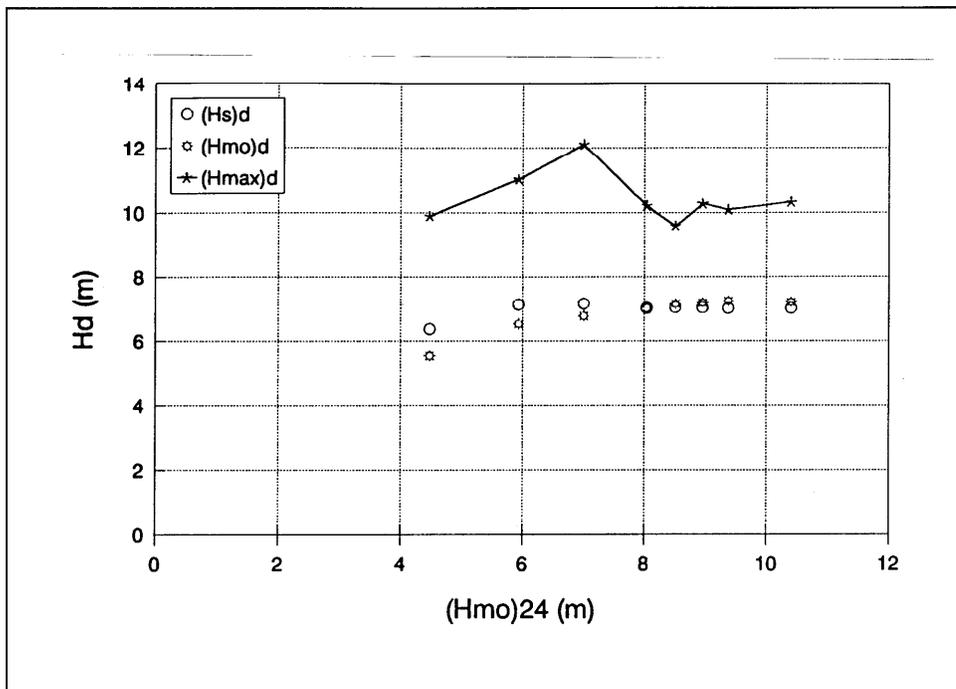
Figure 24. Wave height at north roundhead, 17-sec waves

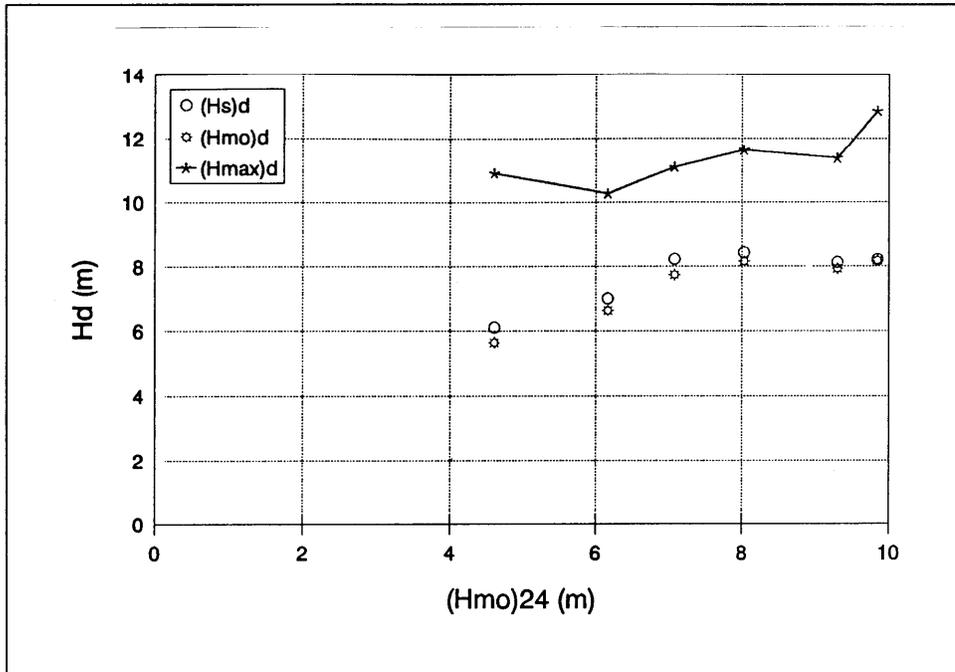
Figure 25. Wave height at north roundhead, 20-sec waves

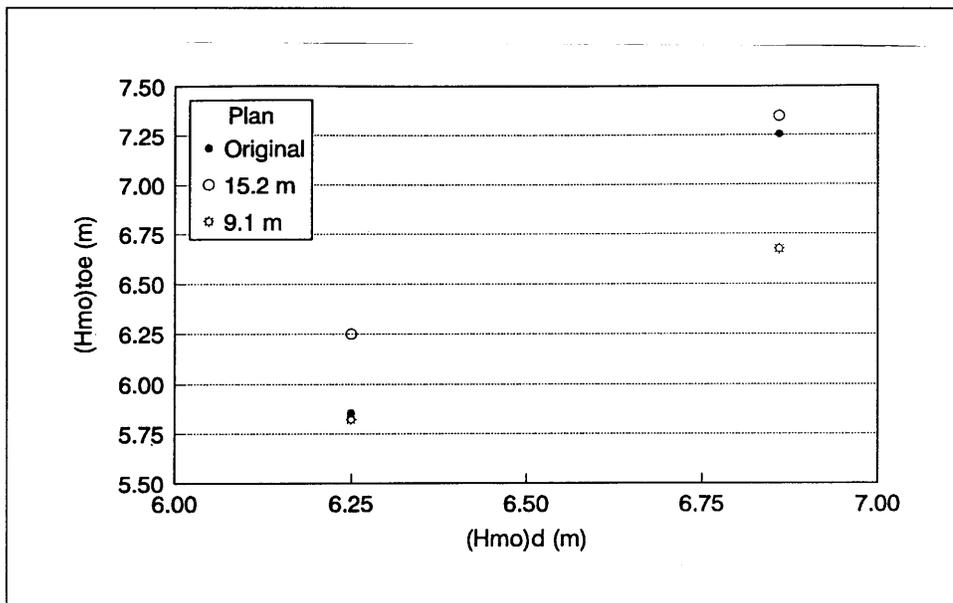
Figure 26. Comparison of 13-sec wave heights at leeside toe to crown width

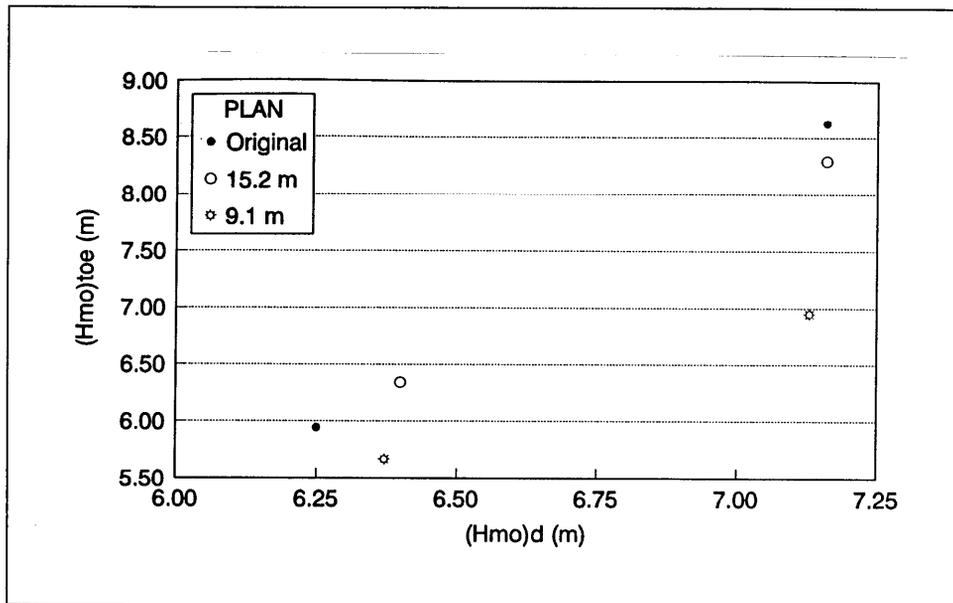
Figure 27. Comparison of 17-sec wave heights at leeside toe to crown width

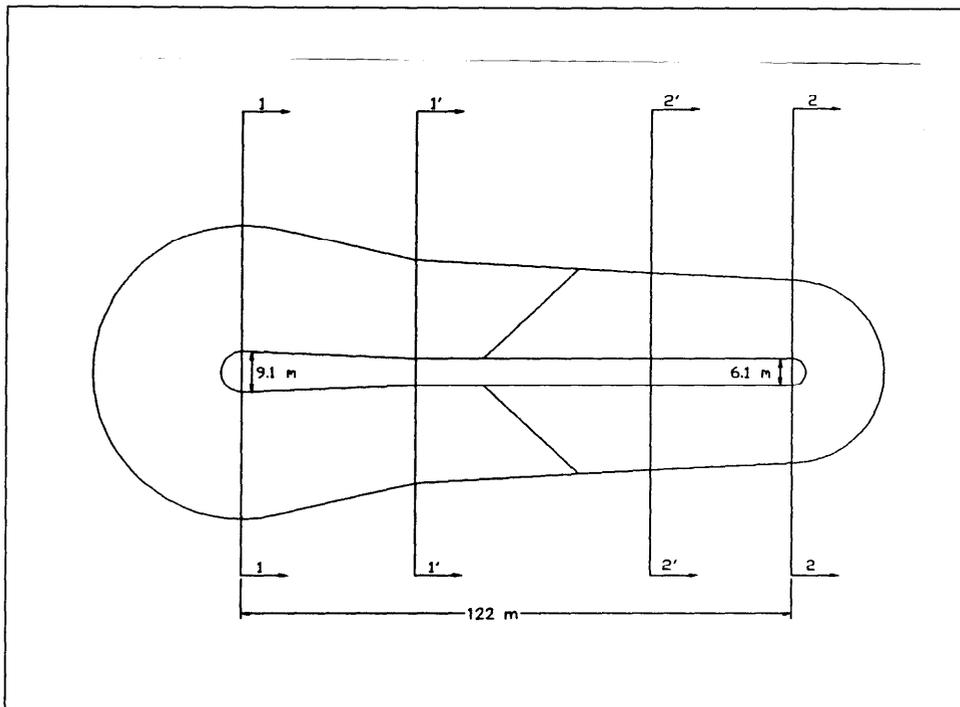
Figure 29. Modified Noyo breakwater plan

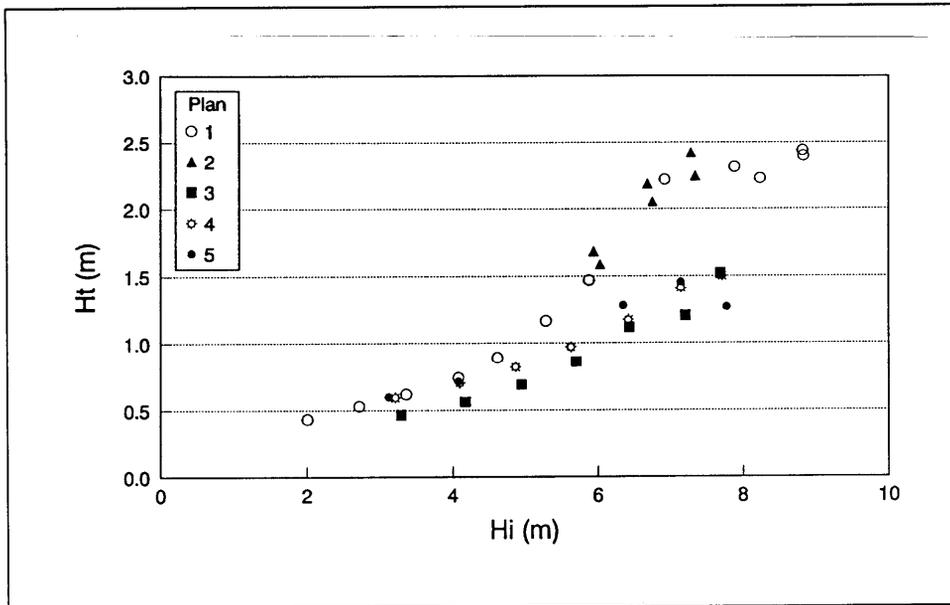
Figure 35. Two-dimensional stability wave transmission, 13-sec waves

Design conditions were based on analyzed data from the two-dimensional stability tests. Measured transmitted wave height  $H_t$  from the two-dimensional stability plans is shown as a function of incident wave height  $H_i$  in Figures 35 through 37 for regular waves. Prior to testing of small-scale cross sections, comparison criteria were established. The following results and observations were considered to develop transmission test criteria:

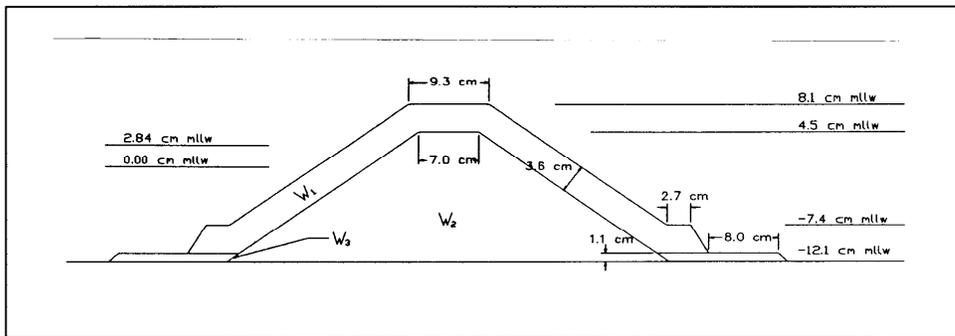
The armor stone of Plan A was replaced with heavier stone, 44 to 86 g, and the core size remained the same for Plan B (Figure 38). It was desired to increase transmission for the 13-sec waves and decrease transmission for 17- and 20-sec waves. The larger armor stone was more porous and would allow more energy to transmit through the breakwater, but it was also more stable and would maintain the design crest elevation and reduce overtopping. Figures 39, 41, and 42 show that the more stable armor stone reduced transmission for the 20-sec waves by 8 percent to +25 percent, but transmission also decreased for 13-sec waves to -28 percent of Plan 1 values of  $K_r$ . Use of the heavier stone increased transmission for the 17-sec waves to +30 percent of Plan 1 values (Figures 40 and 42).

Figure 38. Cross section of Plans A, B, and C

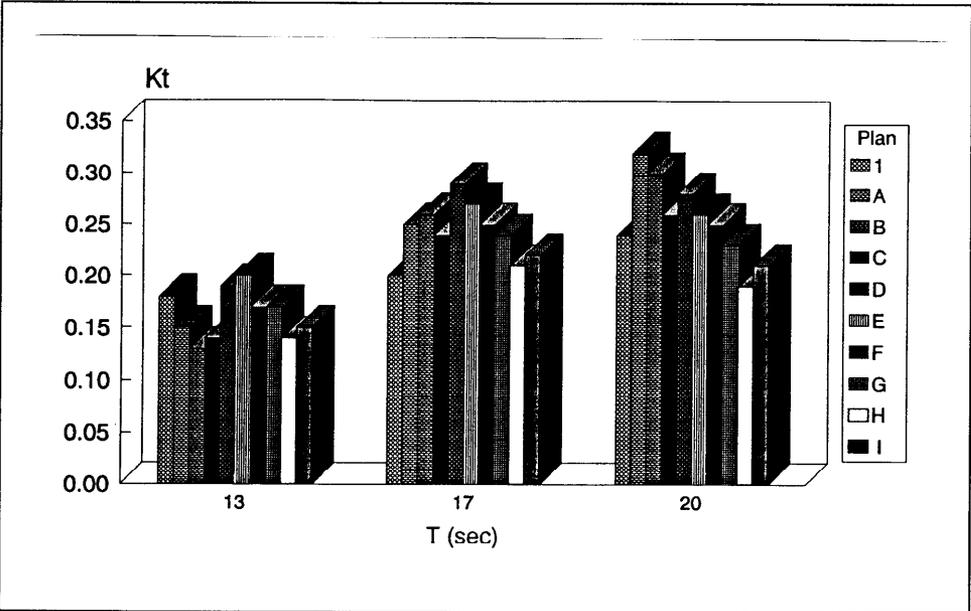
Figure 42. Comparison of  $K_t$  between Plan 1 and Plans A through I

period waves approached depth-limited breaking conditions near the cross section, and it was felt that transmission of the 13-sec waves occurred mainly through the core material. Therefore, core and armor stone sizes were increased for Plan D to 86-148 g and 5-11 g, respectively. Reduction of transmission for the 17- and 20-sec periods was attempted by placing a thin metal strip level with the crown elevation and into the structure a distance  $Y_1 = 5.1$  cm (Figure 43). Figures 39 and 42 show that transmitted 13-sec waves for Plan D increased to +6 percent of Plan 1 values. However, transmission for the 17-sec and 20-sec waves also increased to 45 and 17 percent, respectively, higher than desired transmission (Figures 40 through 42).

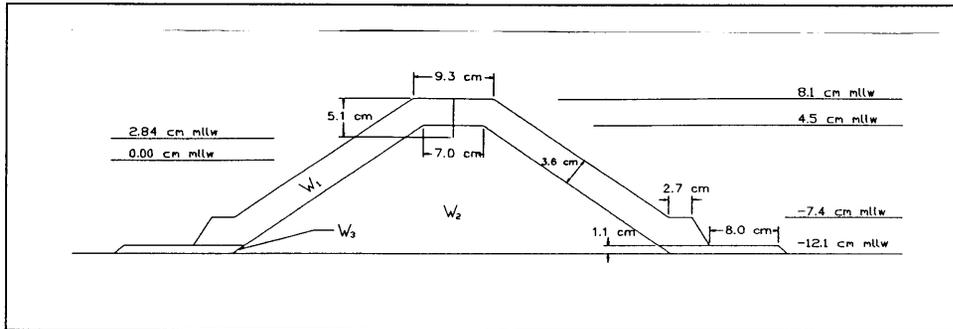
Figure 43. Cross section of Plan D

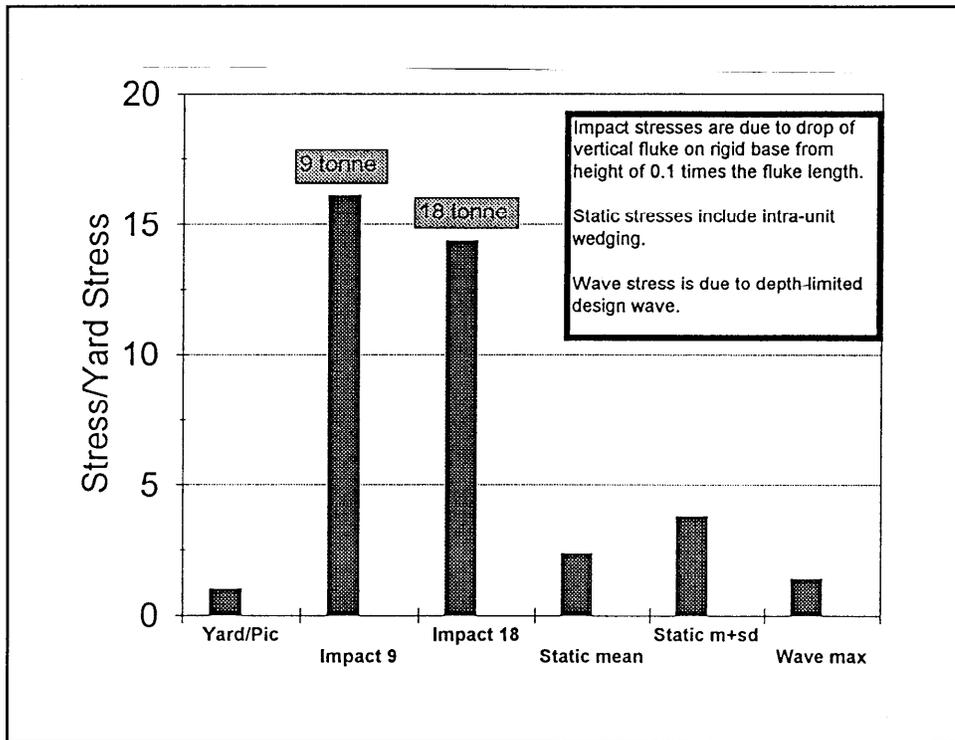
Figure A1. Relative magnitude of dolos stresses for various loads

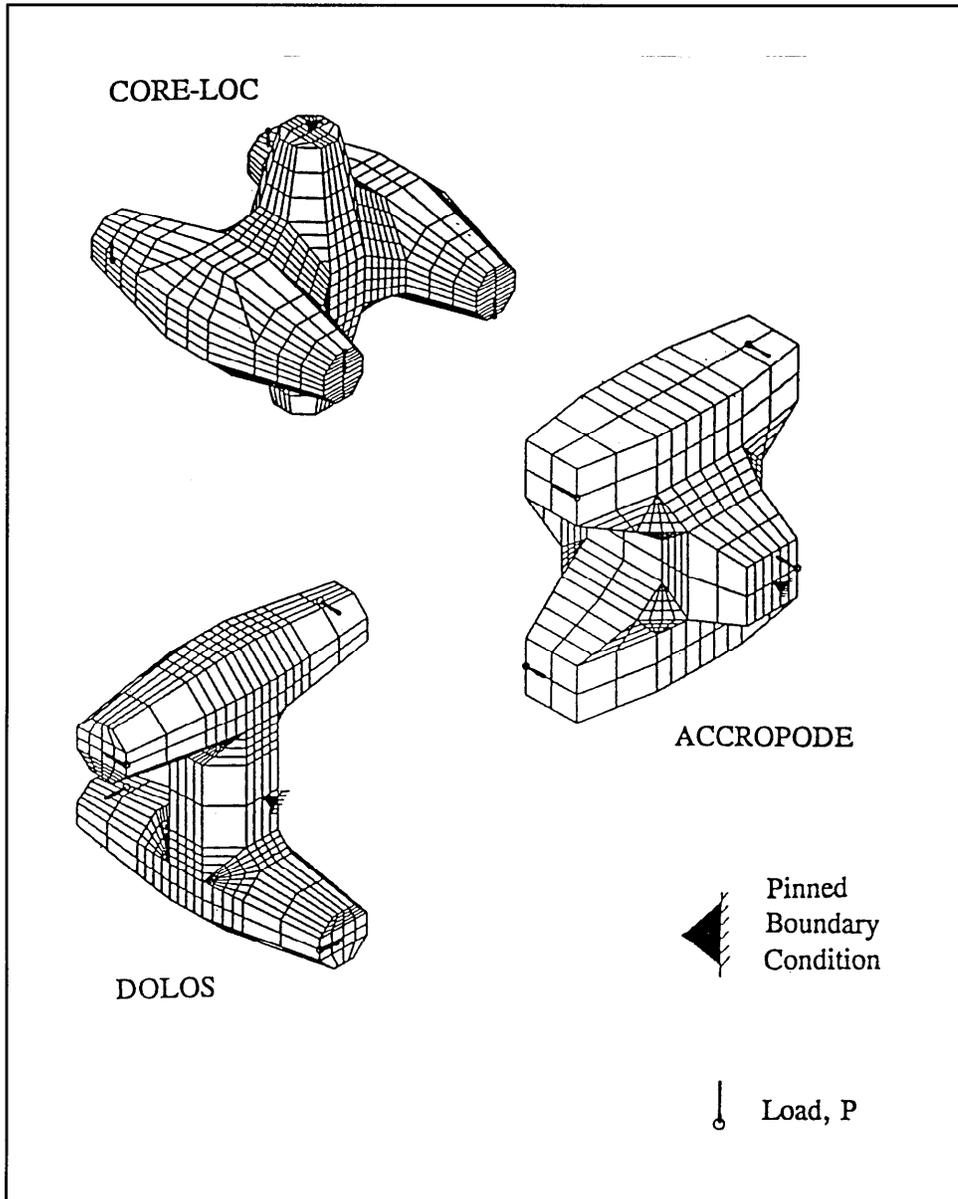
Figure A2. Loading and boundary conditions for torsional loading comparison

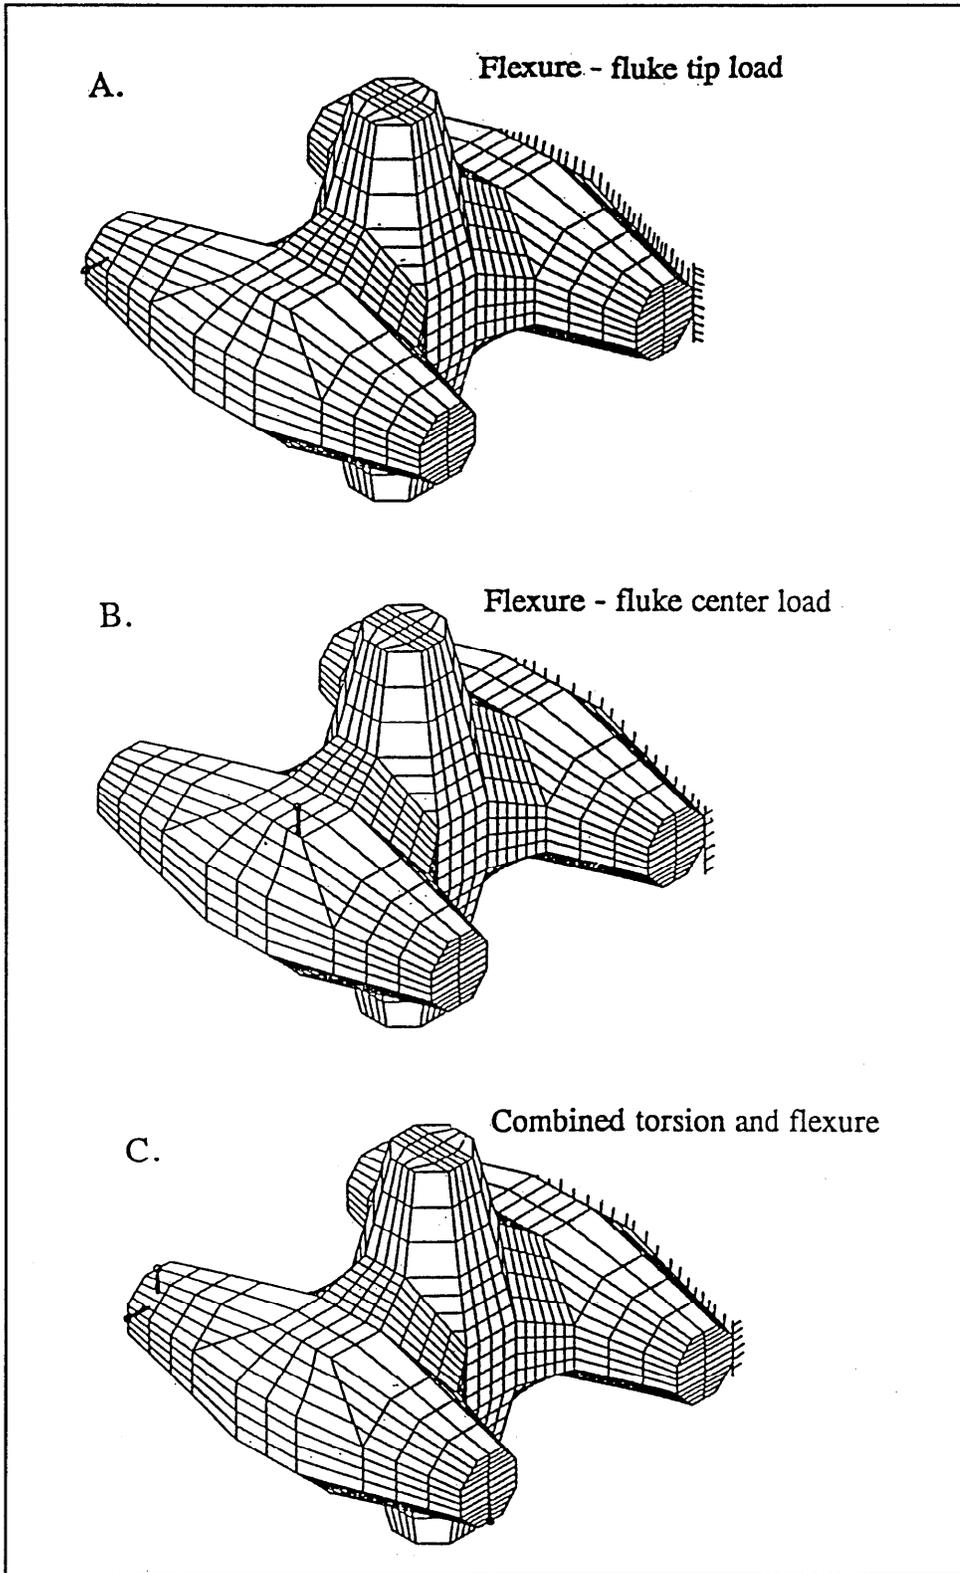
Figure A3. Loading and boundary conditions for various loading conditions

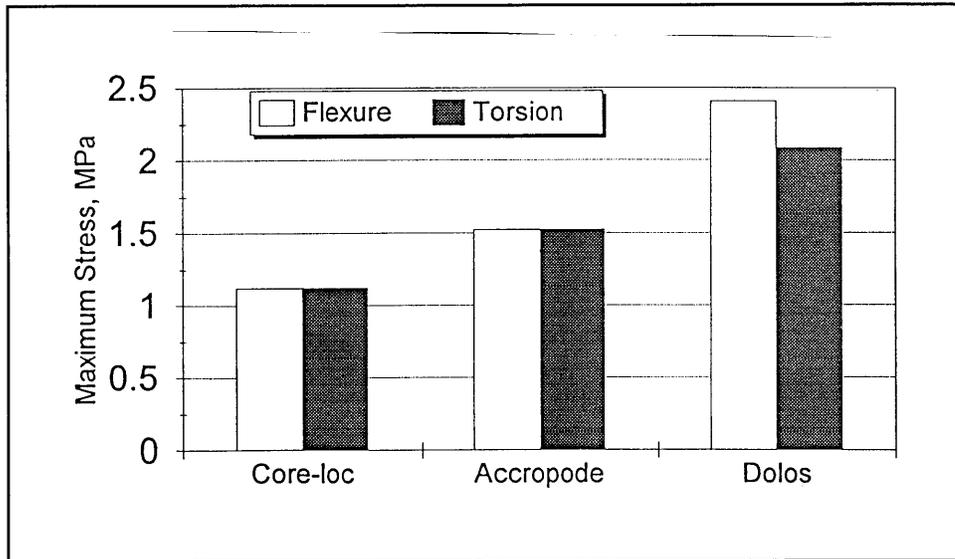
Figure A4. Finite element structural response comparison

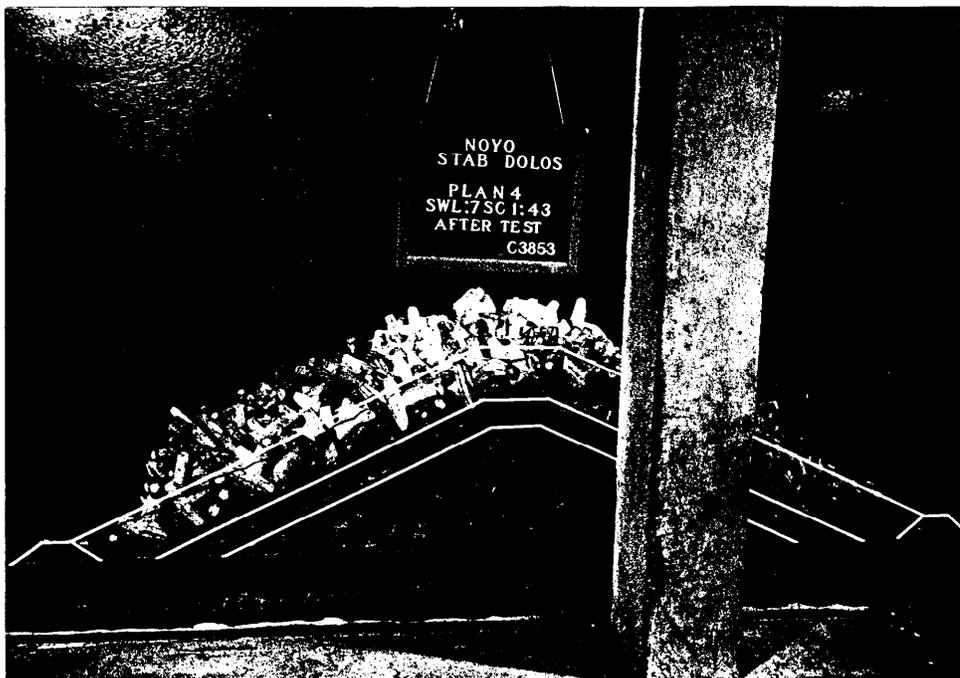
Photo B18. Plan 4, Side view, after testing

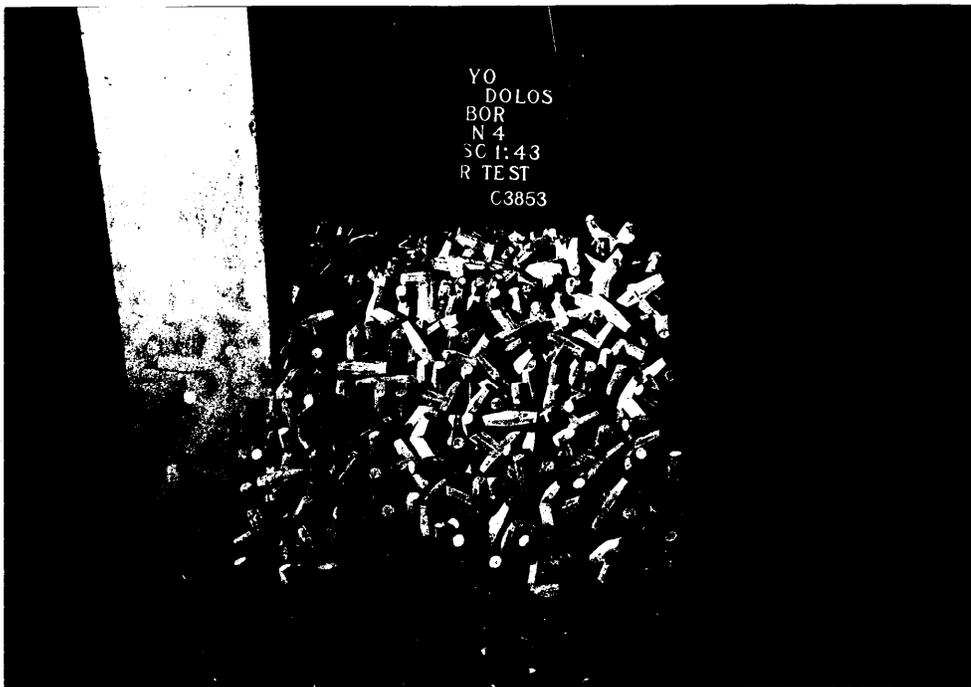
Photo B20. Plan 4, Leeside view, after testing
