## ***National Erosion Control Development and Demonstration Program (Section 227)***

# **Cape May Point, N.J.**

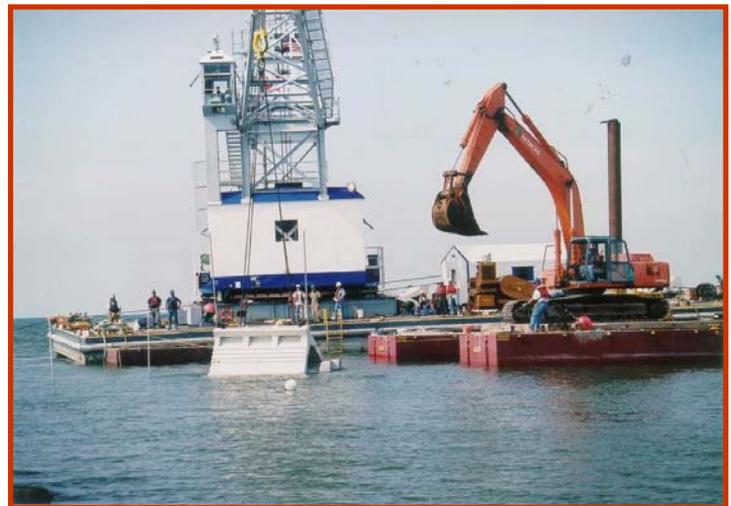
**Prefabricated concrete Beachsaver Reef™ is installed**

The Beachsaver Reef is a reinforced prefabricated concrete breakwater. The breakwater is narrow-crested due to its triangular shape, with the smallest dimension at the crest width. Each unit is 1.8 m (6 ft) high, 3 m (10 ft) long and 4.5 m (15 ft) wide, with a crest width of 0.45 m (1.5 ft), and weight of around 186,825.3 N (21 tons). The units interlock with each

other and were placed in a line across the seaward end of the groin cell. A new innovation was to place a filter cloth with a concrete-filled tube on the landward end as a base under the structures to prevent scour and settlement (experienced with the 1994 placement in cells 2 and 3). A line of 72 units was constructed completely across cell 5 using a barge-mounted crane and rocks were placed to connect the Beachsaver Reef with the adjacent groins, making a closed compartment.
