National Erosion Control Development and Demonstration Program (Section 227)

Pickleweed Trail, Martinez, CA

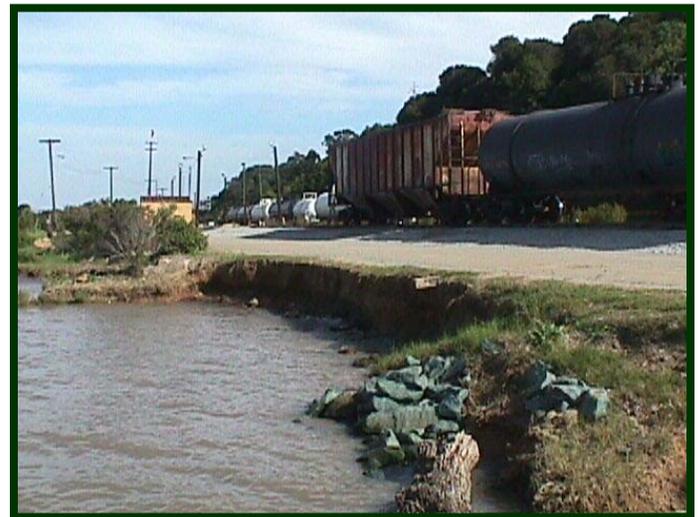
Eroding bank at high tide

Pickleweed Trail is experiencing erosion due to what appears to be some combination of tidal currents, vessel wake, and wind wave action. The trail is sandwiched between the strait and the main line of the Union Pacific Railroad. As the erosion process continues, the land available for potential relocation of the trail diminishes and is limited by its proximity to the railroad. Attempts to control erosion with riprap armoring have brought limited success in adjacent areas. According to trail users familiar with the area, erosion is claiming approximately 1.5 m (5 ft) of shoreline per year in the unprotected areas.
