## ***National Erosion Control Development and Demonstration Program (Section 227)***

# **Sacred Falls Park, Hauula, Hawaii**

### **Description**

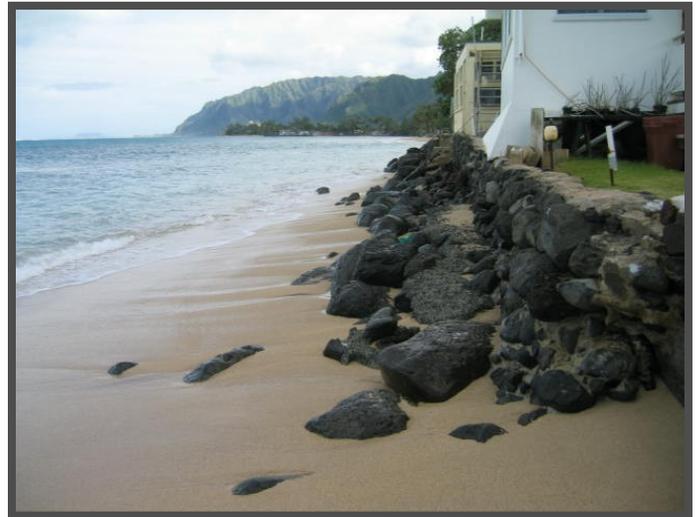
**Shoreline recession along beach**

Continual, yet manageable, erosion of the beach at Sacred Falls Beach Park has reduced beach width to a point that it is almost totally submerged during high tide. Some deterioration of the coast highway is evident. Recreational use of this tourist destination is minimal due to lack of beach width. Shoreline recession must be abated.
