# Coastal Engineering Technical Note

## ELBLOC™ REVETMENT UNIT - PRELIMINARY GUIDANCE

**PURPOSE.** To provide preliminary guidance for using the ELBLOC™ revetment unit on coastal revetments.

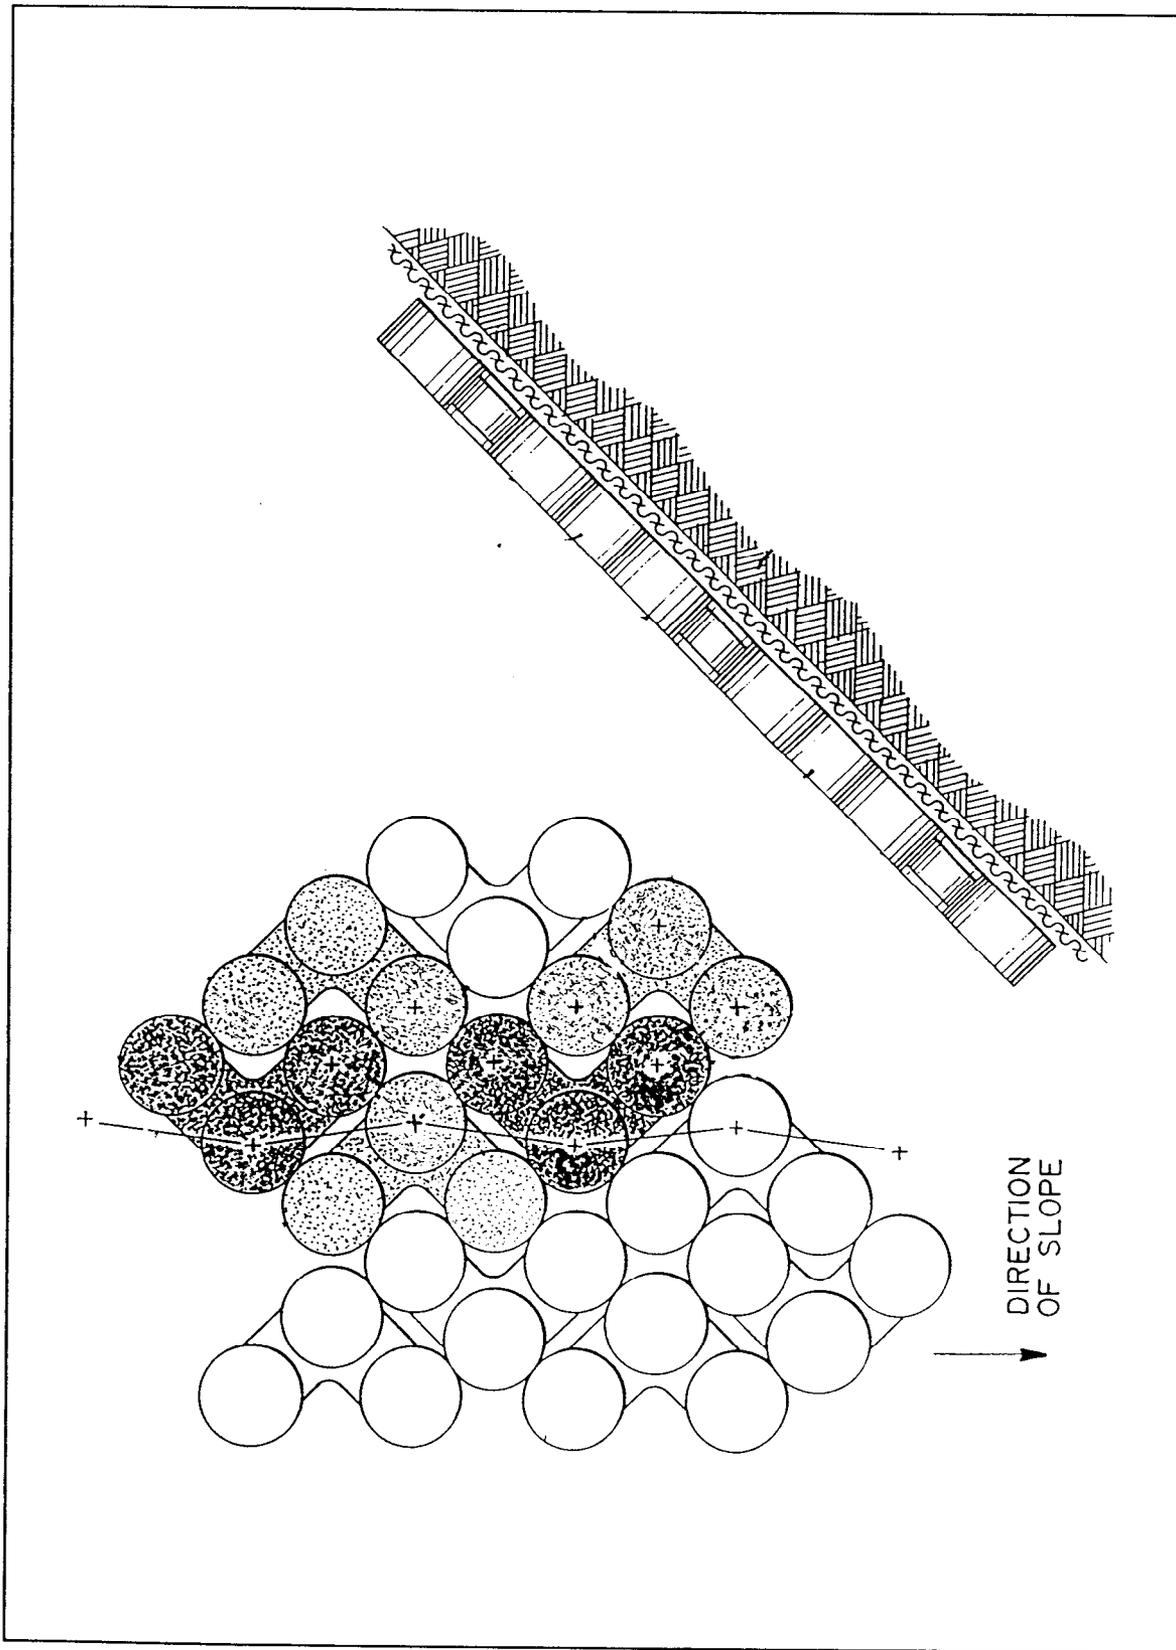
Figure 1. ELBLOC™ revetment units

**BACKGROUND.** A new, patented revetment unit, the ELBLOC™ (U. S. Patent No. 5,176,466, Revetment Unit and Method for Protecting Shoreline or Waterway), has been developed at the U.S. Army Engineer Waterways Experiment Station's (WES's) Coastal Engineering Research Center (CERC). The ELBLOC was developed to meet a need for a highly stable revetment unit with a simple, easily moldable design. The revetment unit will protect shoreline or waterway embankments from erosion caused by waves or currents. It is L-shaped, has a low center of gravity for stability, maximizes area covered per unit weight, and is designed to be placed in a fitted, interlocking matrix which has sufficient porosity to allow drainage and prevent excessive water pressure under the units (Figure 1).

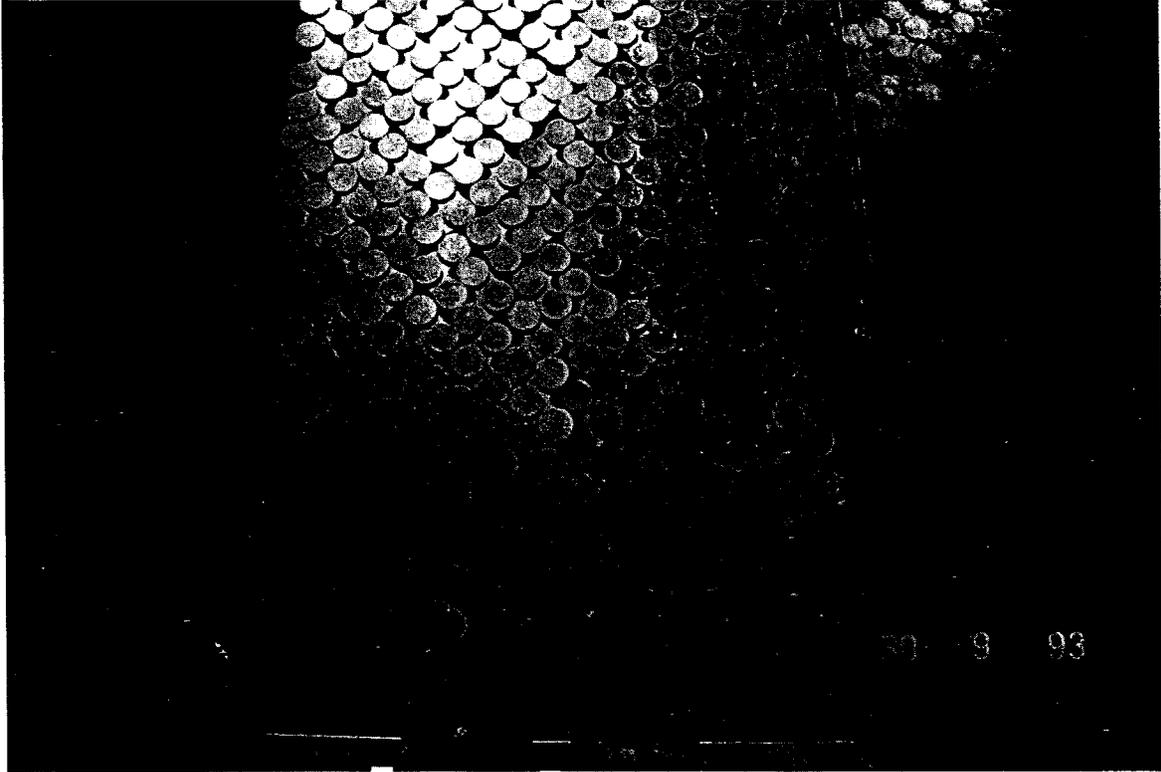
Figure 2. Test revetment

Model revetments formed from the units were tested in a WES laboratory wave flume using model units weighing approximately 0.3 lb with a specific gravity of 2.27. For the initial test, the model revetment was placed on a mound of crushed stone with a 1V:1.33H (37-deg) slope. The placement pattern is shown in Figure 2. Chain was placed along the edge of the revetment to simulate continuity of interlocking and prevent flume wall effects. Tests were conducted using short period waves, partly to simulate limited fetch conditions and partly because previous tests on other revetment units had indicated lower stability with shorter wave periods (McCartney and Ahrens 1975). Tests involved nonbreaking waves or surging breaker conditions and were run in 3-min bursts (Camfield, Hennington, and Reed 1993).
