# **Application of Regional Sediment Approach to Hickahala Creek Watershed, Northern Mississippi**

*by David S. Biedenharn, Chester C. Watson,  
John B. Smith, and Lisa C. Hubbard*

**PURPOSE.** Biedenharn (2004) described the systematic approach to Regional Sediment Management (RSM) that has been developed as part of the Demonstration Erosion Control (DEC) project. The purpose of this Coastal and Hydraulics Engineering Technical Note (CHETN) is to describe how this RSM approach was successfully applied to the Hickahala Creek watershed in northern Mississippi.

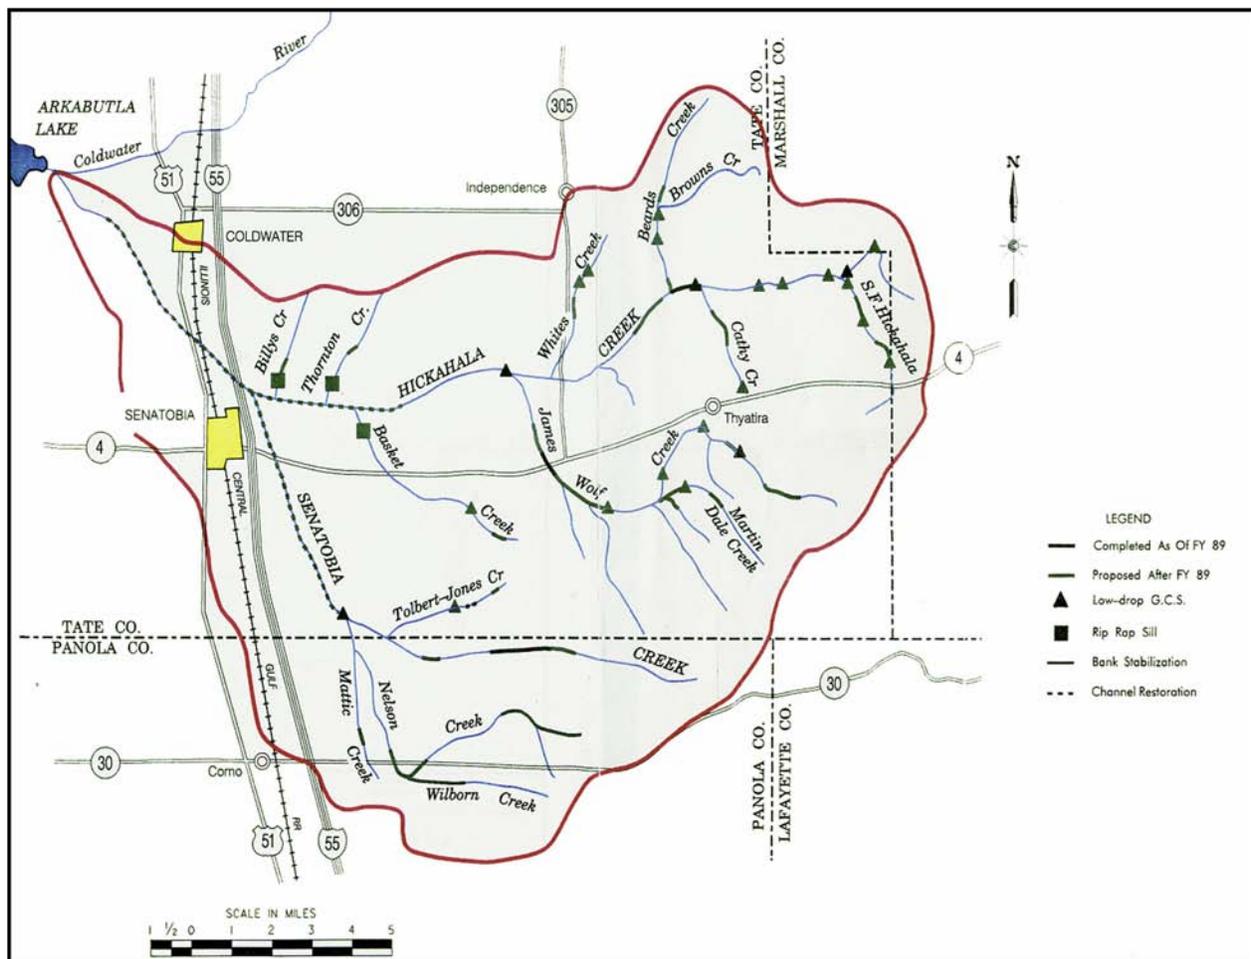
Figure 2. Hickahala Creek Watershed, Northern Mississippi.

Hickahala Creek and several major tributaries such as Senatobia Creek were cleared and straightened for the first time in the 1930s under the direction of local drainage districts. A flood-control reservoir, Arkabutla Lake, was constructed by the Corps of Engineers on the Coldwater River in the early 1940s. The maximum flood-control pool for the reservoir inundates Hickahala Creek upstream from the confluence with Coldwater River for approximately 10 km, to a point above the confluence with Senatobia Creek (Figure 2).

**Plan Selection.** The data in Table 2 summarize the selected plan for the Hickahala Creek watershed. Figure 2 shows the limits of the channel improvement work, and the location of proposed grade control structures and the general areas requiring bank stabilization.

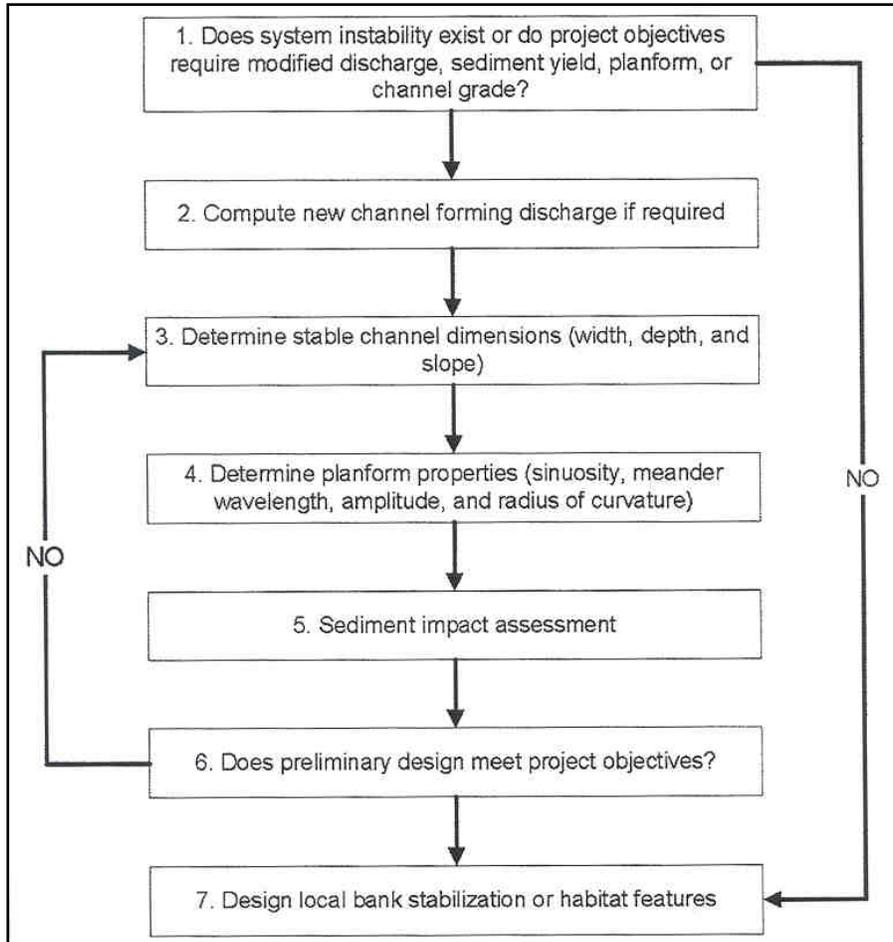
Figure 3. Plan evaluation, and preliminary design sequence.

**Plan Evaluation and Preliminary Design.** Figure 3 shows the steps in the plan evaluation and preliminary design sequence. Biedenharn (2004) discusses the plan evaluation and preliminary design sequence in detail.

The first step in the design sequence shown in Figure 3 asks a critical question: “Does system instability exist or do project objectives require modified discharge, sediment yield, planform, or channel grade?” Based on the geomorphic assessment, it was found that system instability did indeed exist in the form of severe channel degradation in the upper portions of the watershed, with channel aggradation along the lower reaches of Hickahala and Senatobia Creeks. It was also apparent that project goals of a sustainable flood control channel along lower Hickahala and Senatobia Creeks might require changes in the sediment yield, discharge, and channel grade. Therefore, it was necessary to proceed to Step 2 in the design sequence.

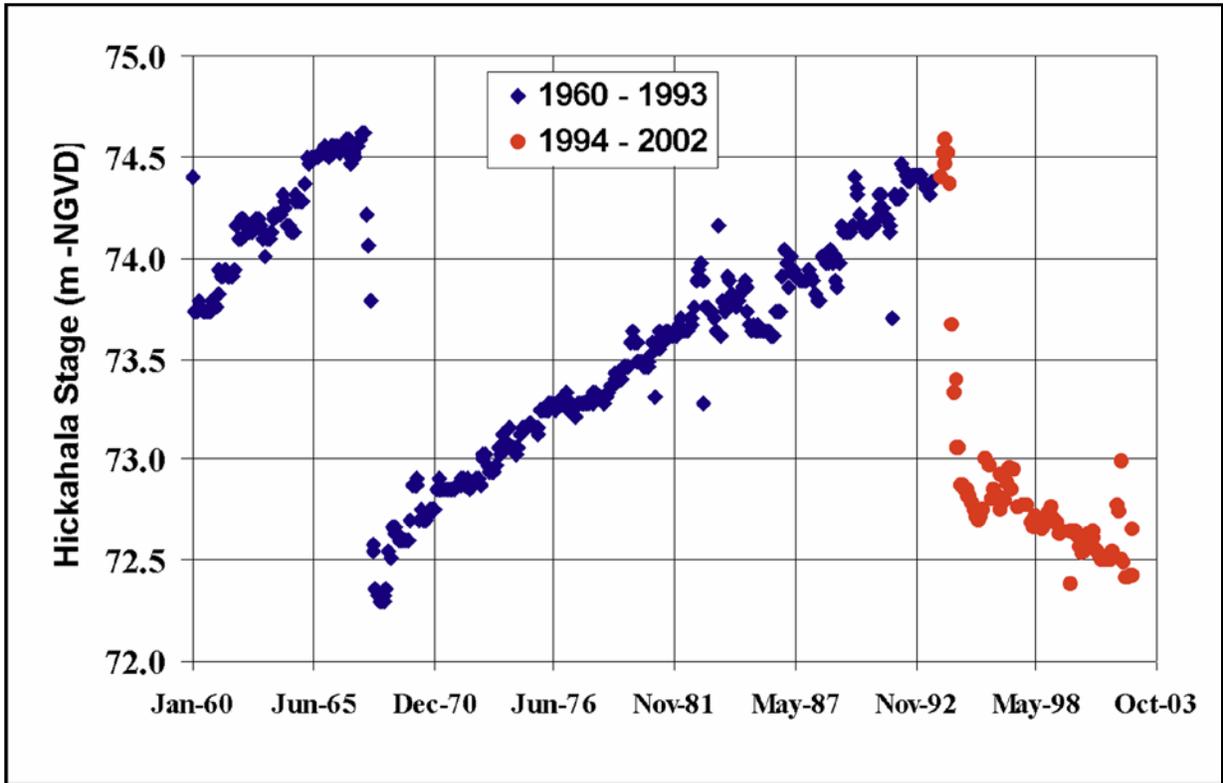
Figure 4. Minimum monthly elevation of gage readings on Hickahala Creek.

As shown in Figure 4, the 1967 channel work lowered stages on Hickahala Creek about 2.3 m, from about 74.6 m to about 72.3 m. However, stages immediately began to increase and by the early 1990s, stages were once again approaching 74.5 m. The response to the 1994 channel improvement work is much different from the earlier response. The 1994 channel improvement project initially lowered stages from about 74.5 m in March 1994 to about 72.8 m in January 1995 (Figure 4). Post-project aggradation occurred immediately following the 1967 work. However, no aggradational response to the recent work has been observed through September 2002. Field observations also confirm the absence of any significant aggradation.

CHANNEL RESPONSE TO IMPLEMENTED PLAN. The channel improvement work on Hickahala and Senatobia Creeks was completed in 1994. Figures 4 and 5 show the effects of the project, including the minimum stage from 1960 to present at the Hickahala and Senatobia Creek gages, respectively. These gages are located near the upper limits of the channel improvement project (Figure 2). Figures 4 and 5 also show the response to the earlier channel improvement work in about 1967, as well as the response to the present project.

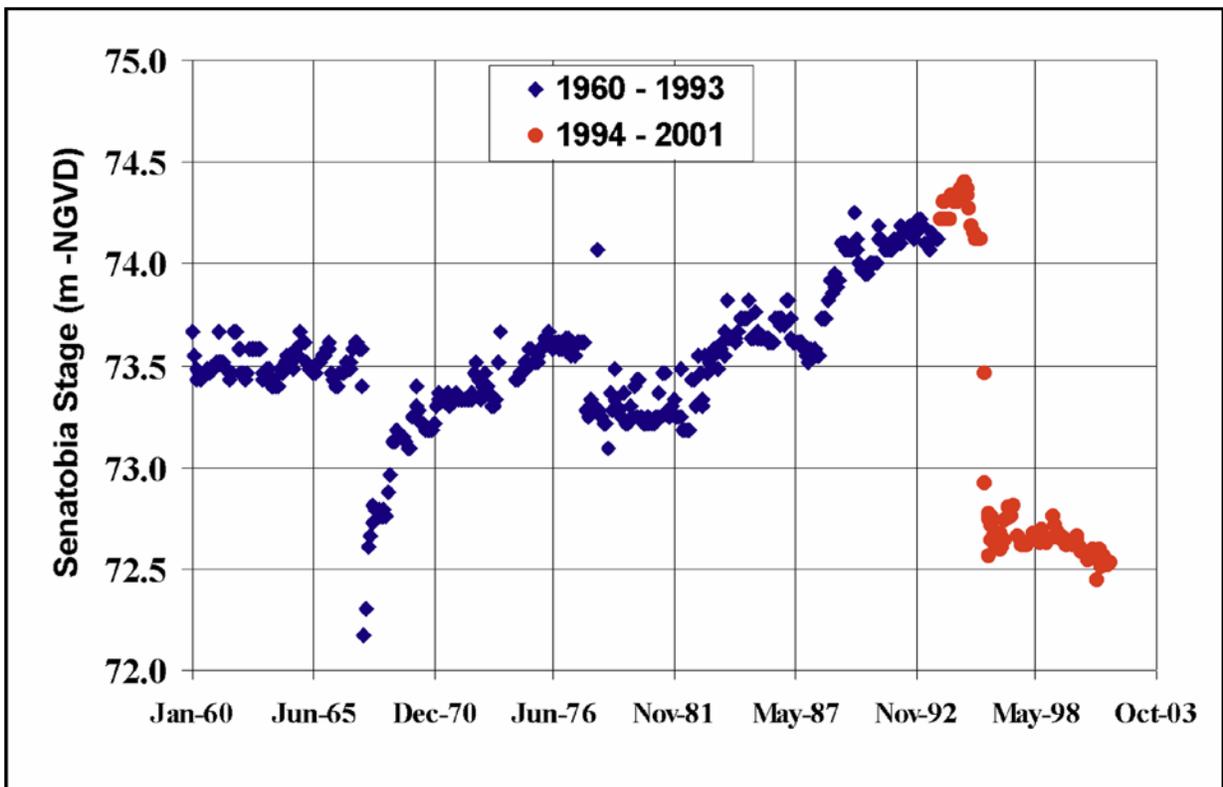
Figure 5. Minimum monthly elevation of Senatobia Creek Gage Readings.

Figure 5 is similar to Figure 4, and indicates the minimum elevation of Senatobia Creek through time. On Senatobia Creek, the rebound from the 1967 channelization was immediate and most of the flood level reduction was lost within 3 years. The data from the present channel work indicate that falling stages began in February 1995 at a stage of about 74.4 m, and continued to fall to a low of about 72.5 m in September 2001. No aggradation is shown at this time and the channel continues to increase in flood capacity.

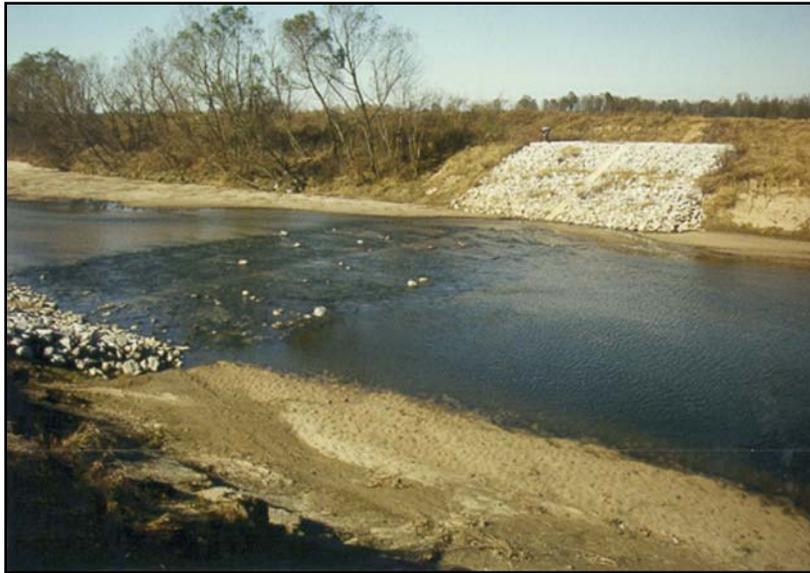
Figure 6. Initial riprap sills.

An important component of the channel improvement project was the construction of the erosion control features in the upper watershed. Perhaps some of the most important structures, at least in the short term, were the two riprap sills constructed just upstream of the upper limits of the project on Hickahala and Senatobia Creeks. These sills were initially constructed at the existing bed elevation with no drop across them (Figure 6). However, a 2003 field inspection of these structures revealed about 1 m of drop across each structure (Figure 7). Had these structures not been built, approximately 1 m of additional bed lowering would have advanced upstream for many kilometers resulting in accelerated sediment supply to the downstream project area. This increased sediment load would have severely impacted the longevity of the project. Additionally, riprap sills were also constructed near the mouths of all tributaries entering the project area.
